## Sikanni Bridge Fire - Triaging an Emergency Response

Paper prepared for the session ST - Transportation Structures  
2024 Transportation Association of Canada (TAC) Conference & Exhibition  
Vancouver, British Columbia

In August 2022, a transport tanker carrying a highly flammable liquid crashed into the south approach barriers at the Sikanni Chief River Bridge resulting in a full closure of the Alaska Highway (Highway 97) in northern BC. The fire generated intense heat that resulted in extensive structural damage and brought forward severe concerns for weakening of the bridge load carrying members. As a critical link to Northern Canada and then to Alaska, USA, there was extreme pressure to get this highway safely re-opened as quickly as possible. An emergency response was initiated immediately with a rapid damage assessment that enabled light vehicle traffic to be restored shortly after the incident. The emergency response and structural assessment continued until full unrestricted truck traffic was restored on the bridge. While the primary focus was forensic review and structural evaluation of the residual load carrying capacity, several concurrent bridge engineering teams w

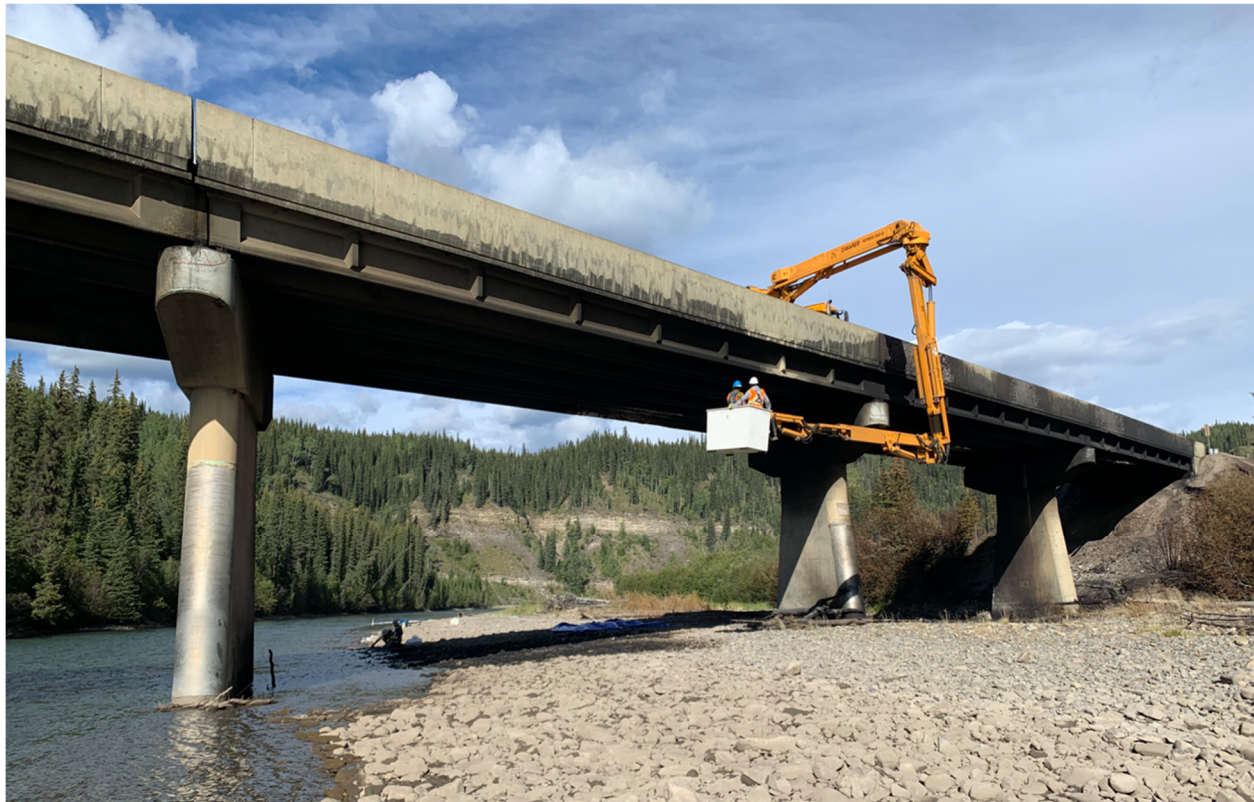
Figure 2. Spans 1, 2, and 3 of the Sikanni Chief River Bridge

When the bridge engineer arrived at the bridge site, the flames were extinguished but the scene was still hot. A rapid damage assessment through visual inspection was completed followed by interviewing the person that fought the fire. Visual inspection was completed from the bridge deck and from the ground level below the bridge. Significant spalled areas of concrete were observed on the underside of the girders on Span 1 and Span 2 along with localized areas of spalled concrete on the underside of girders within Span 3. Within Span 1 and Span 2, the damage was most severe on the exterior girders near the drain outlets.

The bridge deck showed signs of fire damage on the parapets with exposed aggregate and localized spalling on the traffic face of the concrete barriers on the south end of the bridge. When interviewing the individual that fought the fire, the responding bridge engineer learned that a tandem axle water truck was used for fire suppression and was driven down the centre portion of the bridge. The water truck was filled five times (at the north approach to the bridge) and travelled the full length of the bridge to fight the fire at the south approach. This resulted in 10 passes of the truck over the entire length of the bridge, 5 passes with the truck full of water, and 5 passes with the truck empty. The water truck vehicle registration was reviewed, and the net vehicle weight was listed as 19,700 kg with an operating gross vehicle weight (GVW) of 29,550 kg.

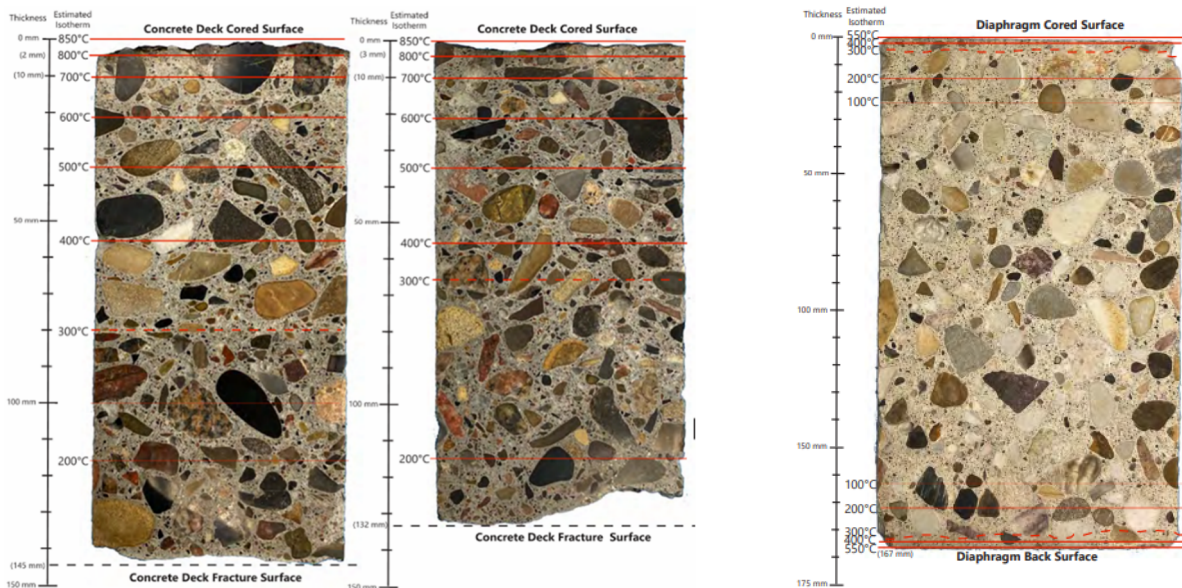
Figure 3. Heat profile for deck cores DS2 (left), DS5 (centre) and G1S1D3 (right)

Two cores (GN4C, DN1) were used as control specimens to represent the service condition of the girders and deck respectively. Figure shows an example of the heat profiles, detailed for two of the concrete deck cores and one of the diaphragm cores.

- Gradational pink colouration due to oxidation of FeOH (iron hydroxide) within the cementitious paste and some arenite and other siliceous aggregate particles was observed to depths that were up to 15 mm from the cored surfaces (along pre-existing cracks). This reddish discolouration and the decrease in the intensity of interconnected sub-parallel and perpendicular micro-cracks (boundary and intrapaste) within the cementitious matrix and within quartz grains indicated the extent of 300°C temperatures approximately 10 mm to 15 mm from the cored surface and 5 mm to 10 mm from the back surfaces.

- Discolouration of the cementitious paste within deck cores were observed as a charred, dark grey colour up to 5 mm overlying a light buff colour up to 20 mm.

- Underlying the light buff cementitious paste was a light grey colouration to a depth of 80 mm associated with random dark red/pink coloured patchy areas within some siliceous aggregate, indicating the 300°C isotherm.

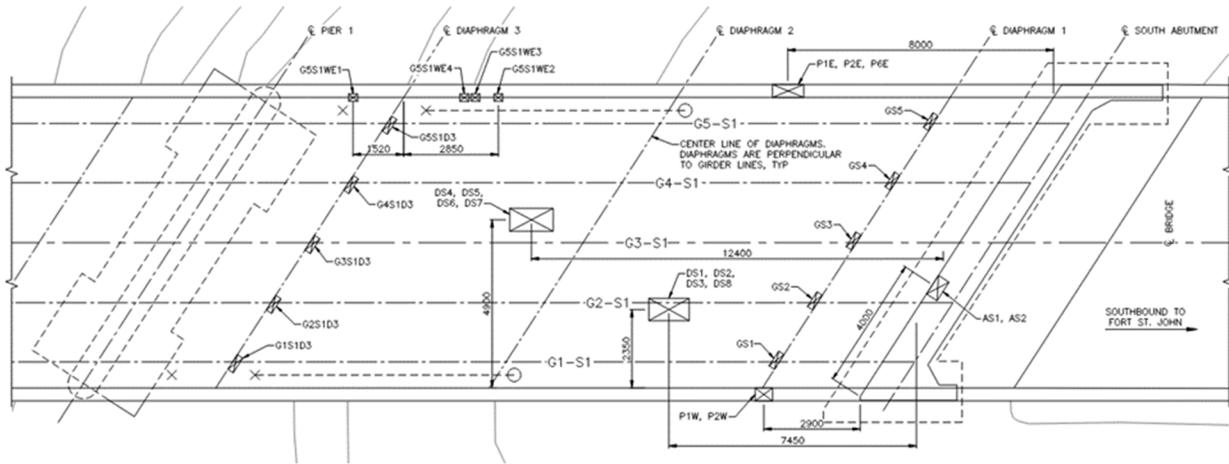
Figure 7. Span 1 core locations

61 concrete cores of approximately 69 mm (3") and 100 mm (4") in diameter were collected from the main structural elements and visually examined. Of these, a sample size of 17 and 9 cores were selected for compressive strength and petrographic examination, respectively. Remaining cores were preserved for future testing, if required. Cores were collected at representative areas of both damaged and undamaged locations of the bridge to allow for comparison. As such, all cores were either extracted from high heat zones (i.e. Span 1) or no heat zones (i.e. Span 5).

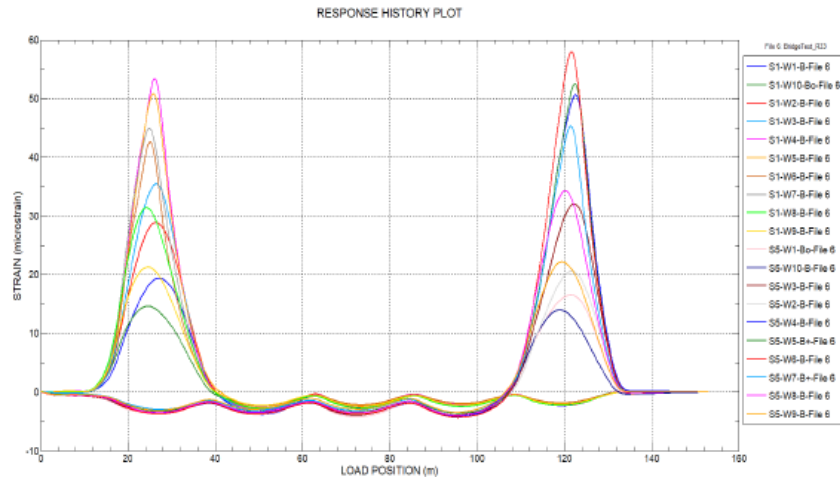
Figure 3. Example of response symmetry between spans

- The comparative analysis revealed that the damaged span was performing linear elastically and in a similar manner to the undamaged span. In general, the global response magnitudes measured in Span 1 matched reasonably well with the undamaged Span 5 response. On a localized level, strain magnitudes varied on a few of the girder webs. The more damaged locations were showing incrementally smaller strain than their undamaged equivalent. While the differences were small in magnitude, this phenomenon isn't atypical for a bridge that has sustained some degree of damage (i.e. reduced section/stiffness, microcracking, etc.) as load tends to be shed both transversely and longitudinally away from the damage.

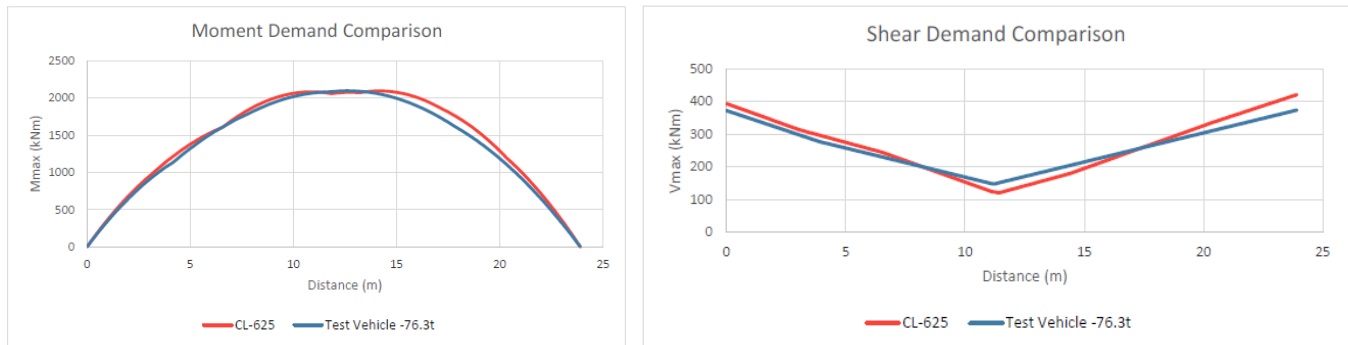
Figure 5. Load effect comparison

- The structure responded linearly elastically under all tested conditions;
- The dynamic load amplification depended on the direction the truck was travelling and varied between the spans, ranging from 1.03 to 1.09;
- The results were within the elastic range of the prestressed concrete and much less than the pre-determined stop criteria;
- The analytical model conservatively predicted the structural response (i.e. all in-situ responses were less than predicted by finite element model); and
- Span 1 and 2 (damaged) performed in a comparable manner to Span 5 (undamaged).

The above findings demonstrated that the fire did not cause an appreciable loss of structural capacity up to the CL-625 design load and that strengthening of the girders was not required.
