The Old Skeena River Bridge Rehabilitation and Recoating of a 100-Year-Old Steel Truss

Paper prepared for the session Transportation Structures
2024 Transportation Association of Canada (TAC) Conference and Exhibition
Vancouver, British Columbia

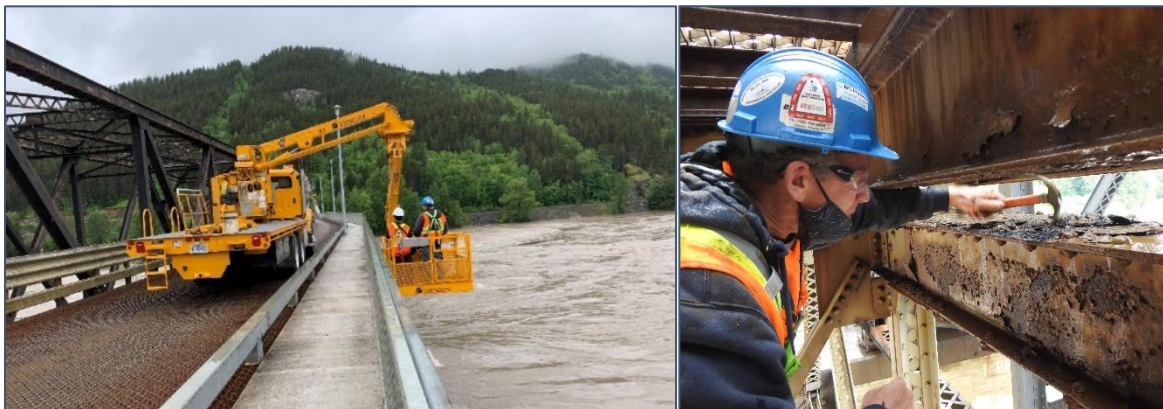
Figure 8: Snooper Truck Inspection (left) and Top Chord Inspection (right)

- Upper Chords were in worse condition than Lower Chords and the West side of the truss was in worse condition than the East side (the West side is adjacent to the CN Rail bridge).
- The existing coatings system had failed, and severe rust was found at multiple locations but section loss was mainly on secondary members. A small hole in a primary diagonal truss member was noted during the inspection (Figure 9, right).
- The quantity of components requiring repair approximately doubled following snooper truck inspection compared to the previous quantity identified from the 2016 rope and ladder access inspection (see Figure 8 and Figure 9).

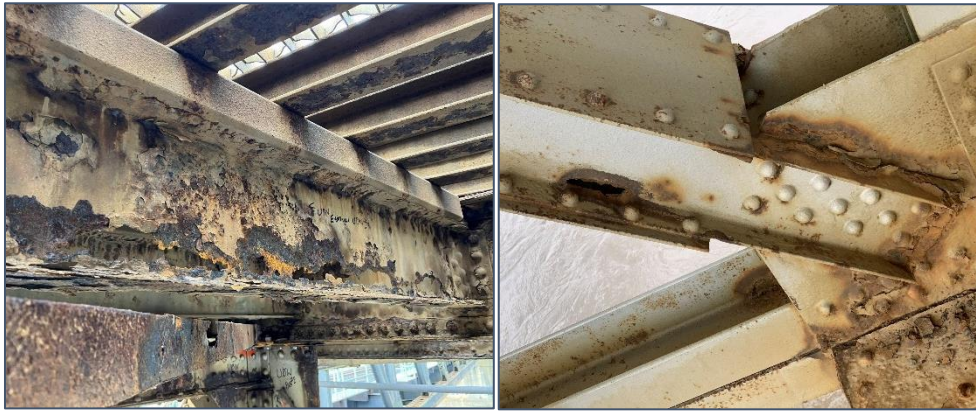
Figure 9: Examples of Severe Corrosion in Deck Stringer (left) and Truss Diagonal (right)

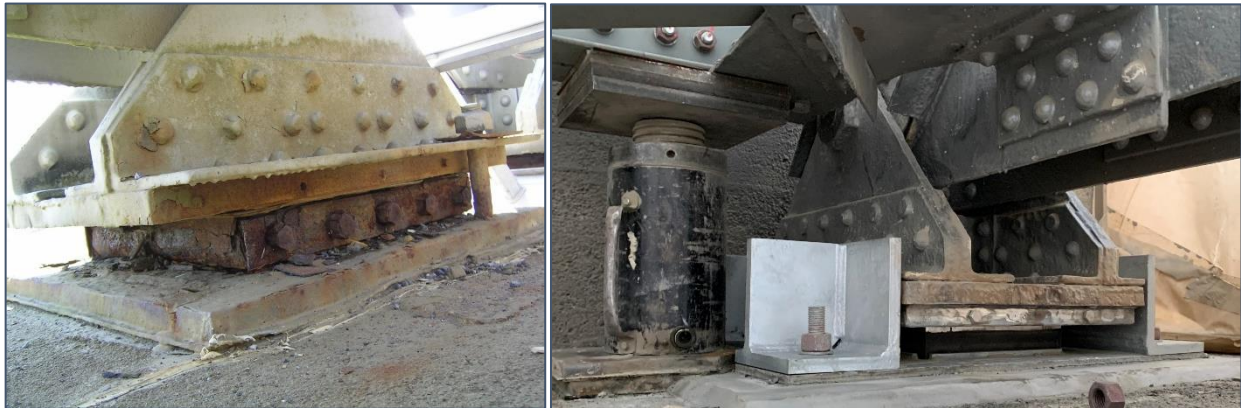
The original truss structure utilized 12 steel roller bearings at the expansion locations. All the rollers had corroded such that the bearings were unable to expand, although the existing fixed bearings were in fair condition. Details were developed to replace the roller bearings with sliding elastomeric bearings with lateral restrainers (see Figure 10).

Figure 10: Existing (Seized) Roller Bearings (left) and New Sliding Elastomeric Bearings with Lateral Restraint (right)

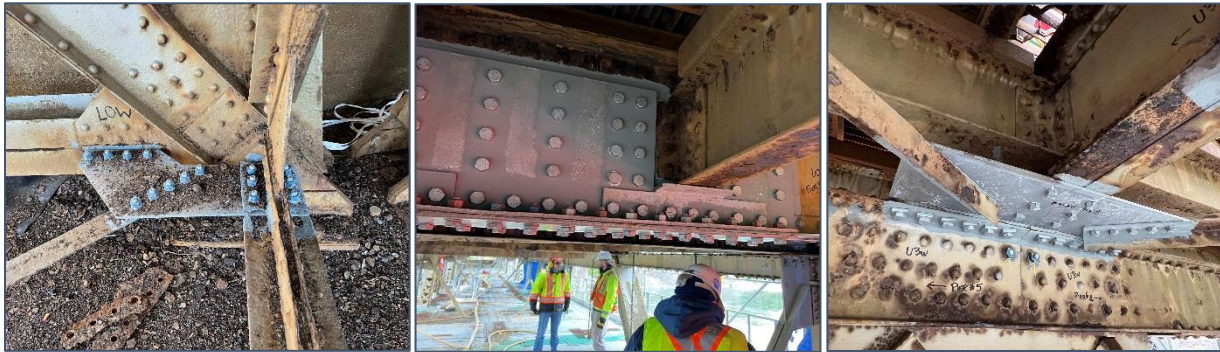
Figure 11: Typical Repairs at Lower Gusset (left), Floor Beam (centre) and Upper Gusset (right)

Details were developed to repair members identified during the initial condition inspection. The design repairs utilized galvanized components which could be prepared ahead of time (see Figure 11). During construction, several additional locations requiring repairs were identified once scaffolding access was provided and sandblasting had cleared off some of the excess surface corrosion. Initially, additional repair locations were repaired using galvanized sheets and angles cut on site, but eventually, plain steel sheets (prime coat applied on site) were used to avoid impacting the schedule and because everything would be covered during the full recoat of the bridge.

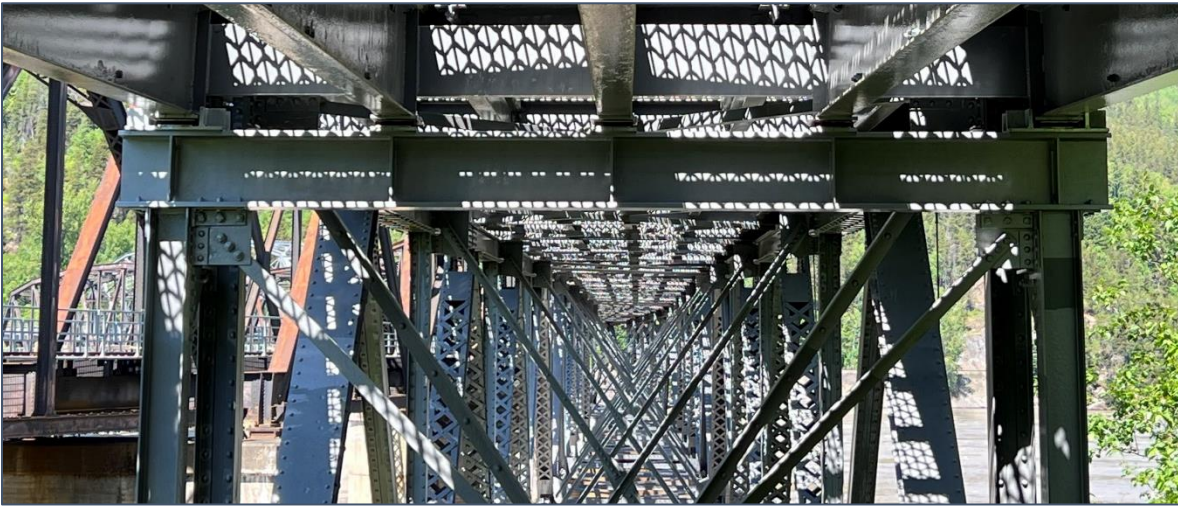
The cap beam for the 50' (15.2 m) South approach span at Pier 7 was visibly warped and was one of the limiting members in the load capacity of the bridge. In fact, the 2021 snooper inspection had to access the bridge from the north side only and reverse off the bridge to avoid driving over Pier 7. A new cap beam was designed, including a temporary support beam with brackets for jacking, and the approach span stringers were seated on new elastomeric bearings (see Figure 13).

Figure 13: New South Approach Cap Beam and Elastomeric Bearings at Pier 7

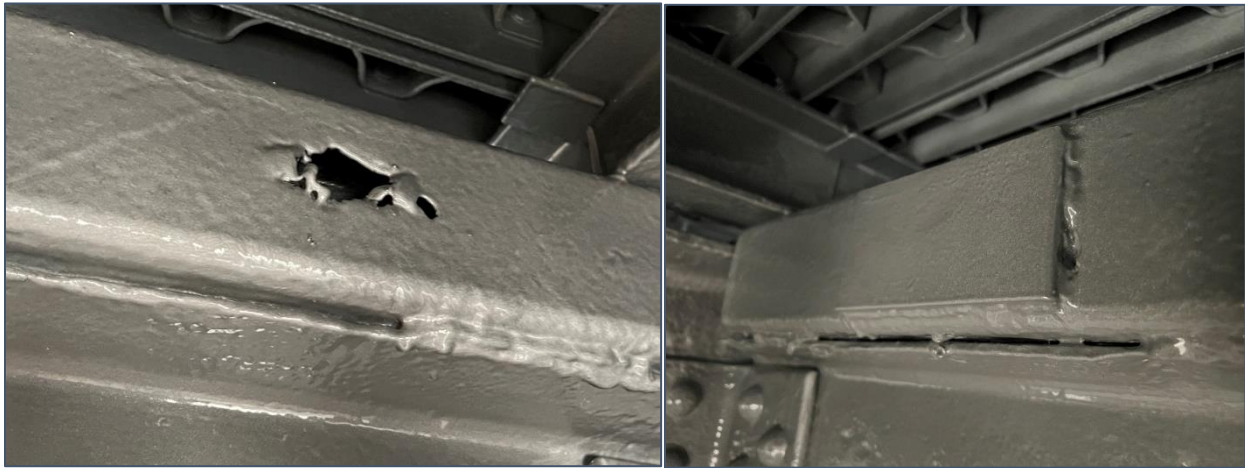
- HSS members which were part of the steel decking system from 2001 which had been corroding from the inside, resulting in several perforations following blast cleaning (see Figure 20). These were repaired with a cover plate, and fortunately, they were mainly only present on the south approach span.

Figure 20: HSS Perforations Exposed by Blast Cleaning (left) and Cover Plate Repair (right)

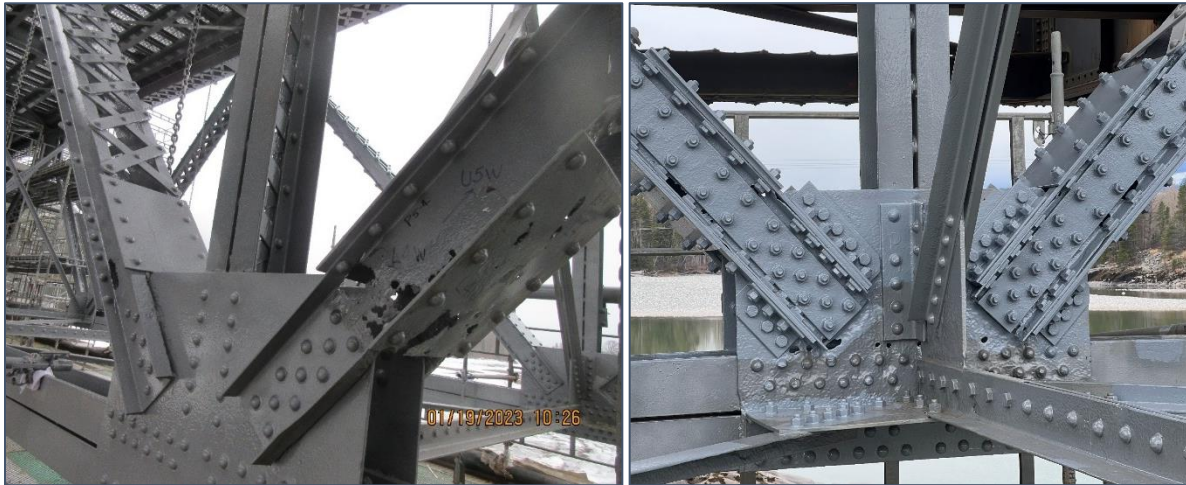
- Truss diagonal chords and tension (bottom) chords revealed large openings at several locations (see Figure 21 and Figure 22) which were not fully revealed until after blast cleaning and coating operations. Compare Figure 21 with the much smaller 'pre-blast clean' holes shown in Figure 9. Once revealed, a rapid analysis was performed to determine if construction could continue, followed by further analysis to determine a repair methodology which considered maintaining integrity of the structural load path.

Figure 21: Large Holes in Primary Diagonal Members (left) and Completed Repairs (right)

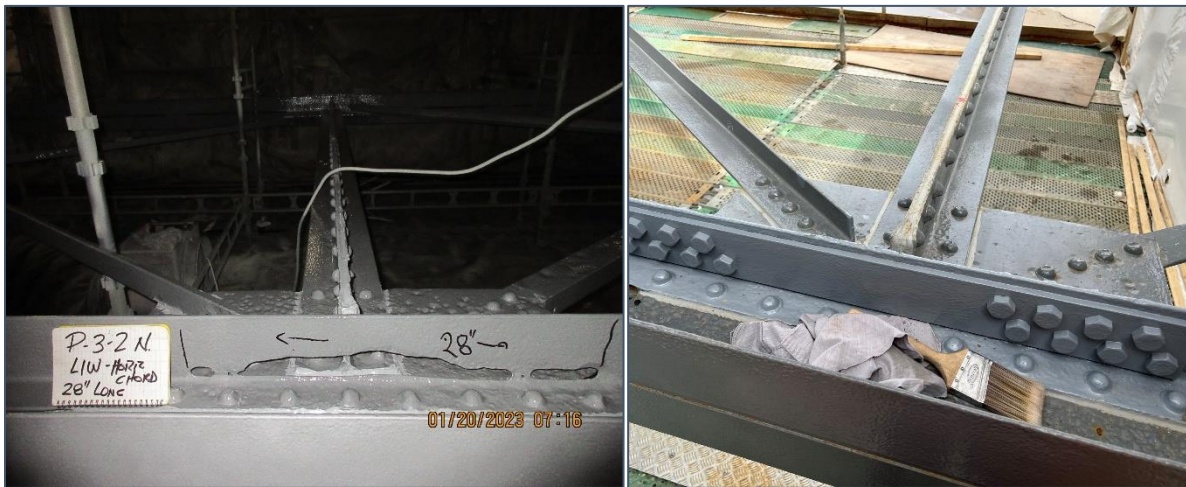
Figure 22: Large Holes in Primary Tension Member (left) and Completed Typical Repair (right)

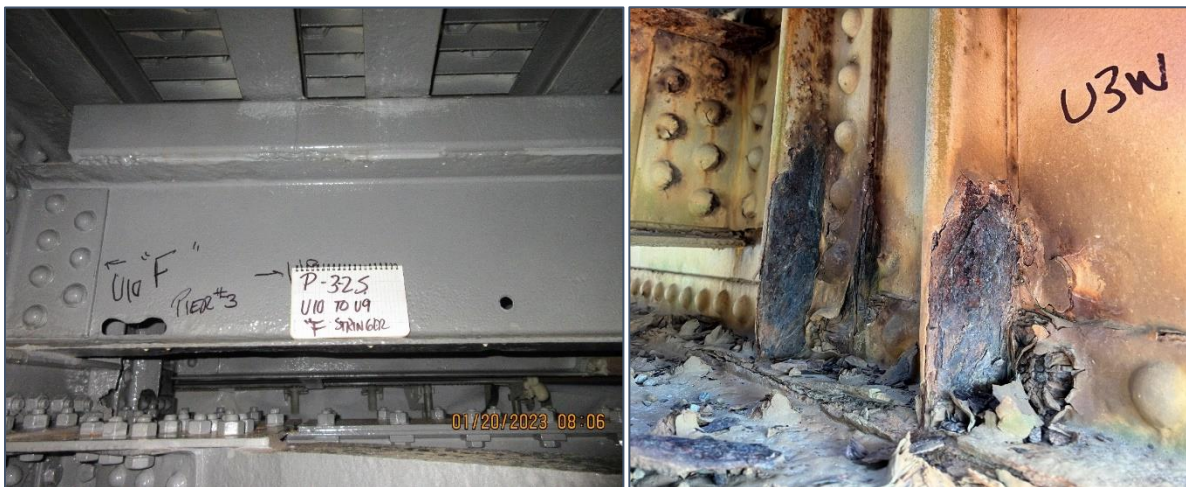
- Additional damage and perforations to several floor beams and stringers was revealed following blast cleaning (see Figure 20). The damage on some stringers was so significant that it was more cost-effective to replace the entire stringer than to implement the stringer repair design.

- The bearing stiffeners at the ends of several floor beams had deteriorated such that there was no contact between the stiffeners and the bottom flange (see Figure 23). Due to space constraints for making the repairs, a load capacity analysis was performed which demonstrated that a single replacement stiffener could provide adequate bearing capacity for the floor beams compared to replacing all four existing bearing stiffeners.

Figure 23: Post-Blast Clean Damage to Stringer (left) and Pre-Blast Clean Floor Beam Bearing Stiffeners (right)

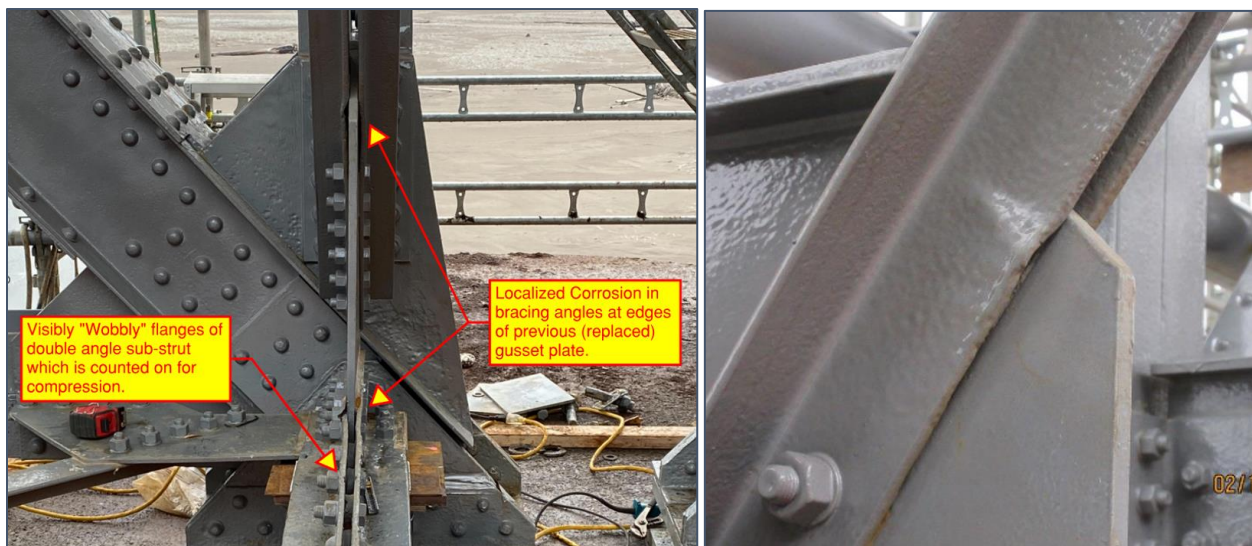
The existing trusses were not designed for jacking for bearing replacement. The bearing replacement design included jacking modifications consisting of new gusset plates and / or additional stiffeners. Design assumptions considered that the secondary bracing members of the truss would provide some lateral support when the bridge was jacked. During jacking operations for the deck truss spans, localized corrosion of the secondary bracing members resulted in visible deformations during jacking (see Figure 25). Jacking was halted, and supplemental bracing was designed and installed to prevent further deformations from occurring.

Figure 25: Deterioration of Secondary Bracing Resulting in Observed Deformations During Jacking

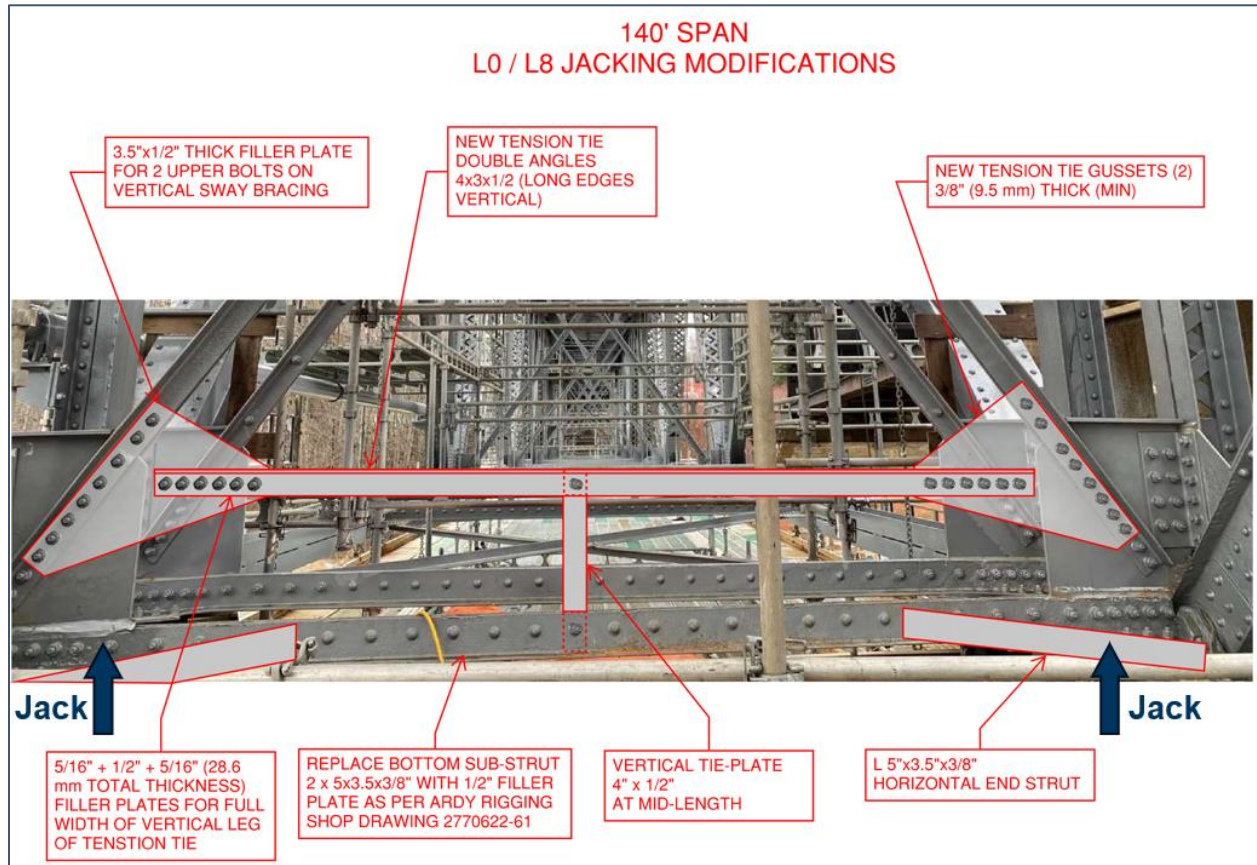
Figure 26: Additional Bracing Installed During Construction to Prevent Jacking Deformations
