Revitalizing Heritage Infrastructure: Preserving the Touchette Bridge's 70-Year Legacy

Paper prepared for the session Transportation Structures
2024 Transportation Association of Canada (TAC) Conference & Exhibition
Vancouver, British Columbia

Egis (formerly McIntosh Perry) was tasked with extending the service life of the 74-year-old Touchette Bridge over the South Nation River near Casselman, Ontario. The bridge was a 73 m long single-span Parker through truss bridge with a timber deck on steel stringers supported by steel floor beams.

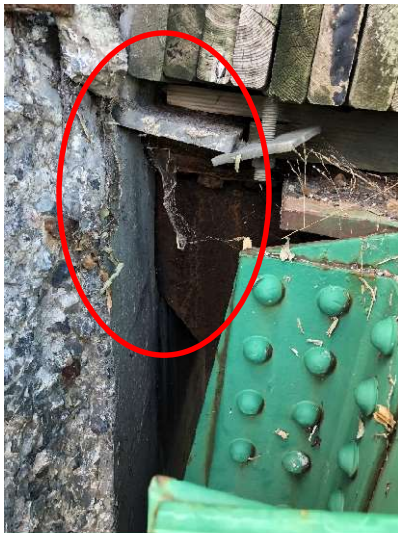
Figure 4 shows the south end of the truss bearing against the ballast wall and Figure 5 provides evidence that the uni-directional pot bearings had exceeded their movement capacity as the PTFE had become dislodged due to excess movement.

Figure 4. Truss Against South Abutment

Based on the position of the south abutment and deck end, it appeared that the south abutment had rotated inward toward the water.

The main concern at this point is the stability of the south abutment as it appeared the structure (truss) is bracing the south abutment. To rehabilitate the structure, the south abutment would need to be stabilized prior to any work being completed on the structure.

Based on these preliminary results, it was expected that the insufficient lateral capacity in the wall and piles is likely a primary factor for the south abutment movement. The team recommended to the Municipality that a dead man anchor system be installed to provide additional support.

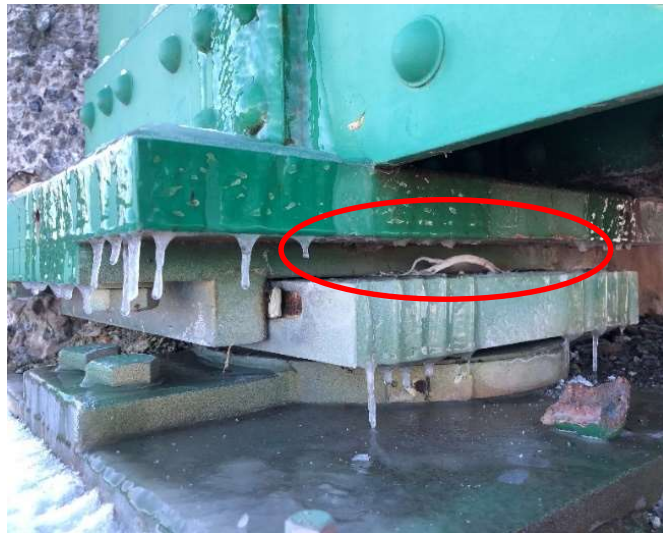
Figure 5. Dislodged PTFE at South Bearings

Ideally, the longitudinal position between the upper and lower bearing assembly would have changed as the superstructure contracted in colder temperatures. However, as illustrated in Figure 7 and Figure 8, the position of the bearings remained unchanged despite the temperature drop, indicating a malfunction in their intended functionality. Notably, no abnormal issues were observed with the north abutment's fixed pot bearing.

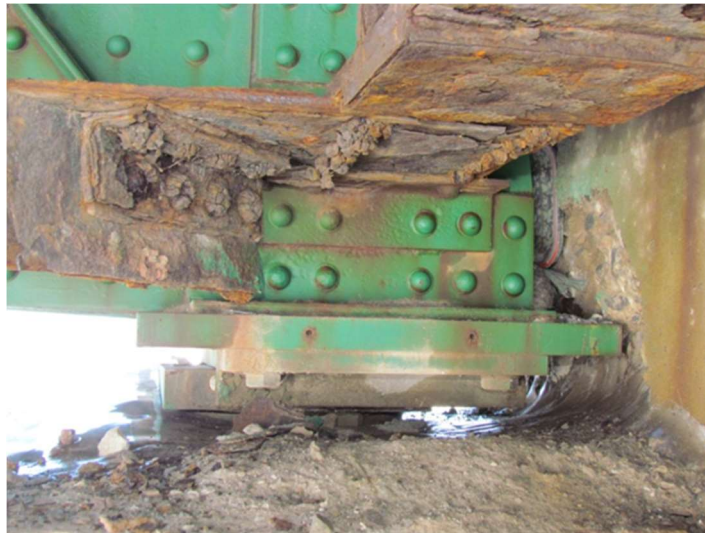
While previous inspection reports did not raise concerns regarding the bearings, photographic evidence indicated that both the bearings and the deck end have remained in the same position for over a decade. To verify this, the team conducted close-up inspections of the south abutment bearings at two different temperatures: 20 degrees Celsius (in September 2021) and 0 degrees Celsius (in December 2021).

Figure 6. Superstructure Against South Abutment Ballast Wall from 2012 Winter Inspection

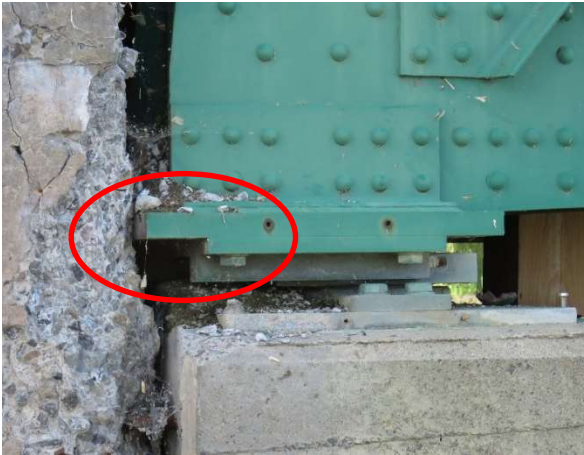
Figure 7. South Abutment Bearings in September

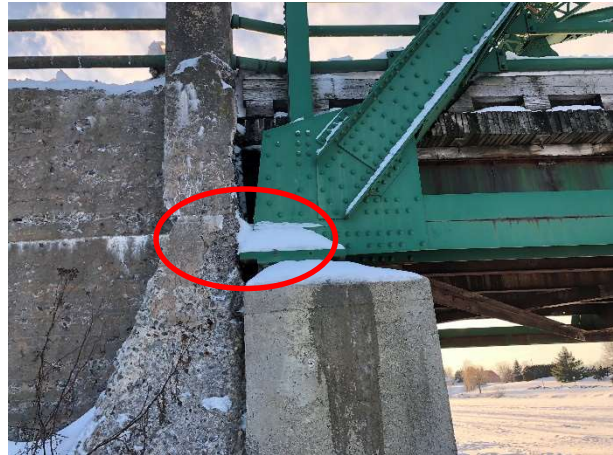
Figure 8. South Abutment Bearings in December

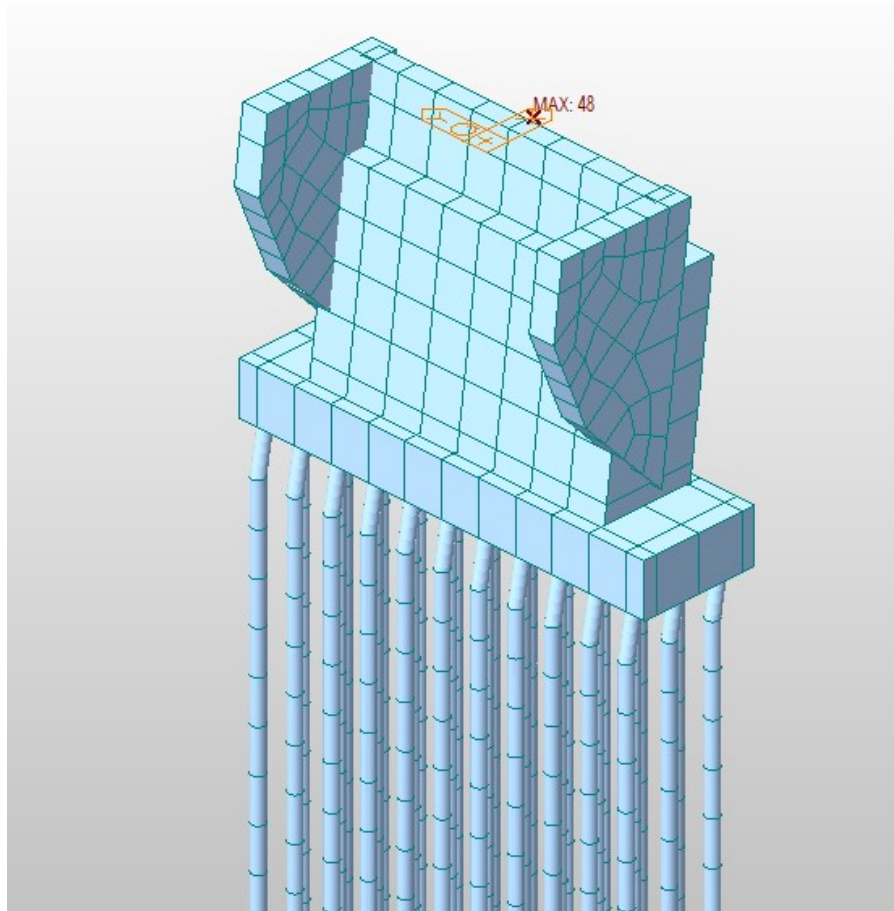
The model showed that under active pressure, the top of the abutment rotated in by 50 mm as shown in Figure 10. The lateral resistance provided by the superstructure was ignored as the upper and lower bearing are unrestrained from sliding in the opposite directions.
