The Pattullo Bridge Emergency Repair

David Woolford, P.Eng., TransLink
Darryl Matson, P.Eng., Buckland & Taylor Ltd.

Paper prepared for presentation

of the 2009 Annual Conference of the
Transportation Association of Canada
Vancouver, British Columbia

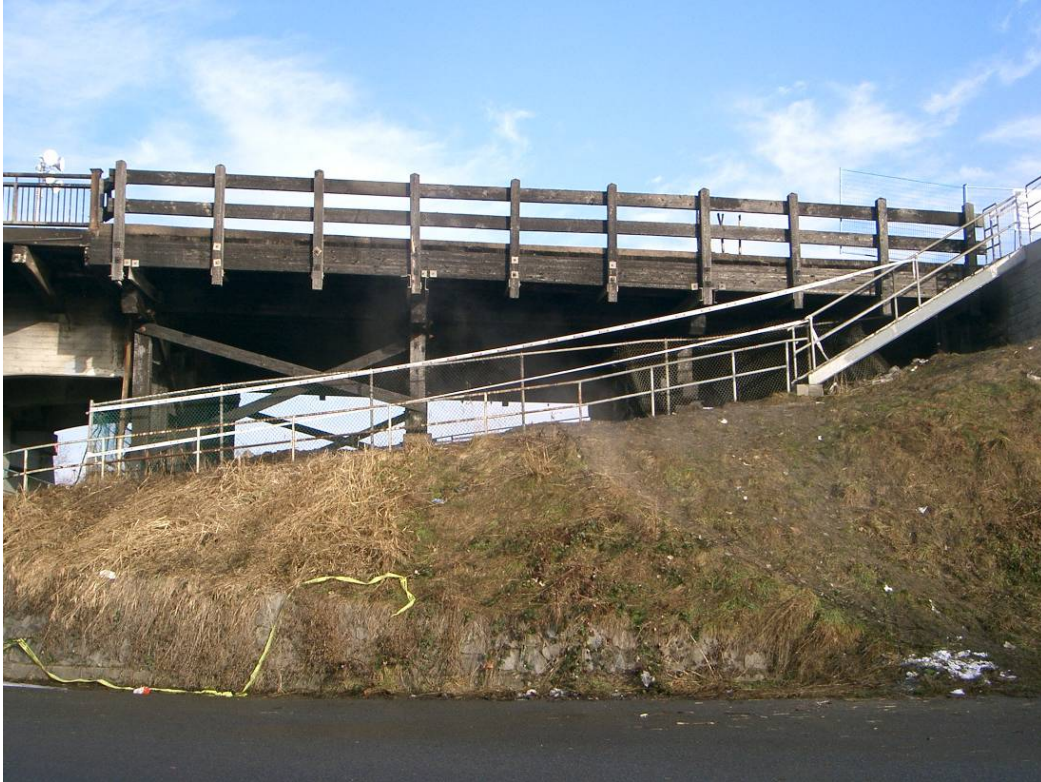
The Fire was extremely difficult to extinguish due to the congestion of timber and creosote treatment and reignited several times in joints and behind splice plates. TransLink managed to get a close proximity inspection at approximately 6am. At that time visibility was poor due both to smoke and thick fog. A further inspection was required at first light to conclusively evaluate the damage to the structure. Further to the second inspection, the structure was noted to be damaged beyond repair with significant section loss occurring in several members (Figures 2 & 3).

Figure 2. Fire Damaged Timber Spans

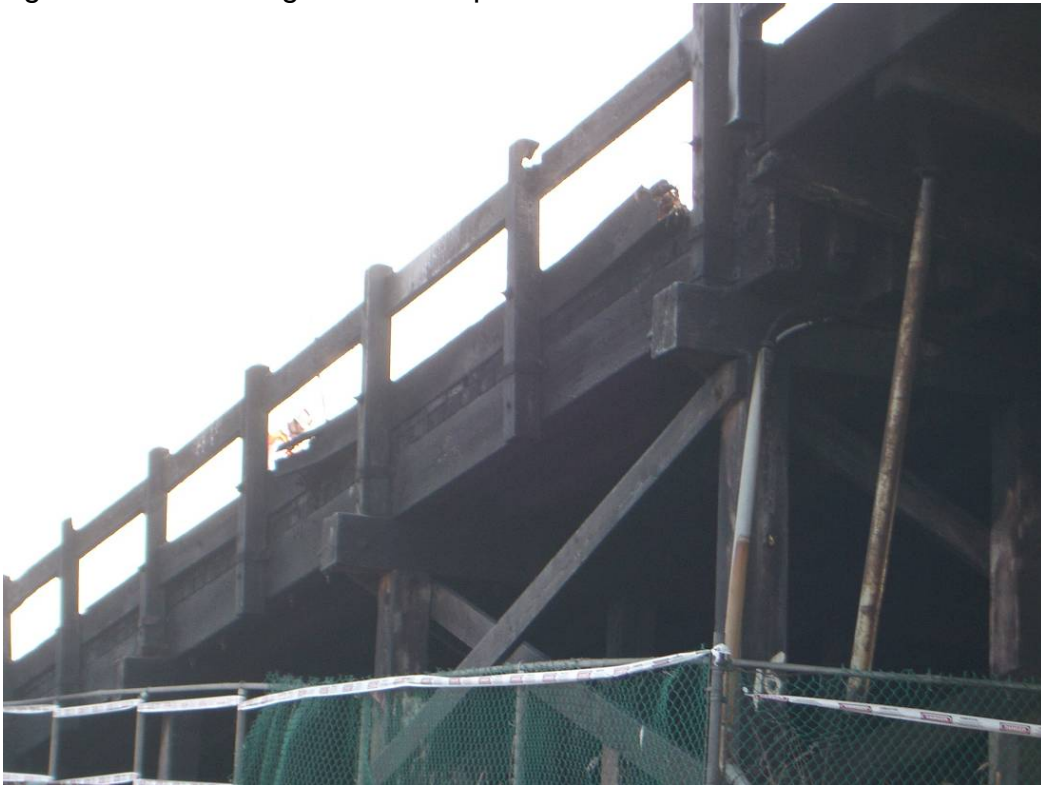
Figure 3. Close up of Fire Damage

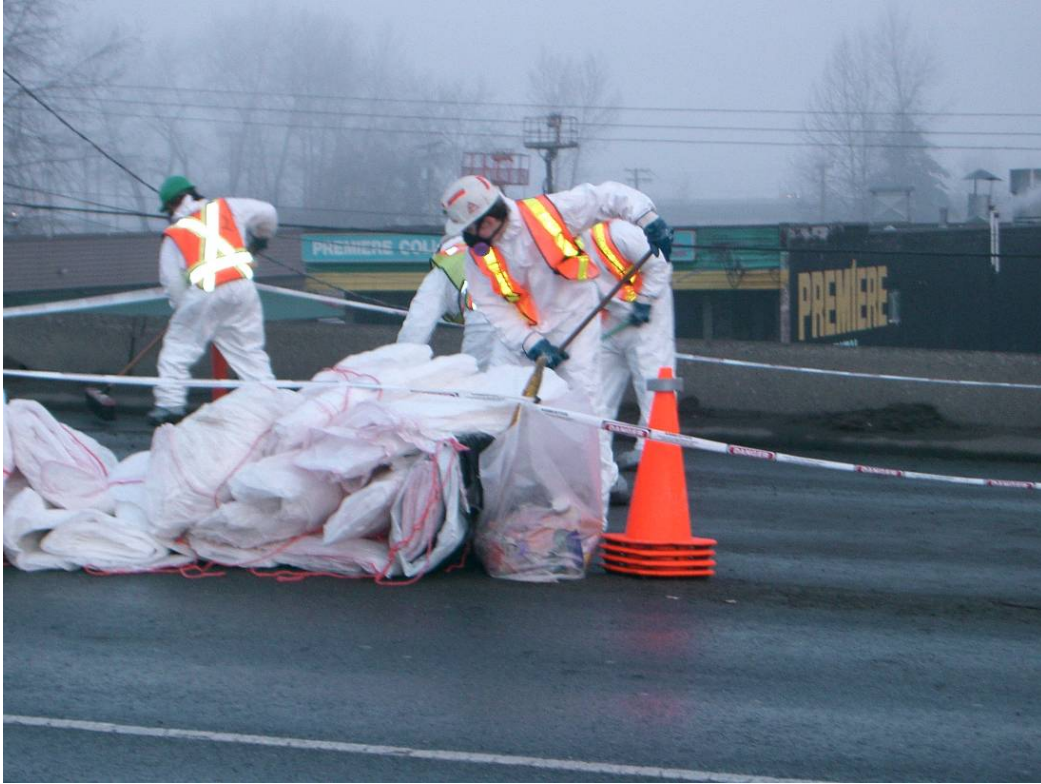
Figure 4. Specialized Person Protection for Demolition of Asphalt

As mentioned previously, the asphalt wearing surface on the timber spans was potentially asbestos containing. A specialized contractor (Enviro-vac) that had previously been retained to demonstrate the effectiveness of a non-standard pavement removal method was brought in to undertake demolition of the fire damaged timber spans. To maintain the non friable nature of the asbestos the asphalt needed to be scraped and removed intact, rather than being ground from the deck. Contaminated asbestos material needed to be contained at all times, and all workers in the containment zone were required to wear special protective equipment (Figures 4 & 5). The creosote treated timber required less onerous handling; however, the two waste streams had to be separated as they had to be transported to two different disposal sites (Figure 6). Cross contamination of the waste would cause the waste to be rejected from either waste site. Demolition commenced in the late afternoon of Monday January 19, 2009 and was completed by Wednesday, however transportation of the contaminated material continued until the following morning (Figure 7).

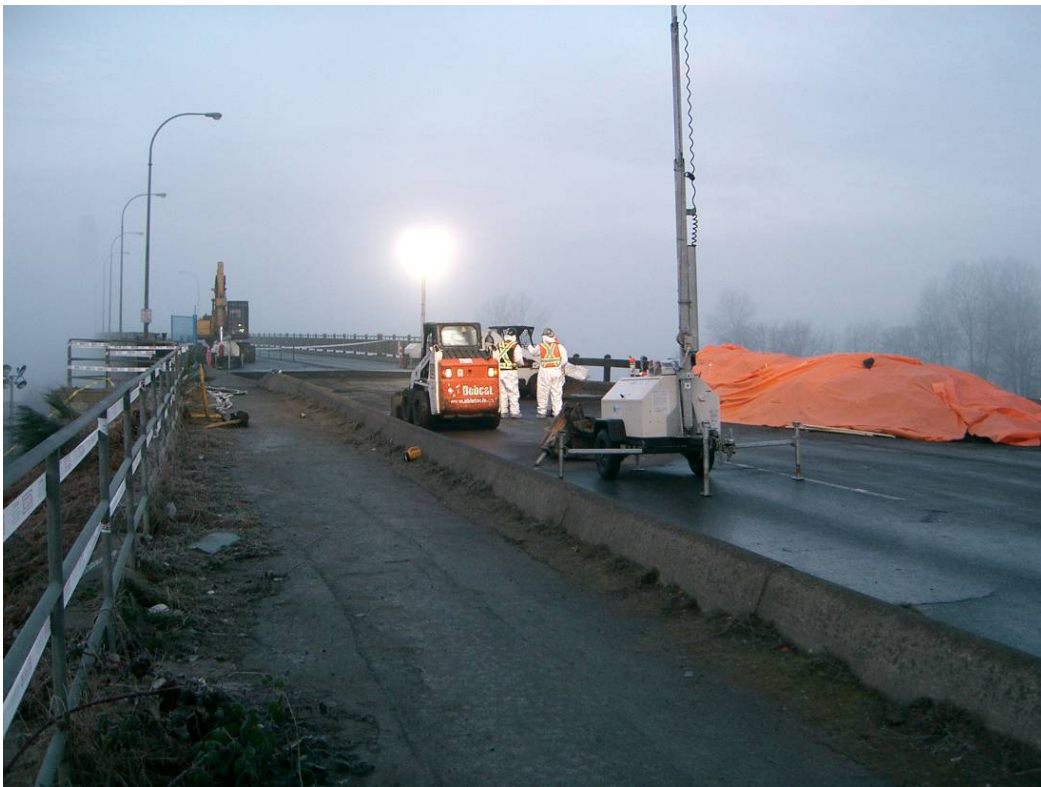
Figure 5. Containment of Asphalt Waste

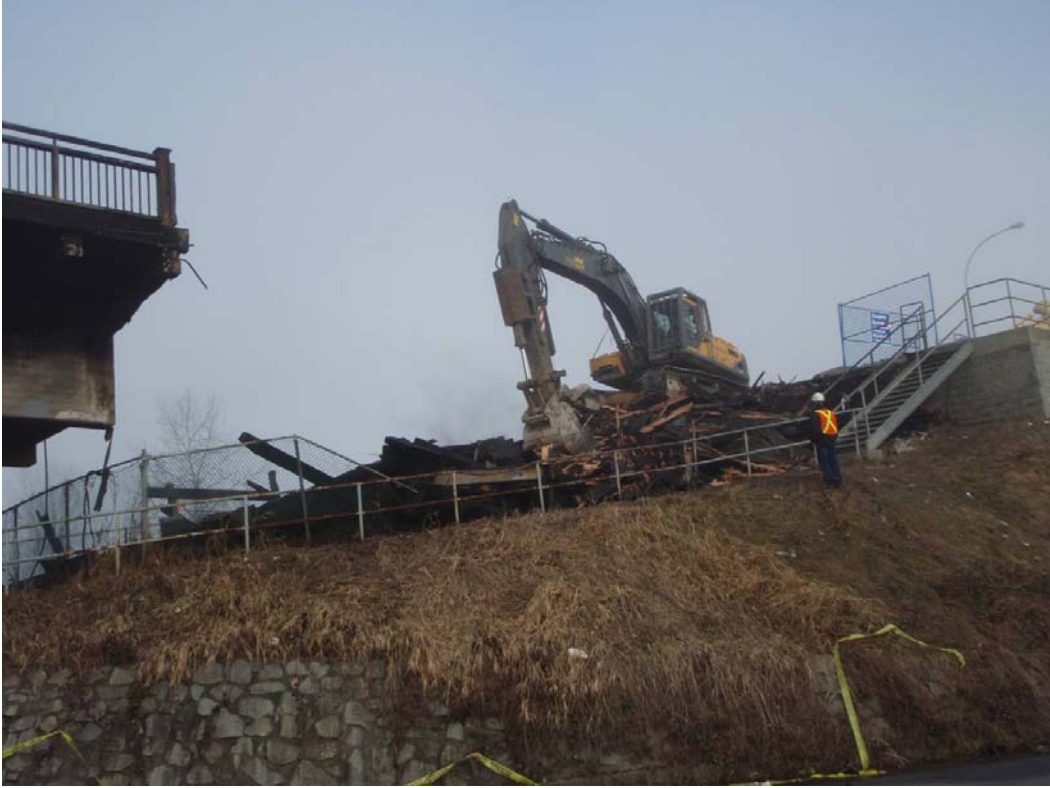
Figure 6. Demolition of Creosote Timbers

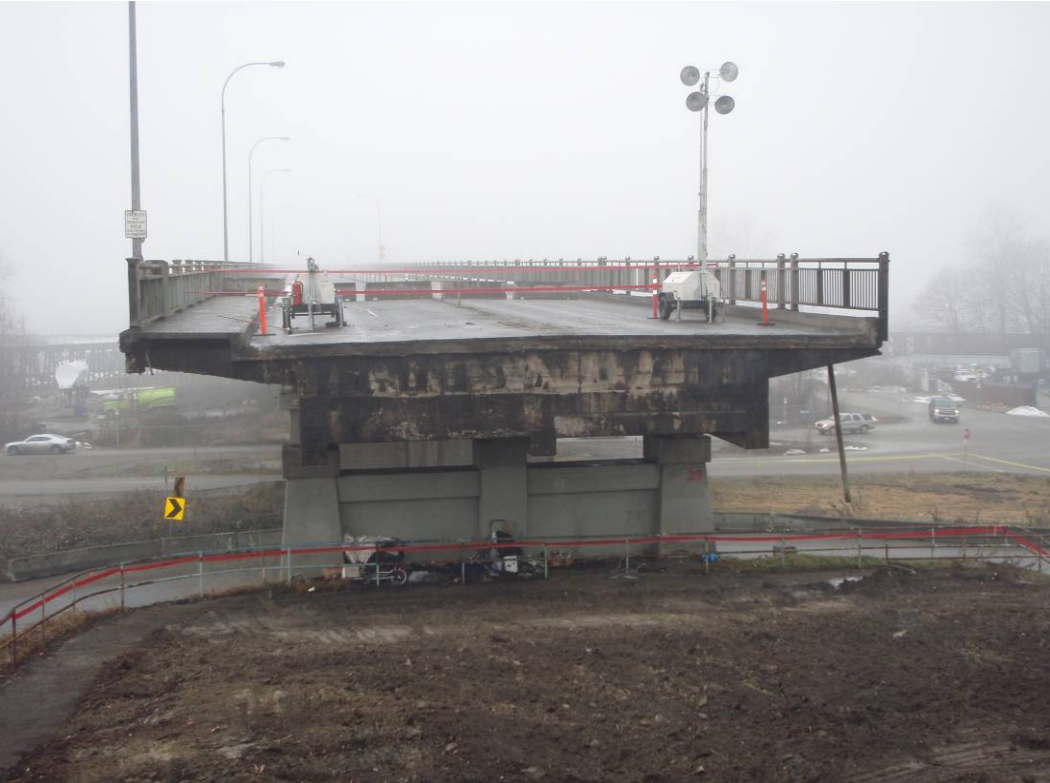
Figure 7. Site after Full Demolition

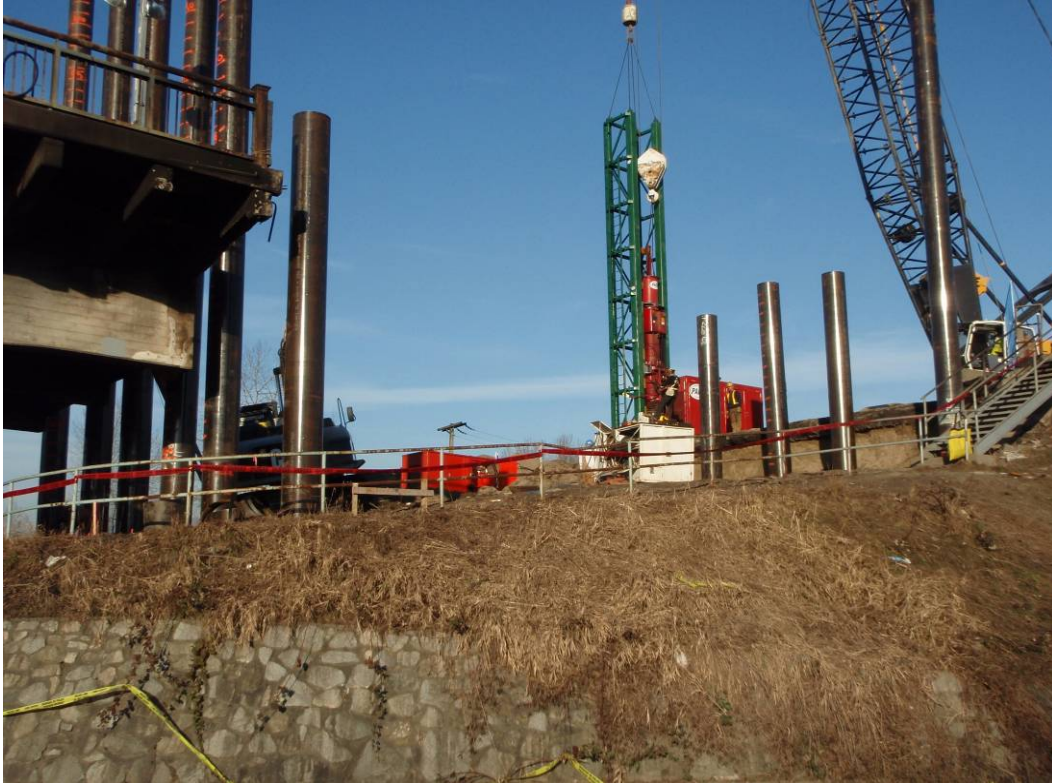
Figure 8. Pile Driving Underway

A piled foundation was selected for the new structure to minimize the potential of future settlements. Six 610 x12mm open ended pipe piles were driven at each end of the span (effectively one per girder end). Based upon the previous geotechnical investigations a granular layer was expected at approximately 20m below ground, and an estimated total length of 35m per pile was required to develop the require axial capacity for the new structure.

Surespan began mobilizing equipment and staff from various locations across BC and the Yukon on Tuesday, with equipment and manpower arriving at the Pattullo site on Wednesday. Surespan mobilized redundant equipment in the event of breakdowns, such as multiple sets of pile driving leads and two cranes. Thursday morning pile driving commenced and continued throughout the night using a combination of drop, vibro and diesel hammers (Figure 8). Pile driving was completed early Saturday morning. Concurrently with the pile driving operations, a steel fabrication shop was making all of the necessary changes to the steel girders.

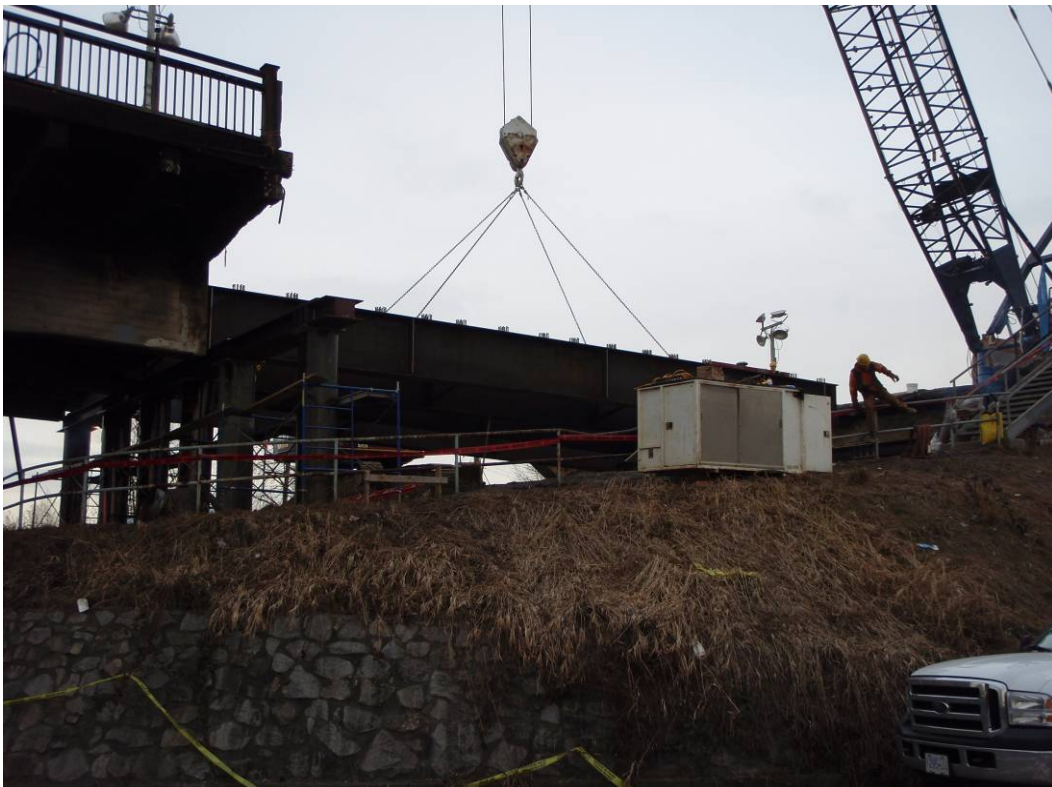
Figure 9. Erection of a Pair of Girders

Saturday morning the piles were filled with concrete, and the pile caps were erected immediately afterwards. The girders were erected in pairs during the day, and deck panels were placed throughout the evening (Figures 9, 10 & 11). Each of the stud pockets was grouted overnight, along with the gap between the new span and the existing Structure.

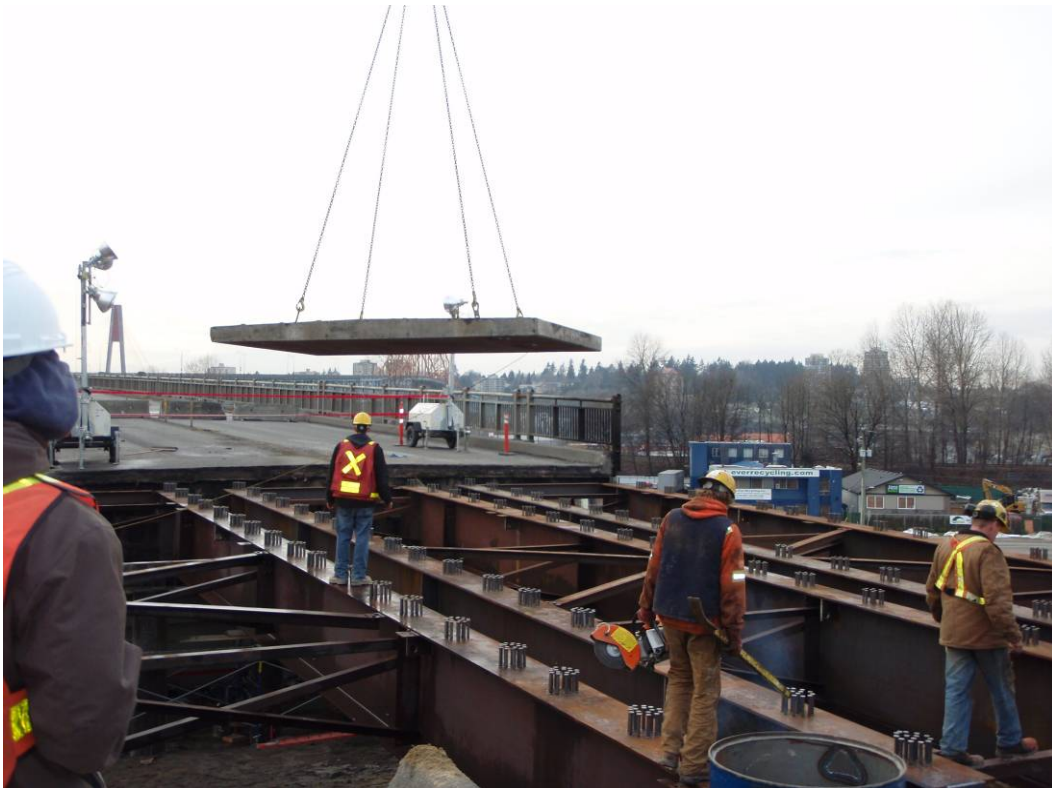
Figure 10. Erection of a deck panel

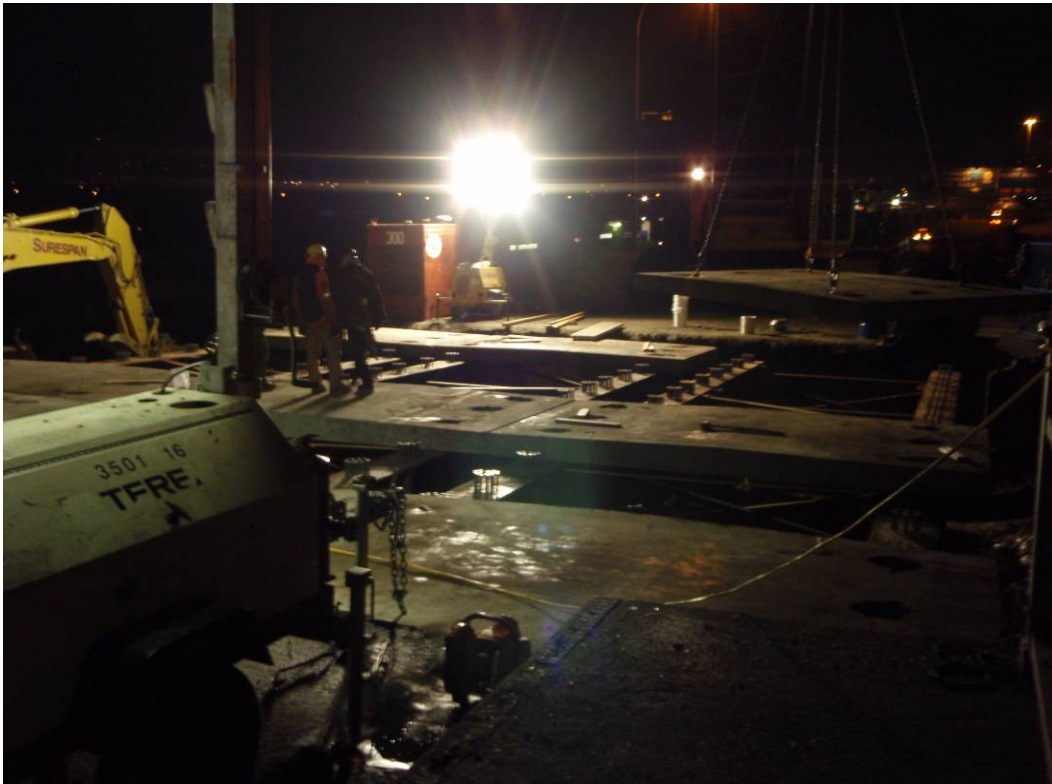
Figure 11. Work Continues through the night

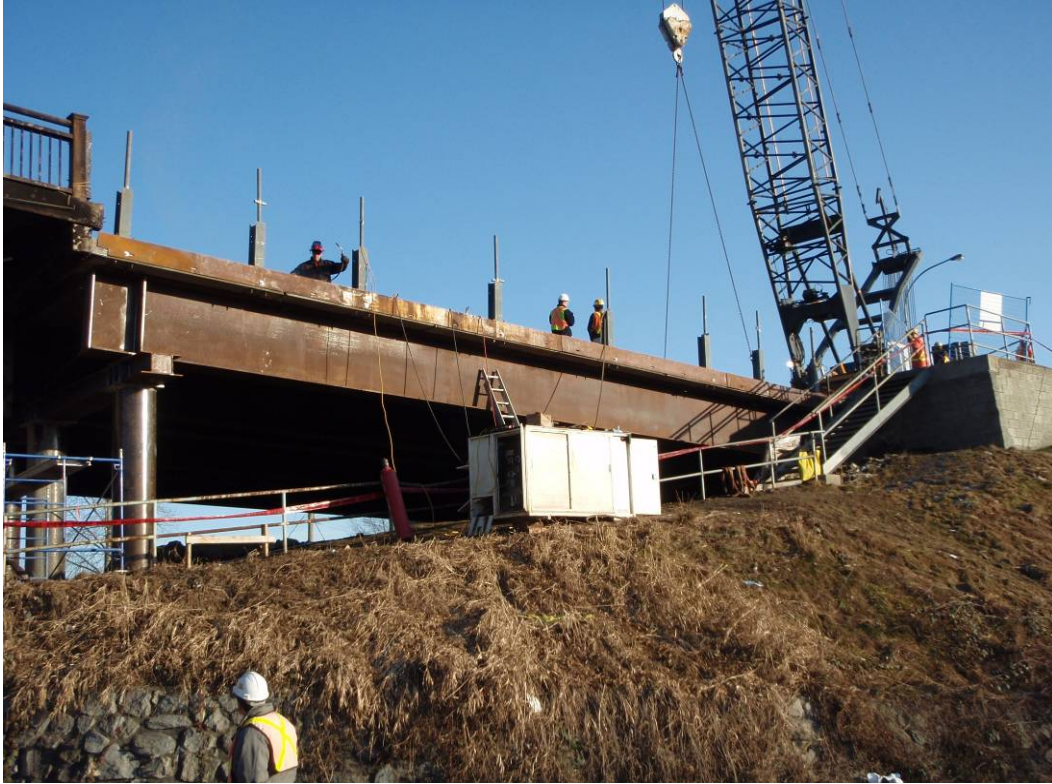
Figure 12. Installation of Railing

By Sunday morning all of the major structure components were in place and the abutment backwall was installed. Backfilling commenced during the afternoon, along with the installation of railing posts (Figures 12 & 13). Once the backfilling was completed asphalt paving on the span commenced.
