Approach Channel Bridge Rehabilitation

Paper prepared for the session ST – Transportation Structures
2024 Transportation Association of Canada (TAC) Conference & Exhibition
Vancouver, British Columbia

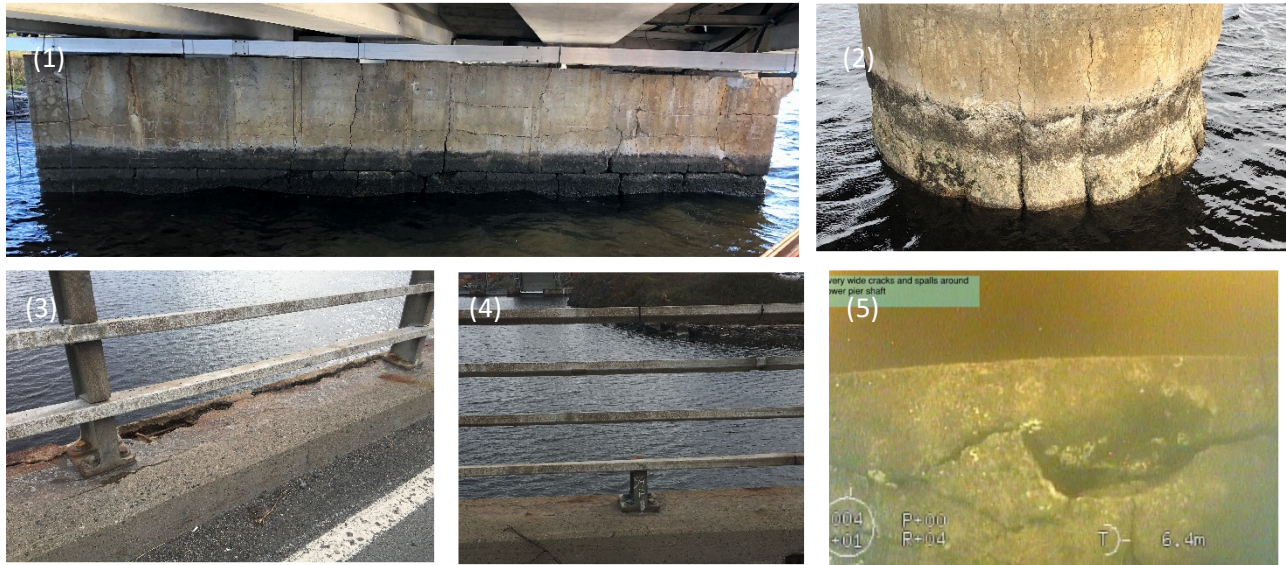
The following figure 5 provides a sampling of sampling of the high criticality defects observed during the detailed visual inspection.

Figure 5. Condition of existing structure (1) wide pattern cracking in the south abutment; (2) severe scaling at the water line and wide vertical cracks in the upper pier shafts; (3) Exposed rebar in curbs and overhangs; (4) broken and missing rail posts; (5) very wide cracks and delamination of the lower pier shafts

- Stabilization of the south abutment breast and wingwalls by crack injection and post-tensioned grout bonded concrete anchors.
- Encapsulation and strengthening of the pier cap beams using externally bonded carbon fiber wrap as well as the implementation of a hybrid cathodic protection system for the top surfaces.

- Repair the lower pier shaft severe defects by tremie build-out and encapsulate the upper shaft with a grouted steel pipe casing.
- Repair localized severe concrete defects in the girders including replacement and restressing of severed prestressing strands and patching under pre-load.

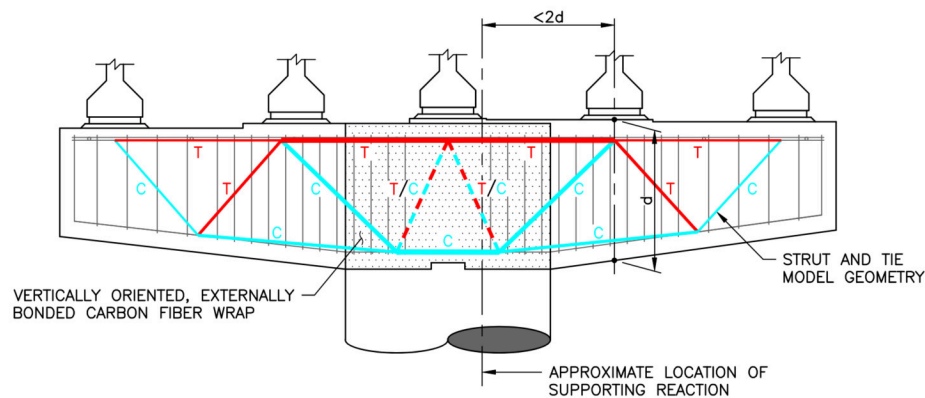
The pier hammer heads were included in the superstructure evaluation due to the structural behaviour of the cantilevers and their apparent slenderness. The initial evaluation was completed by treating the cantilevers as conventional beams and checking both shear and flexure at the root of the cantilever. Using this methodology an LLCF of 0.99 in shear was determined, which, combined with the recognition that the region in question is a discontinuous region, led to a refinement of the analysis using strut and tie modelling. However, due to the lack of reinforcement over the pier shaft, the strut and tie models were deemed inconclusive. As such, it was deemed necessary to provide supplementary reinforcement directly over the pier shaft. Rehabilitation designers collaborated closely with a contractor specializing in the design and installation of externally bonded carbon fiber reinforced polymer reinforcing to develop an appropriate strengthening solution.

Figure 6. Strut and Tie Model of cap beam indicating high tensile forces in the region with little shear reinforcement.

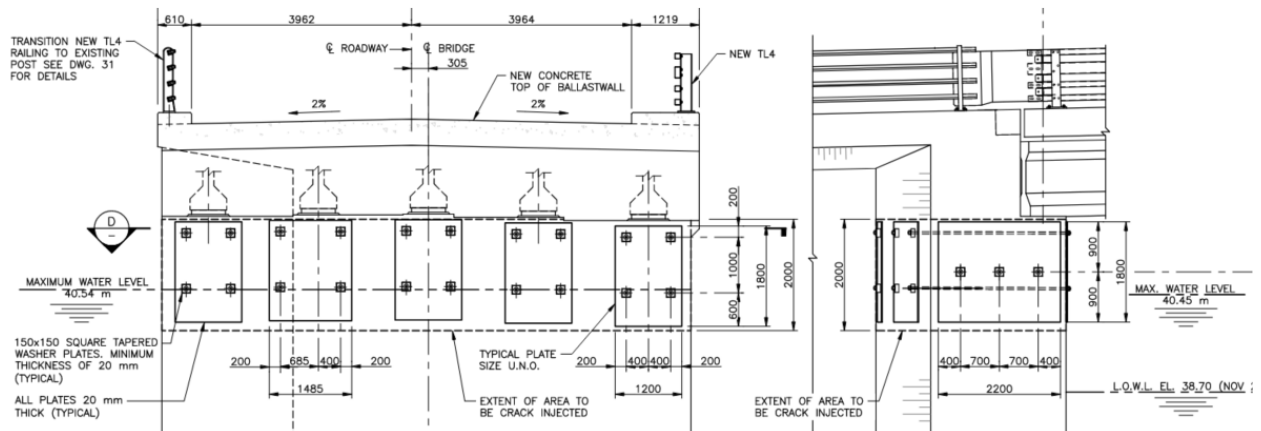
The south end of the bridge bears on a portion of the Mactaquac dam called the north bulkhead wall which is a gravity retaining structure that has AAR damage including wide pattern cracking and severe scaling of the concrete above water level. A review of record drawings and materials testing revealed that there is minimal reinforcement and unsound concrete in the bridge seat area. A conventional replacement by encapsulation approach would have resulted in extensive concrete removals below the bearings. As such, the approach taken to stabilize the bridge seat was to inject all the medium to wide cracks with a resin-based grout followed by installation of galvanized steel confinement plates anchored to the concrete surfaces using post-tensioned grout bonded anchors (see Figure 10).

Figure 10. South Abutment confinement plates

The anchors are 25 mm dia. threaded steel bar in 100 mm diameter holes. Through bars are horizontal and plated at each end and bonded anchors slope downwards at 15 degrees and have a 6 m embedment depth. Plating is located under each girder and, together with crack injection and nominal post-tensioning forces, provides the confining stresses to maintain aggregate interlock and resist the applied bearing forces.

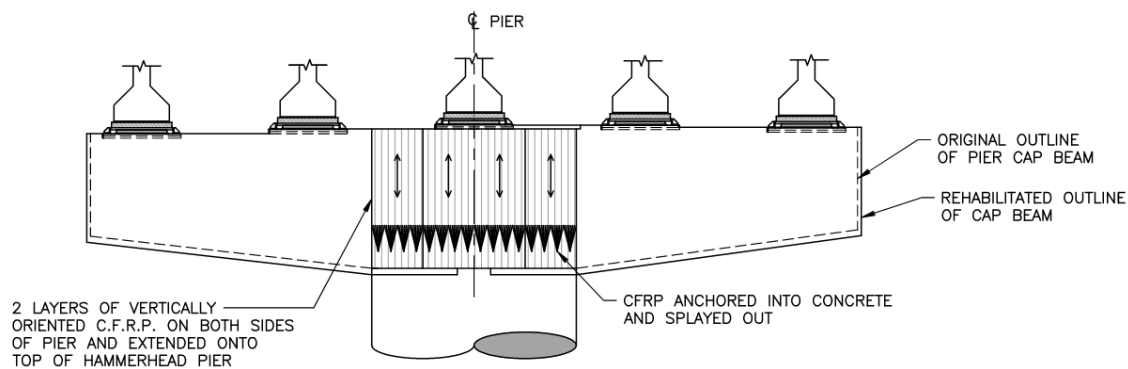
To address the existing pattern of medium to wide cracks in the vertical faces and soffits of the pier cap beams, the existing piers will have the surface concrete removed to the mid-depth of the existing stirrups. The surfaces of the beam will be built out using a layer of self-consolidating concrete anchored to the existing with a doveled-in layer of new reinforcement to control cracking. Galvanic anodes will be incorporated into the overbuild to minimize the corrosion of existing reinforcement. A hybrid galvanic protection system is incorporated into the top surfaces of the pier caps to both protect and repassivate the existing flexural reinforcement against further corrosion.

Figure 11. Externally bonded CFRP strengthening of the pier cap beams.

Vertically oriented, externally bonded, carbon fiber reinforcement will be applied to the pier surface directly over the pier column to provide axial tensile resistance in this area as identified by the strut-and-tie modelling. (See Figure 11)

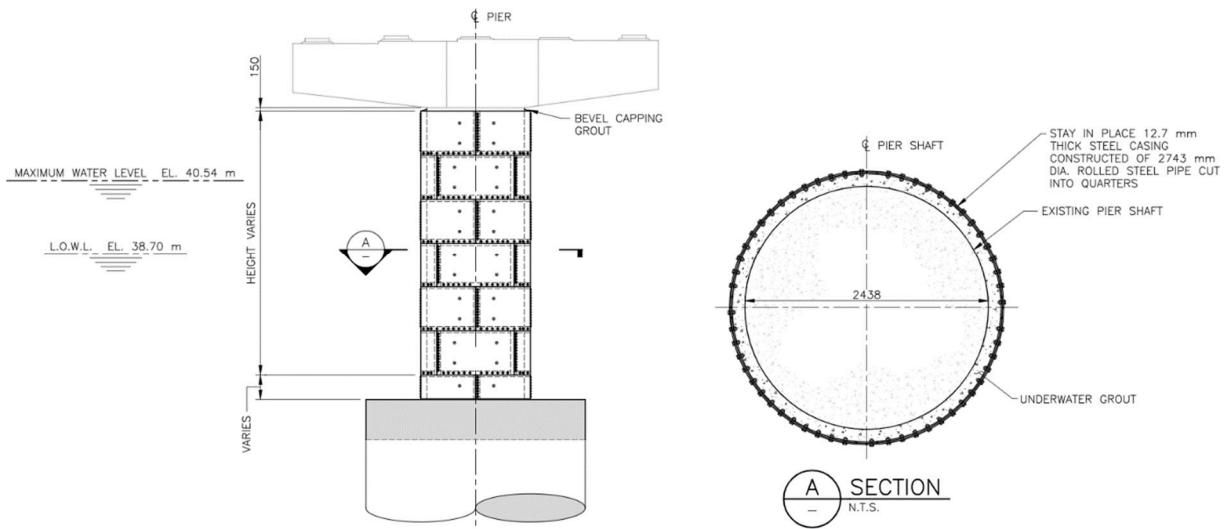
Above this, the upper shaft has extensive wide vertical cracking due to AAR expansion and severe scaling at the water line due to freeze-thaw and an inadequate air void system. To confine the cracking and protect the shaft from further deterioration, the shaft will be encapsulated using 13 mm steel casing plates fabricated from sections of 2743 mm dia. rolled steel pipe. The casing will be filled with a shrinkage compensated underwater grout.

Figure 12. Grouted steel pipe encapsulation of the upper pier shafts

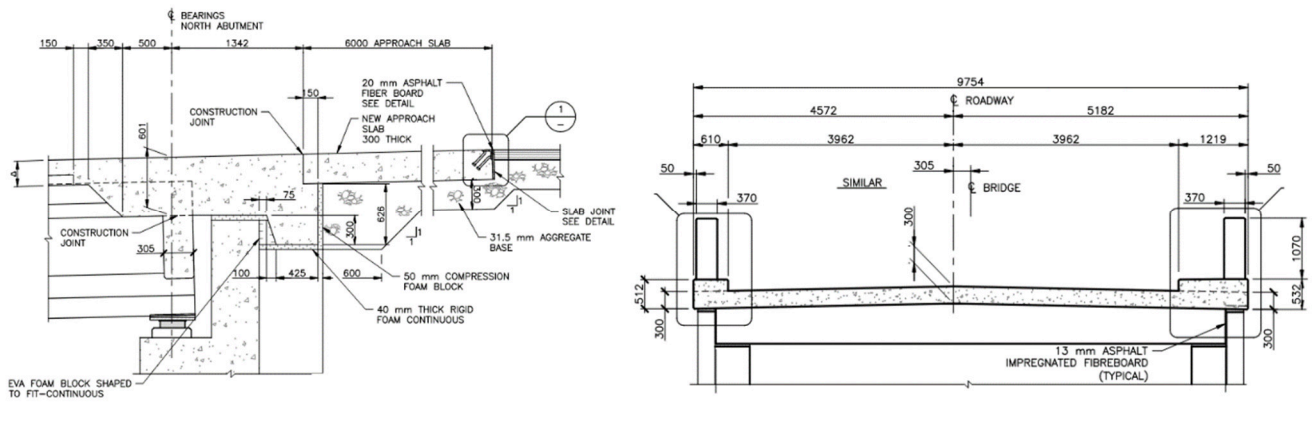
The end posts, curbs, sidewalks, and expansion joint were all in poor condition and both the end posts and wingwalls were found to be insufficient to resist the desired TL-4 barrier loading. As such, a semi-integral conversion was investigated whereby a new approach slab would be supported by an extended deck edge stiffening element. The approach slab extends over the existing wingwalls, thereby isolating the wingwalls from barrier impact forces. The sidewalk, curb and end posts are integral with the approach slab.

Figure 13. North Abutment semi-integral conversion section (left) and approach slab configuration (right)

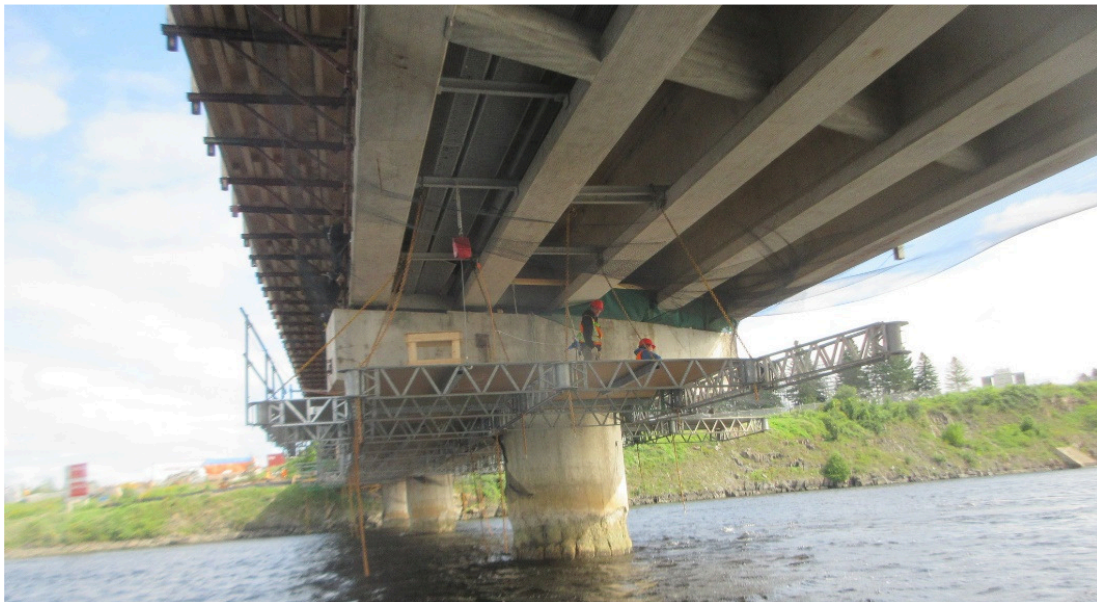
Figure 14. Suspended scaffolding erected under bridge for pier encapsulation and bearing replacement work.

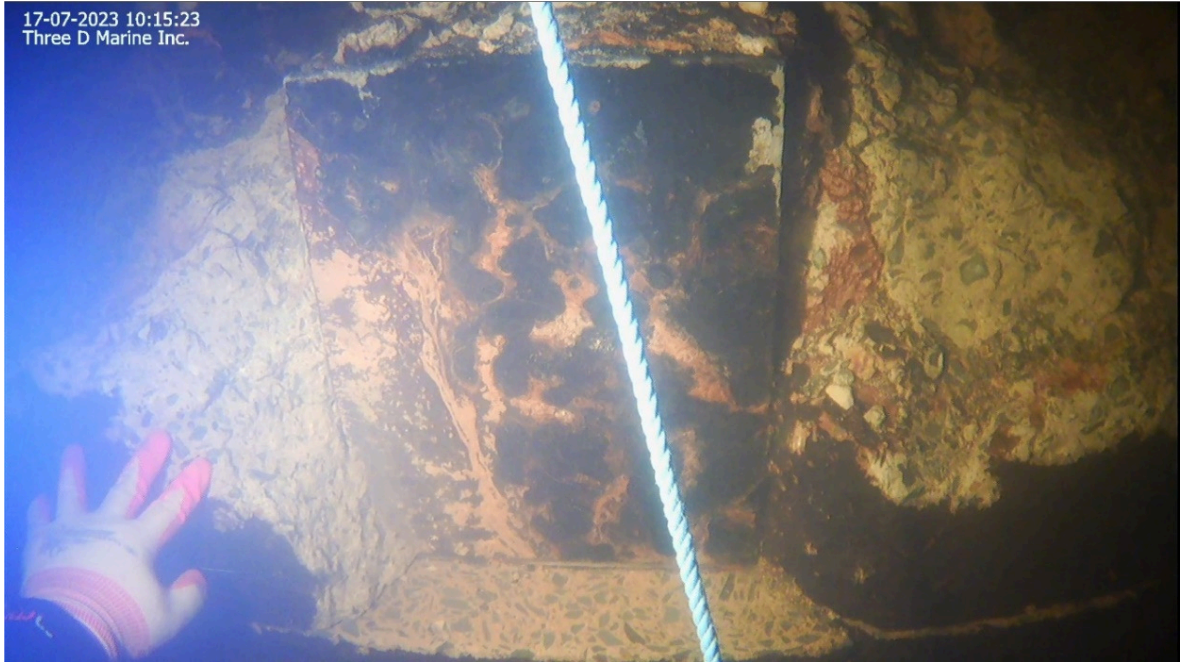
The upper shoulder of the lower pier shaft has extensive concrete delamination and disintegration due to AAR expansion and lack of confinement steel. The top 600 mm of this element will be reconstructed and a new 1.0 m thick reinforced tremie concrete cap added to provide confining hoop stress to the lower shaft.

Figure 15. Lower pier shaft concrete removals completed exposing embedded pile steel. Note circumferential saw cut. The removals in this area will be reinforced and tremie concreted.

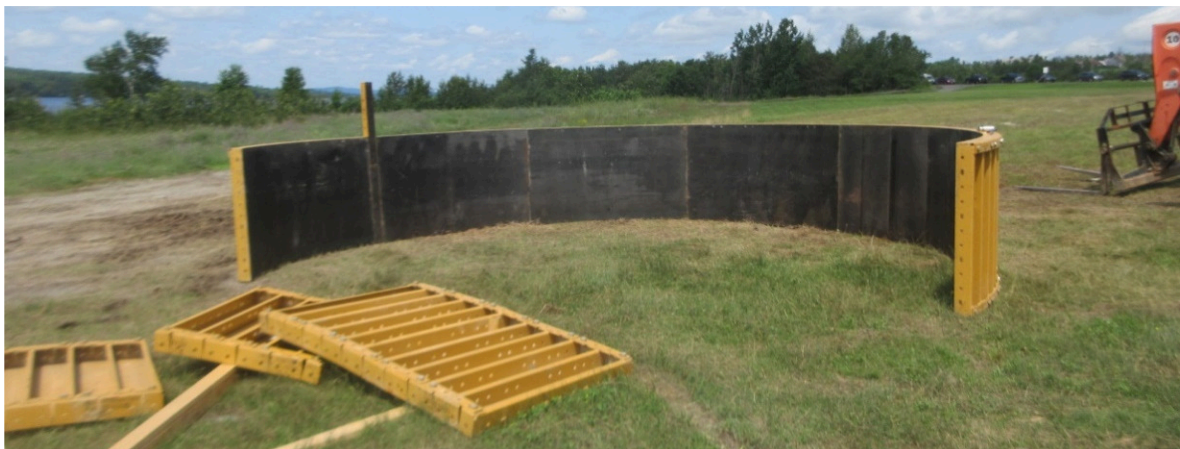
Figure 16. Dry fit of circular EFCO form on grade before lowering segments and installing form on lower pier shafts underwater for eventual tremie concrete placement

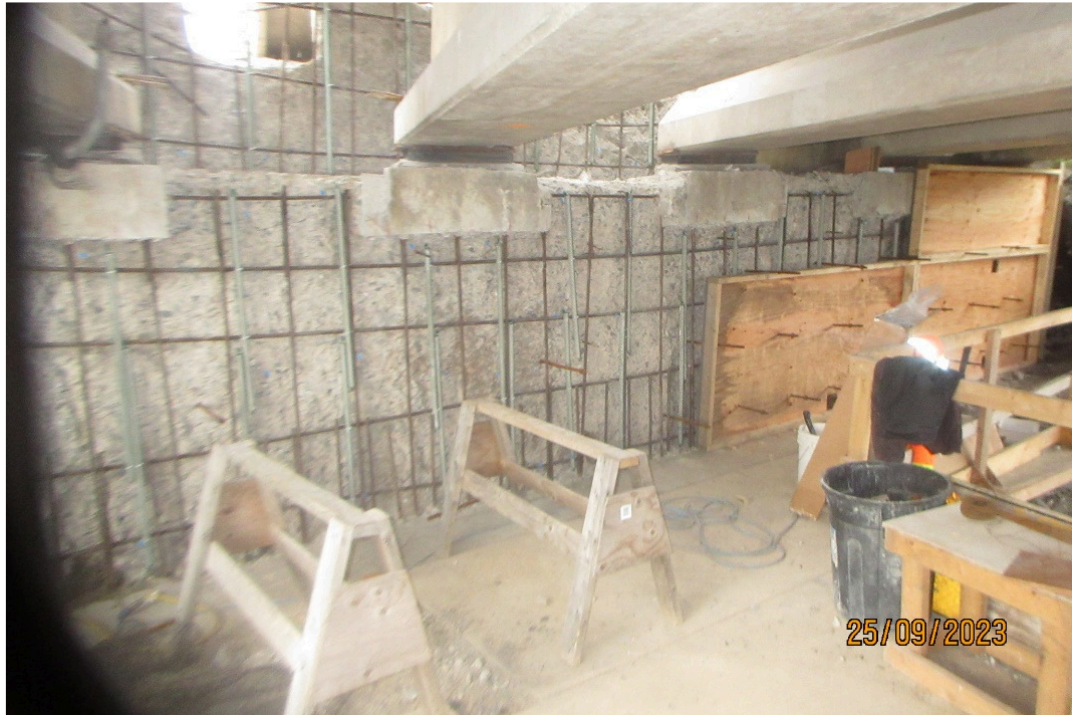
Figure 17. North Abutment breastwall has been reconstructed incorporating a distributed anode system. Bearing replacement will be completed later.

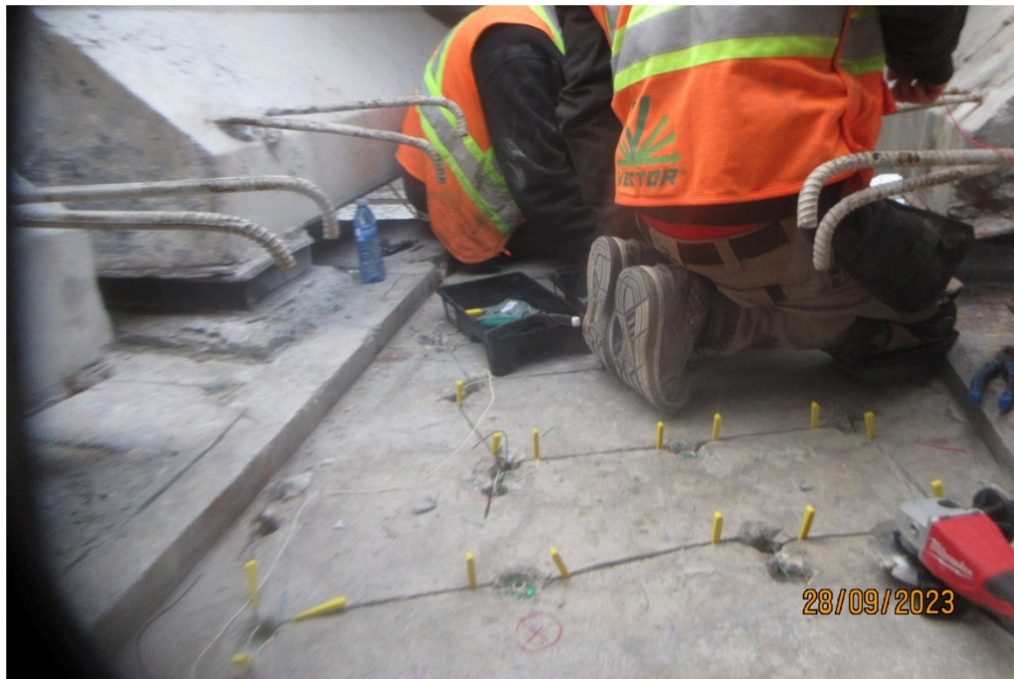
Figure 18. Hybrid Fusion galvanic anodes being installed into the top surfaces of the pier hammerheads by Vector Corrosion Technologies.

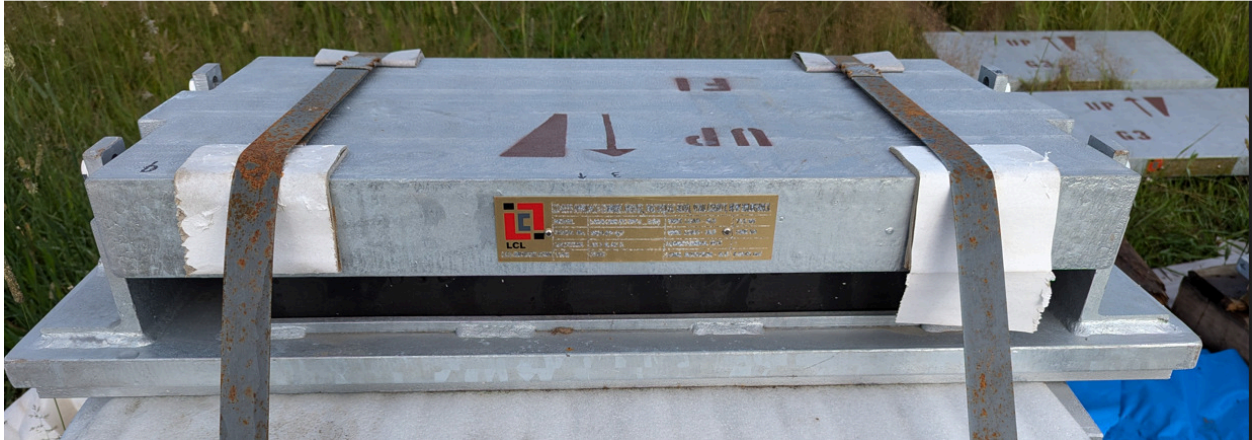
Figure 19. New bearing assemblies have been fabricated and delivered to site.

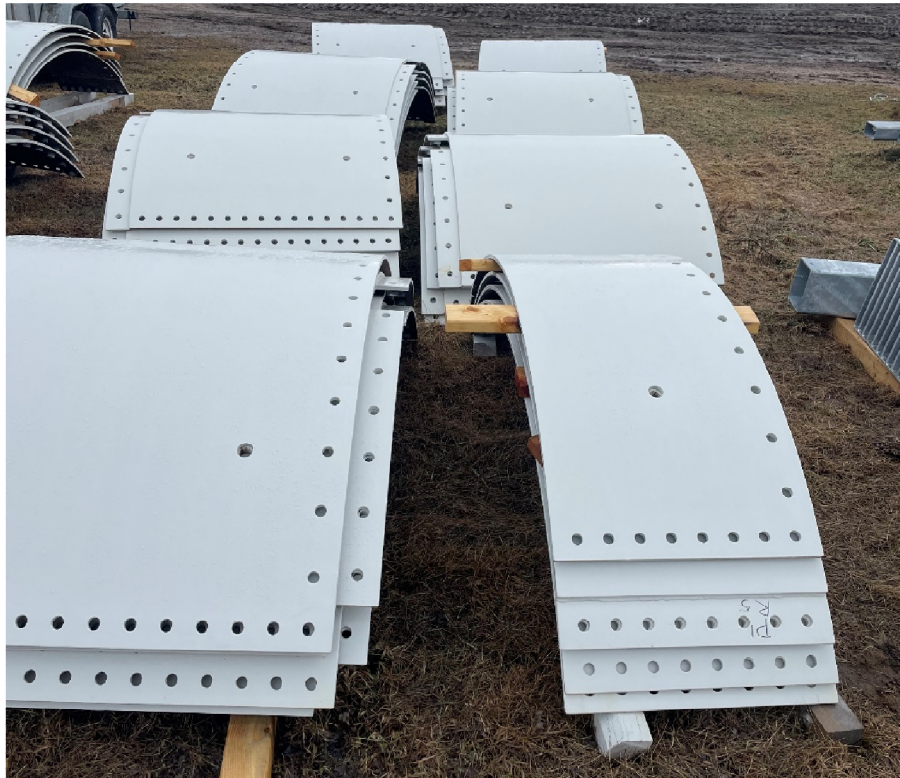
Figure 20. Coated upper pier shaft casing plates have been delivered to site and await installation.

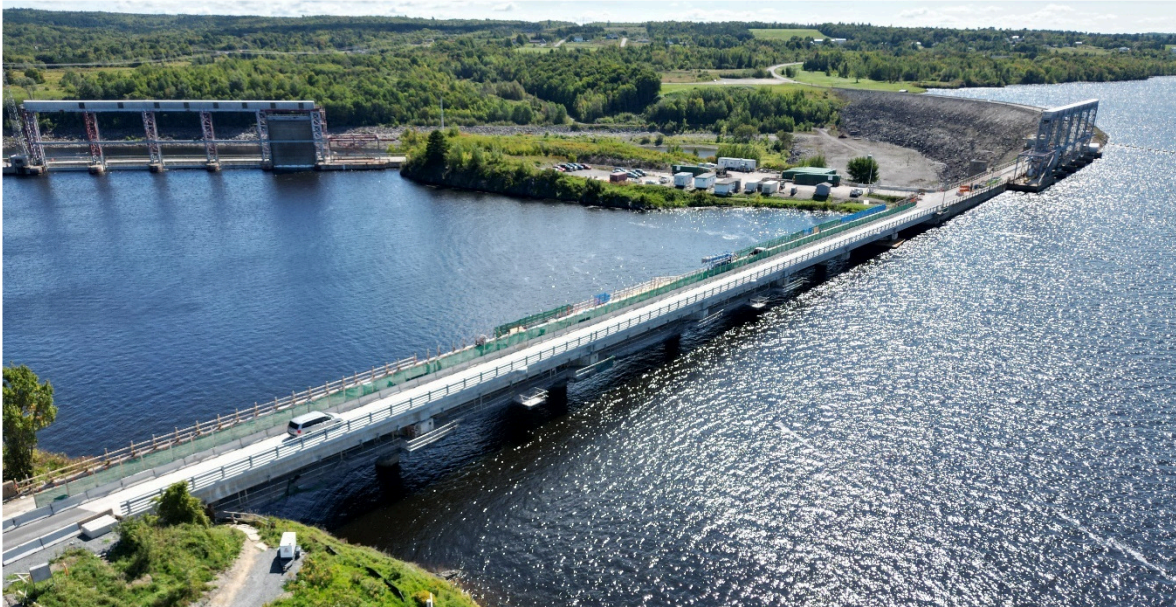
Figure 21. West half of deck rehabilitated and open to traffic.

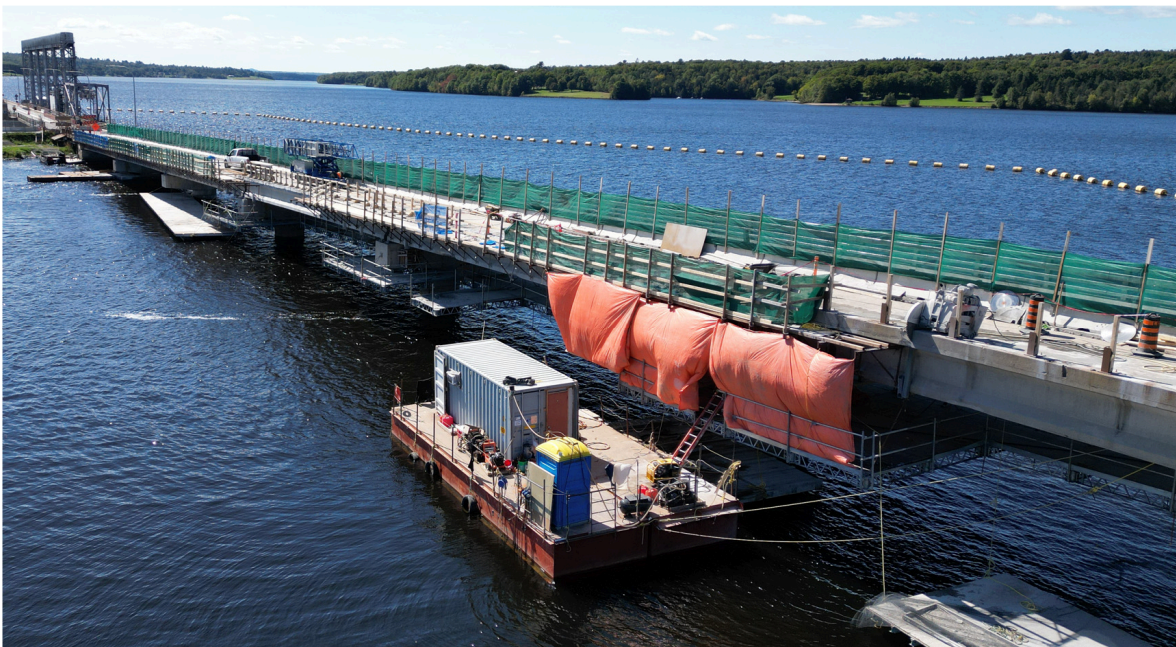
Figure 22. East half of deck asphalt and barrier partially removed.
