Red Lillooet River Bridge Deck Renewal

Paper prepared for the session **INFRASTRUCTURE & ASSET MANAGEMENT – Transportation Structures**
2024 Transportation Association of Canada (TAC) Conference & Exhibition
Vancouver, British Columbia

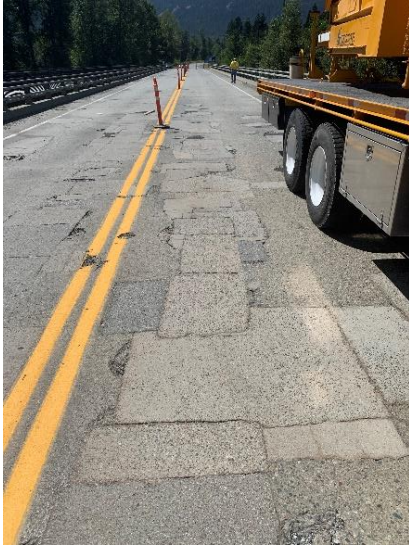
The top of the deck had been extensively patched and was in poor condition. The varying condition, size, shape, and material of the patches, and the areas of spalling lead to very poor rideability (see *Figure 3*). The deck overhang, however, was generally in good condition except for the south overhang along the entire span 2.

Figure 3 – (a) Deteriorated surface with patches

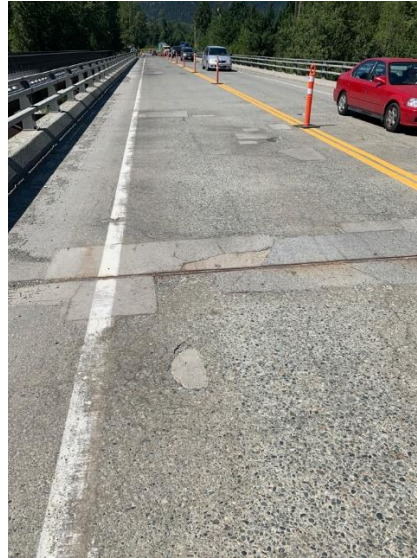
(b) Surface patches around deck joints

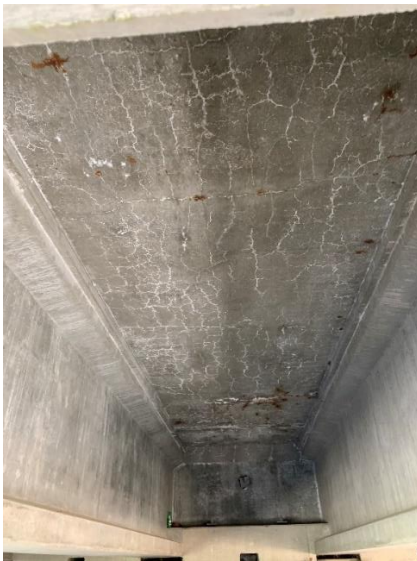
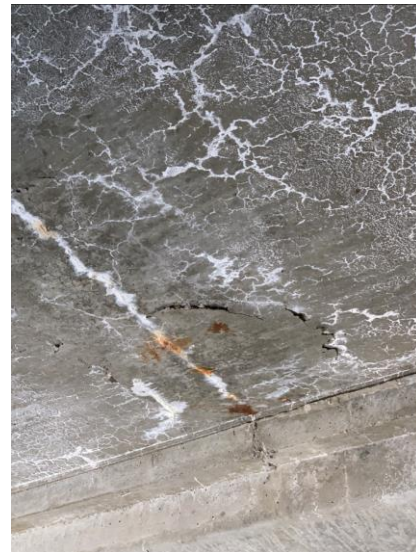
The deck soffit also had varied levels of visible deterioration. Spans 1, 2, and 4 were in poor condition with most of the soffit surface having visible deterioration that included map cracking, transverse cracks, efflorescence staining, rust staining from rebar corrosion, spalling, and delaminated concrete (see *Figure 4a* and *Figure 4b*). Despite the poor conditions in other area in the soffit, most of the soffit of Span 3 was in good condition (see *Figure 5*). Hammer sounding was used to check for areas and extent of delamination.

Figure 4 – (a) Area of deck soffit with deterioration (b) Crack and delaminated concrete in deck soffit

Full depth repair was necessary for the deck area showing significant deterioration such as map cracking, rust staining caused by rebar corrosion, spalling, and delaminated concrete. This scheme required the full depth of the existing concrete deck along with the top mat reinforcements to be

removed and replaced, and the bottom mats reinforcements to be cleaned or individually replaced when severely corroded or damaged.

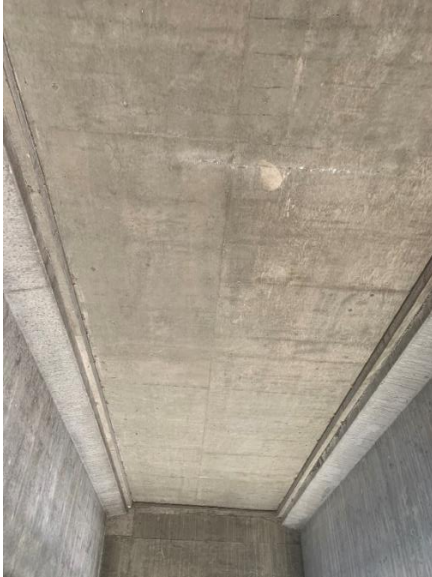
Figure 5 – Area of deck soffit with good condition

Partial depth repair was suitable for the deck area that had little to no visible concrete deterioration and no observable rebar corrosion in the deck soffit. This scheme required only the top half of the existing concrete deck along with the top mat reinforcements to be removed and replaced. The bottom half of the existing concrete deck remained intact.

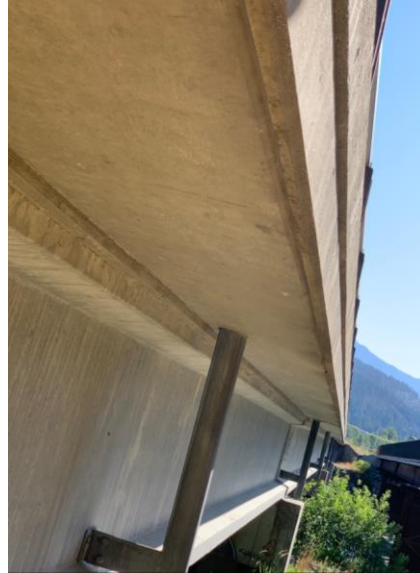
Figure 6 - Overhang soffit in good condition

Majority of the overhang / cantilever portion of the deck was in good condition (see *Figure 6*). Minor defects such as hairline cracks with some efflorescence staining were visible.

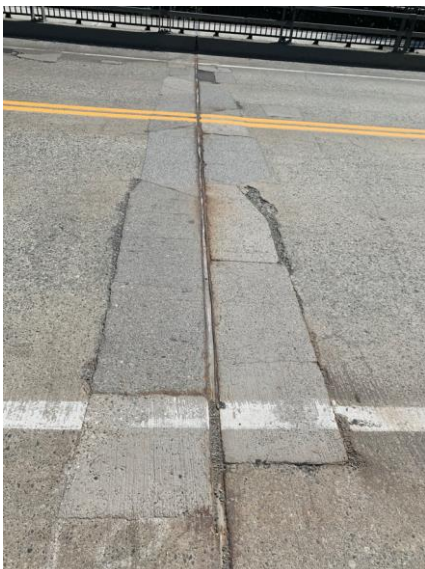
There are three armoured flexible sealant joints between deck spans, one over each pier. All three deck joints were corroded with pitted armour and the flexible seal appears to be leaking (see *Figure 7*). The leaking deck joints appeared to be contributing to concrete degradation of the girder ends at the piers (see *Figure 8*).

Figure 7 - Deteriorated deck joint and concrete

The seals of the existing deck joints over the piers were degraded and the leakage from the joints contributed to the concrete deterioration and reinforcement corrosion in the girder ends and pier caps. To reduce the need for future maintenance, the deck joints were replaced by reinforced link slab with a poly sheet for debonding. The link slab was designed for the girder end rotation induced by the service live load on the bridge spans, in accordance with the Caner and Zia's method¹. In general, link slab will greatly improve rideability and user comfort compare to deck joints. *Figure 13* *Figure 11* shows the design details of the link slab.

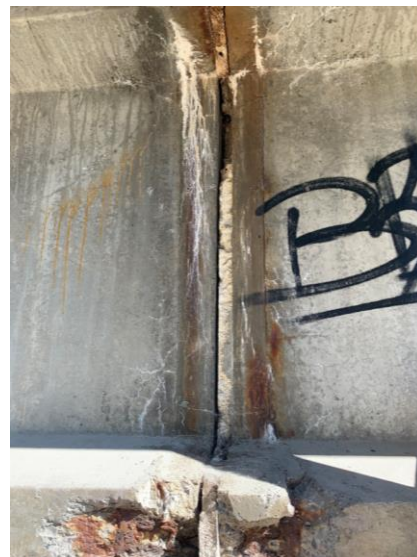
Figure 8 - Girder ends with spalling and corroded strands

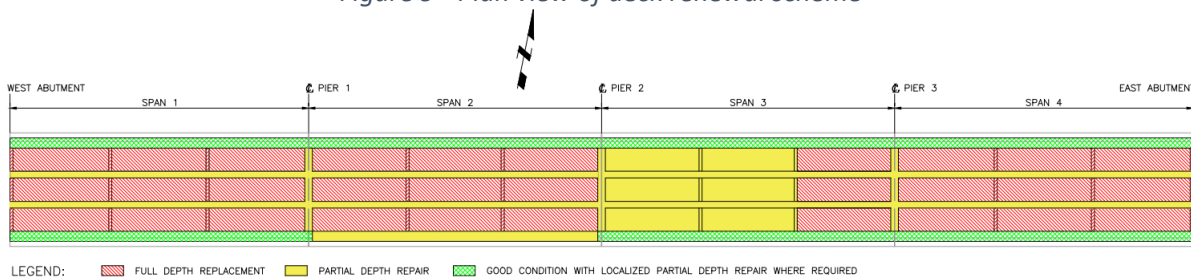
Based on the outcome of the inspection and condition assessment, we considered two deck renewal schemes: full depth repair and partial depth repair. *Figure 9* shows an overview of the deck renewal scheme: approximately 60% of the deck area required full depth replacement (red shade), 25 % required partial depth repair (yellow shade), and the remaining 15 % did not require repair (green shade).

Figure 9 - Plan view of deck renewal scheme

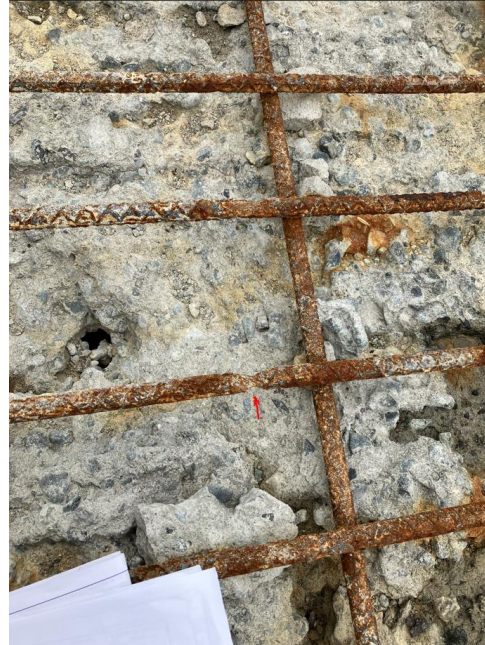
Figure 15 - Severely corroded rebar
