# **St. Andrews Lock and Dam Corrosion Protection System 5 Year Case Study**

**Paper prepared for presentation at the  
Innovations in Bridge Engineering Session  
of the 2004 Annual Conference of the  
Transportation Association  
of Canada, Quebec City, Quebec**

## **St. Andrews Lock and Dam Corrosion Protection System – 5 Year Case Study**

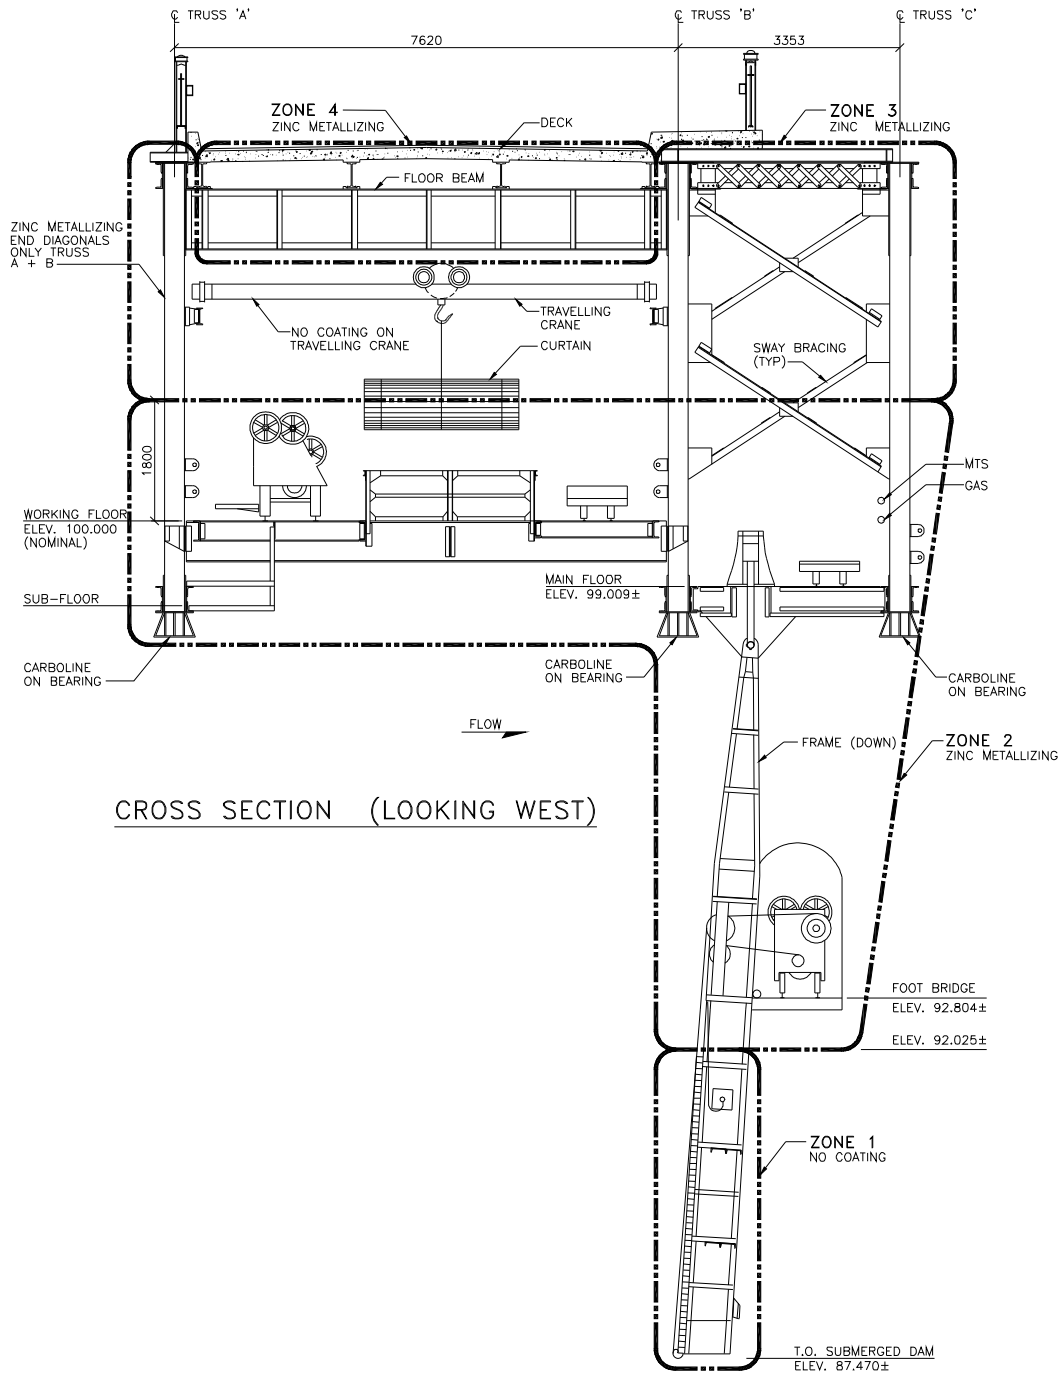
Figure 2. Cross Section of Bridge Showing Coating Zones

Zone 1, the "Fresh Water Immersion Zone," consisted of the lower portion of the dam frames that are immersed in the water when the dam is in operation. This area has the harshest corrosion environment as the frame sections are partially submerged in water during the summer months; and they are exposed to ice fog in the winter. Prior to construction this portion of the original frames were deteriorated to such a degree that it would be impossible to sandblast them. Therefore, they were not coated and were replaced in 2001-2002.

Zone 2, the "Moderate (Industrial) Zone," consisted of the remaining portion of the dam frames and lower half of the main truss section. This zone was determined to be in a high humidity environment typical of moderate industrial exposure. Zone 3 was defined as " Seacoast Marine," and is the upper half of the trusses excluding the main floor beam protected by the bridge soffit. This zone is also exposed to humidity as well as very corrosive deicing salts, which come from the roadway above. Finally, Zone 4, the "mild (rural)" Zone contains the main floor beams and cross bracing located immediately under the roadway. Bridgecote was specified as the base bid for this zone and was changed to metallizing during construction for a small incremental cost. This area is well protected from almost all environmental elements and exposed to a very passive corrosion environment.

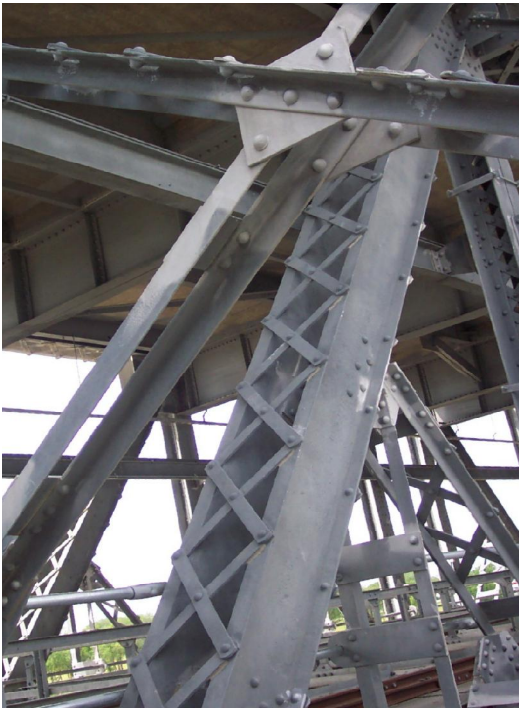
Wardrop Engineering inspected the structure in 2000 and 2001 (Years 1 and 2 of the warranty period) to monitor the condition of the coating. Inspections during these two years revealed that there was approximately one failure for every 65 ft<sup>2</sup> of structural steel and that the typical failure size was smaller than a quarter. It confirmed that overall the condition of the coating was in excellent shape and was performing very well. Coating failures were isolated to the backs of rivets and edges of flanges (Photo 2). In addition, the caulking of the pact rust joints was also performing extremely well (Photo 3).

**Photo 2. Typical Condition of Coating**

All failures that required repair were minor in nature and would be defined as localised failures. They typically included the backs of rivets, and the edges of flanges. Overall, less than 0.1% of the structural steel required repair. These areas were difficult to coat areas and locations where the dry film thickness of the coating could not be measured. Areas of galvanizing that were partially damaged during the abrasive blasting were also repaired. Although the size of failures was minimal, it still took the contractor a significant amount of time to inspect the structure and walk/climb over the 380,000 ft<sup>2</sup> plus of structural steel.

Formal warranty repair works occurred in 2002 and 2003 and will be completed in the early summer of 2004. Each year the contractor mobilised a small crew of painters and a NACE certified inspector to perform the repair work and inspection. The repair areas

were identified by the NACE inspector and by Wardrop to the painters. The painters then worked ahead of the inspectors making repairs to all failures. Once the painter was satisfied that all areas had been completed they were inspected by the contractor's NACE quality control inspector. Any areas requiring touch-up were identified and repaired. Finally, a quality assurance inspection was performed as the final litmus test for the work. Again, any areas requiring repair were identified and repairs were made. In addition, the contractor's inspector monitored all aspects associated with the work including the ambient conditions, mixing of the paint and application.

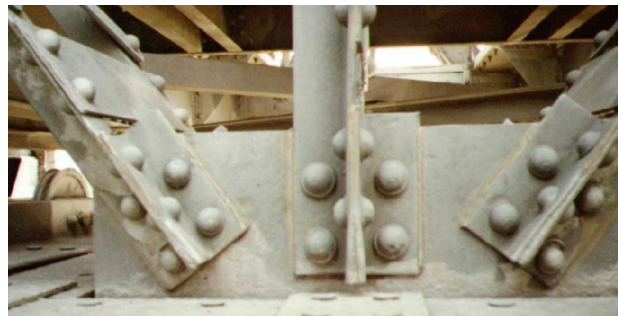
**Photo 3. Typical Condition of Caulking of Pack Rust Joints**

Reasons for the success of the caulking are likely attributable to the excellent adhesion to the metallizing surface, the extremely dry ambient conditions during the construction, and the extensive removal of the pact rust during construction. At all locations, Mulco SupraExpert caulk was applied to the joints.
