# **Specification Improvement to Deliver Safe and Durable Concrete Pavement in Ontario**

Susanne Chan, M.A.Sc., P.Eng.  
Senior Pavement Design Engineer,  
Ministry of Transportation Ontario

Paper prepared for presentation at the  
Innovation in Geotechnical and Materials Engineering Session

at the 2020 TAC Conference & Exhibition

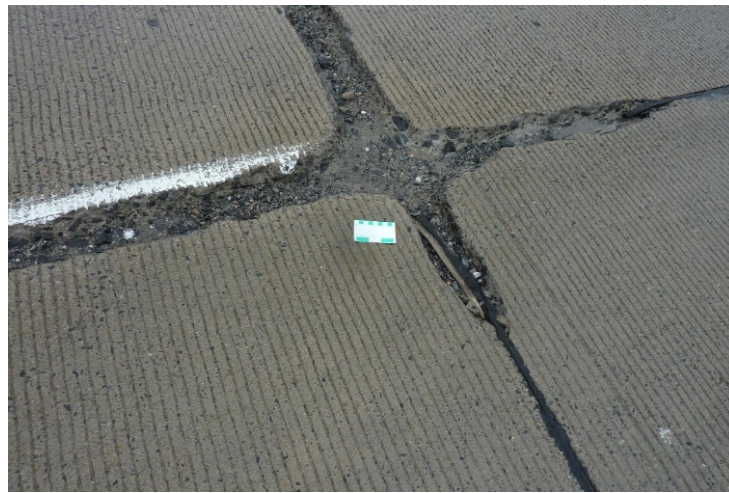
**Figure 2: Deteriorated Joints on Highway 417**

Many joints in this section of concrete pavement, both longitudinal and transverse, were visibly deteriorated and spalled at the pavement surface (Figure 2). There were also joints in this section that appeared intact at the surface. An investigation was carried out by taking cores at the joints that appeared intact to examine the condition of the concrete below the sealant. Cores were also taken mid-panel to test the material properties of the concrete. In addition to the core samples taken from the deteriorated section of the highway, cores were taken from adjacent sections, constructed at approximately the same time, but which were not exhibiting signs of distress at the surface. Examination of these cores revealed significant deterioration in the sections of the highway not yet exhibiting surface distress. Examination of the cores and joints revealed that water entering the joints was not moving through to the underlying base. Some cores had very narrow, hairline cracks, which limited the flow of water through the joints and some joints remained uncracked.

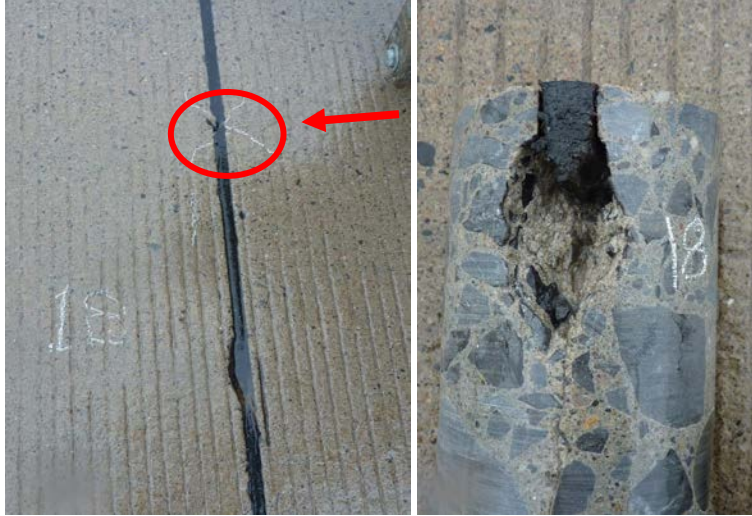
**Figure 3: Deterioration Below the Surface of a Visibly Intact Joint on Hwy 417**

A core taken at a joint on Hwy 417 that appeared to be intact, revealed significant deterioration of the joint below the sealant (Figure 3). This was typical of the joints from this contract of Hwy 417 where there was no significant deterioration at the surface.

From observations, the joint deterioration started in the area of the initial joint sawcut and reservoir cut, below the joint sealant. It appeared to have started in the lower half of the sawcut zone, and worked its way out and up, eventually popping off the surface of the concrete pavement. Deterioration was typically limited to the top third of the concrete in the joint area. Concrete below the joint sawcut was not affected, and adjacent concrete outside of the joints was not affected.

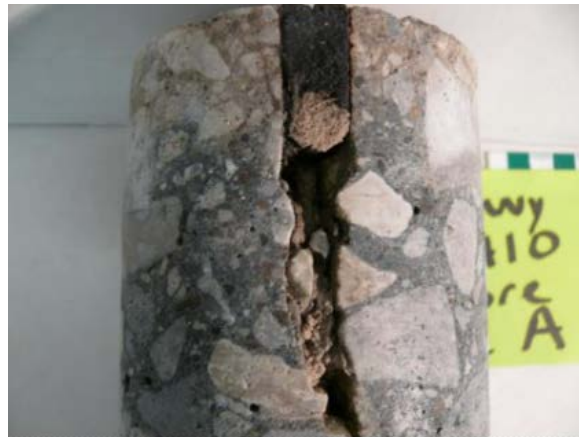
**Figure 4: Premature Joint Deterioration (core taken from Highway 410)**

Based on the finding that even a visibly intact joint has underlying deterioration, an investigation was carried out to determine if the same problem was occurring in concrete pavement elsewhere in the province. Sections of concrete pavement were examined on Highway 401 near Windsor and Highway 410 near Brampton, where there were no signs of deterioration at the pavement surface. However, further investigations showed some freeze-thaw damage has been occurring at these joints (Figure 4), but at lower severity than Highway 417.

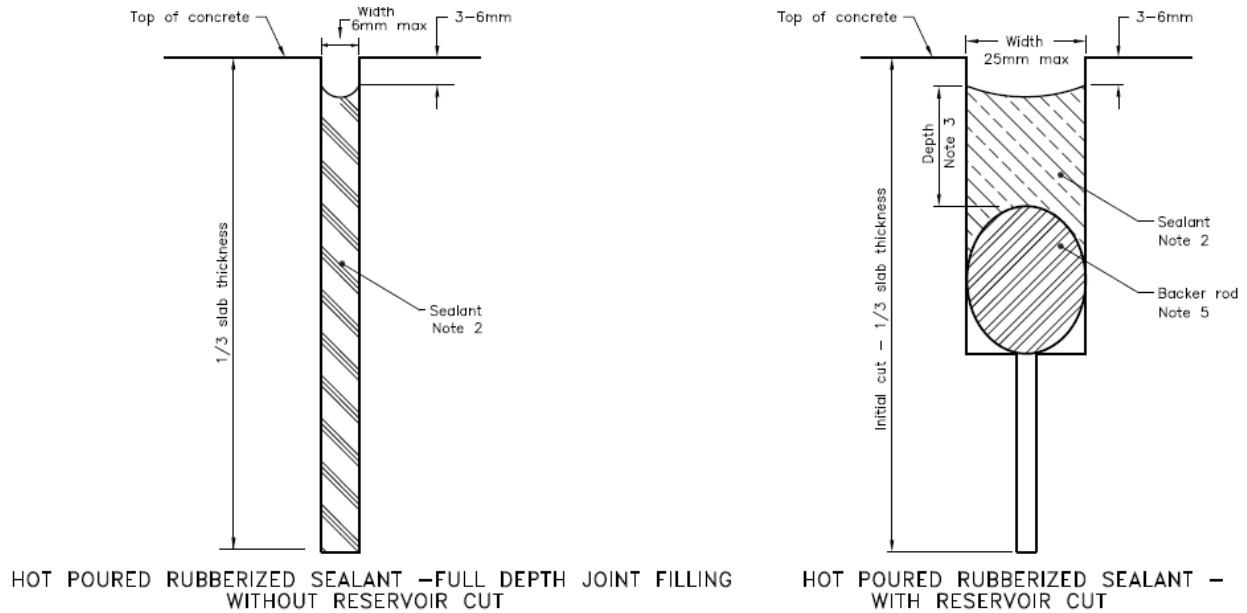
**Figure 5: New and Old Joint Design Schematics**

This change in joint design was made, because it was found that the joint deterioration started in the area below the joint sealant and backer rod, and above the bottom of the sawcut. Water, containing deicers, ponded in this area leading to the joint deterioration. The new joint design is narrower with a maximum width of 6 mm (Figure 6), and the joint is filled top to bottom with joint sealant.

One of the major changes in the new special provision is the joint design. The joint design was changed from one which included a 25 mm wide reservoir cut with backer rod to a 6 mm wide joint filled with a low-modulus joint sealant (Figure 5).

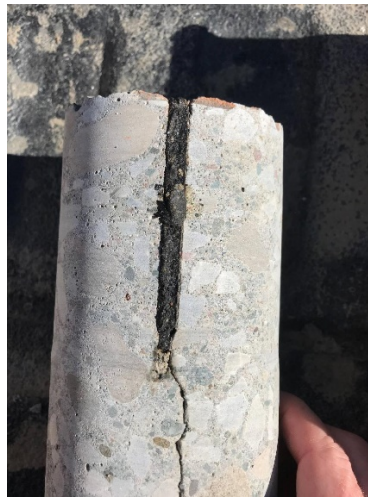
**Figure 8: Core at the Joint Filled with Sealant**

Another challenge was the construction of the new joint design. The contractor was required to produce a narrow joint cut with a maximum width of 6 mm, properly clean the joint to remove sawcut slurry and debris and then fill with a low modulus hot poured rubberized asphalt joint sealant to completely fill the joint. Cores were taken from joints to assess the joint cleaning and filling. Figure 8 shows an example of a well filled joint.
