Debris Flow Mitigation at the East Gate Landslide

Patrick Zerr, P.Eng.
Project Manager
McElhanney Ltd.

Paper prepared for presentation at the “Innovation in Roadway/Embankment Materials and Geotechnical Engineering Session” of the TAC 2023 Conference & Exhibition, Ottawa, ON

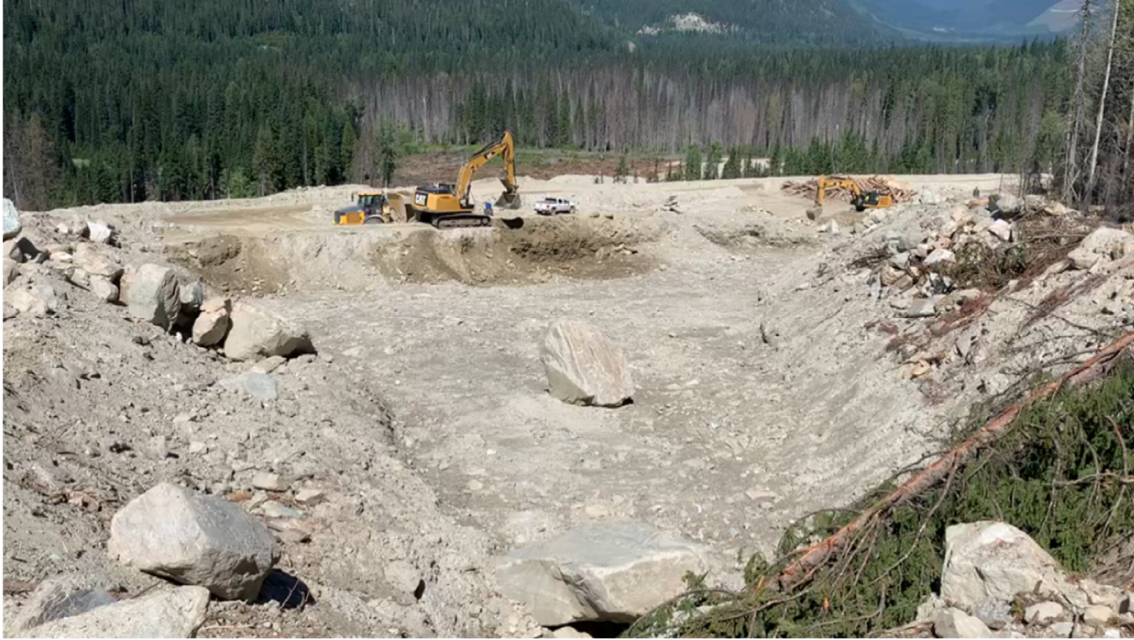
Figure 5 - Excavation of MRB

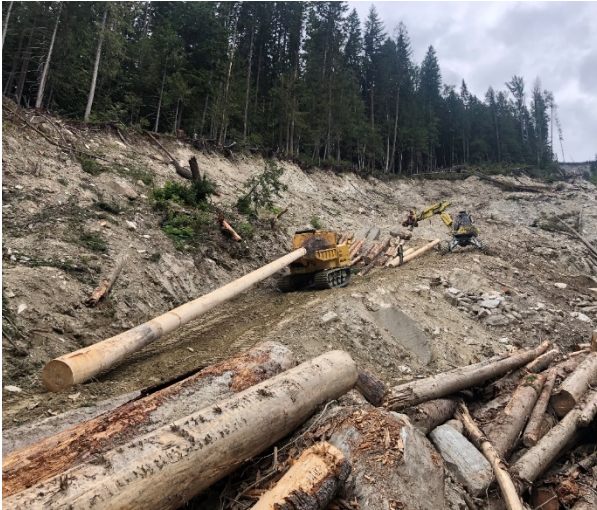
Figure 12 - Log supply by tracked vehicle along temporary access road. Photo by McElhanney (July 25, 2020).

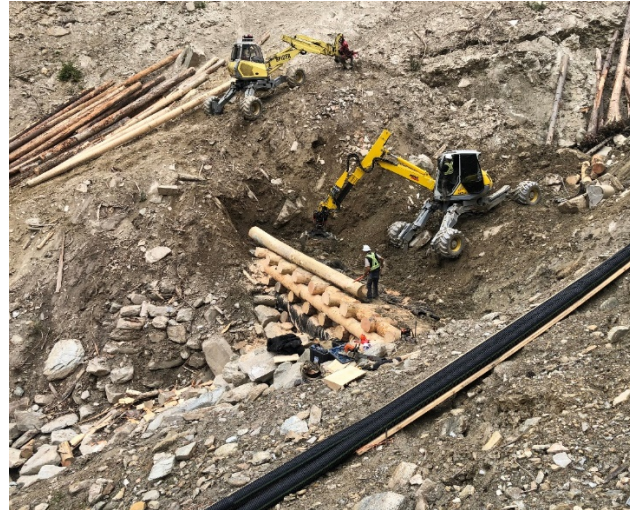
Figure 13 - Log placement for dam construction with spider excavator. Photo by McElhanney (July 25, 2020).

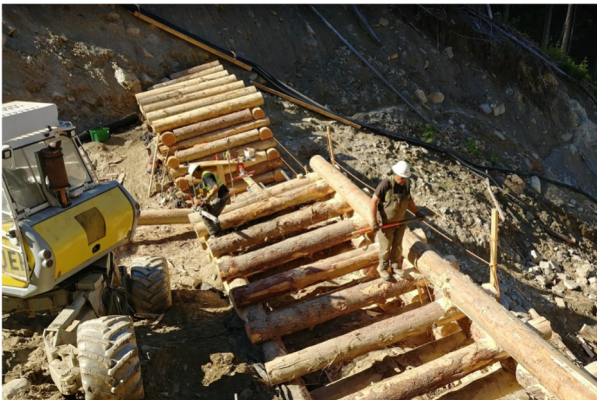
Figure 14 - Final placement and connection of logs completed by hand. Photo by McElhanney (August 18, 2020)

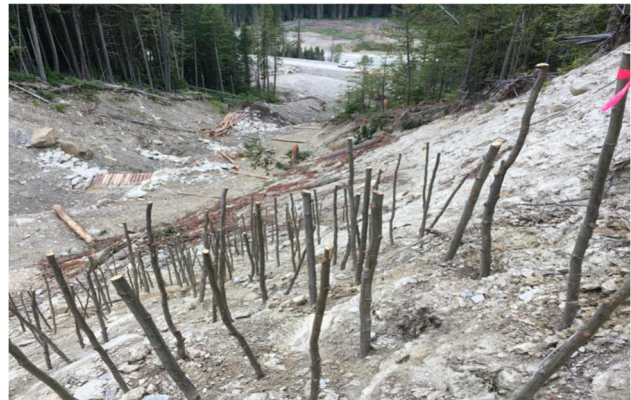
Figure 15 - Live-staking of gully side slopes. Photo by Brinkman Restoration. (August 31 – September 2, 2020)

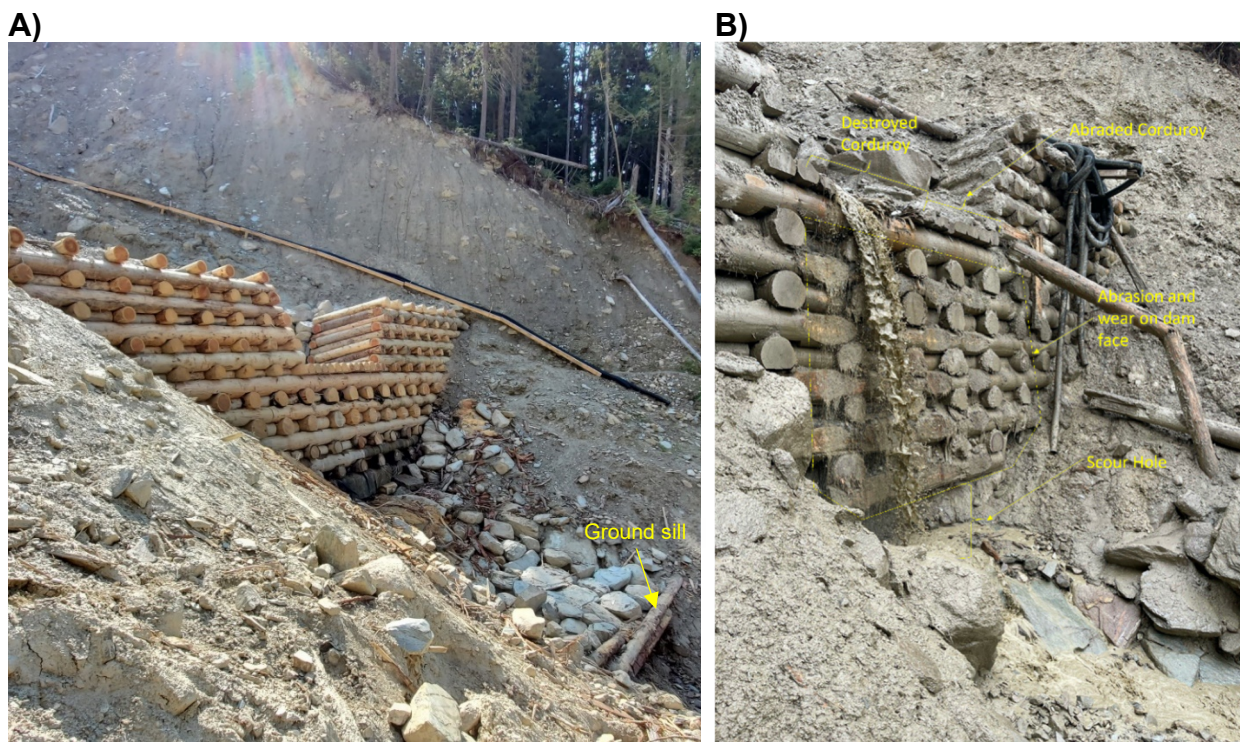
The 2020 Pilot Check Dam experienced its first debris flow on November 5, 2020 without damage; some minor deposition occurred on the right (in flow direction) wing wall. However, a ground sill made from logs across the channel and located several metres downstream to hold riprap in place was destroyed. This was likely due to insufficient lateral embedment.

Figure 16 A) 2020 Pilot Check Dam at end of construction (Photo Sept. 5, 2020 by BGC, J. Stratton), note; the downstream log ground sill was destroyed in the Nov. 5, 2020 debris flow event. **B)** Photo of 2020 Pilot Check Dam taken on June 9, 2021, note; destroyed (sacrificial) corduroy in weir, abrasion and wear on the dam face and scour hole undermining the check dam (Photo by Pierre Friele).

- **Toe Scour:** Figure 16 shows significant toe scour occurred. In addition, the foundation soil was washed out under the front mud sill (i.e., lower most stretcher). This poses a stability concern. Toe scour may have been accelerated by loss of the ground sill during the November 5, 2020 event. However, the scour hole may have formed regardless.

- **Abrasion:** Significant abrasion and wear is evident (Figure 16): The corduroy lining of the weir bottom was installed with round tops and flat milled bottoms. The round tops of the corduroy logs were abraded and flattened by an estimated 2 to 5 cm. The right half of the weir the corduroy was destroyed. The channel facing sides of the wing walls also show wear and abrasion but still appear to be intact. On the battered downstream check dam face, the debris has abraded concave shapes into the stretchers and worn the front of exposed headers.

- **Other Wear:** A piece of wood was split of the lowermost front stretcher of the left wing wall (Figure 16), presumably from a point load (boulder or log).

The root cause for the toe scour was identified as the limited integrity of the rip rap splash pad. It is likely that the high energy of the debris flow event was sufficient to dislodge one boulder creating a weakness of the entire splash pad which eventually washed-out. To create a splash pad acting as a single solid element, grouting of the riprap was introduced in the 2021 construction season.

This component of the check dam was always considered a sacrificial element, given the extreme exposure to the debris flow, and designed to be easily replaced in due course; what was not anticipated was the fact that it took only one year to damage it to the point that a replacement was already needed. Despite the knowledge that this system, also when fully built, would require regular maintenance until the duncutting is fully stabilized and the side slopes revegetated, the idea of an annual replacement of the corduroy was not acceptable. To strengthen the corduroy a 0.5in thick steel plate was installed and bolted to the check dam.

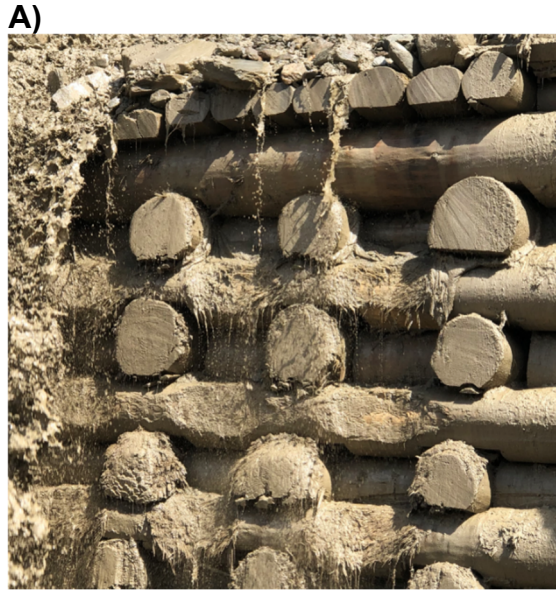
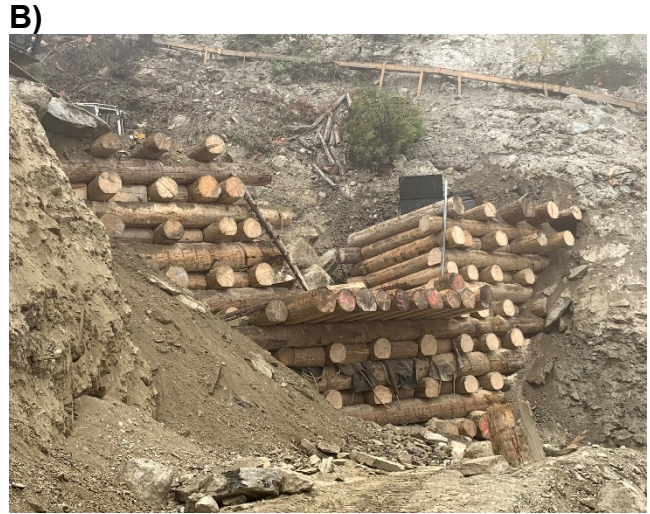
The angle to which the check dam is built (5V:1H) allows the water and mud flow to slide along the face of the check dam and also makes the front face an easy target for boulders and other debris transported downstream, which resulted in the significant abrasion shown in Figure 17A. To prevent this from happening in the subsequent check dams, the weir sill logs were cut 0.5 to 1.0m longer, creating an overhang which effectively protects the face of the structure. Figure 17B shows the improved check dam.

Figure 17 A) Front face abrasion observed after the 2021 freshet (Photo by Pierre Friele). B) New check dam built in 2021 with overhang to protect front face from abrasion (Photo by McElhanney)

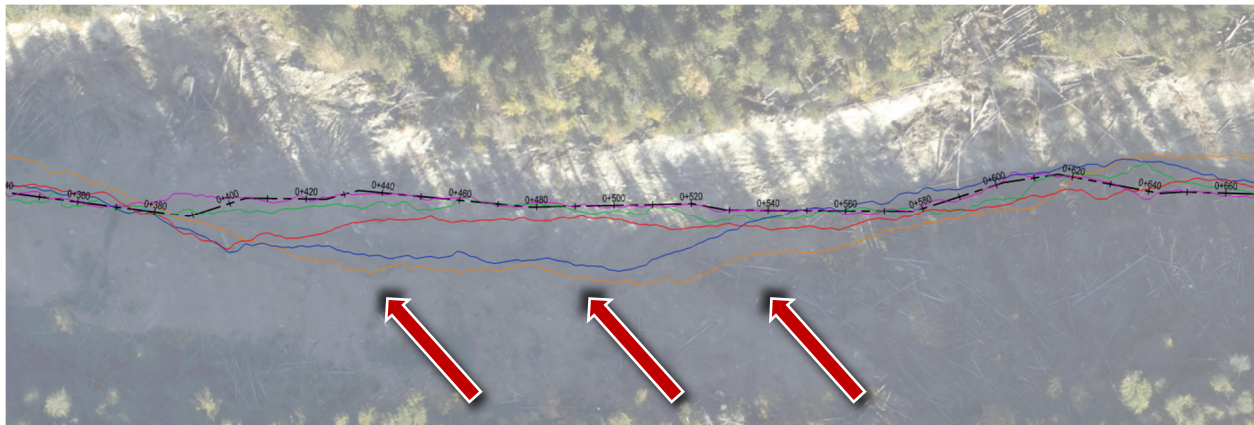
Between 2021 and 2022 significant movements occurred upstream of Check Dam 6, caused by a lateral landslide which pushes material from the left side of the gully towards the thalweg, which shifted over 20 meters since 2015 as shown in Figure 18.

Figure 18 Thalweg migration over the years. In orange, lower in the image, is the thalweg in 2015; in magenta, the thalweg in 2022

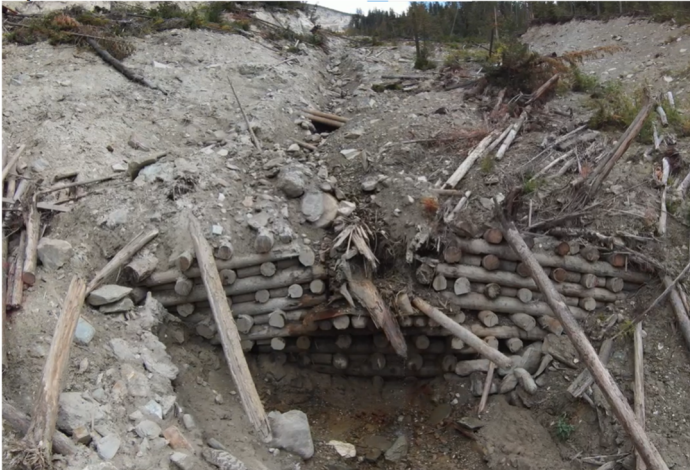
Due to this movement, as well as the lack of wing walls, Check Dam 6 has been completely buried by Spring 2022. Check Dam 4 and 5 were subject to significant damage, varying to partial crushing to complete failure and loss of the wing due to the soil pressure and significant displacements (Figure 19A).

Figure 19 A) Damage to Check Dam 5 caused by the Lateral landslide. B) Construction of sill log structures to stabilize the thalweg.

Fixing the damaged check dams was a relatively simple task, because of the modular construction of the structures. The contractor had to remove the damaged sections, re-establish a horizontal plane and re-assemble the wing walls.

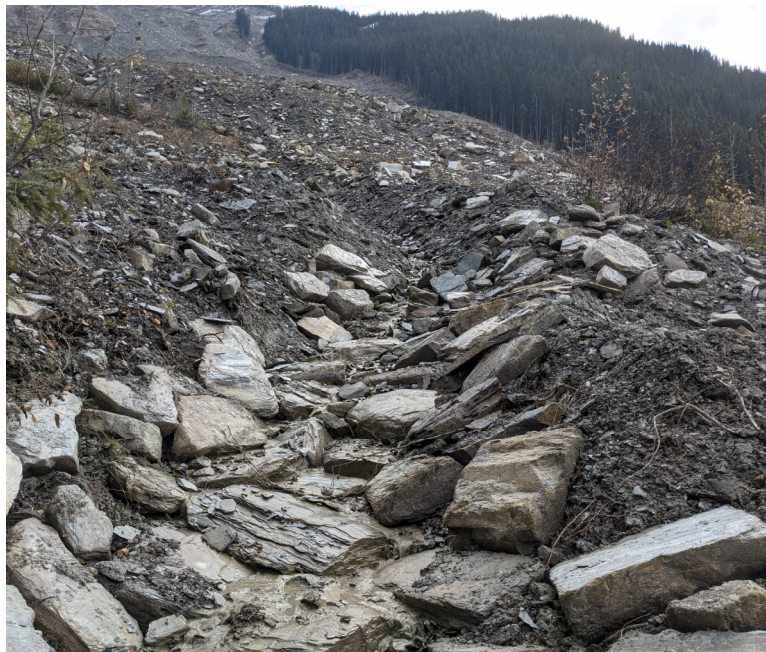
Figure 20 Drainage diversion in the upper catchment area
