**CRASH PERFORMANCE OF ENERGY-ABSORBING
GUIDE RAIL TERMINALS**

Ryan W. Esligar, MScE, UNB Transportation Group
Eric D. Hildebrand, PhD, PEng, UNB Transportation Group

of the 2012 Conference of the
Transportation Association of Canada
Fredericton, New Brunswick

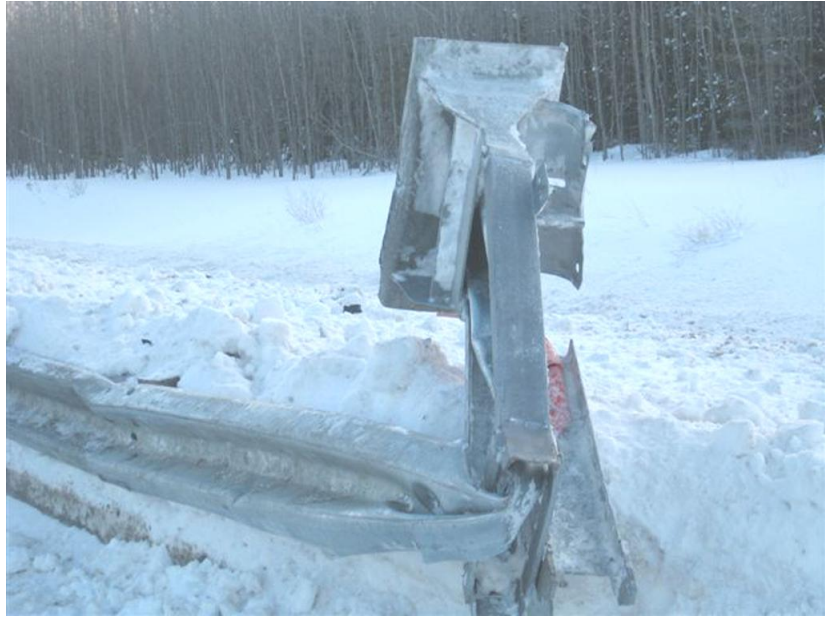
The retrospective review provided evidence of at least one collision in 2009 that was affected by a heavy accumulation of snow behind the terminal head. The snow had been cleared from the front of this EAGRT, exposing the terminal head, but had been left to accumulate behind the guide rail and terminal head. When the EAGRT was struck the snow prevented the guide rail from extruding through the terminal head. The guide rail jammed, causing the terminal head to swing upward as demonstrated in Figure 4. The terminal head was not able to absorb energy as designed. This caused the vehicle to decelerate suddenly. There were three occupants in the vehicle and all were transported to hospital with injuries.

FIGURE 4: Terminal head kinked upward adjacent to snowbank (Source: Brun-Way, 2009)

The study provided evidence that clearing snow from the front of an EAGRT's terminal head while leaving it to accumulate behind the EAGRT system is not ideal. It appears that the best option is to allow the terminal head to become buried in the snow. This will reduce the amount of impacts to the terminal head and requires less effort for snow removal. If a road authority decides to clear the snow from the front of an EAGRT's terminal head, it should also be cleared from behind the EAGRT system to provide adequate space for the extruded guide rail to travel during a collision.

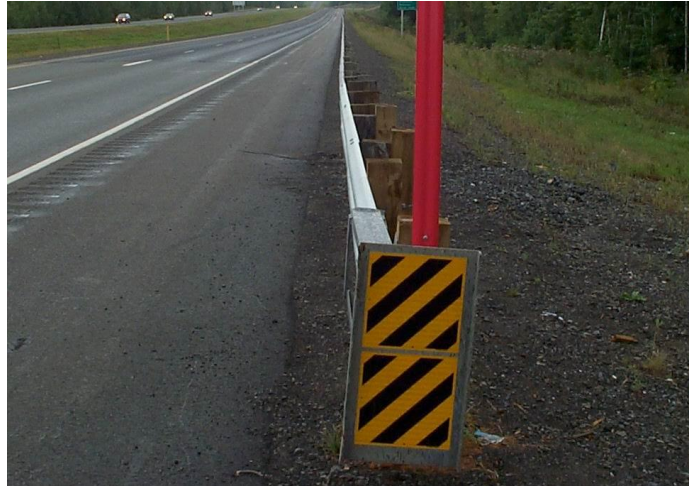
The EAGRT in Figure 5 was included in this study and was installed with a minimal offset of 15 cm, resulting in a flare of 100:1. There is nothing technically wrong with this installation; however, the installation does not take advantage of the maximum flare allowed by the manufacturer. In contrast, it is important to ensure an EAGRT system is not installed with too much flare. Figure 6 is an example of an EAGRT system installed with a 10:1 flare, which is more than allowed by the manufacturer. The EAGRT in Figure 6 was located in another province and was not part of this study.

FIGURE 5: EAGRT installed with 100:1 flare

None of the EAGRTs included in the detailed analyses were installed with the maximum allowable offset (flare). Any new EAGRT systems used in Snowbelt regions that are installed at a new location or at an existing location to replace a damaged system should be installed with a flare of 25:1 from the edge of the road, when possible. This would be extremely helpful in reducing snowplow impacts in areas that receive heavy amounts of snowfall. It may also be beneficial to consider using other systems such as the Flared Energy-Absorbing Terminal (FLEAT) which can be installed with a larger flare than the ET-Plus and SKT-350 systems (11). This would further reduce the probability of an impact with a snowplow.

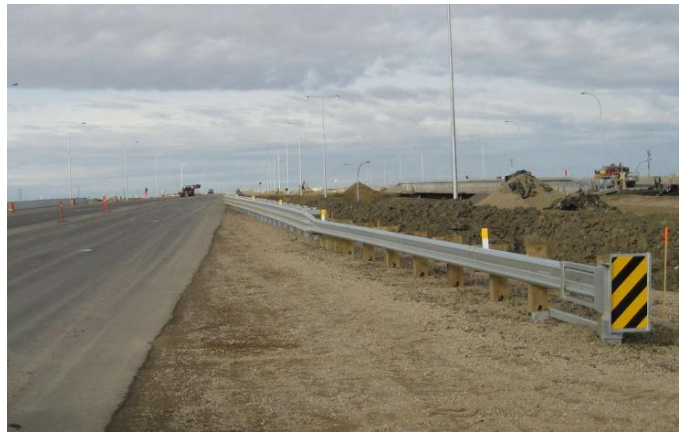
FIGURE 6: EAGRT installed with 10:1 flare

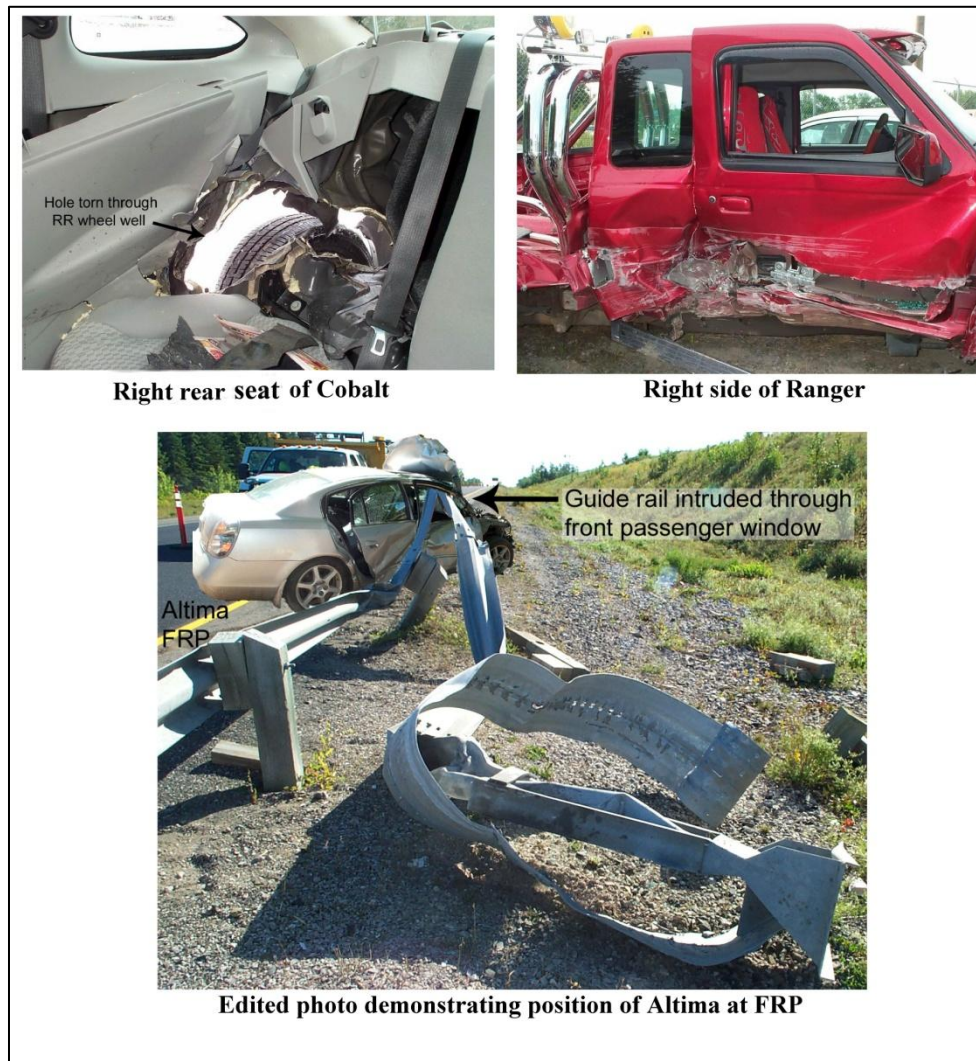
The Cobalt was impacted on its side, causing the terminal head to intrude directly into the rear occupant compartment. The Ranger was also impacted on its side, causing the lower portion of the door to intrude into the occupant compartment. The Altima was initially impacted on its left front corner, causing the vehicle to rotate into the guide rail. A kinked section of the guide rail then intruded through the front passenger window. Figure 7 demonstrates the extent of damage and intrusion into each vehicle.

FIGURE 7: Examples of intrusion into occupant compartment

The guide rail became kinked in all three of these collisions. Kinking of the guide rail is something that occurs often during EAGRT impacts and is unavoidable in many instances due to rotation of the vehicle. NCHRP 350 allows kinking of the guide rail during its crash tests, provided that no part of the guide rail or EAGRT intrudes or penetrates, or shows potential for intruding or penetrating, into the vehicle (2, 7). In fifteen of the eighteen collisions studied at least one section of the guide rail became kinked during the crash. The Altima demonstrated that the guide rail does have the potential to kink and enter the occupant compartment during a head-on impact; however, this was not a common occurrence throughout the study.

Sections of guide rail often become kinked during EAGRT collisions, which was the case in fifteen of the eighteen collisions included in the detailed analyses. A kinked section of guide rail intruded into the occupant compartment of one of the vehicles, but did not result in any injuries. Intrusion of the guide rail into a vehicle's occupant compartment should be considered for future studies.

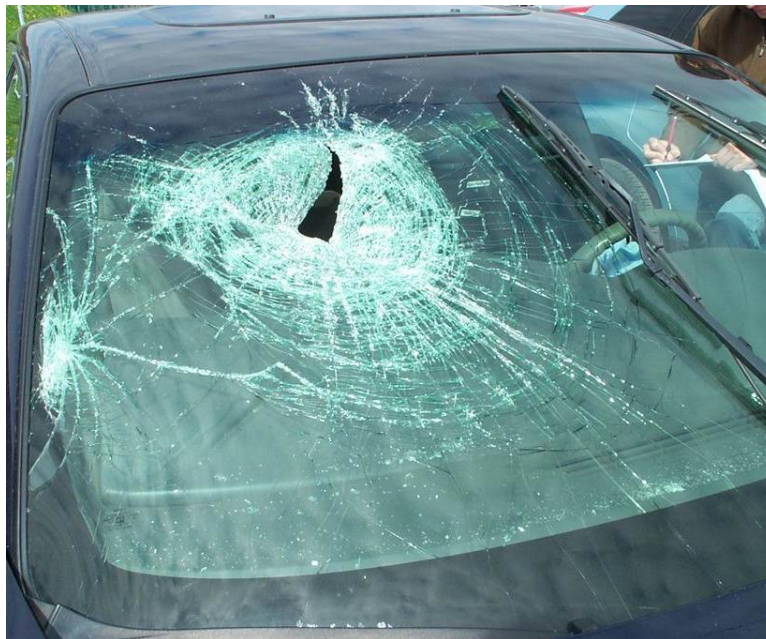
There were three instances during the study where the windshield of the impacting vehicle was struck by an exterior object other than the hood. These three vehicles were the Impala, the Neon, and the Rio5. The windshield of the Impala suffered the most damage and was actually punctured, as shown in Figure 8. All three collisions involved an ET-Plus system equipped with CRT wood posts. The damage was likely a result of contact with a CRT post, which typically break into two pieces when struck. This was not observed in any other collision involving HBA or plug welded posts because these types of posts are designed to remain attached to their ground anchors after impact, with the exception of the first post (8, 9, 10).

FIGURE 8: Punctured windshield of Impala

The HBA, plug welded, and CRT posts were all represented in the detailed analyses. There were data that suggested CRT posts may have made contact with and damaged the windshields on three of the vehicles in the study; however, there was not enough evidence to prove the damage was indeed caused by contact with the posts. The potential for CRT posts to act as a projectile during a crash is something that should be monitored in future studies.
