Highway 40 South of Kananaskis Lakes - Epicentre of the Storm

Des Kernahan, P. Eng.
Senior Transportation Engineer
Associated Engineering

Erin Rooney, P. Biol.
Biologist/Regional Manager
Summit Environmental Consultants, Inc.

Paper prepared for presentation at the
*Emergency Repair and Construction of
Transportation Infrastructure Damaged by
Catastrophic Environmental Events*

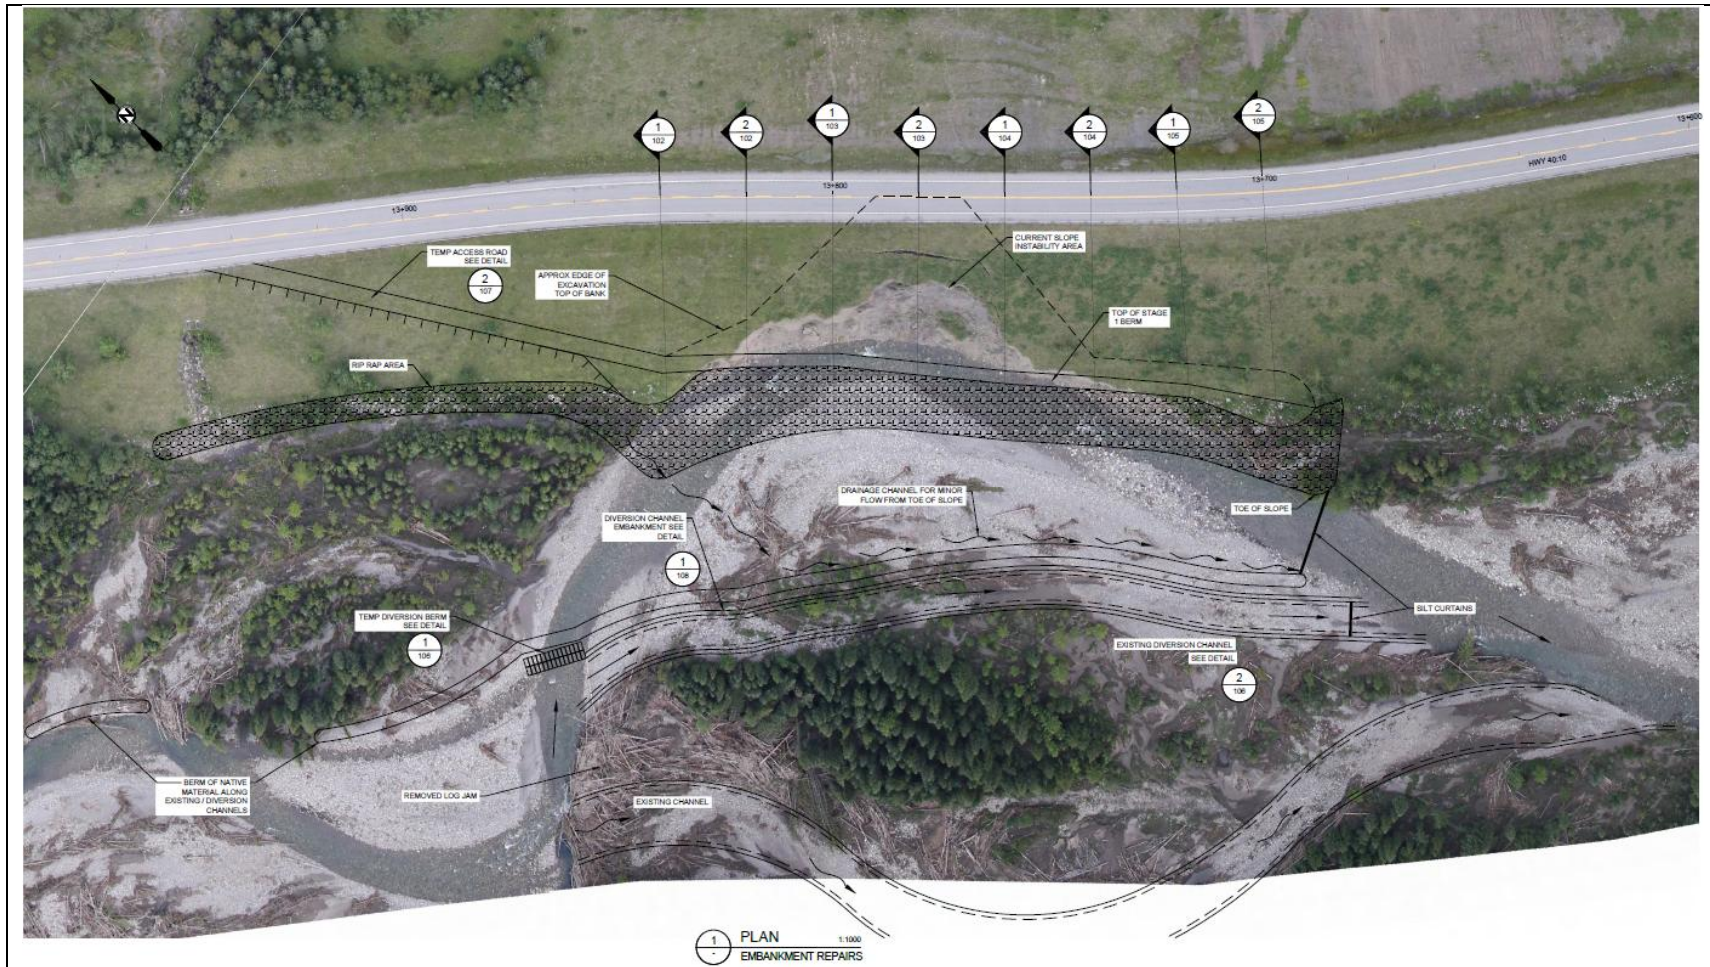
Figure 5 - Site 129 Rehabilitation plan drawing

The plan for this site changed in late October 2013, when cracking on the roadway surface was noted above the failure. This created a major concern that the slope instability was larger than originally assumed, and if this site were left in its current state freshet flows in the spring of 2014 could further scour the toe of the embankment. This could result in additional upslope failure, and subsequent failure of the road surface itself. In addition to the potential disruption to the highway, complete failure would result in large inputs of sediment into the Highwood River, which would impact fish and fish habitat. Hydrotechnical work was initiated to determine an effective plan for diverting the main flow away from the toe of the slope to allow it to be reconstructed and armoured to prevent future damage. Due to the concern of major damage occurring during freshet flows, the initial goal was to complete the first stage of the repair prior to winter shut down. Winter conditions arrived before plans and regulatory approvals could be obtained. Changing site conditions in the spring of 2014 resulted in activities starting in late May, during high water. Diversion channels were constructed and established, and built to withstand freshet flows.

A plan showing the diversion and reconstruction plan is included as Figure 5. The approach is based on a temporary diversion of the river that minimizes the disturbance to the watercourse and fish habitat, and utilizes the historical capacity of the river that is currently being limited by a large log jam. The toe of the re-constructed slope has been established to an elevation above the high-water mark, and was not affected by 2014 freshet flows because of the diversion measures implemented. Completion of the reconstruction of the slope will be completed mid-summer 2014.

Once isolation was complete, the repairs of the embankment slope commenced with the addition of fill material, rebuilding of the slope to match the adjacent embankment slope (approximately 2.5 Horizontal to 1 Vertical). The fill consisted of native rock/washout material excavated from other washout sites along Highway 40 and borrow material. The toe of the embankment slope (Stage 1 berm) was armoured with heavy rock rip rap (approximately 4 metres high, 600 cubic metres). Approximately 30,000 cubic metres of fill material was required to entirely repair the embankment slope.

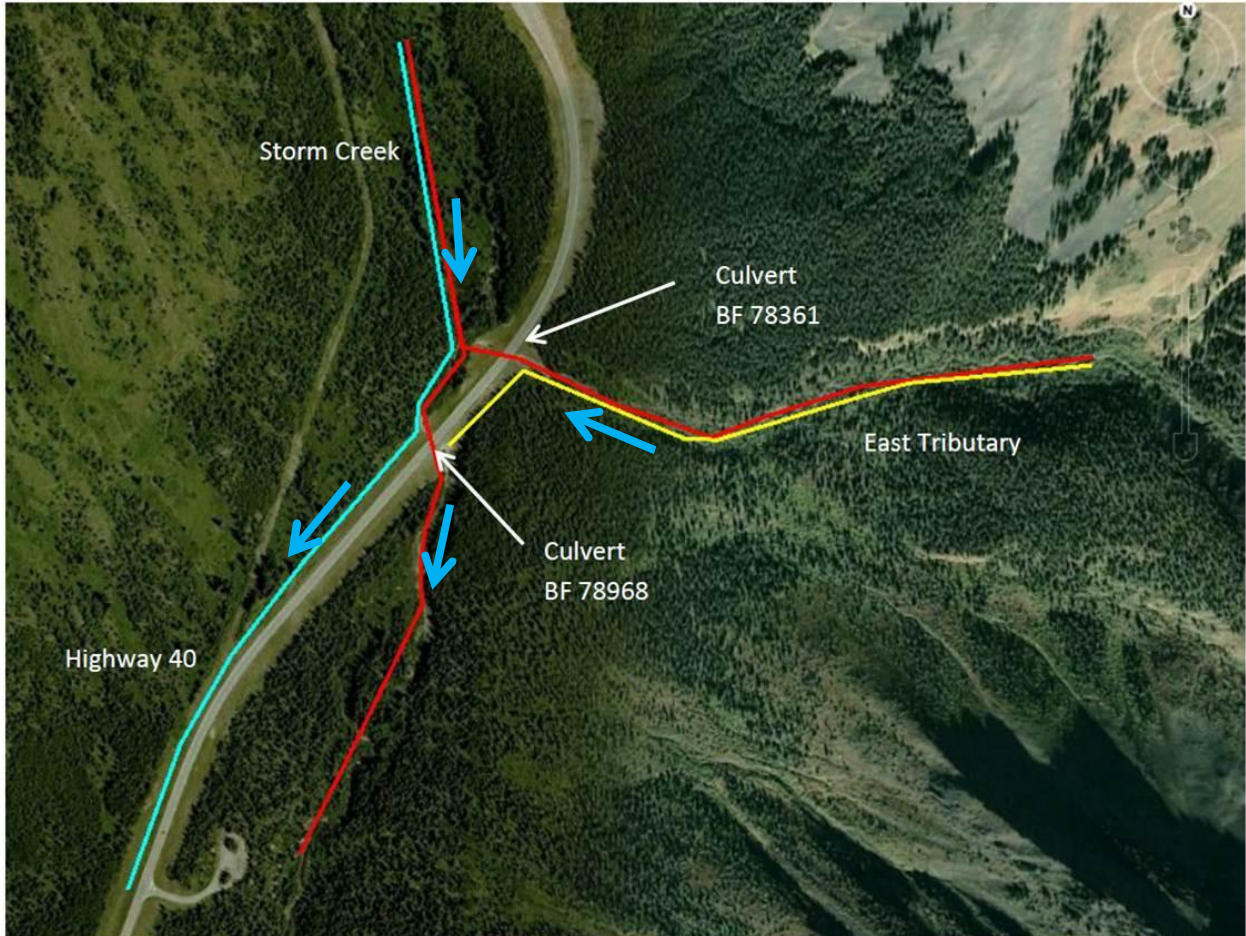
Figure 6 - Site 92 Flow Interaction (red indicates pre flood flow pathways and turquoise and yellow indicate post flood pathways)

Site 92 was the most complex site on the project from a hydrological, environmental and repair strategy perspective. At this location, major debris flows plugged two large diameter culverts and existing drainage courses, resulting in a complete change in the location of Storm Creek and a tributary from the east as illustrated in Figure 6. BF 78361 is a culvert on the north end of the site and conveys flows from the east tributary. A second, larger culvert (BF 78968) south of BF 78361 services Storm Creek itself. The infilling of BF 78361 diverted the east tributary along the east side of Highway 40 for about 160 metres to where it rejoins the original channel of Storm Creek. The infilling of BF 78968 resulted in Storm Creek being diverted away from its original course to the west side of the highway, creating a new highly unstable channel carved out along the west ditch line of the highway for about 2.5 kilometers.

It was apparent during the initial assessment that at some point during the flood the east tributary flowed over top of the highway, then re-establishing a new channel east of the highway resulting in major erosion damage to the east sideslope, the northbound lane road structure and half of the southbound lane road structure for approximately 160 metres between the two culverts. This left only one lane drivable, and deteriorating due to erosional forces and instability of the embankment. In addition, there were numerous locations along the new Storm Creek channel on the west side of the highway where major scours impacted the sideslope and west side of the road structure. In order to re-establish pre-flood conditions, encourage stability of the channel, maintain adequate flow for fish passage and water quality along this section of Storm Creek, a seven stage construction plan was developed and executed as described below. This work was completed in the fall of 2013.

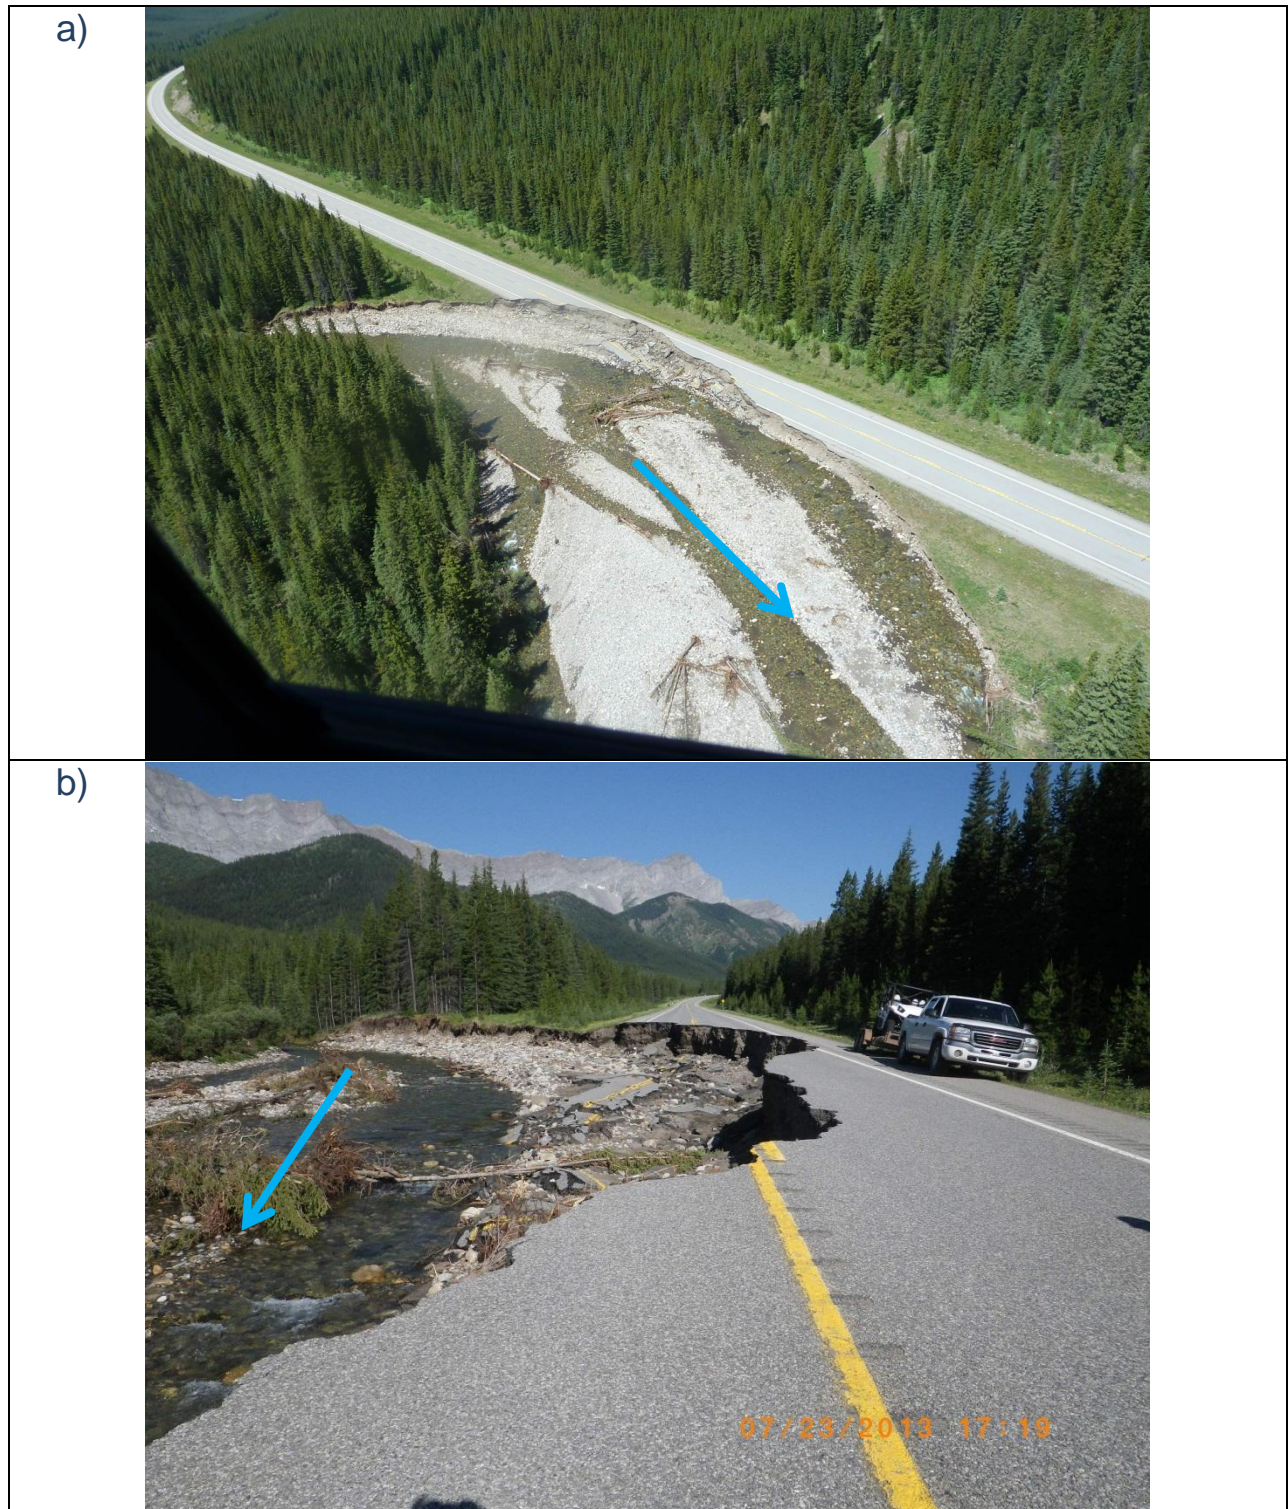
At site 106, there was an existing meander in Storm Creek to the west of the highway. During the flood the water level raised significantly, resulting in the outside of the meander pushing further to the east where it caused major erosion damage to the highway embankment. The resulting scour was approximately 70 metres long, and at the widest point only the east shoulder of the pavement surface remained in place as illustrated in Photoplate 1.

Photoplate 1 - Site 106 Storm Creek a) aerial photo post 2013 flood; b) Site photo facing upstream

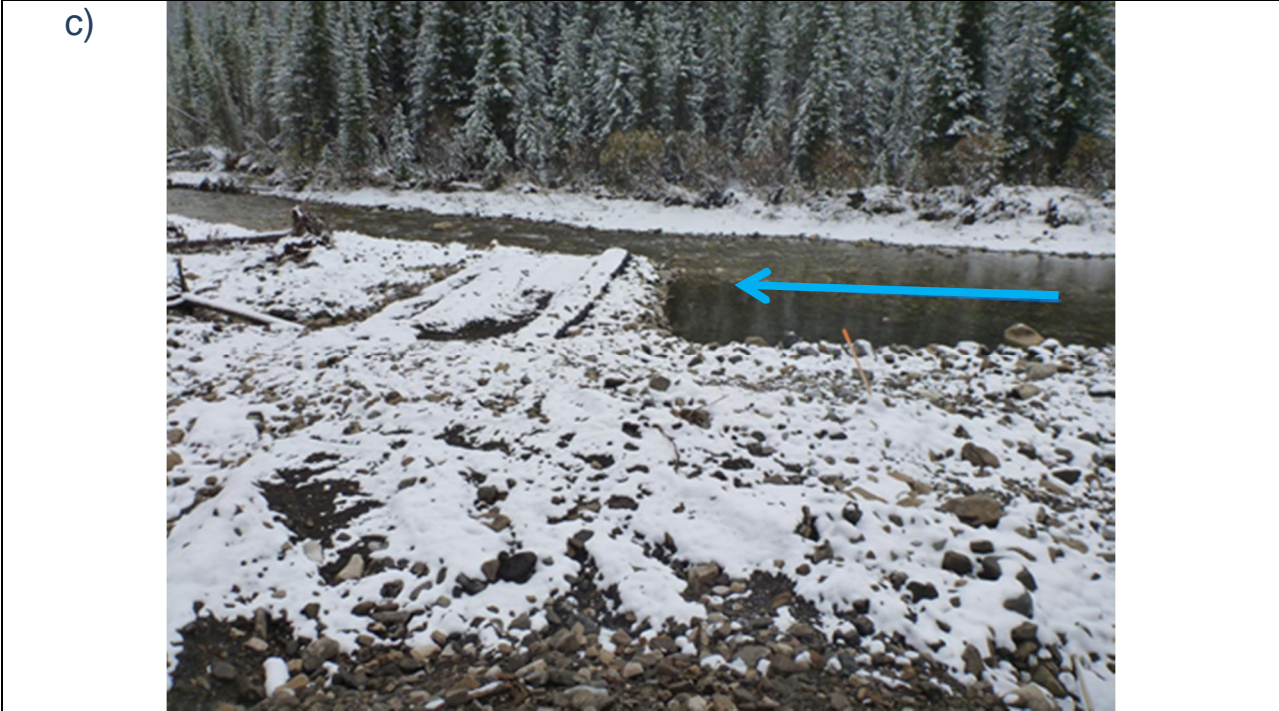
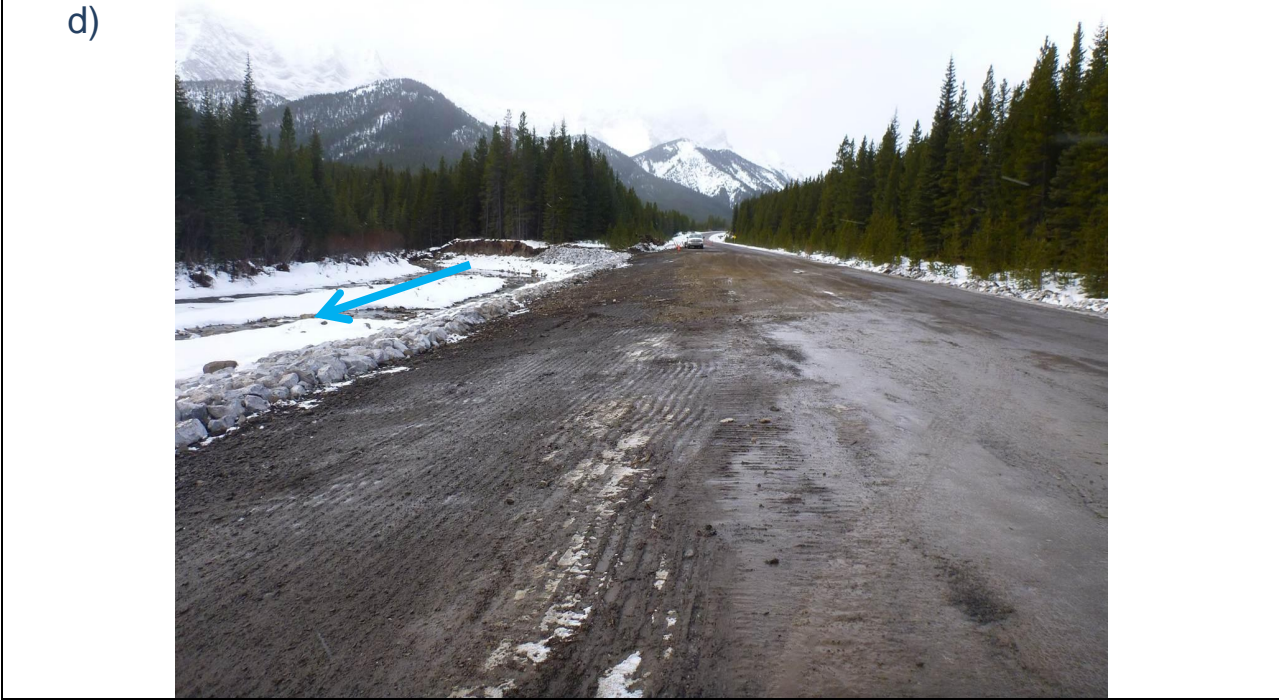
Photoplate 1 (cont'd) - Site 106 Storm Creek c) Isolation berm installed outside of Restricted Activity Period; d) Post rehabilitation activities

The first step at this site was construction of an isolation berm on the upstream end of the site to enable the reconstruction of the highway embankment to be completed in the dry. Storm Creek is a Class A stream, with highly sensitive bull trout fish spawning habitat. As such, the lowest impact instream work window was between August 16 and 31. As the Contract had not been awarded prior to this period in 2013, the isolation work at this site (and several other sites) was completed as part of the Stage 1 work carried out by Alberta Transportation's Maintenance Contractor. The isolation berm, shown in Photoplate 2, was constructed using lock blocks, locally sourced rock and geotextile.

Once the isolation measures were in place, the reconstruction of the roadway embankment was relatively straight forward and was included in the Stage 2 portion of the Contract. The embankment was reconstructed using locally sourced rock debris, with grades and contours to replace the pre-flood conditions. Heavy rock rip rap was used to armour the embankment to the high water level to protect the roadway from future high flow events. The reconstructed road embankment is shown in Photoplate 2.

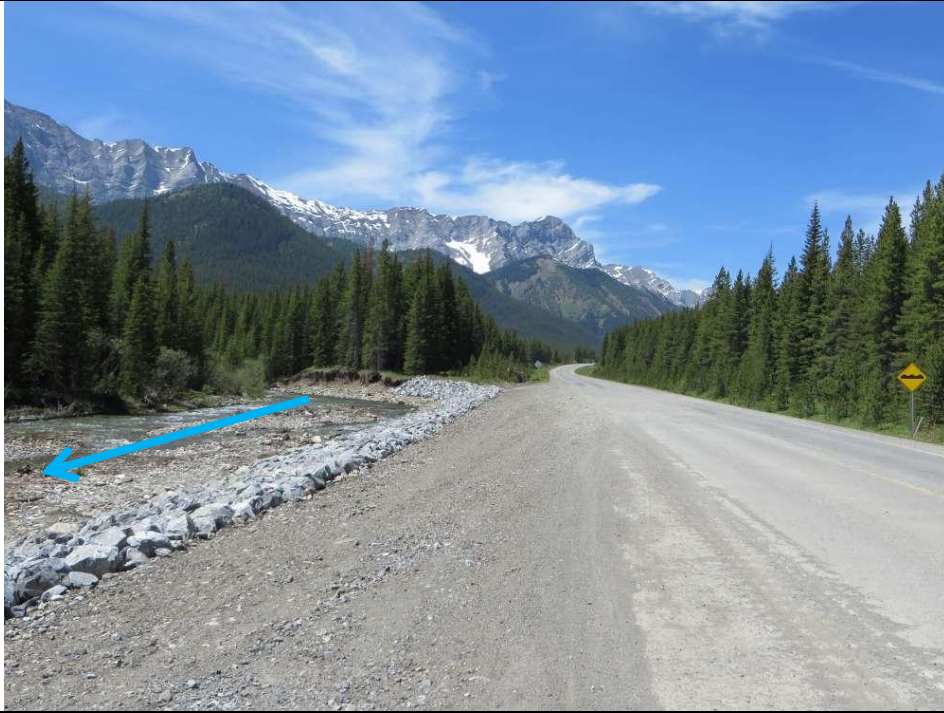
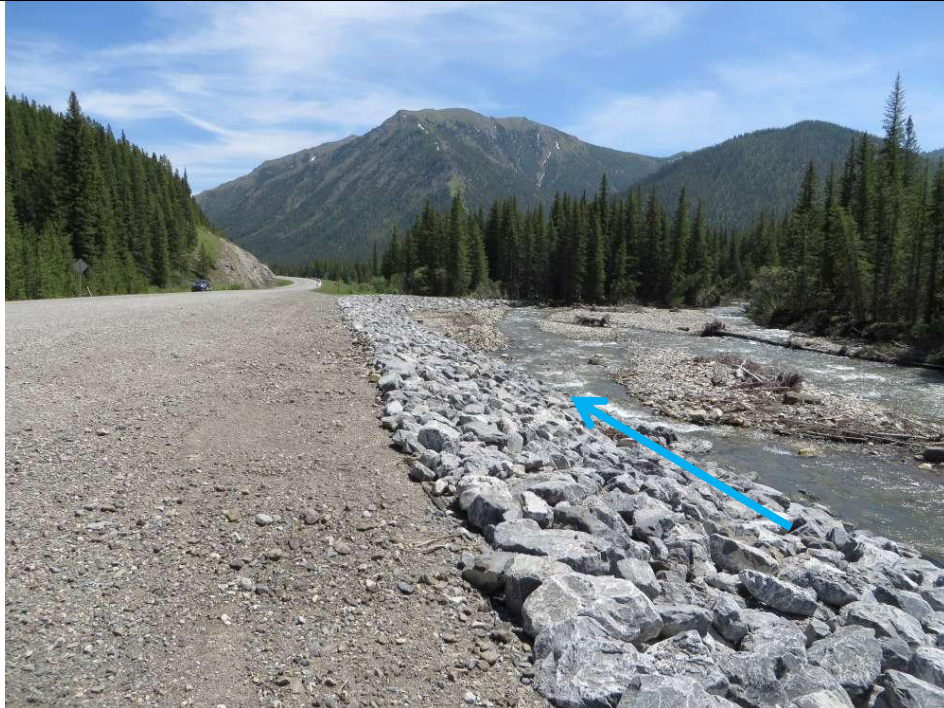
Photoplate 1 (cont'd) - Site 106 Storm Creek e) Post rehabilitation activities in summer 2014; f) Post rehabilitation activities in summer 2014

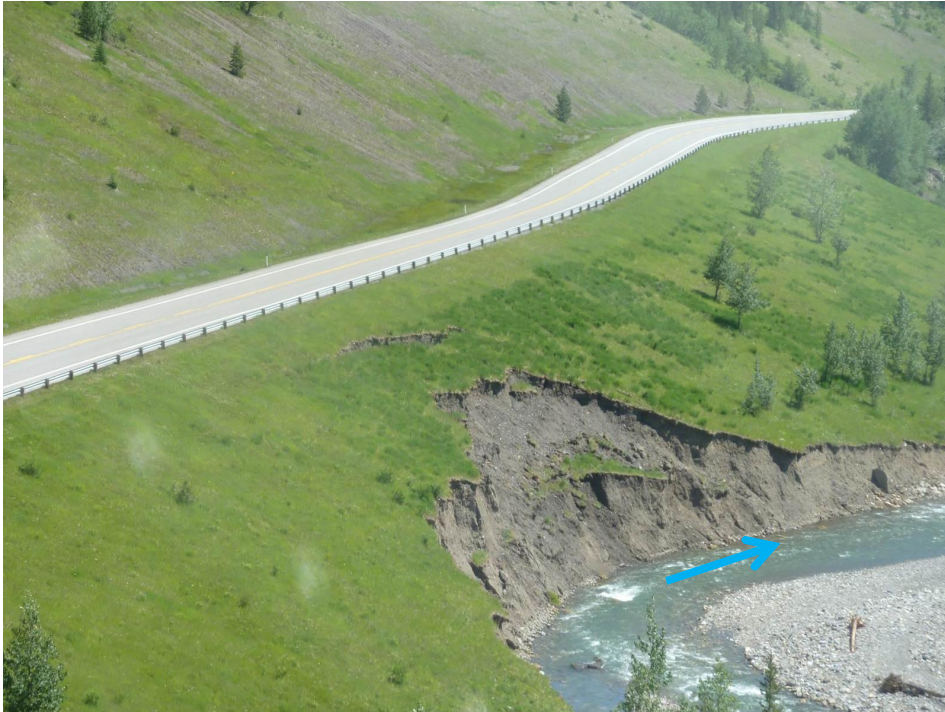
Site 129 is located between the Lantern Creek and Lineham Creek Recreation Areas, approximately 14 km north of Highwood House (junction with 541 and 940). At this location, Highway 40 is approximately 17 metres higher in elevation than the Highwood River. Prior to the flood event, the main river channel was west of the toe of the highway slope. The entire floodway and valley bottom shows historical use of another channel further west, approximately 150 metres from the fill slope. During the flood, these channels became blocked with tree and rock debris, forcing the main flow of water to the east towards the highway. As a result, a major erosion scour was created at the toe of the embankment slope, resulting in subsequent upslope failure as shown in the aerial photo in Photoplate 3. The failure was approximately 130 metres long at the base and 11 metres high, with an additional major crack on the sideslope between the main failure and the roadway surface. During the initial site investigation, this location was designated as a Stage 4 site, on the basis that it was less urgent as it was not impacting the roadway

Photoplate 3 Site 129 Highwood River – a) Post 2013 floods facing downstream; b) During reclamation, diversion channel and slope re-building

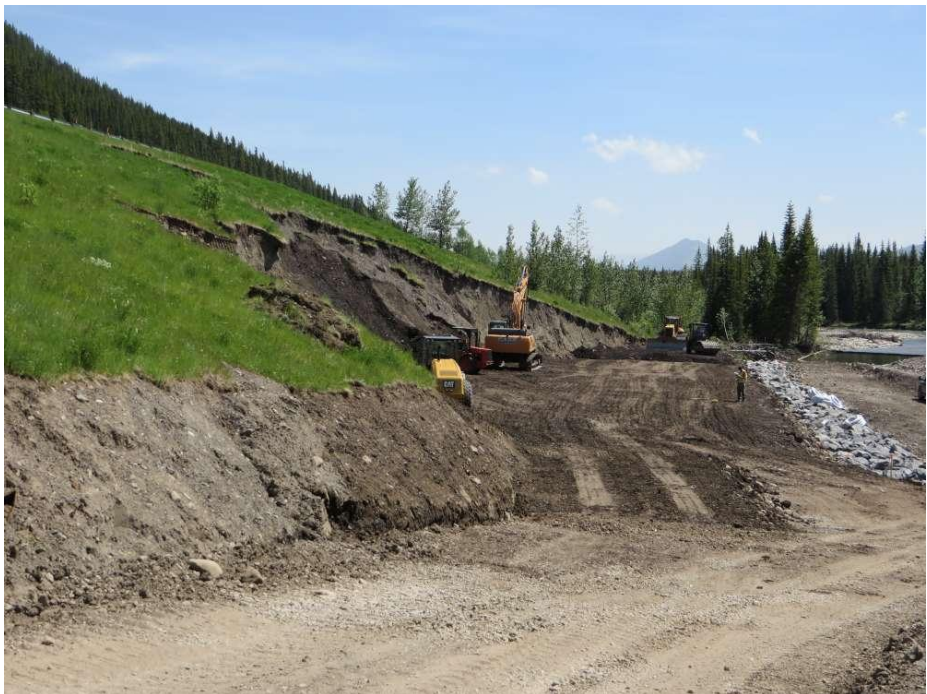
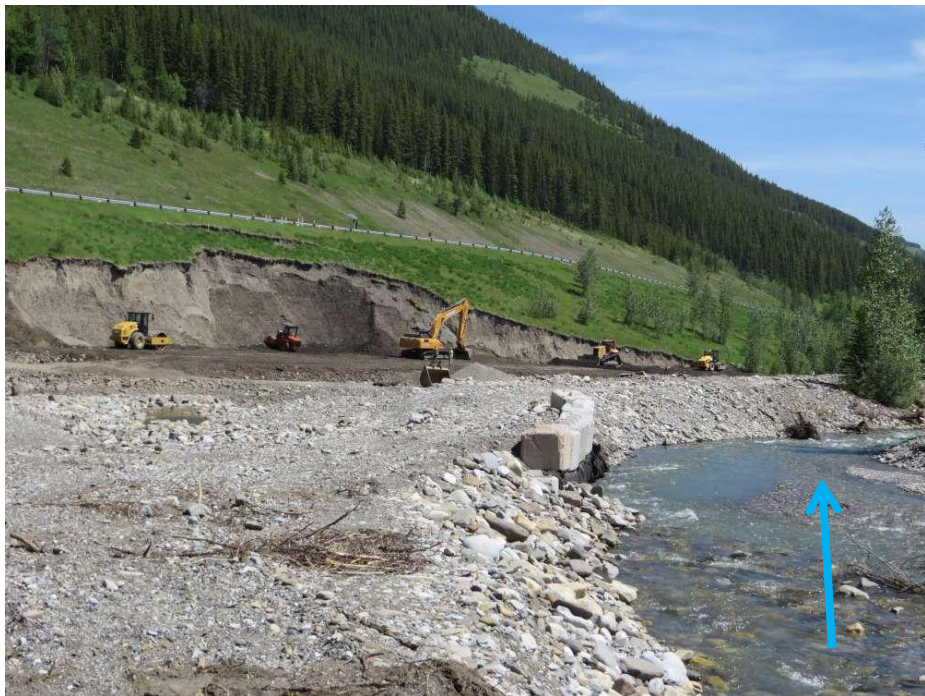
Photoplate 3 (cont'd) Site 129 Highwood River – c) During reclamation, slope re-building; d) during reclamation, slope re-building – note temporary diversion lock-block berm

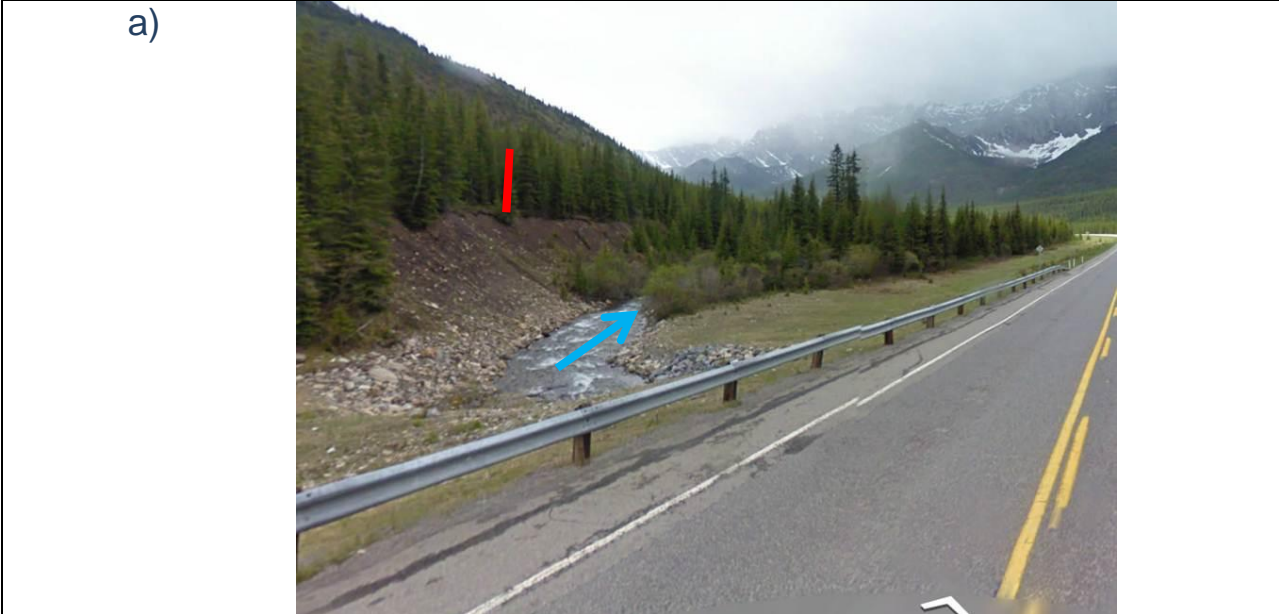
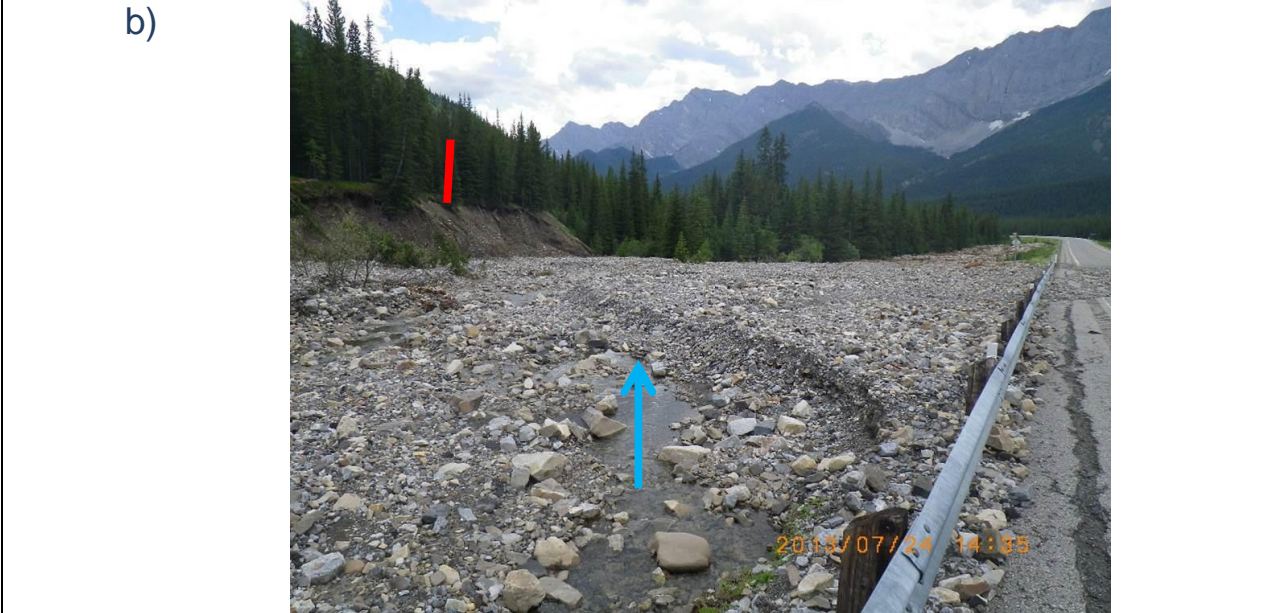
A sequence of pictures looking downstream from BF 78968 are included in Photoplate 4, showing the pre-flood, post-flood and post-repair conditions.

Photoplate 4 - Site 92 Storm Creek a) Pre- 2013 flood; b) Post 2013 Flood. Point of reference indicated with red line.

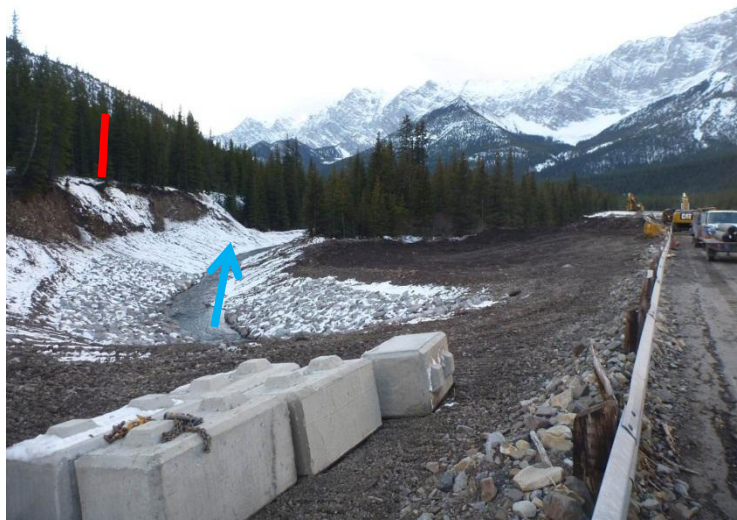
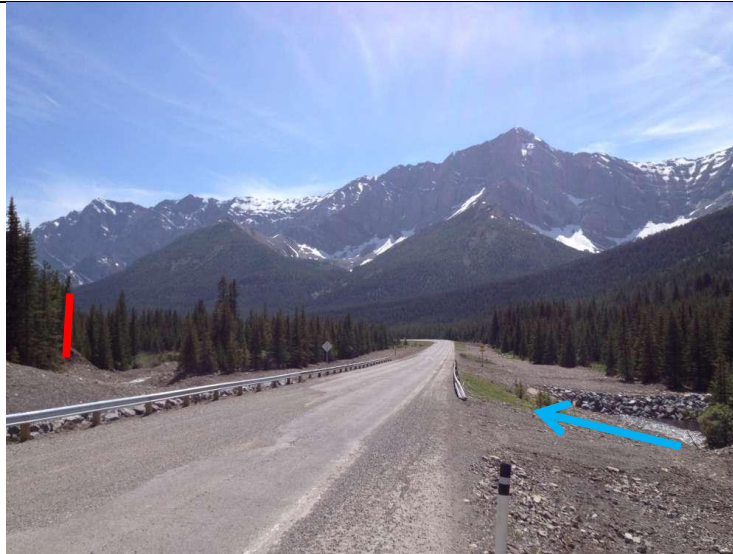
Photoplate 4 cont'd- Site 92 Storm Creek c) Post-Reclamation d) Summer 2014 Post Reclamation

Stage 7 involved widening out the east ditch to the highway side slope embankment between BF 78361 and BF 78968 to maximize the channel cross-section and provide emergency over flow should BF 78361 be plugged in a future flood event. The roadway embankment was re-established using approximately 1,000 cubic metres of native rock and fill. Heavy rock rip-rap was placed along the side slope to prevent future erosion and protect the embankment from another major flood.

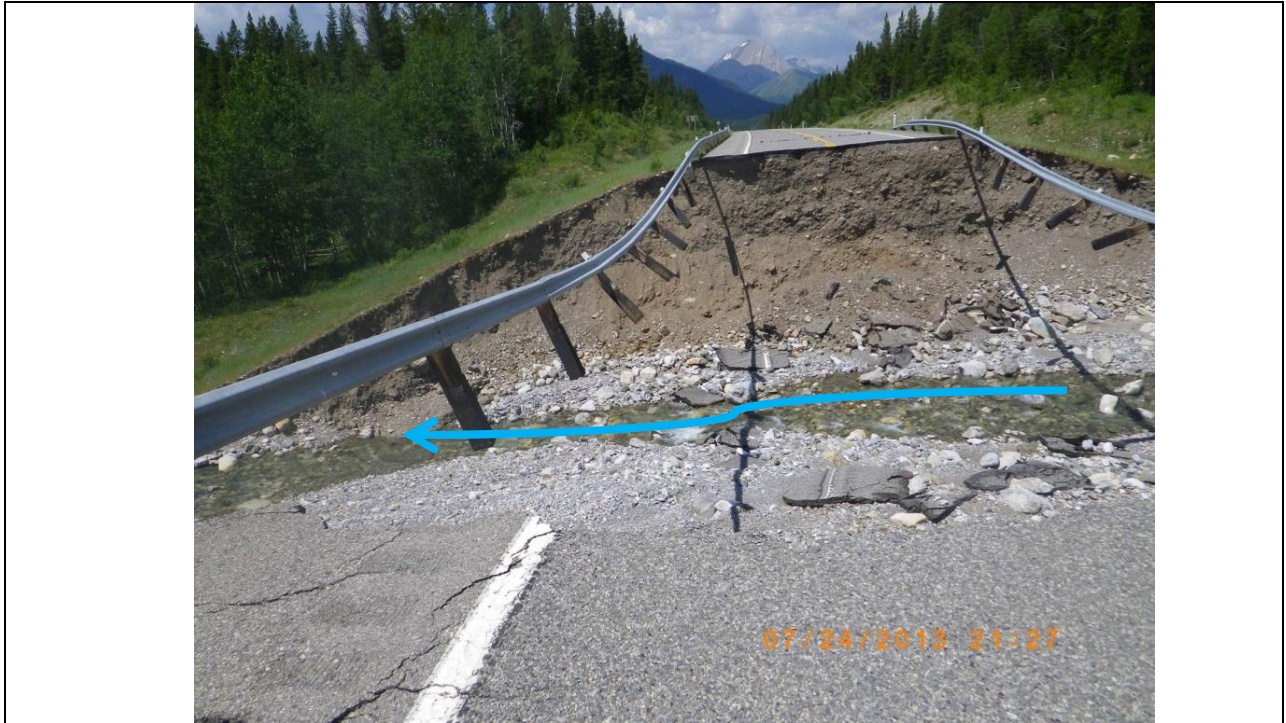
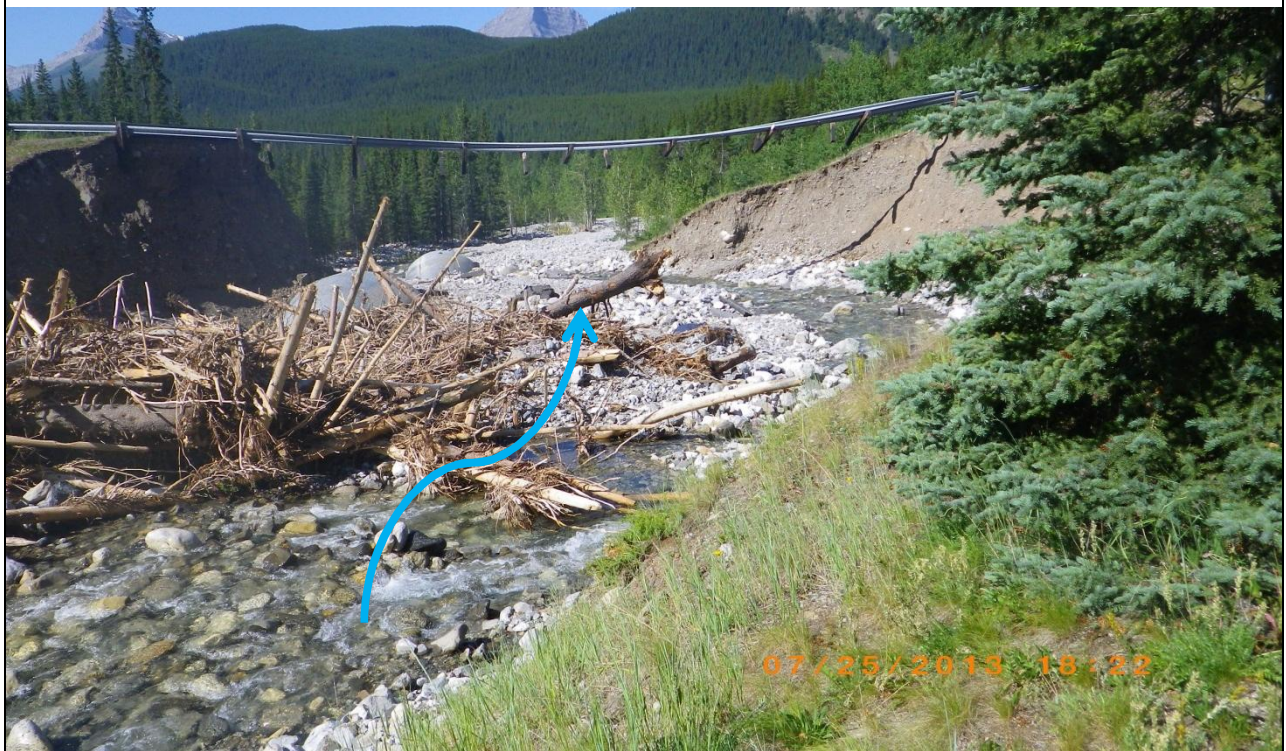
Photoplate 5 - Site 133 Lineham Creek site facing north; Facing downstream
