KICHI SIPI BRIDGE TO CROSS LAKE INNOVATIONS IN DEEP FOUNDATION DESIGN AND CONSTRUCTION

Paper prepared for presentation
at the Innovations in Bridge Engineering Session
of the 2005 Annual Conference of the
Transportation Association of Canada
Calgary, Alberta

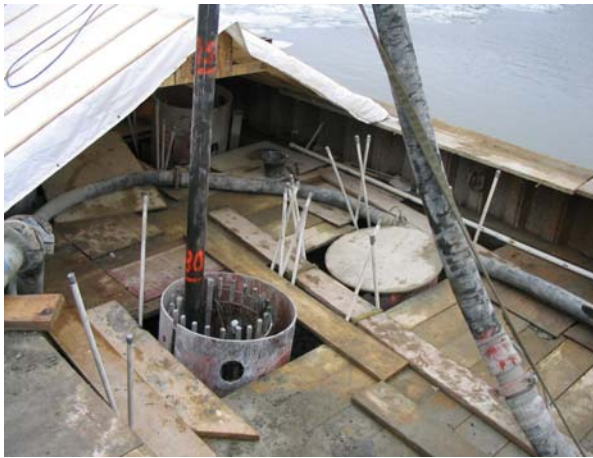
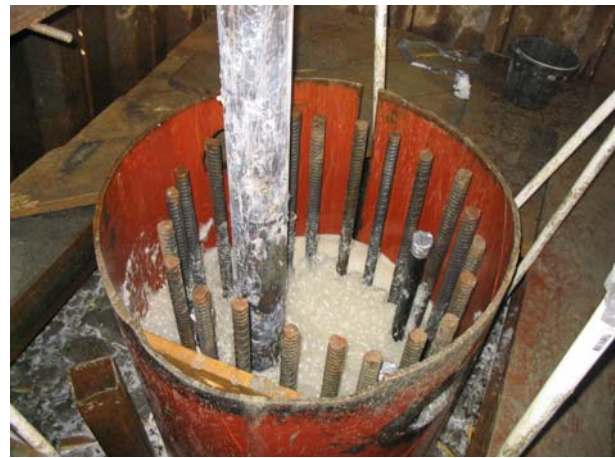
The final caisson of eighteen on the project had a line plug early in the pour. It is believed that the tremie pipe may not have been fully re-inserted into the already placed tremie concrete following clearing of the line plug. During the time that the Contractor encountered difficulties placing the tremie concrete in the caisson in question, it was observed that the water in the caisson was becoming white and foamy, a potential indicator that some of the admixtures had washed out of the concrete. The attached photo documents this observation; however the nature of the deficiencies in the concrete was not known until after the Crosshole Sonic Log testing was completed.

Photos 10 & 11: Close-up view of tremie placement at an individual caisson. Note the milky colour and foam in the water of the caisson that later required remediation.

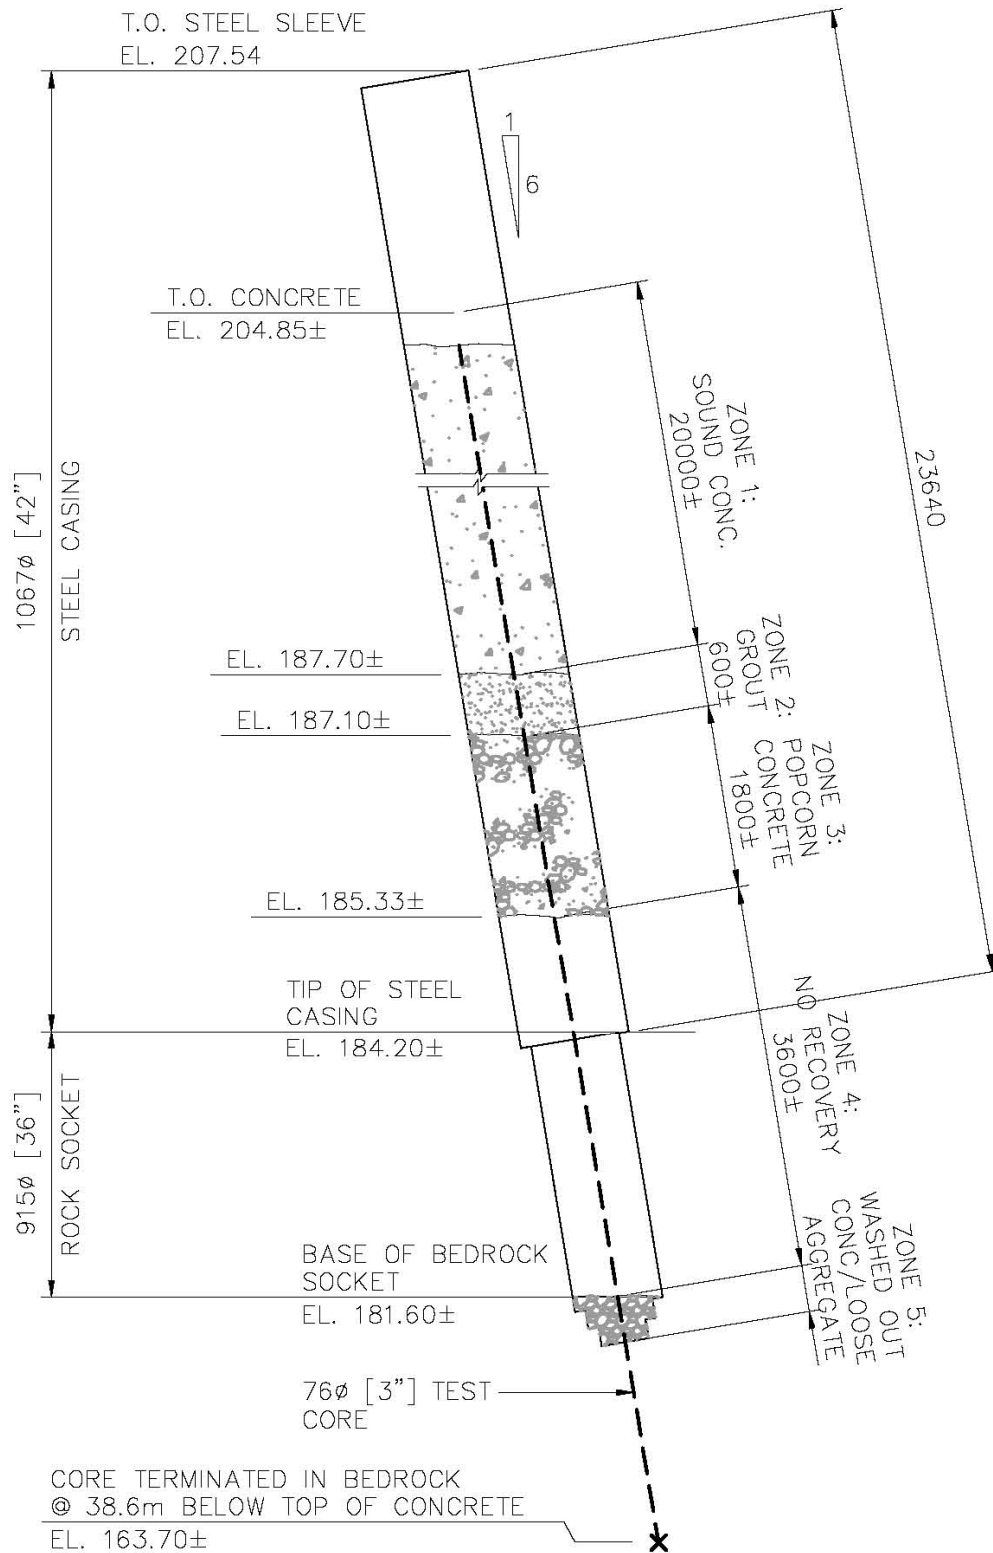
Results from all six tube pairings tested in the caisson identified two potential anomalies. The first anomaly was evident between approximately 16.1 and 17.3 metres depth and appeared to be a zone of somewhat softer (low density) material. The second anomaly was evident between approximately 18.2 and 21.5 metres depth and appeared to be a zone of very soft (very low density) or voided material. The remainder of the concrete above 16.1 metres appeared to be consistent with sound and uniform conditions, similar to all previous caissons. A sketch illustrating the defective zones is provided in Figure 5.

The anomalies were later verified by a full-depth 75 mm diameter core, and the core results verified that the bottom 6.83 metres of caisson concrete was of questionable quality, including, in descending order, a zone of primarily grout with a trace of coarse aggregate, a zone of voided and honeycombed or “popcorn” concrete, and a zone where no core recovery was possible. This lowest zone was assumed to be a loosely bound coarse aggregate matrix. The average compressive strength of samples taken in the upper grout zone was approximately 7 MPa.

Figure 5: Sketch showing the defective concrete zones as identified by the CSL testing and verified by coring.

- In the zone of good concrete (Zone 1 as per Figure 5) the smooth walls of the core hole were visible.
- In the zone of primarily grout (Zone 2) there was no aggregate visible in the matrix. Various voids were visible.
- In the zone of “popcorn” concrete (Zone 3) various voids were visible, including larger open voids and areas of honeycombing. Darker aggregate appeared to be visible as part of the concrete matrix. It also appeared that though the hydrodemolition did not remove the concrete as intended, at a minimum it removed any loose cement/sand mix adjacent to the core. In general the voids seemed to be relatively large in size, with larger voids interconnected and surrounded by what appeared to be a “solid” concrete matrix. In this region various CSL tubes and reinforcing bars were also visible among the voids, which assisted in orientating the view and providing a sense of scale.

Several repair and replacement options were discussed, and a decision was made to hydrodemolish and airlift the questionable concrete in the bottom 6.8 metres of the caisson, add pre-placed aggregate, and pressure grout the repair zone from the bottom up to fill the voids in the aggregate with a cement/sand paste. Pre-placed aggregate was to be backwashed prior to pressure grouting to facilitate bond. This method had never been attempted before in Manitoba and raised a number of concerns that were noted and discussed prior to initiating the repair.

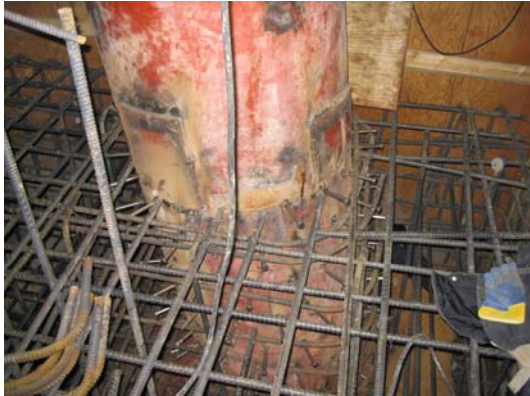
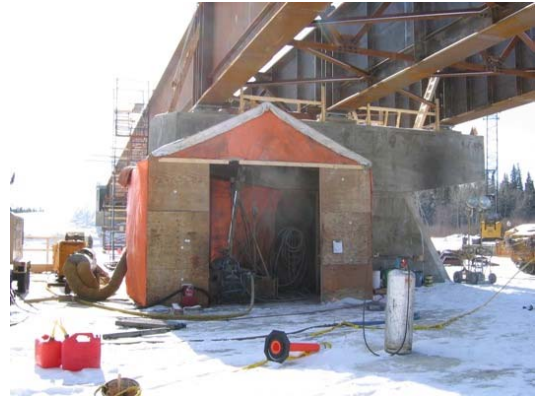
Photos 12 and 13: (Left) View of the steel Nelson studs welded onto the exterior of the sleeve as part of the modifications to provide fixity between the caisson and the pile cap. (Right) View of heated enclosure to facilitate coring, hydrodemolition and grouting operations, as well as dywidag installations off the ice in cold weather.

Due to the tight construction schedule and continued remediation of the caisson, the Contractor requested permission to proceed with construction of the submerged pile cap and the pier, prior to completion of the remediation works. During design the caissons had been located outside the footprint of the pier shaft above to improve constructability (reduce congestion of reinforcing) but within half the distance of the pile cap depth to eliminate the demand for shear reinforcing. (A nominal amount of shear reinforcing was still included in the pile cap.) As a result, the

caisson steel sleeve could be left intact, protruding up through the water and future ice level to maintain access to the caisson, while constructing the pile cap around this caisson. Also, in order to proceed with this work, pile cap modifications were required to allow access to the caisson, yet ensure transfer of loads from the pile cap to the caisson in the final configuration. Nelson studs were welded to both the exterior, and later the interior of the steel caisson sleeve to allow load transfer from the pile cap concrete through the steel sleeve into the caisson concrete.

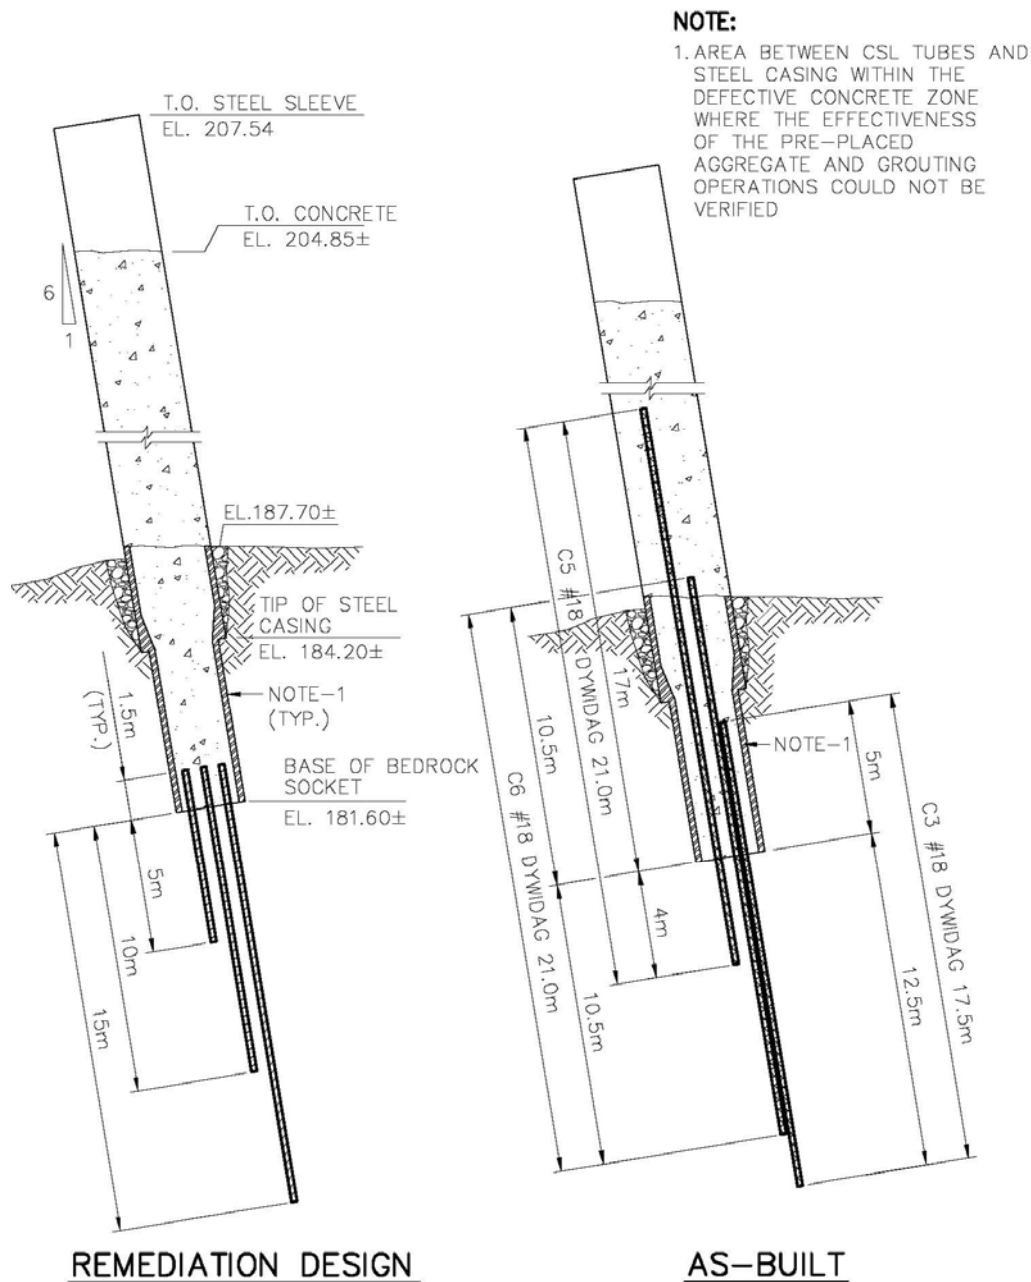
Early coring efforts resulted in losses of steel casing and core barrels within the repair zone, which further reduced an already limited target zone at the base of the rock socket and increased the complexity of the dywidag installations. For these reasons, the Contractor was only able to install dywidag anchors to depths that extended 4, 10.5, and 12.5 metres into the bedrock below the base of the rock socket. It was determined that the overall skin friction provided by the three mini-piles as installed was adequate for the required vertical load transfer.

Based on site observations during the caisson remediation, hydrodemolition did not appear to effectively remove any defective concrete from the caisson's rock socket, and as a result the repair in this portion of the defective zone would not allow for adequate transfer of the vertical load from the caisson into the dywidag anchors. To ensure that adequate vertical load transfer was provided two of the three dywidag anchors were extended up into the sound caisson concrete above the defective zone of concrete, effectively "bridging" the repair zone. Final analysis of the completed installations verified that vertical load transfer was provided irrespective of the quality of the concrete repair in the bottom six metres of the caisson. In effect, the pre-placed aggregate and grout was required only to encase and provide lateral support to the dywidag bars within the repair zone.

Figure 6: Dywidag installation details to transfer vertical and lateral loads from the sound concrete in the caisson to the underlying bedrock.

Three dywidag anchors were installed in the mini-piles to transfer the vertical and lateral loads to the bedrock as a pinned connection. Figure 6 indicates the design requirements for the dywidag installations, as well as the as-built conditions.

As noted previously the initial design consisted of three dywidag installations in 122 mm diameter mini-piles. The three dywidags were to be embedded a minimum of 1.5 metres into the caisson and extend 5, 10, and 15 metres respectively into the bedrock below the base of the rock socket. Due to difficulties encountered during coring and hydrodemolition, these installation requirements were revised during caisson remediation to best suit the present conditions.
