Forensic Pavement Study: Practical Methods, Analysis and Applications

Paper prepared for presentation

of the 2010 Annual Conference of the
Transportation Association of Canada
Halifax, Nova Scotia

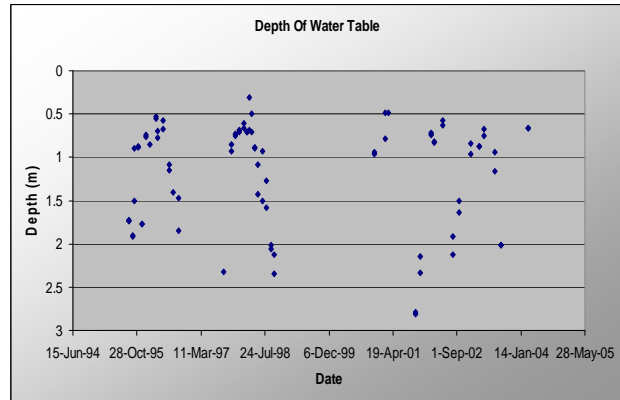
Figure 8: Annual Water Table Trend (360801)

Figure 8 provides annual water table elevations from the piezometer installed at station 30.48m of section 360801. The results indicate a seasonal change in water table with the majority of samples showing a water table of less than 1m from the surface to periods when the water table fell to a depth greater than 2m from the surface. The depth to water table at the time of the forensic study was 1.08m. The median between the east and west lanes has a culvert that passes under the west bound lanes and drains towards Lake Ontario. The eastbound passing lane has a curb with catch basins draining to the median whereas the driving (slow

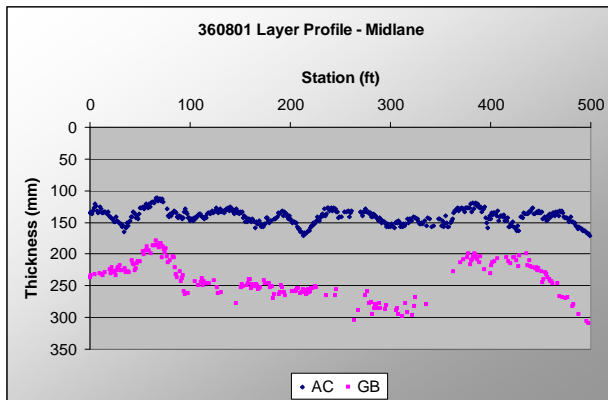
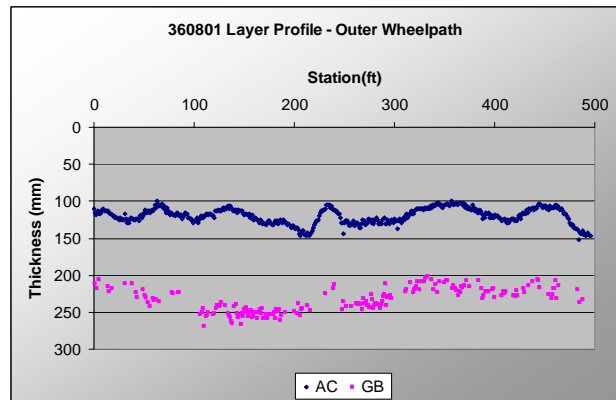
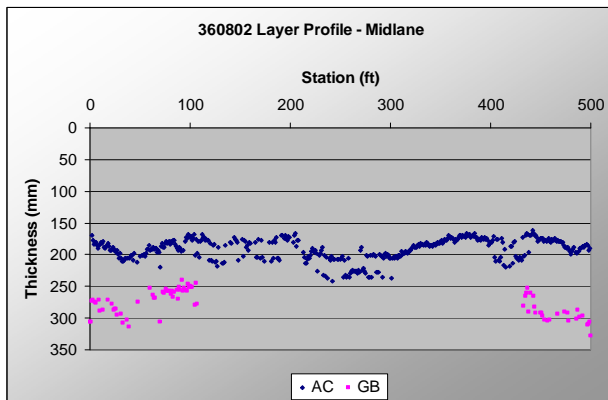
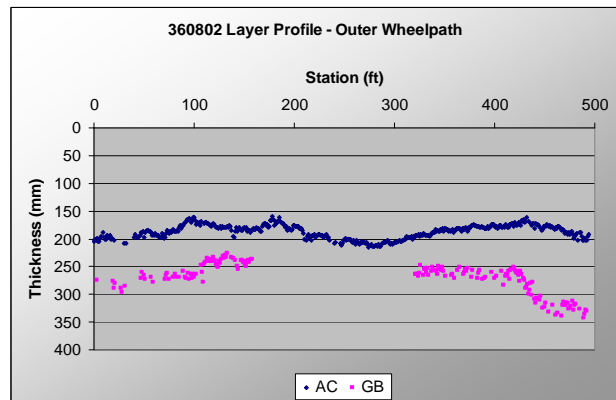
This data was collected for the purpose of documenting the variability in thickness of the asphalt surface and aggregate base layers of the pavement structure. Figures 9 & 10 and Figures 11 & 12 provide the results of the GPR survey for the midlane and outer wheel path of sections 360801 and 360802, respectively. To determine layer thickness at the time of construction, rod and level measurements were taken at 15.2m intervals at the completion of final grade for each pavement layer. These results were used to determine the average, minimum, maximum thickness and standard deviation of each layer. In addition to the rod and level measurements, core samples taken outside the limits of the 152.4m section were also used to determine the sectional layer thickness.

The results of these surveys indicate a high variability in the thickness of the various layers with the average thickness for of the aggregate base being thicker than design specifications for 360801 and within specifications for 360802. The asphalt surface layers were found to be thicker than the design specifications in both cases. This variability was confirmed by the results from the GPR survey. Tables 4 and 5 provide a comparison of the layer thicknesses as determined from the rod and level survey and the GPR survey for each section. The results show a lower minimum and higher maximum thickness for the AC material in most cases. There is also a fairly large difference in AC thickness from centerline to edge of pavement. The midlane, on average, is thicker than the inner and outer wheelpath. The aggregate material also shows high variability as is evident by the higher standard deviation over the length and width of the sections. GPR is an excellent method of determining variability within a pavement structure with some tolerance limitations when determining actual thickness. The GPR data for this section would indicate that the construction platform was variable with the construction tolerances being outside the design specification of ± 7 mm.

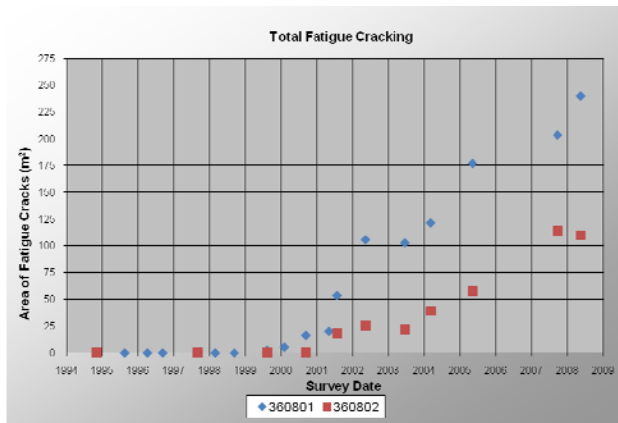
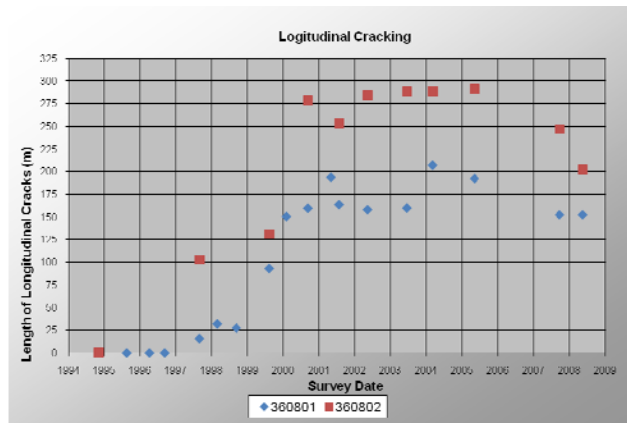
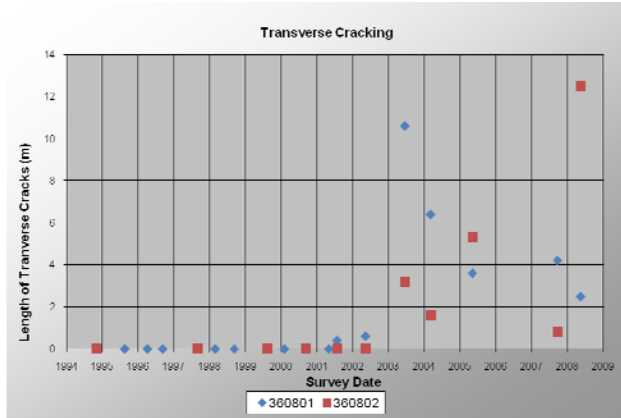
The historical trend for the four distress types (fatigue, longitudinal wheelpath & non wheelpath, and transverse cracking) evident on the pavement surface of both sections are provided in Figures 13 to 15. The results are from surveys conducted from 1994 to the final distress survey on May 2008. The survey results from both sections indicate distress started to appear at the centerline pavement joint in September 1997. For 360801, a small amount of longitudinal wheelpath cracking started to appear in the September 1998 survey eventually turning into fatigue cracking in July 2001. First signs of transverse cracking began to show up at this time as well. All distresses became more predominant in 2002 progressing steadily up until the final survey in 2008. Slight scraping marks on the pavement surface in the midlane and edges were first noted in the August 1995 survey and were visible throughout the life of the pavement. These marks were attributed to snowplow blade damage. For 360802, low severity longitudinal wheelpath cracking started in 1998 with the first sign of transverse cracking showing up in the 2003 survey. Fatigue or alligator cracking became predominant in 2001 at which time there was also a large increase in the length of longitudinal cracking which steadily increased until the final survey.

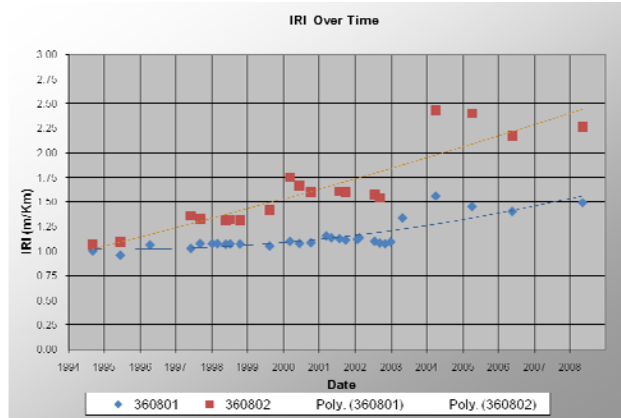
Figure 16: Historical Trend in IRI

Figure 16 provides the historical IRI data for both sections. Section 360801 had an initial IRI of 1.00m/km. The historical IRI shows that the pavement roughness remained fairly constant up until 2001 and then steadily increased up to the final set of data collected in 2008 having an IRI of was 1.49m/km. The increase in roughness seems to mirror that of the accumulated distress that occurred on this section. The surface distresses on this section are mainly in the slight to moderate category with minimal distortion on a section with practically no longitudinal grade. Based on these results, the ride quality can be considered acceptable with no near term intervention required, although due to the high and increasing levels of distress, the long term preservation of this pavement section could require some remedial intervention. Section 360802 had an initial IRI of 1.07m/km. The IRI at the time of final survey was 2.26m/km having showed substantial change in roughness over time. Although there is less distress on this section when compared with 360801, it is considerably rougher. The results indicate the IRI for this section is approaching the design limit and near term corrective action should be considered.

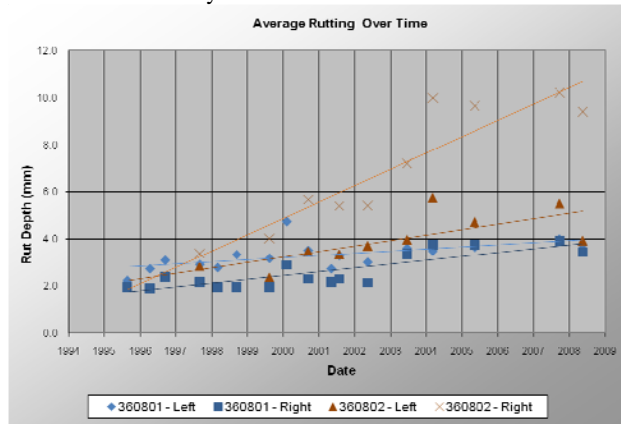
Figure 17: Graphical Presentation of Rut Depth over Time

The historical trends in rut depth from the Dipstick® transverse profiles are provided in Figure 17. At 360801, these results indicate a very slight progression in rut depth over time with the left rut in most cases being slightly deeper than the right. Figure 18 shows the rut depth data collected during the May 20 forensic study over the full 152.4m section. The average rut depth for the survey on May 20, 2008 was 3.4mm in the right wheelpath and 3.8mm in the left wheelpath. Typically the rut formations in the right wheelpath are deeper than the left as there is less lateral support, but the differences are so small in this instance that they could be considered the same. The rut depth increased since the first survey in 1995 but not to any great extent. The results of the transverse profile survey would indicate that rutting is not an issue. At 360802, rutting appeared fairly early on this section and increased steadily up until the final survey. Figure 19 shows the rut depth data collected in May 20 over the full 152.4m section. The average rut depth for the final survey was 9.4mm in the right wheelpath and 3.9mm in the left wheelpath. The results of the transverse profile survey would indicate that rutting is higher than what would be expected based on the traffic volume and lack of commercial content.

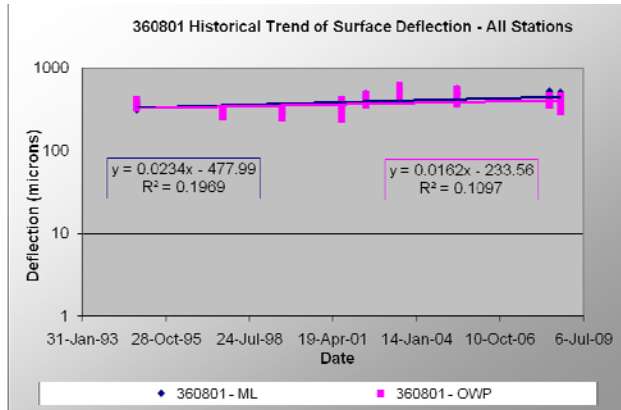
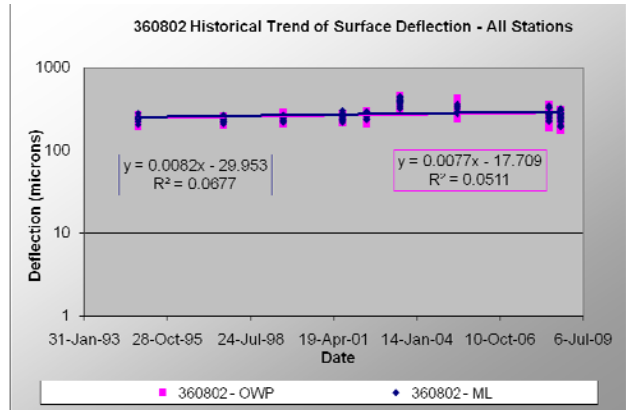
The FWD data was collected following the guidelines and protocols established for the LTPP program. A total of 19 drops (3 seating, 4@26kN, 4@40kN, 4@54kN and 4@72kN) were taken at each test point. The average normalized temperature corrected deflections for the 40kN equivalent loading for all the stations for both midlane and outer wheelpath were plotted with time. The surface deflection trends, as reported from the sensor located under the load plate, are provided for all stations in Figures 20 & 21 for 360801 and 360802, respectively.

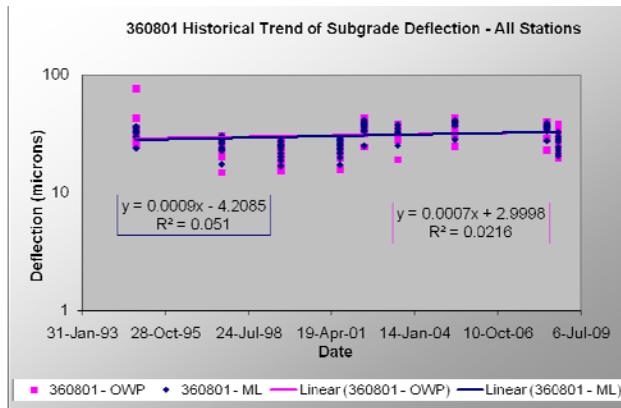
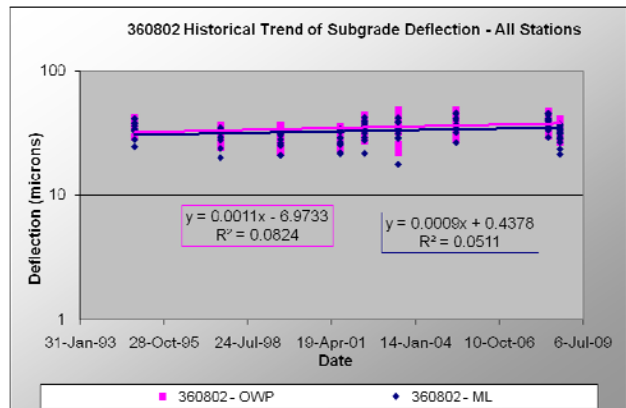
Similarly, the results representing the subgrade deflection trends, as reported from the sensor located 1.524 meters from the load plate, are provided for all stations in Figures 22 & 23 for 360801 and 360802, respectively. Section 360801 shows a continual increase in deflection indicating the pavement is losing strength as time progresses. 360802 shows a similar trend although less pronounced. The subgrade deflection trends indicate that the deflections have been very stable with time as only a slight change is evident. The results indicate only a small difference between the midlane and outer wheel path deflections, most likely due to the various distresses in each area.

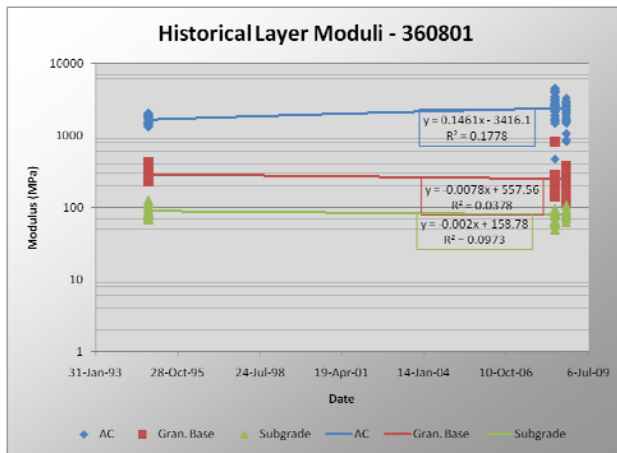
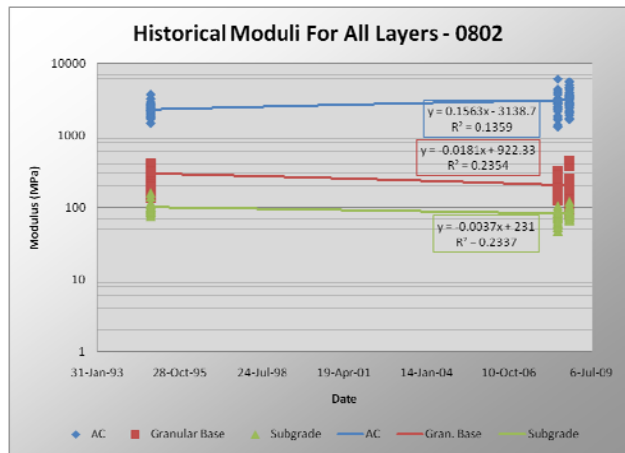
The backcalculated pavement resilient moduli from the FWD deflection data is provided in Tables 6 & 7 as well as in graphical form in Figures 24 & 25 for sections 360801 and 360802 respectively. The moduli were adjusted to a reference temperature of 25°C. Figure 24 shows a slight decrease in moduli for the granular base and subgrade layers, but nothing significant. Conversely, Figure 25 illustrates the moduli of the granular base and subgrade layers decreasing in strength over time.

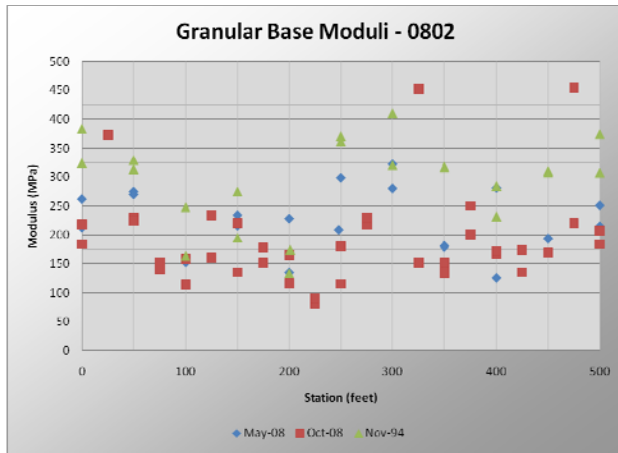
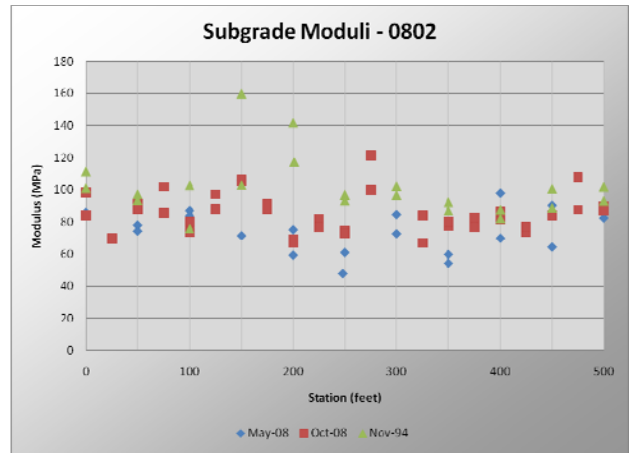
Figures 26 and 27 show the difference in the moduli of the granular and subgrade layers for Section 360802 between the period just after construction and the time of the Forensic Study. The moduli at station 76.20m for the granular base and station 60.96m for the subgrade show a decrease in strength of between 2.5 to 3 times that of what was constructed. The strength decreases in the unbound layers can be associated to the rutting problems on Section 360802. There was minimal difference observed between the midlane and outer wheelpaths of both sections; this again is somewhat consistent with the distress observed on the surface which was located over the complete surface area rather than being primarily associated with the wheelpaths.

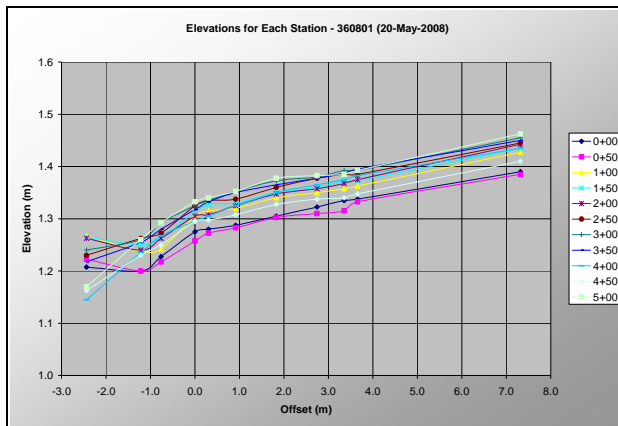
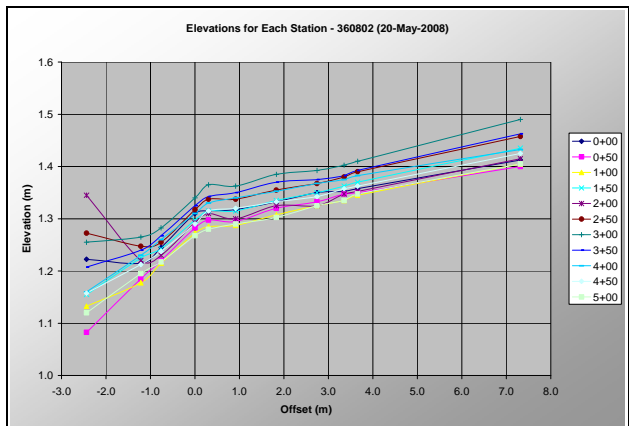
An Eleven-Point set of levels were taken at 15.24m intervals over the 152.4m length of both sections. The results of the elevation survey are provided in Figures 28 and 29 for sections 360801 and 360802, respectively. At 360801, the results show a slight deviation in elevation at the wheelpath location with a 1.7% slope for both lanes of the pavement and a 3.6% slope from edge to just off the paved shoulder. At 360802, the results show a slight deviation in elevation at the wheelpath location with a 1.8% slope for the both lanes and a 4.5% slope from edge to just off the paved shoulder. These results would indicate sufficient slope for water runoff from the pavement surface but a slightly greater slope for the right lane could accelerate the runoff. Between the shoulder edge and just off the shoulder there is an increase in elevation for a portion of the section which could impede the runoff of the moisture from the pavement. Improvements could be considered for the abutting turf embankment area.
