**Development of a Structural Asset Management
System for Urban Pavements**

**Paper prepared for presentation
at the No Road – No Load: Enabling the Economy
while Protecting Pavement Structures Session
of the 2007 Annual Conference of the
Transportation Association of Canada
Saskatoon, Saskatchewan**

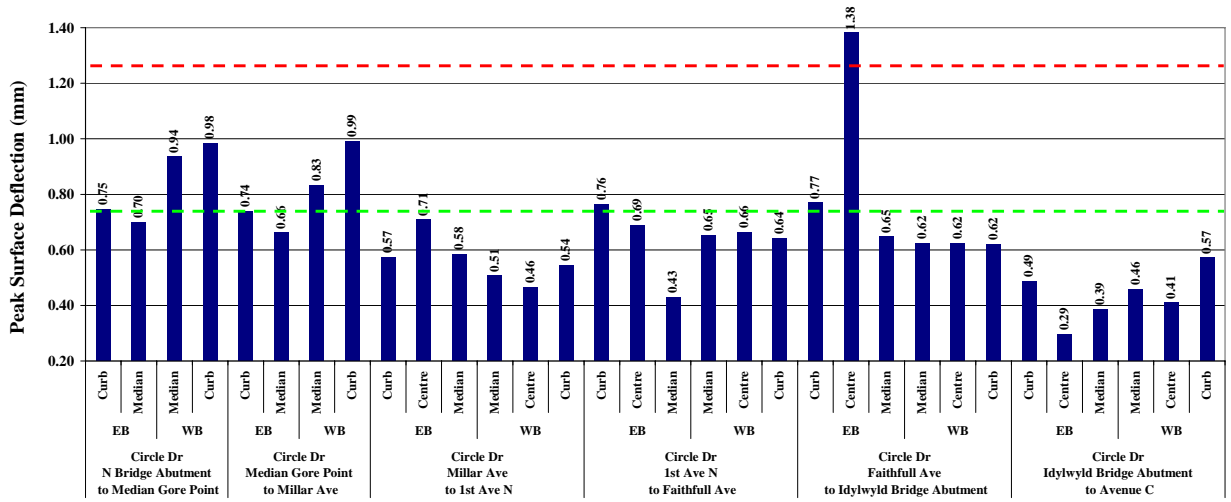
Figure 1 Peak Surface Deflection at Primary + 50% Loading of Expressway

Deflection profiles were collected on specified expressway segments by lane and by direction. The expressway considered within the scope of this study included Circle Drive from North River Crossing Bridge abutment to Avenue C. Figure 1 illustrates the peak surface deflection results at primary plus 50 percent loading. As seen in Figure 1, the peak surface deflection of the expressway segments under primary legal load limits plus 50 percent resulted in dynamic deflection ranging from 0.29 mm to 1.38 mm.

The peak surface deflection profiles obtained across each expressway segment were categorized into good, fair, and poor structural performance based on thresholds as summarized below.

Good: <0.75 mm
Fair: 0.75 mm to 1.25 mm
Poor: >1.25 mm

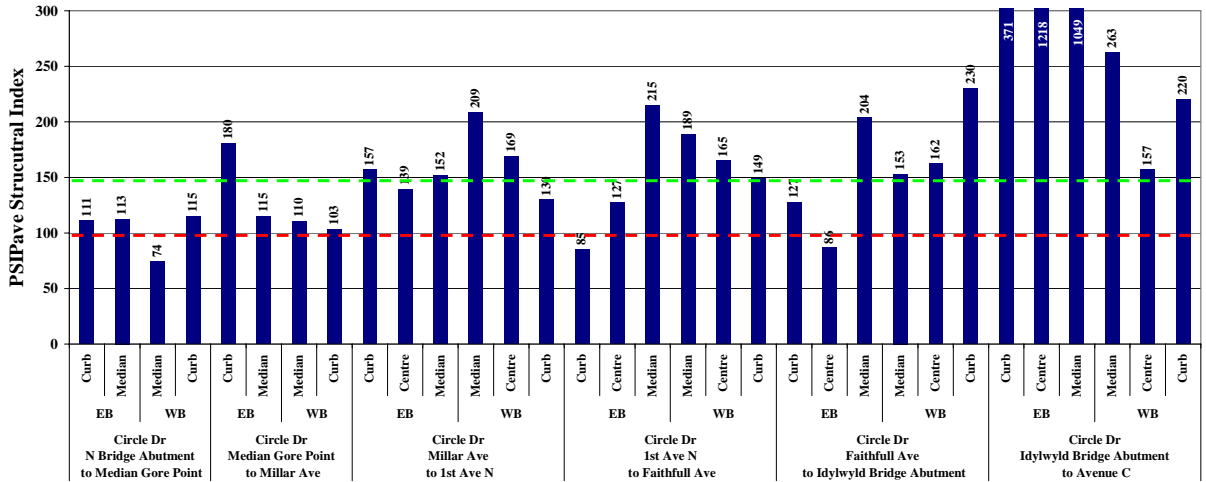
Figure 2 PSIPave Structural Index for Expressway

Figure 2 illustrates the mean PSIPave structural index values of each Circle Drive road segment surveyed. As seen in Figure 2, the PSIPave structural index of the expressway surveyed ranged from 74 to 263 for the flexible pavement structures. It should be noted that the relatively high PSIPave structural index of Circle Drive eastbound from Idylwyld Drive to Avenue C is because this road segment is constructed of jointed plain concrete pavement.

As also presented in Figure 2, the PSIPave structural index of the expressway surveyed was used to rank the selected roads into good, fair, and poor condition states. The thresholds used to categorize the PSIPave structural index of the expressway surveyed are summarized below.

Good: >150
Fair: 100 to 150
Poor: <100

It can be seen in Figure 2, that the PSIPave structural values of Circle Drive from the Idylwyld Bridge to Avenue C in the eastbound direction are extremely high because they are constructed of jointed plain concrete pavement. However, it should also be noted that the structural condition index of the curb lane jointed plain concrete pavement in the curb lane was considerably lower than the other two concrete lanes, which may indicate structural deterioration of this lane.

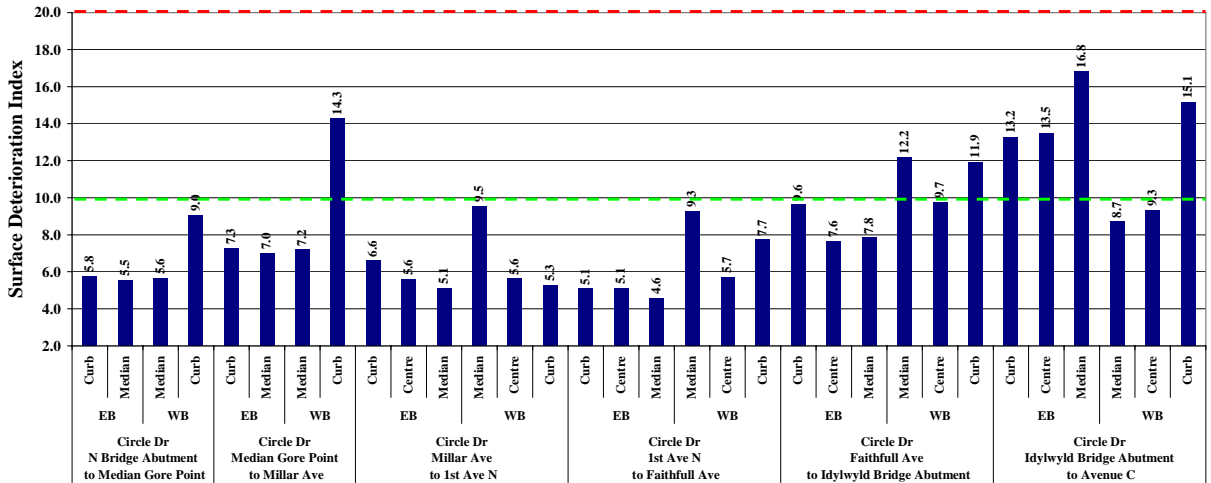
Figure 3 Mean PSIPave Surface Deterioration Index of Expressway

Based on the surface dielectric permittivity profiles, Figure 3 illustrates the average PSIPave surface deterioration index results for the expressway surveyed by segment, by direction, and by lane. As seen in Figure 3, the surface deterioration index was found to range from 4.6 to 16.8.

As also seen in Figure 3, the surface deterioration was used to rank the selected roads into good, fair, and poor condition states. The thresholds used to categorize the surface deterioration of the expressway surveyed are summarized below.

Good: <10.0
Fair: 10.0 to 20.0
Poor: >20.0

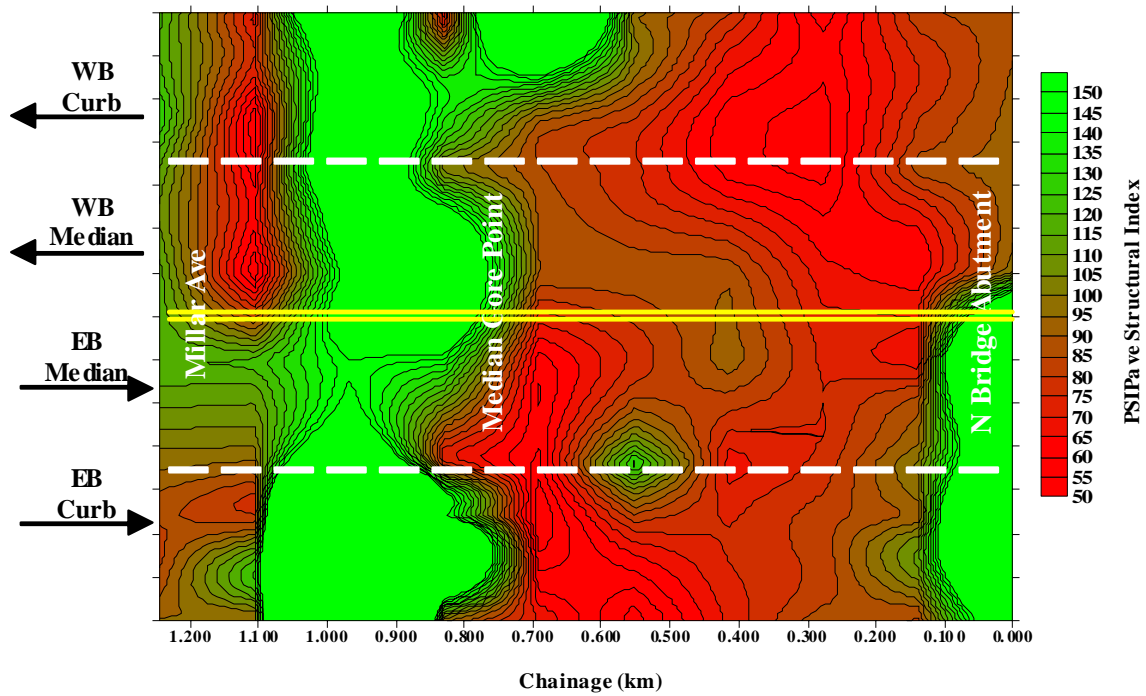
Figure 4 PSIPave Structural Index – Circle Dr (River Crossing to Millar Ave)

Based on the structural condition assessment performed on Circle Drive from the river crossing abutment to Avenue C, Figure 4 illustrates the PSIPave structural index spatially. As seen in Figure 4, the PSIPave structural index of Circle Drive from the river crossing bridge abutment to the median gore point, and near Millar Avenue rated as poor. It can also be seen that the PSIPave structural index near the Warman Road overpass rated as good due to a substructure drainage system installed.

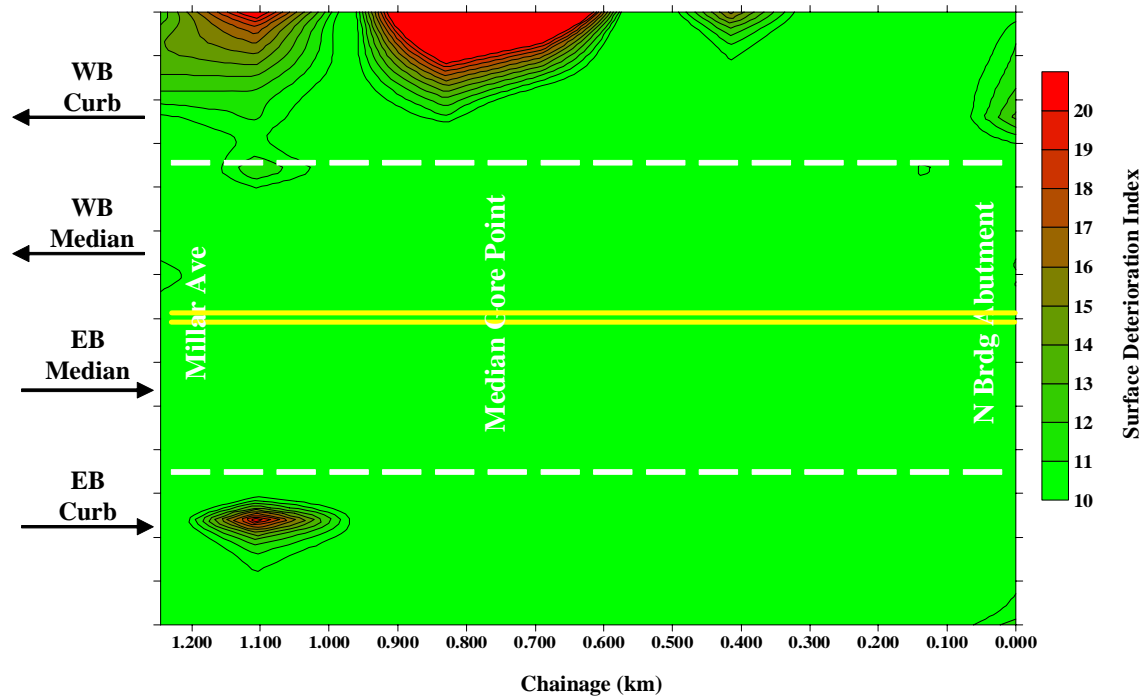
Figure 5 Surface Deterioration Index Contour – Circle Dr (River Crossing to Millar Ave)

Based on the surface deterioration assessment performed on Circle Drive from the east river crossing abutment to Avenue C, Figure 5 illustrates the surface deterioration index spatially. As seen in Figure 5, Circle Drive westbound curb lane from the median gore point to Millar Avenue is exhibiting poor surface condition.

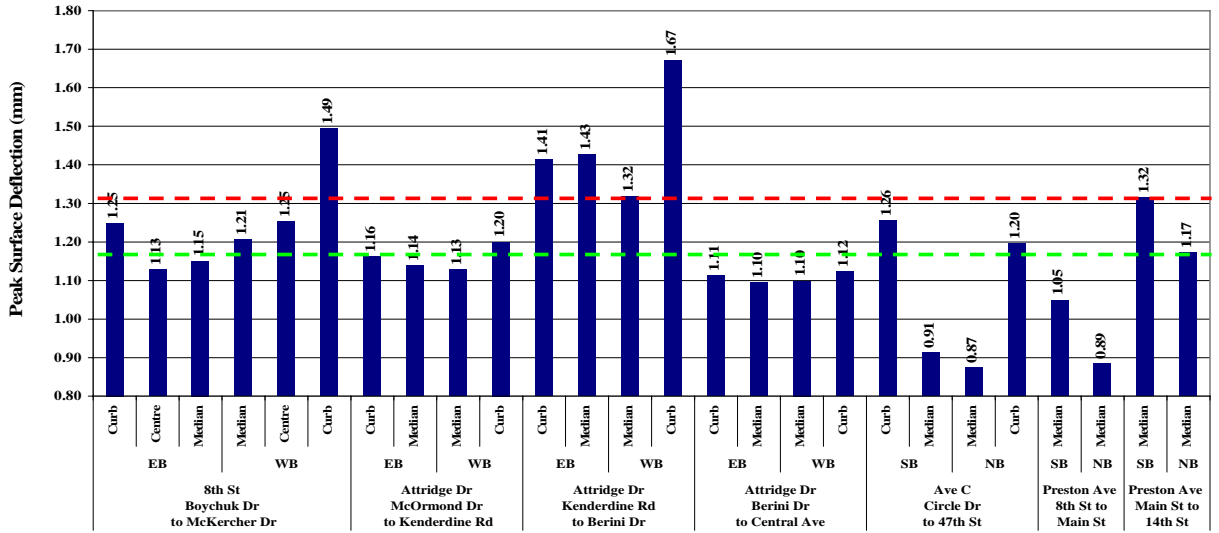
Figure 6 Peak Surface Deflection at Primary + 50% Loading of Arterials

Deflection profiles were collected on specified arterial segments by lane and by direction. The arterials considered within the scope of this study included 8th Street from Boychuk Drive to McKercher Drive; Attridge Drive from McOrmond Drive to Central Avenue; Avenue C from Circle Drive to 47th Street, and; Preston Avenue from 8th Street to 14th Street. Figure 6 illustrates the peak surface deflection results at primary plus 50 percent loading. As seen in Figure 6, the peak surface deflection of the arterial segments under primary legal load limits plus 50 percent resulted in dynamic deflection ranging from 0.87 mm to 1.67 mm.

The peak surface deflection profiles obtained across each arterial segment were categorized into good, fair, and poor structural performance based on thresholds as summarized below.

Good: <1.15 mm
Fair: 1.15 mm to 1.30 mm
Poor: >1.30 mm

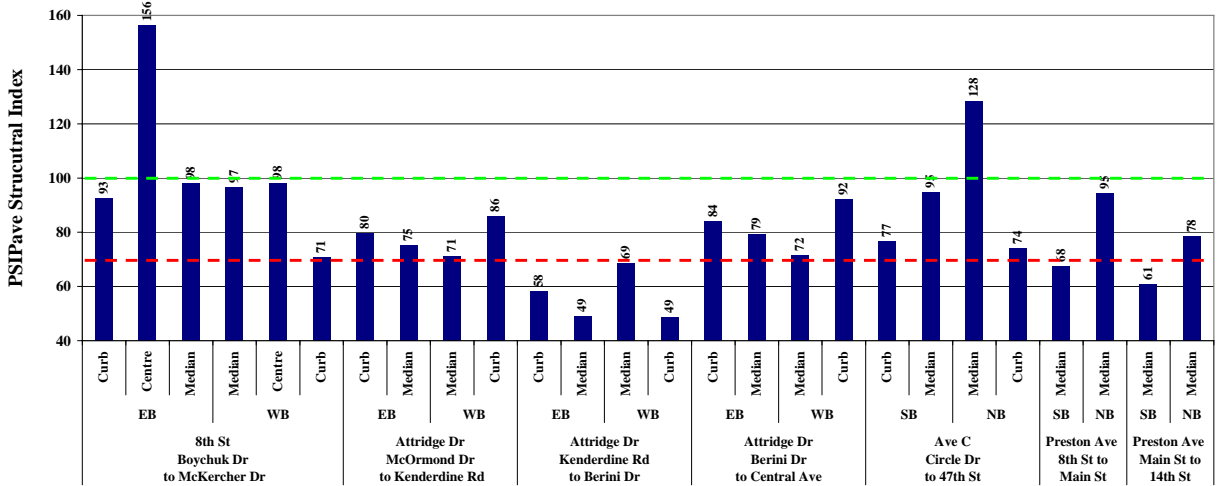
Figure 7 PSIPave Structural Index for Arterials

Figure 7 illustrates the mean PSIPave structural index values of each arterial road segment surveyed. As seen in Figure 7, the PSIPave structural index of the arterials surveyed ranged from 49 to 156.

As also presented in Figure 7, the PSIPave structural index was used to rank the selected roads into good, fair, and poor condition state. The thresholds used to categorize the PSIPave structural index of the arterials surveyed are summarized below.

Good: >100
Fair: 70 to 100
Poor: <70

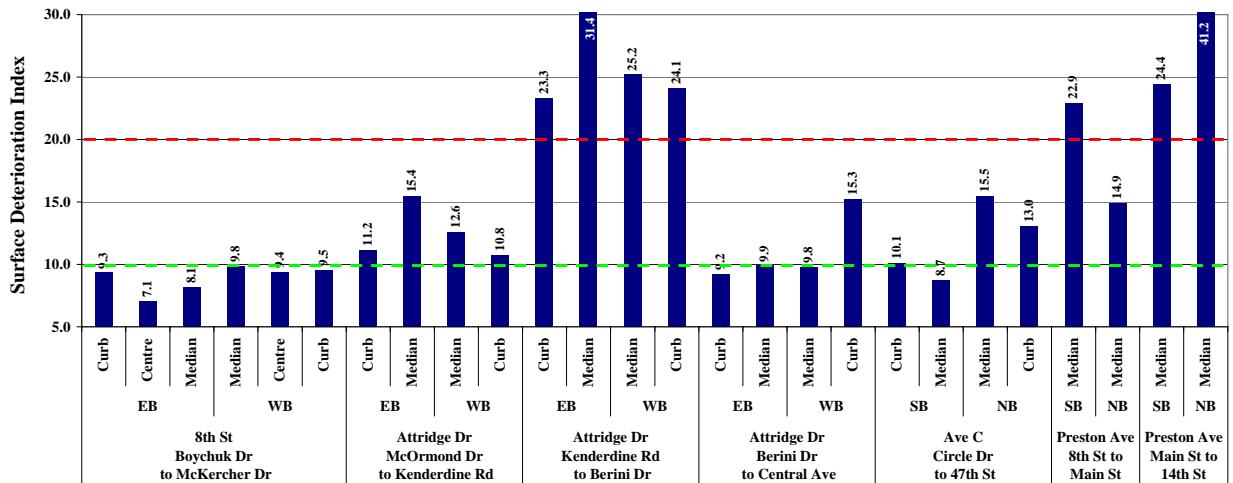
Figure 8 Mean PSIPave Surface Deterioration Index of Arterials

Based on the surface dielectric permittivity profiles, Figure 8 illustrates the average PSIPave surface deterioration index results for the arterials surveyed by segment, by direction, and by lane. As seen in Figure 8, the surface deterioration index of the arterials was found to range from 7.1 to 41.2.

As also seen in Figure 8, the surface deterioration was used to rank the selected roads into good, fair, and poor condition states. The thresholds used to categorize the surface deterioration of the arterials surveyed are summarized below.

Good: <10.0
Fair: 10.0 to 20.0
Poor: >20.0

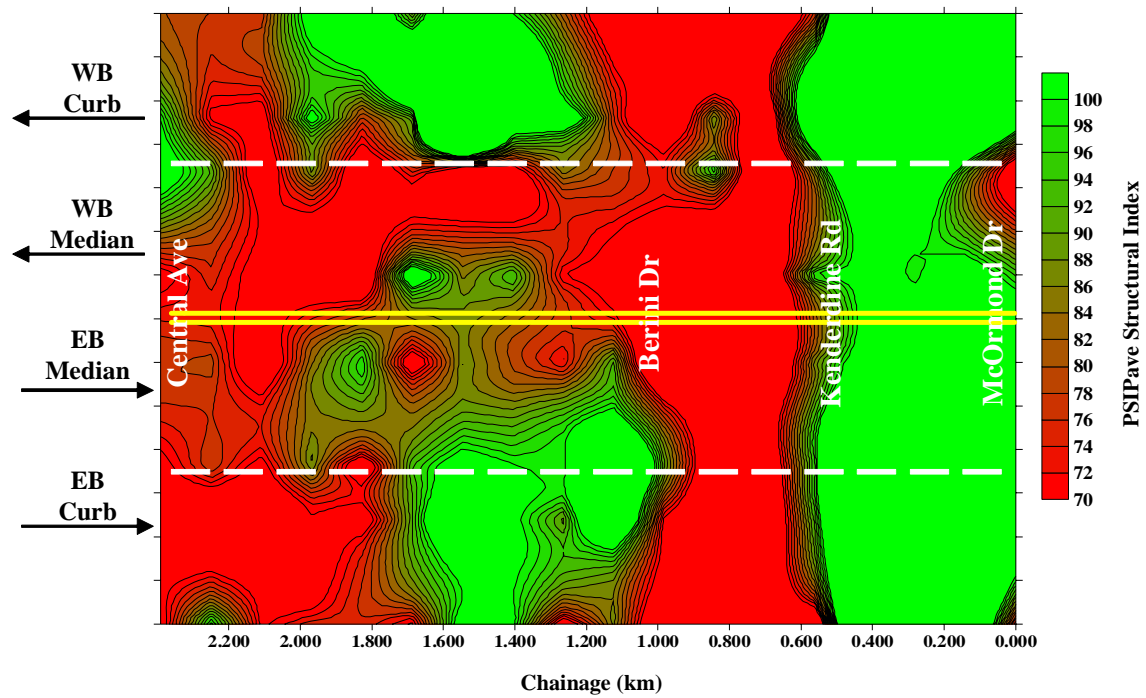
Figure 9 PSIPave Structural Index – Attridge Drive (McOrmond Dr to Central Ave)

Based on the structural condition assessment performed on 8th Street, Attridge Drive, Avenue C, and Preston Avenue, Figure 9 illustrates the PSIPave structural index spatially. As seen in Figure 9, the PSIPave structural index behaviour of the arterials surveyed rated from fair to poor for the majority of the segments surveyed. As seen in Figure 9, the PSIPave structural index of Attridge Drive from Kenderdine Road to Berini Drive rated as poor, with the remainder of Attridge Drive rated as fair.

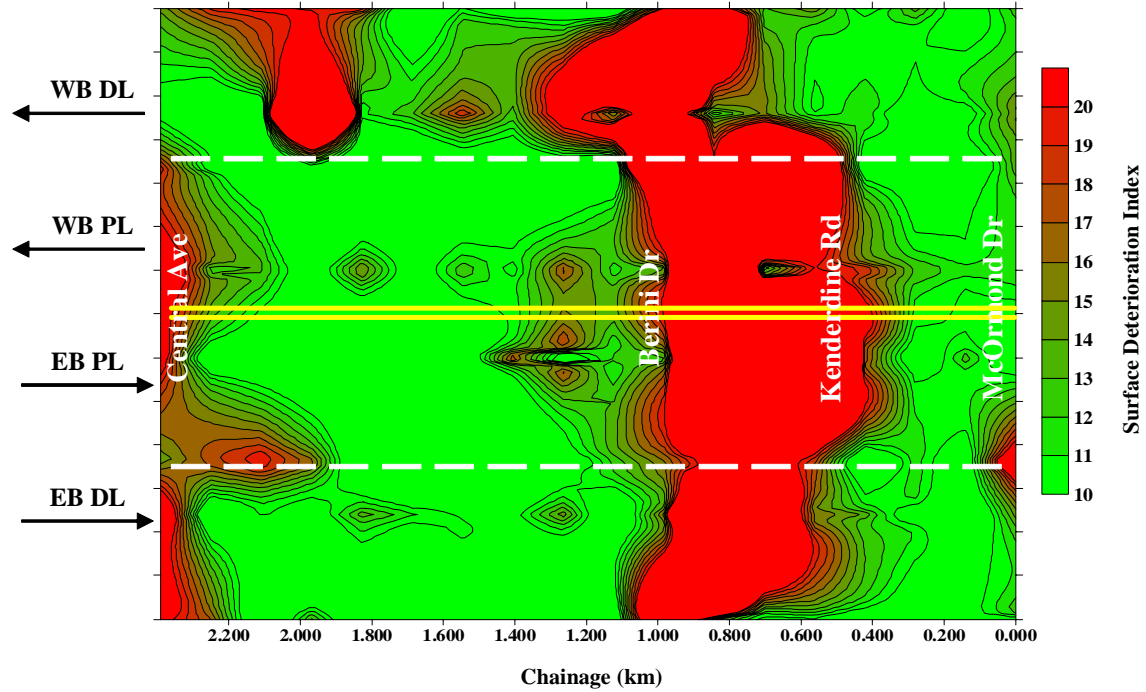
Figure 10 Surface Deterioration Index – Attridge Dr (McOrmond Dr to Central Ave)

Based on the surface deterioration assessment performed on 8th Street, Attridge Drive, Avenue C, and Preston Avenue, Figure 10 illustrates the surface deterioration index spatially for each road segment, respectively. As illustrated in Figure 10, Attridge Drive from Kenderdine Road to Berini Drive, the southern half of the northbound lanes of Avenue C from Circle Drive to 47th Street, and most of Preston Avenue from 8th Street to 14th Street, are exhibiting poor surface condition. The remainder of the arterials surveyed exhibited a good surface condition state.

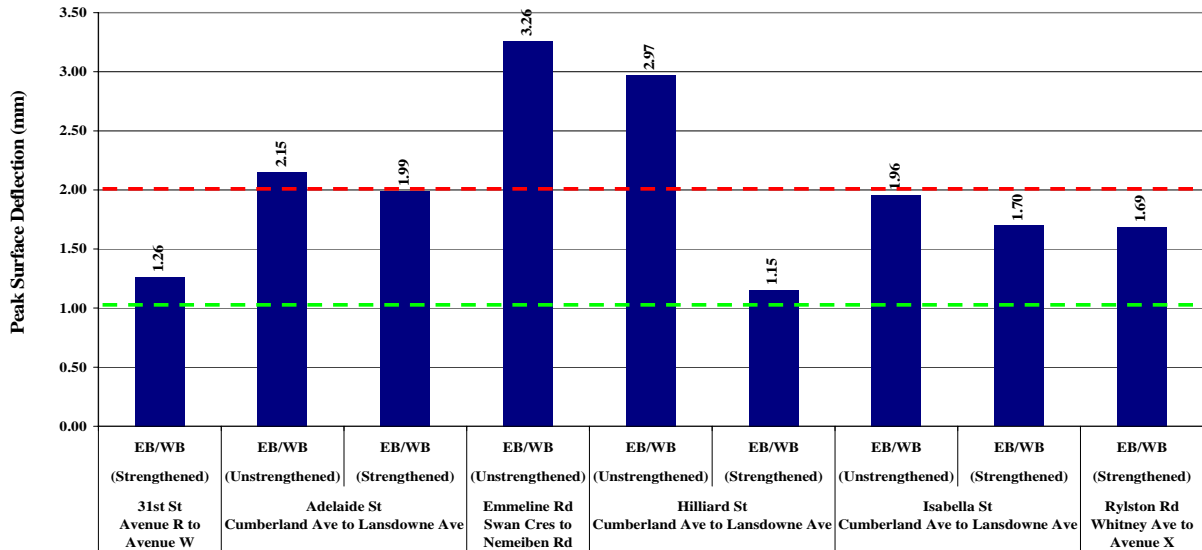
Figure 11 Peak Surface Deflection at Primary + 50% Loading of Locals

Deflection profiles were collected on specified local segments by lane and by direction. The locals considered within the scope of this study included 31st Street from Avenue R to Avenue W; Adelaide Street from Lansdowne Avenue to Cumberland Avenue; Emmeline Road from Swan Crescent to Nemeiben Road; Hilliard Street from Lansdowne Avenue to Cumberland Avenue; Isabella Street from Lansdowne Avenue to Cumberland Avenue, and; Rylston Road from Whitney Avenue to Avenue X. Figure 11 illustrates the peak surface deflection results at primary plus 50 percent loading. As seen in Figure 11, the peak surface deflection of the local segments under primary legal load limits plus 50 percent resulted in dynamic deflection ranging from 1.26 mm to 3.26 mm.

The peak surface deflection profiles obtained across each local segment were categorized into good, fair, and poor structural performance based on thresholds as summarized below.

Good: <1.00 mm
Fair: 1.00 mm to 2.00 mm
Poor: >2.00 mm

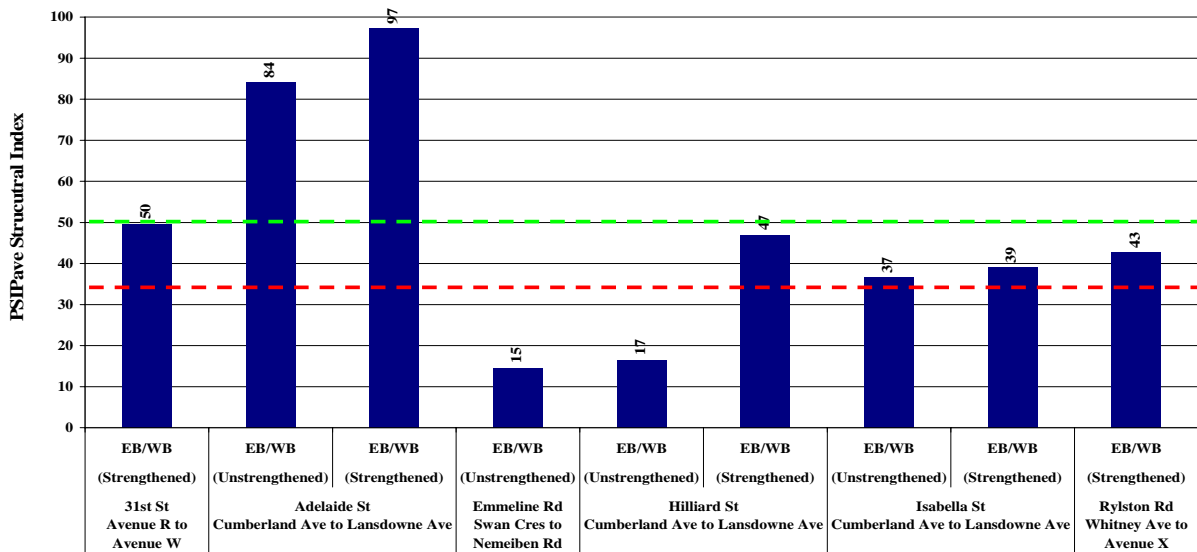
Figure 12 PSIPave Structural Index for Locals

Figure 12 illustrates the mean PSIPave structural index values of each local road segment surveyed. As seen in Figure 12, the PSIPave structural index of the locals surveyed ranged from 15 to 50.

As also presented in Figure 12, the PSIPave structural index was used to rank the selected local roads into good, fair, and poor condition states. The thresholds used to categorize the PSIPave structural index of the local streets surveyed are summarized below.

Good: >30
Fair: 20 to 30
Poor: <20

It can be seen in Figure 12, that the segment of Emmeline Road from Swan Crescent to Nemeiben Road is in poor structural condition and Adelaide Street from McKinnon Avenue to Haultain Avenue rated as fair PSIPave structural index condition. 31st Street from Avenue R to Avenue W and Rylston Road from Whitney Avenue to Avenue X rated as good.

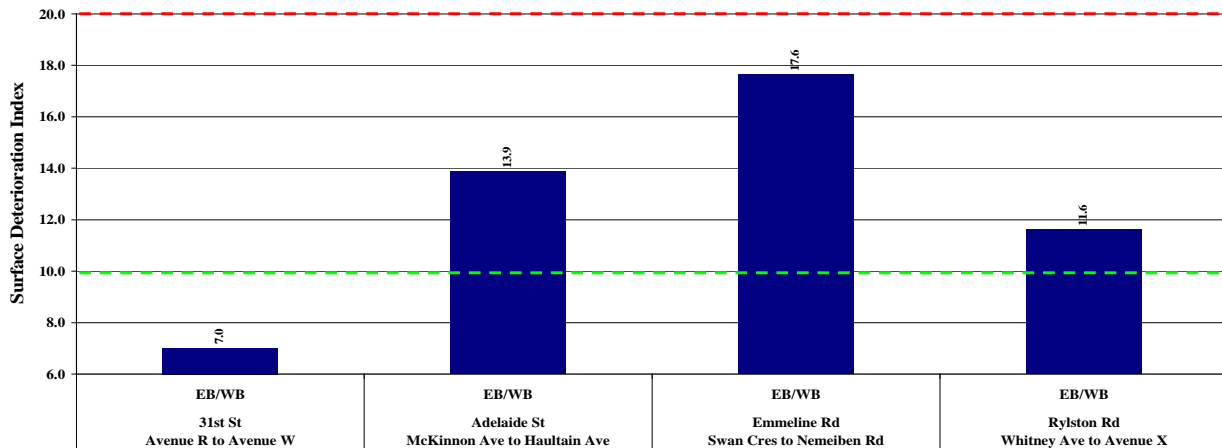
Figure 13 PSIPave Surface Condition Index of Locals

Based on the surface dielectric permittivity profiles, Figure 13 illustrates the average PSIPave surface deterioration index results for the locals surveyed by segment, by direction, and by lane. As seen in Figure 13, the surface deterioration index of the local streets surveyed was found to range from 7.0 to 17.6.

As also seen in Figure 13, the surface deterioration was used to rank the selected roads into good, fair, and poor condition states. The thresholds used to categorize the surface deterioration of the local streets surveyed are summarized below.

Good: <10.0
Fair: 10.0 to 20.0
Poor: >20.0

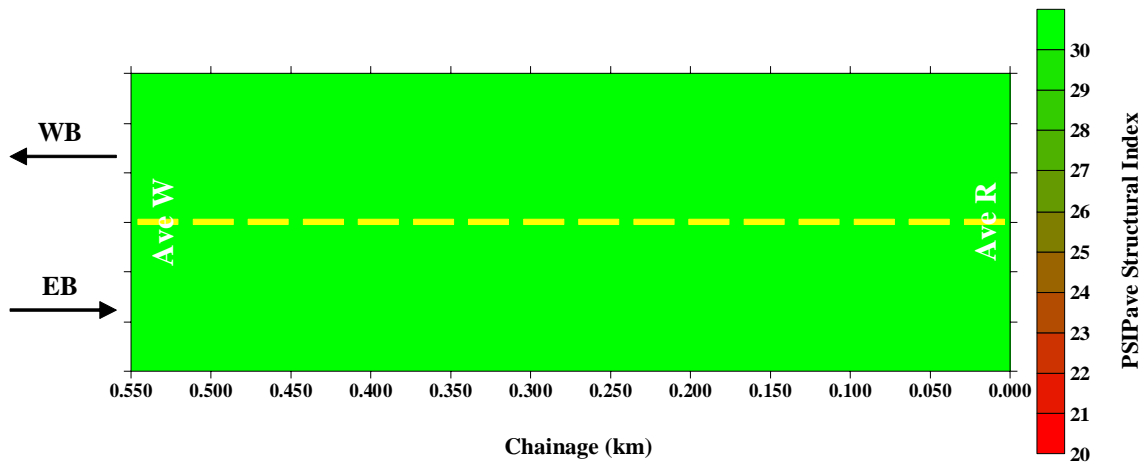
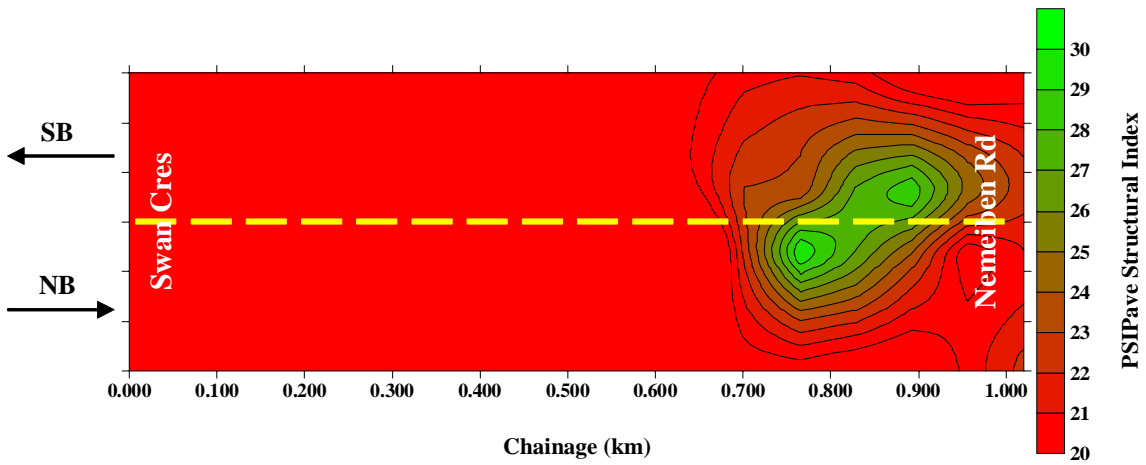
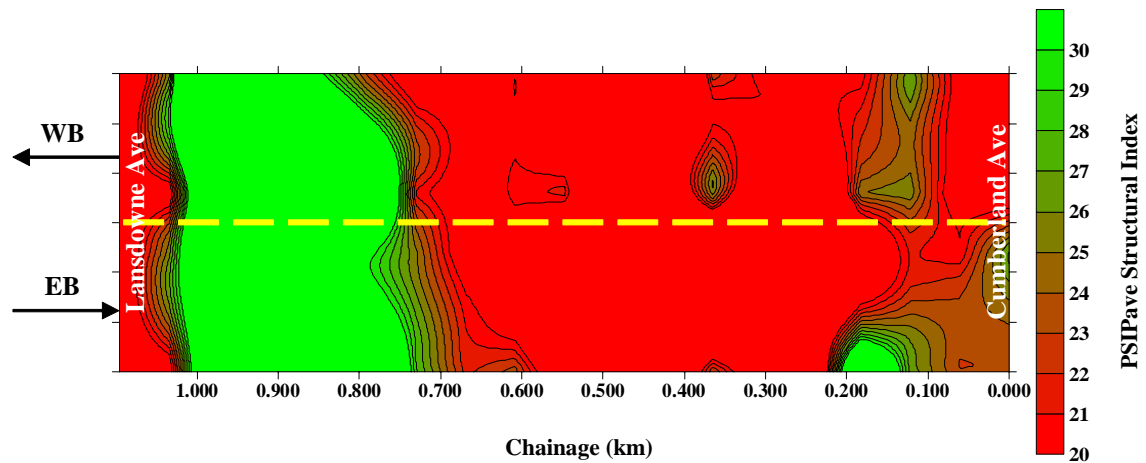
Based on the structural condition assessment performed on 31st Street, Adelaide Street, Emmeline Road, and Rylston Road, Figure 14, Figure 15, and Figure 16 illustrate the PSIPave structural index spatially. As seen in Figure 14, the structural condition of most of 31st Street from Avenue R to Avenue W is in good structural condition state, having previously been strengthened. Figure 15 illustrates poor structural condition state of Emmeline Road from Swan Crescent to Nemeiben Road, an unstrengthened length of the local road. Figure 16 indicates poor structural condition of Hilliard Street from kilometer 0.000 to 0.700 where the road has not previously been strengthened and good structural condition between kilometers 0.700 and 1.000 where the road has previously been strengthened.

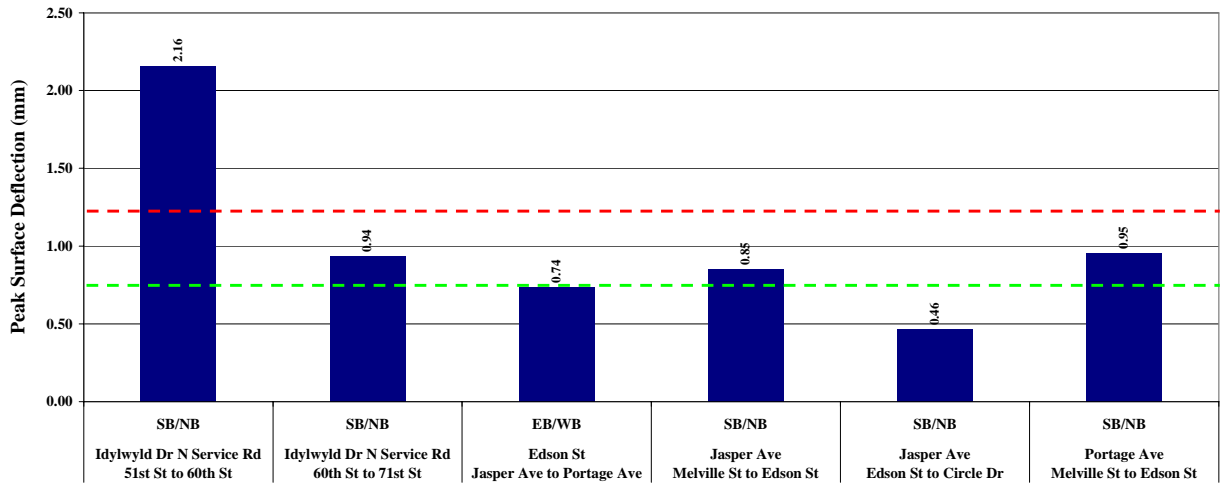
Figure 17 Peak Surface Deflection at Primary + 50% Loading of Local-Industrials

Deflection profiles were collected on specified local-industrial segments by lane and by direction. The local-industrials considered within the scope of this study included Idylwyld Drive N Service Road from 51st Street to 71st Street; Edson Street from Jasper Avenue to Portage Avenue; Jasper Avenue from Melville Street to Circle Drive, and; Portage Avenue from Melville Street to Edson Street. Figure 17 illustrates the peak surface deflection results at primary plus 50 percent loading. As seen in Figure 17, the peak surface deflection of the local-industrial segments under primary legal load limits plus 50 percent resulted in dynamic deflection ranging from 0.46 mm to 2.16 mm.

The peak surface deflection profiles obtained across each local-industrial segment were categorized into good, fair, and poor structural performance based on thresholds of as summarized below.

Good: <0.75 mm
Fair: 0.75 mm to 1.25 mm
Poor: >1.25 mm

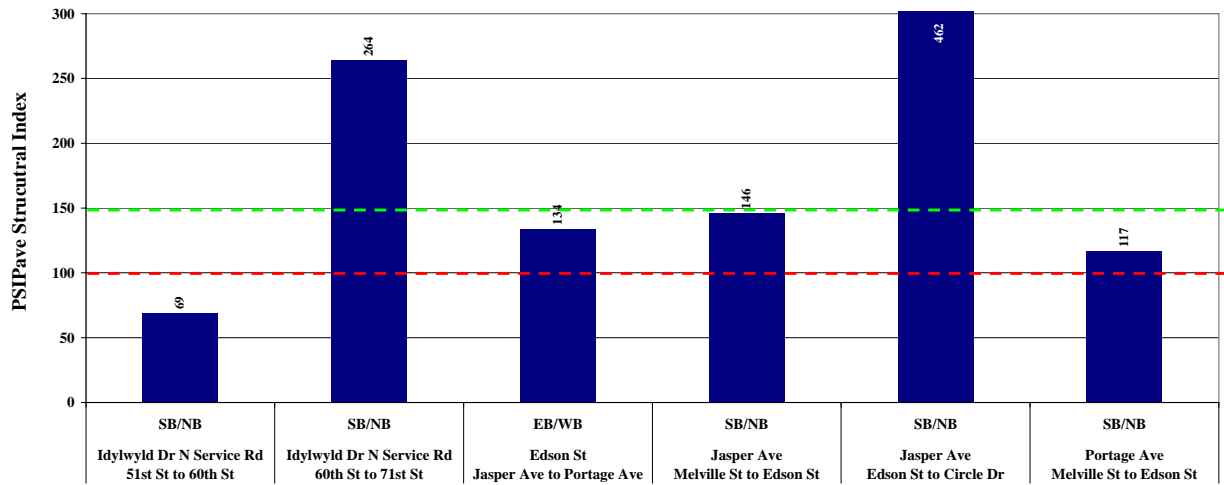
Figure 18 PSIPave Structural Index for Local-Industrials

Figure 18 illustrates the mean PSIPave structural index values of local-industrial road segments surveyed. As seen in Figure 18, the PSIPave structural index of the local-industrials surveyed ranged from 69 to 462.

As also presented in Figure 18, the PSIPave structural index was used to rank the selected local-industrial roads into good, fair, and poor condition state. The thresholds used to categorize the PSIPave structural index performance are summarized below.

Good: >150
Fair: 100 to 150
Poor: <100

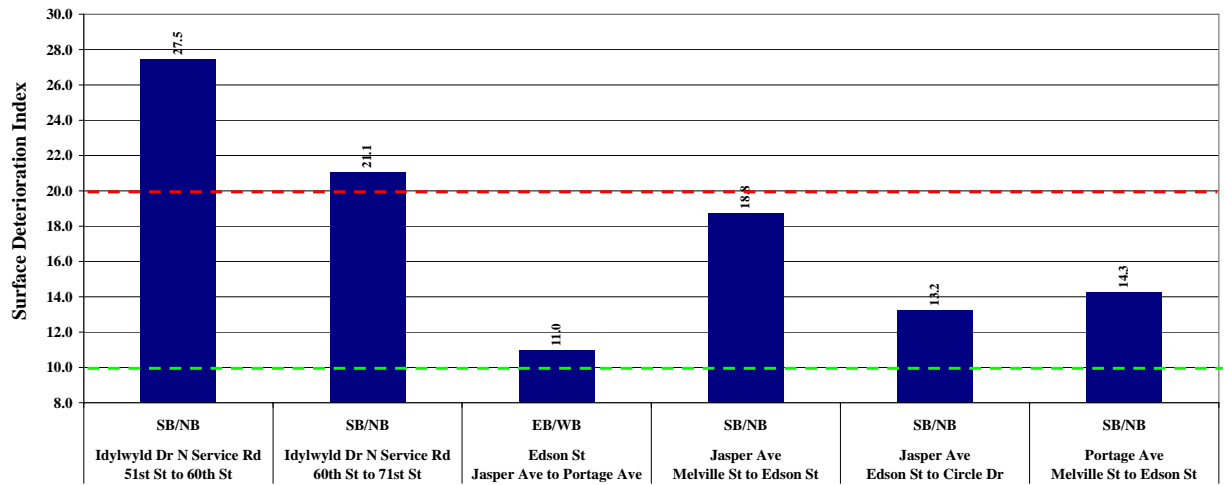
Figure 19 PSIPave Surface Deterioration Index of Local-Industrials

Based on the surface dielectric permittivity profiles, Figure 19 illustrates the average PSIPave surface deterioration index results for the local-industrials surveyed by segment, by direction, and by lane. As seen in Figure 19, the surface deterioration was used to rank the selected roads into good, fair, and poor condition states. The thresholds used to categorize the surface deterioration of the local-industrials surveyed are summarized below.

Good: <10.0
Fair: 10.0 to 20.0
Poor: >20.0

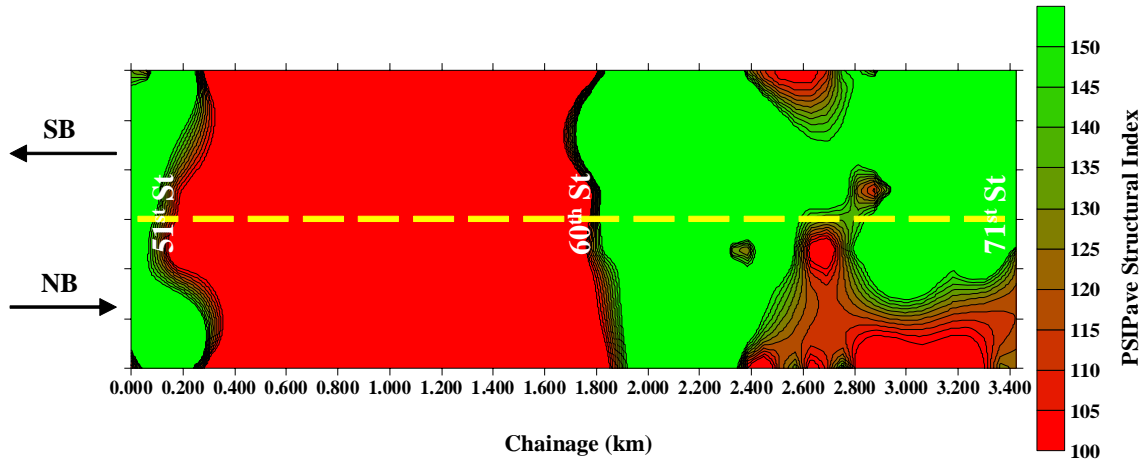
Figure 20 PSIPave Structural Index – Idylwyld Dr N Service Road (51st St to 71st St)

Based on the structural condition assessment performed on Idylwyld Drive North Service Road, Edson Street, Jasper Avenue, and Portage Avenue, Figure 20 illustrates the PSIPave structural index spatially. As seen in Figure 20, the segment of Idylwyld Drive North Service Road from 51st Street to 60th Street is in poor structural condition. The remaining segment of Idylwyld Drive from 60th Street to 71st Street is exhibiting good structural condition.

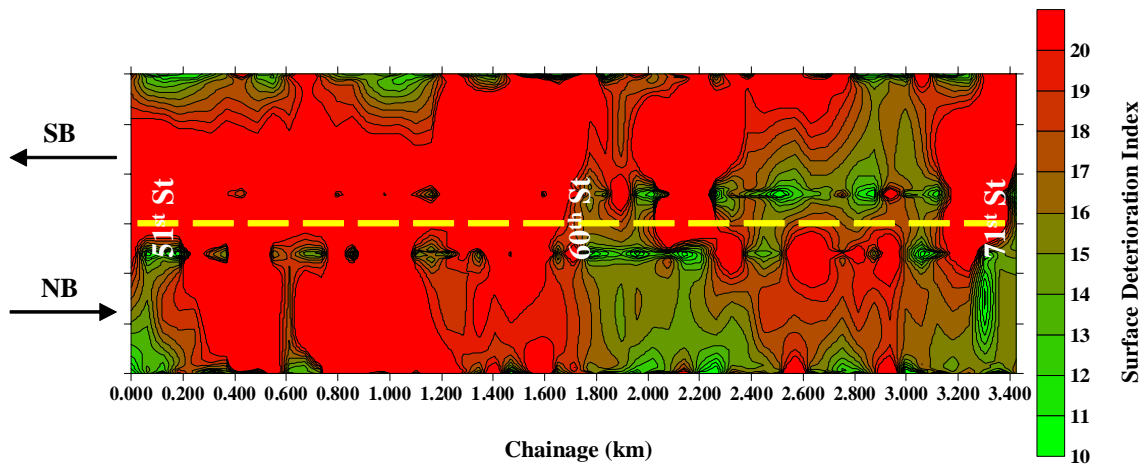
Figure 21 Surface Deterioration Index – Idylwyld Dr N Service Rd (51st St to 71st St)

Based on the surface deterioration assessment performed on Idylwyld Drive North Service Road, Edson Street, Jasper Avenue, and Portage Avenue, Figure 21 illustrates the surface deterioration index spatially. As illustrated in Figure 21, the surface deterioration index of the Idylwyld Service Road is exhibiting poor surface condition.
