INTRODUCTION

SNC Lavalin O&M is the company responsible for the operations, maintenance and rehabilitation of 275 kilometres of Trans-Canada Highway in New Brunswick; from the Quebec border to Longs Creek (west of Fredericton), and Route 95 between the United States border and Woodstock, until 2033.

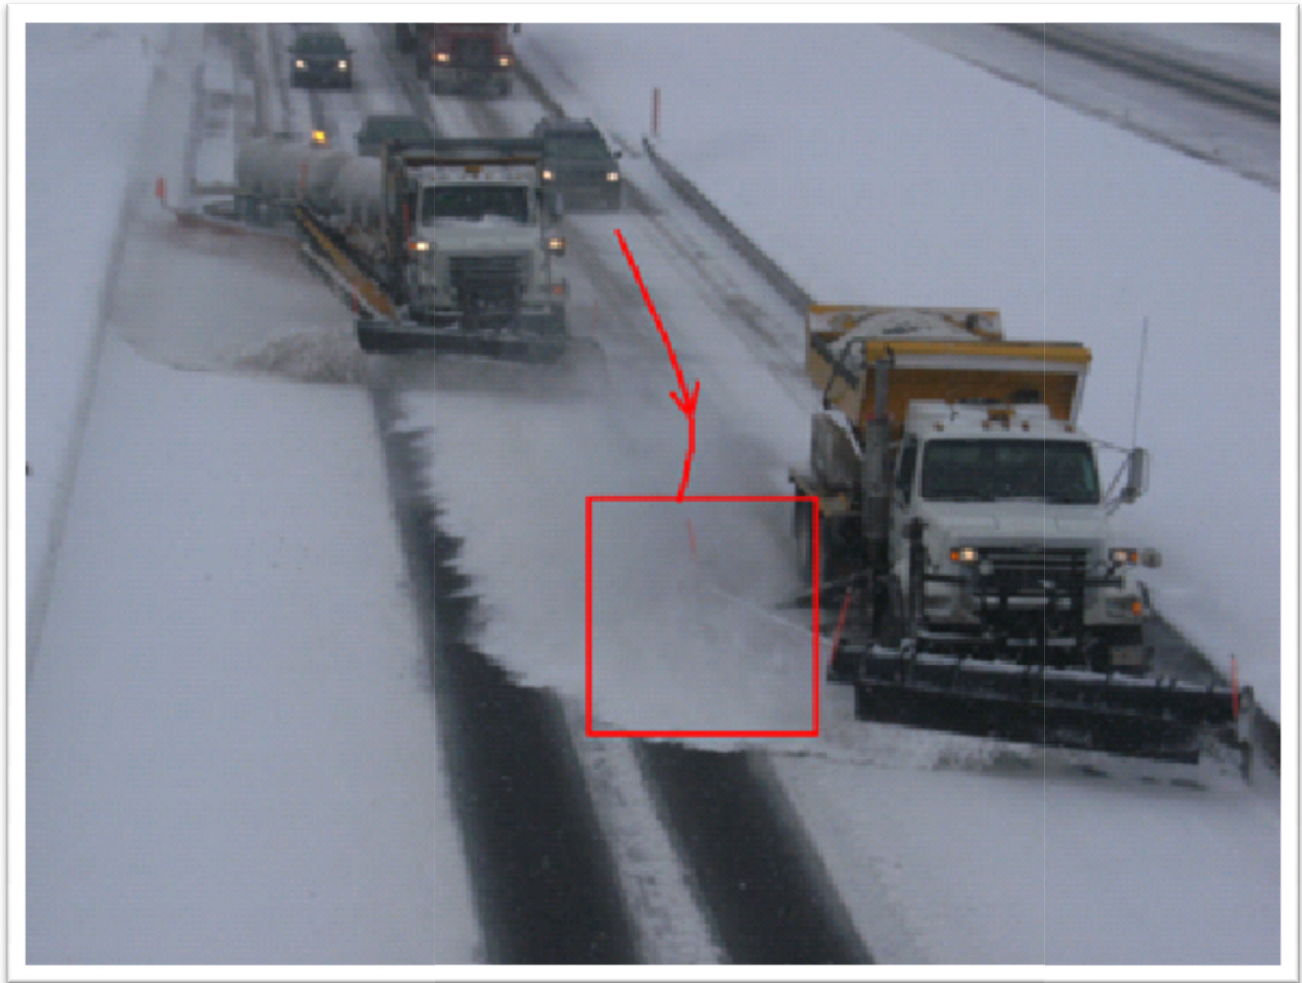
During its winter operations, SNC Lavalin O&M utilizes echelon plowing, the practice of staggering snowplows across all lanes of a multi-lane highway. By passing the ridge of snow from the lead snow plow to the following plow, echelon plowing makes it possible to clear accumulation from all lanes at once. It is, however, extremely dangerous for motorists to pass between or around the snowplows while in this formation, due to the possibility of whiteout conditions between the plow trucks. There is also the danger of impact with the back of the right side wing plow as it becomes obscured by snow.

Figure 1 The danger of impact with the back of the right side wing plow

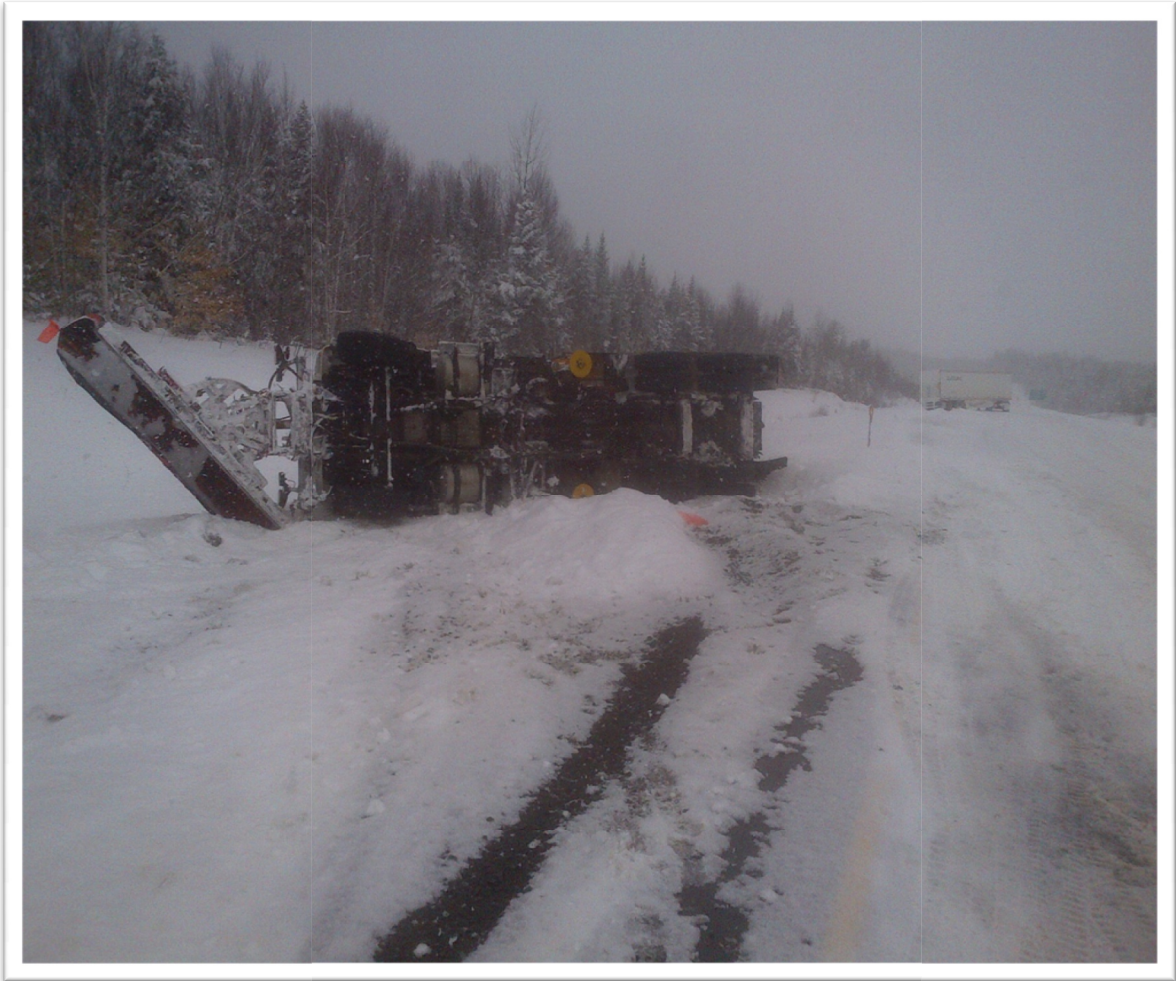
The number of collisions between motorists and the snow plow right wings was an issue even after many public awareness campaigns on the risks involved when passing between the plow trucks. A total of forty four (44) collisions were recorded between 2007 and 2013 (see Appendix A). The collisions recorded were due to motorists attempting to weave between the plows while they are engaged in echelon plowing operations. These collisions, sometimes severe, were a safety concern for our plow operators and the motorists. Also, the plow trucks involved in these collisions could be out of service for months due to serious damage.

Figure 2 Result of a severe impact between a transport truck and the right wing of a snow plow truck in March 2013

After the last collision with injury to the plow operator in March 2013, and in the continuing effort to keep motorists as well as employees safe, SNC Lavalin O&M developed a "Safety Swing Arm". The Safety Swing Arm consists of a 2.7 meter mechanical arm with high intensity flashing lights, installed on the back of the

lead plow truck. When the right side wing plow is deployed, the arm simultaneously extends to create a further visual and break-a-way physical barrier between the motorists and the right wing plow. The Safety Swing Arm has been proven to prevent motorists from hitting the right wing while passing the plow during poor visibility conditions.

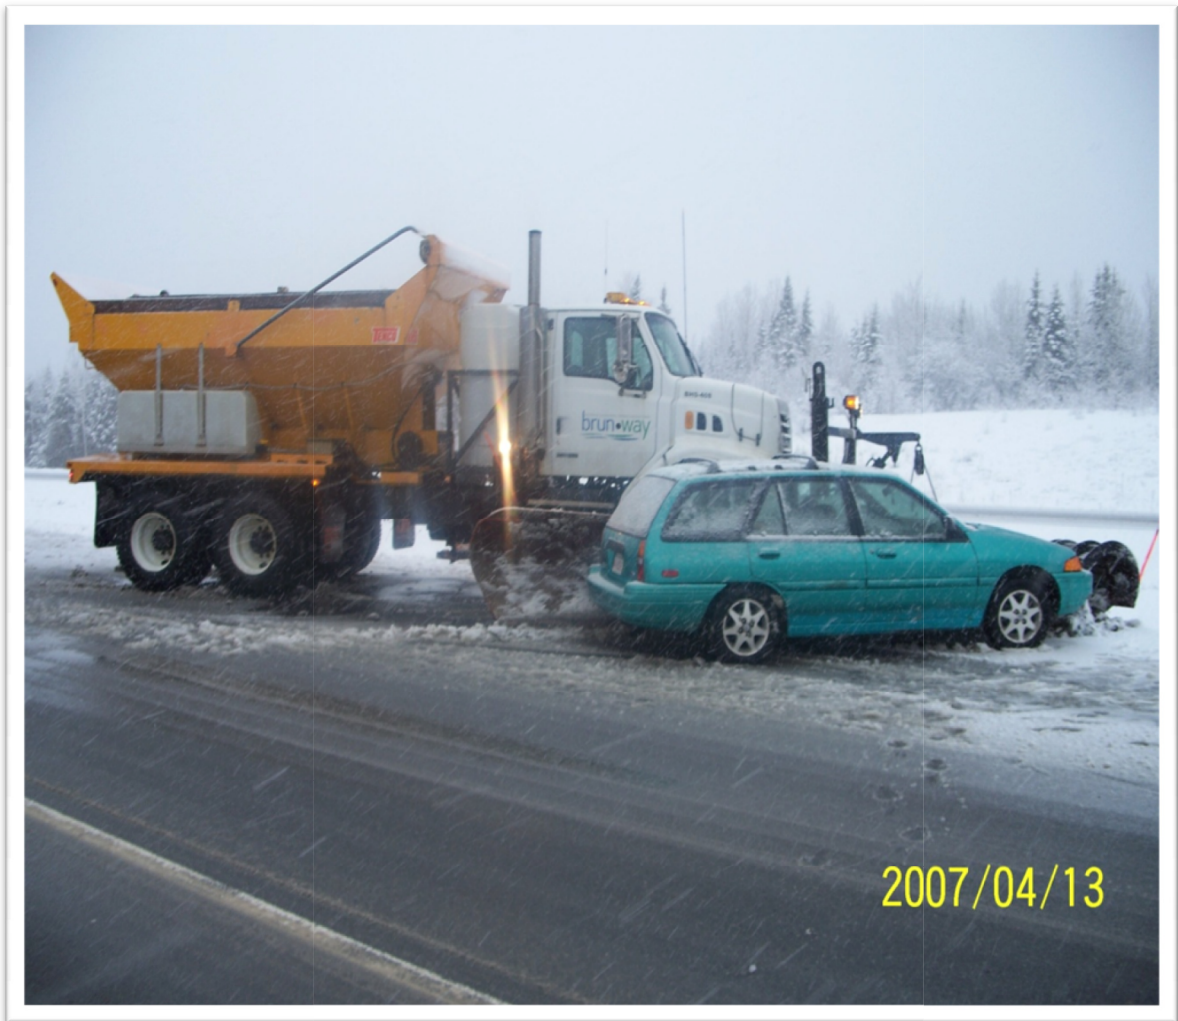
Figure 3 Impact between a small vehicle and the right wing plow

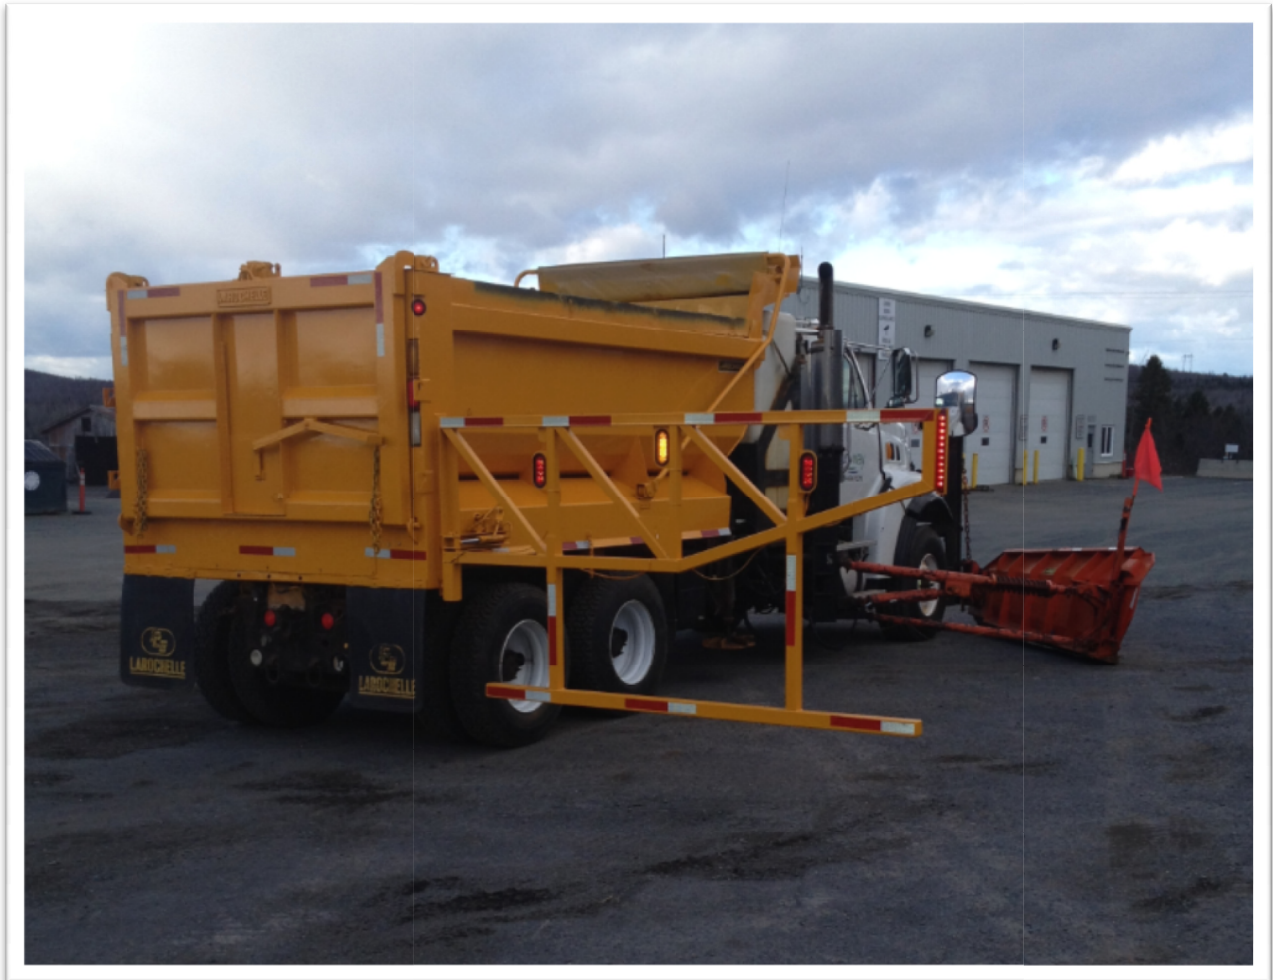
Figure 4 Safety Swing Arm deployed (2nd version, 3.0 meter in length)

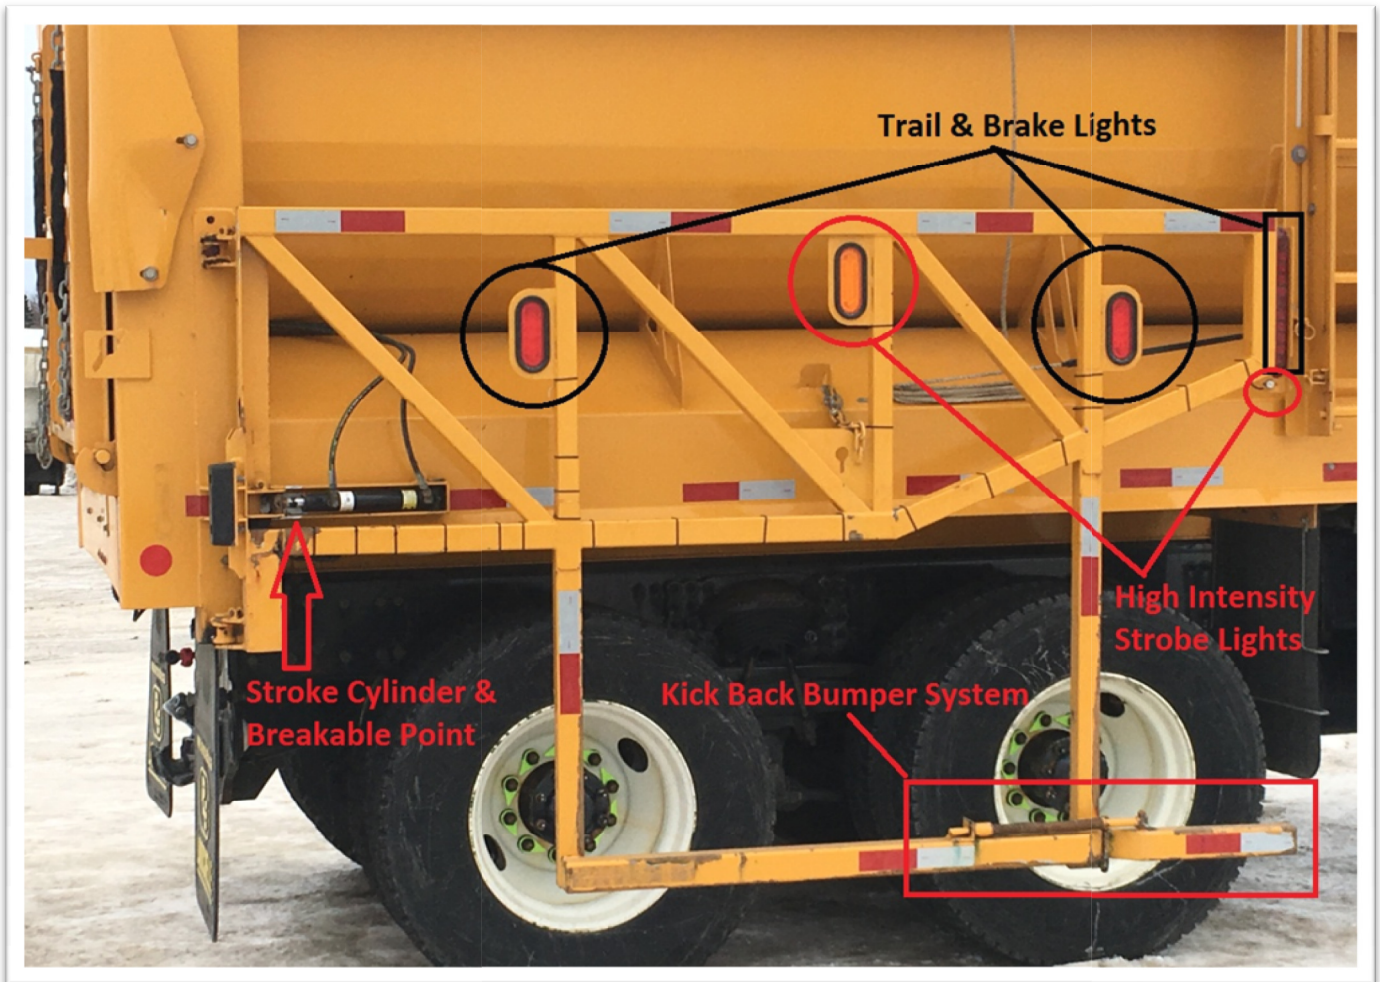
Figure 5 Safety Swing Arm retracted (3rd version, with kick back bumper system, shorter length and overall lighter weight)

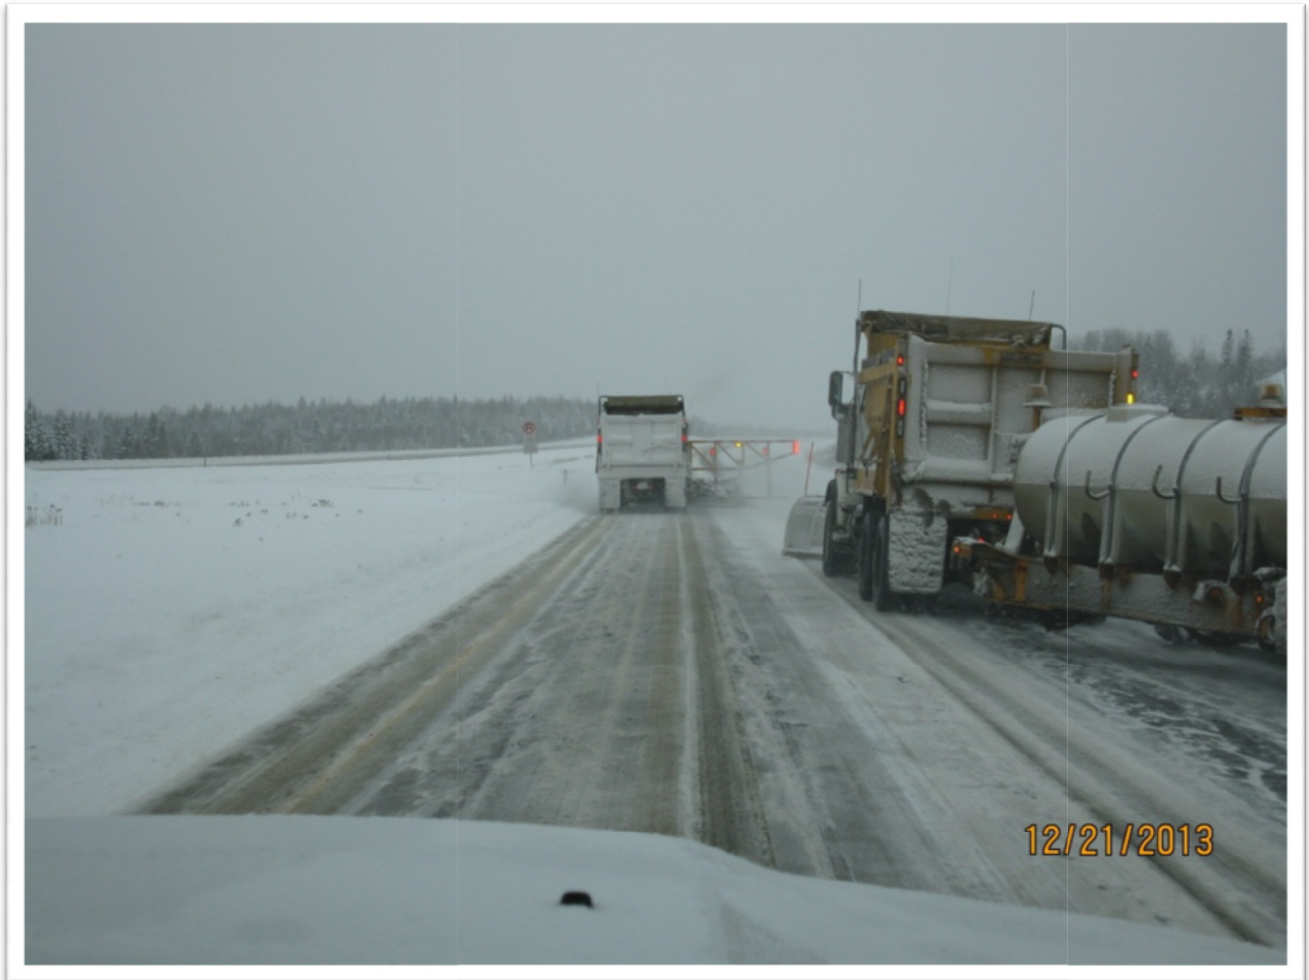
Figure 6 Lead plow (left) with deployed Safety Swing Arm.
