**How to Deal Under Budget Constraints with Pavements on Melting Permafrost at Northern Airports**

Ludomir Uzarowski, Senior Pavement and Materials Engineer, Golder Associates Ltd.  
Bill Morrison, Manager Technical Services and Pavements, Government of Northwest Territories  
Rabiah Rizvi, Pavement and Materials Engineer, Golder Associates Ltd.

Paper prepared for presentation  
at the Sustainability and Climate Change Considerations in Pavements Session

of the 2016 Conference of the  
Transportation Association of Canada  
Toronto, ON

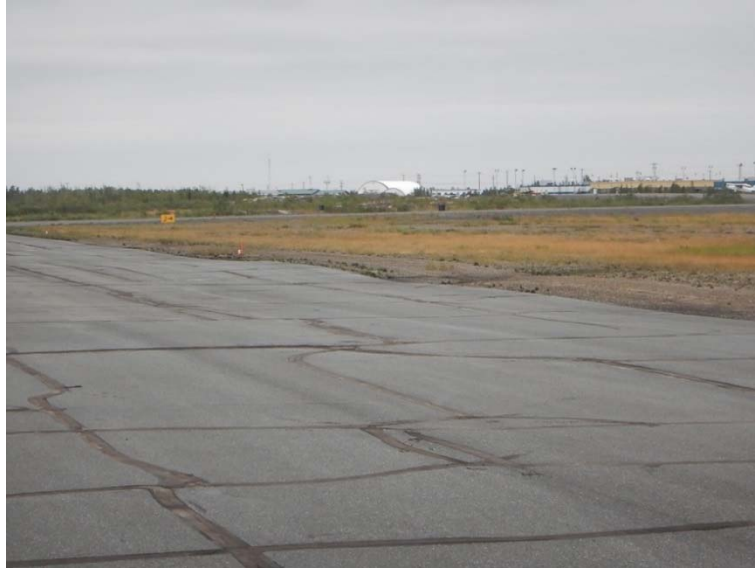
The medium to high severity depressions/settlements of the pavement on Runway 10-28 were the main concern since they are the primary cause of the pavement bumpiness or roughness. Although they were visibly of higher severity in the non-keel zone, as shown in Figures 1 to 3, several bumps extended across the entire runway pavement width. Figures 1 and 2 also clearly show that at some of the bump locations in the pavement there is also a corresponding depression in the shoulder.

**Figure 1: Severe pavement settlements and longitudinal and transverse cracking in the non-keel zone on Runway 10-28 [GNWT, 2014]**

The emergency repairs strategy to address the severe bumps included: limiting turbo jet aircraft traffic until the repairs are undertaken, repairing the bumps in the keel zone first by milling and overlaying with new asphalt; and followed by repairing the bumps in the non-keel zone.

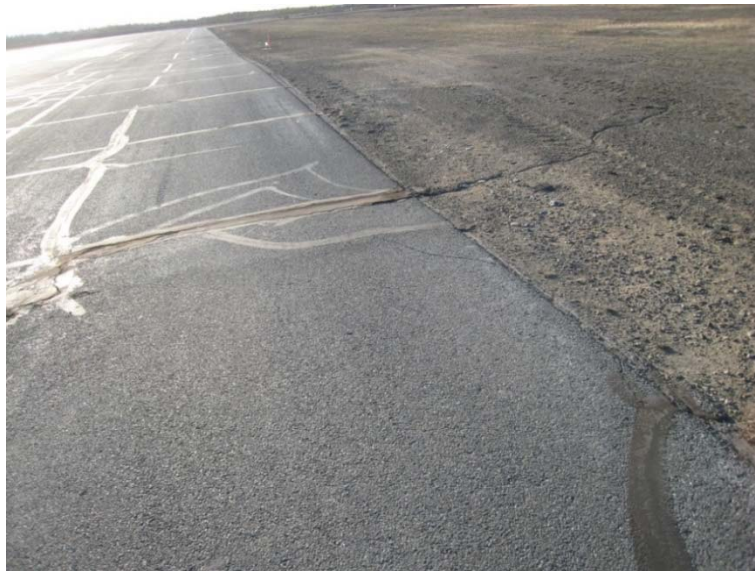
The existing ditches are very shallow and overgrown with vegetation. Ponding water was observed near the intersection of Runways 10-28 and 15-33. Another serious concern about the drainage of Runway 10-28 is the condition of the shoulders. There are numerous depressions in the shoulders on both sides of the pavement, likely due to soil settlement caused by thawed permafrost. This results in water ponding near the edge of the pavement and saturating the pavement instead of flowing to the ditches. Saturated soils speed up permafrost melting. Also, the silty clays and silts under the pavement are frost susceptible and in the presence of water the pavement heaves in the winter. During the spring thaw when the ice melts the soils and granular materials are saturated and weak which results in further deformation of the pavement.

**Figure 2: Severe settlements in the non-keel zone on Runway 10-28 and deep depressions on the shoulder [LU, May 2015]**

The improvement of the drainage conditions of Runway 10-28 was considered critical for the runway pavement performance. It was recommended that the ditches be deepened immediately and the overgrown vegetation should be removed. The runway shoulders should be regraded and filled where necessary so that there are no depressions in the shoulders collecting water next to the pavement edges.

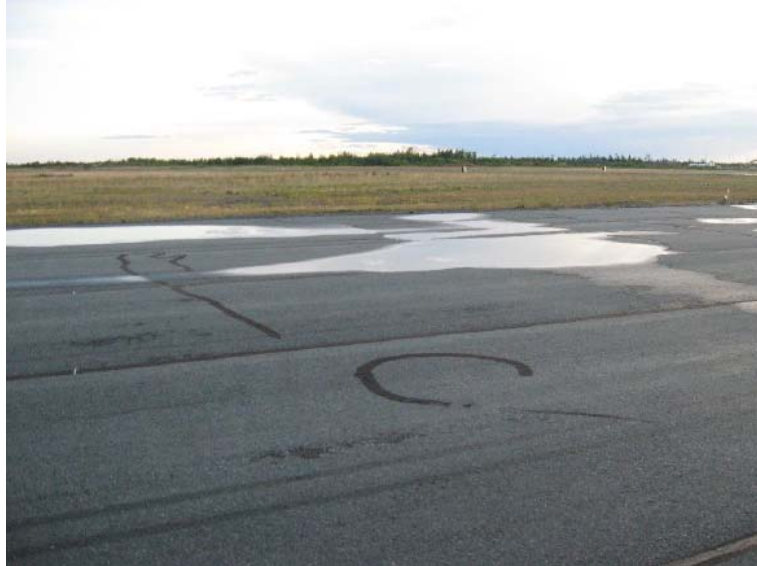
Figure 3: Water ponding in a deep pavement depression Runway 10-28 [GNWT, 2014]

It was also recommended that subdrains be installed on both sides of the runway. The depth of the subdrains should be a minimum 0.5 m below the bottom of the pavement structure. It is also critical that there are enough outlets taking the subsurface water to the ditches.

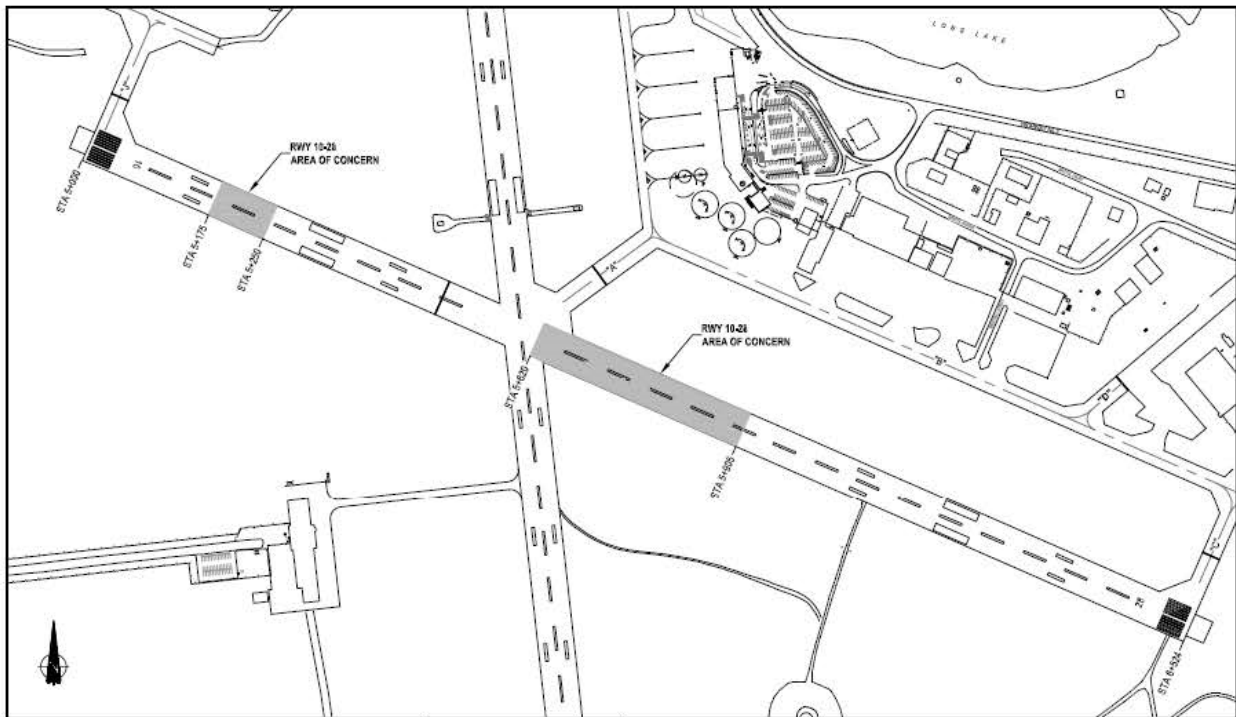
It was observed during the May 2015 visit that the pavement on Runway 10-28 is bumpy, particularly along two sections of the runway. Those locations were previously identified by GNWT as being problematic. GNWT carried out Boeing roughness analysis using the LIDAR survey data. There were locations with excessive bumps. Figures 4 shows the recycle section on the runway.

Figure 4: Rough sections on Runway 10-28 in April 2015 [GNWT, 2015]

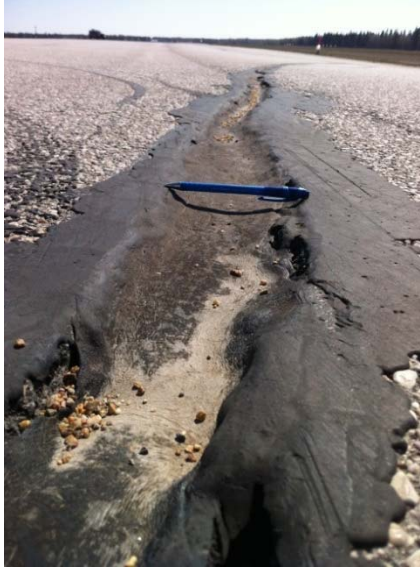
**Figure 5: Severe transverse crack on Runway 14-32 [LU, 2015]**

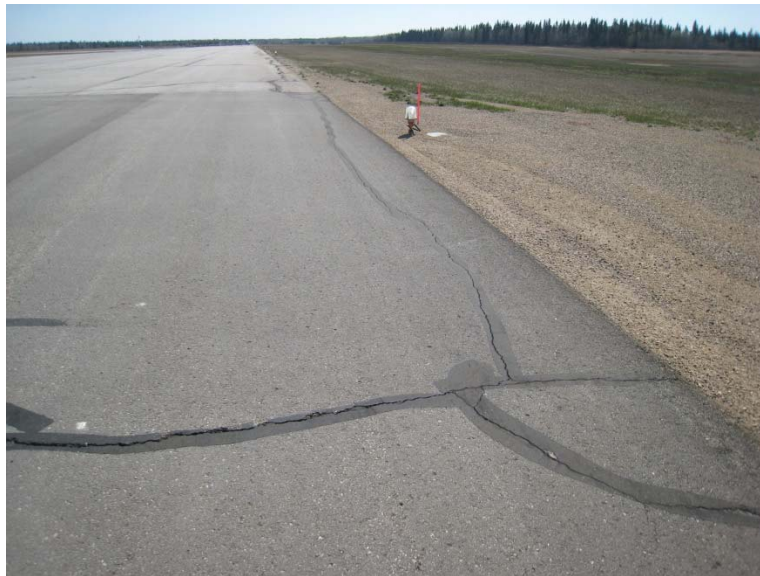
Another serious concern about the drainage of Runway 14-32 is the condition of the shoulders. There are numerous depressions in the shoulders on both sides of the pavement, likely due to soil settlement caused by thawed permafrost. This results in water ponding near the edge of the pavement and saturating the pavement instead of flowing to the ditches. Saturated soils speed up permafrost melting. Also, the silty clays and silts under the pavement are frost susceptible and in the presence of water the pavement heaves in winter. During the spring thaw when the ice melts the soils and granular materials are saturated and weak which results in further deformation of the pavement.

It was observed during the May 2015 visit that the pavement on Runway 14-32 has numerous bumps and settlements in the non-keel zones. It was observed that there were numerous locations where the pavement was patched particularly near the edges in the non-keel zones. It is likely that at least some of the patches were in areas where the pavement exhibited settlements and bumps. No profile or roughness surveys were carried out on Runway 14-32 and therefore it is not possible to comment how severe these bumps are.

**Figure 6: Settlements in the non-keel zone on Runway 14-32 and depressions on the shoulder [LU, May 2015]**

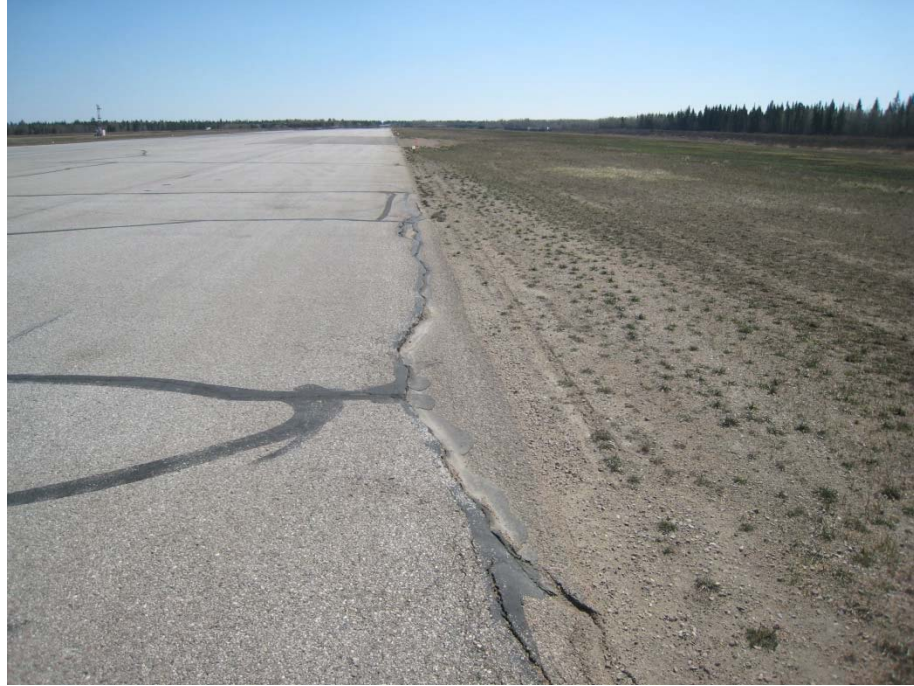
There are 250 mm edge drains located along both edges of the runway pavement. These subdrains were constructed during paving of the runway in 1966; however, the drains are no longer functional. They have collapsed at some locations and are clogged with sand, silt, and gravel. The failure of the subdrain resulted in the failure of the pavement, particularly along the edges. As a short term solution, the catchbasins were capped with heavy duty plastic sheet or with asphalt. There are two outflows from the catchbasins to the Hay River; however, they are not functional. The ditch in front of the outlet from the west subdrain that was inspected during the May, 2015 visit was silted and overgrown with vegetation.

**Figure 7: Pavement failure over the existing subdrain system and depression in the shoulder on Runway 14-32 [LU, 2015]**

It was recommended that new subdrains be installed on both sides of the runway. The existing subdrains were likely constructed during runway paving in 1966 so they are almost 50 years old. If proper maintenance is not applied, the subdrains had likely reached the end of their service life some time ago.

The depth of the subdrains should be a minimum 0.5 m below the bottom of the pavement structure. It is also critical that there are enough outlets taking the subsurface water to the ditches. A minimum of two outlets were recommended on each side of Runway 14-. The design of the subdrains along the entire runway would require careful determination of their longitudinal slope.
