# **Cable Impregnation for Post-Tension Grouting Problems**

David Whitmore, P.Eng, FACI, FCSCE  
Vector Corrosion Technologies Ltd.  
Winnipeg, MB Canada

## **ABSTRACT**

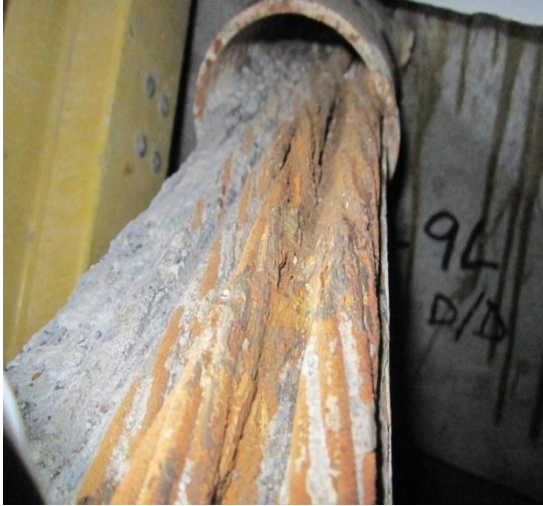
Figure 1. Corrosion evident in voids in a tendon duct near anchorage. (Florida Department of Transportation)

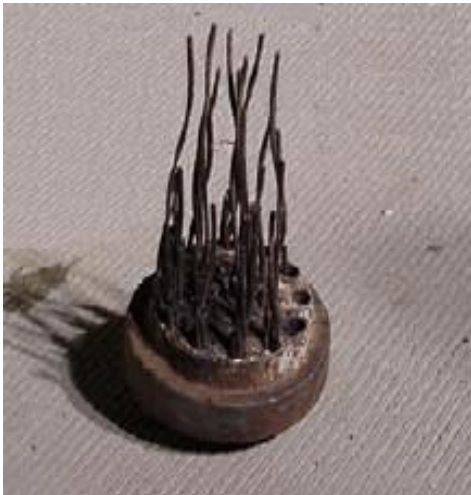
Figure 2. Failed tendon due to corrosion near anchor plate. (Florida Department of Transportation)

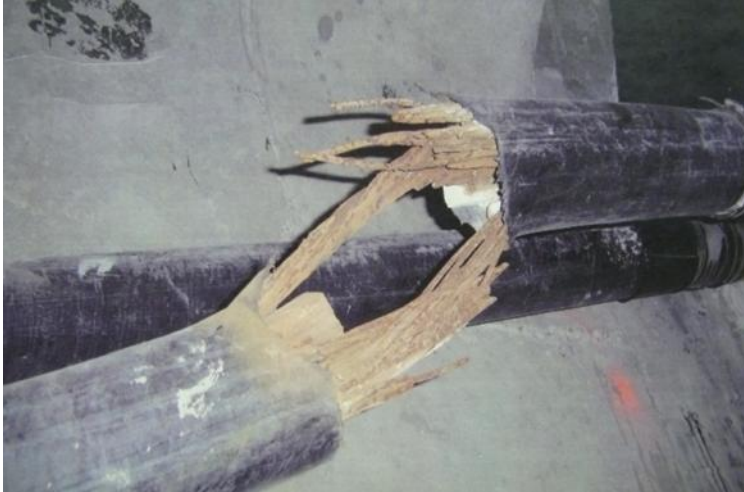
Figure 3. Failed tendon due to corrosion at interface between original Portland cement grout and new grout in re-grouted voids (Virginia Department of Transportation)

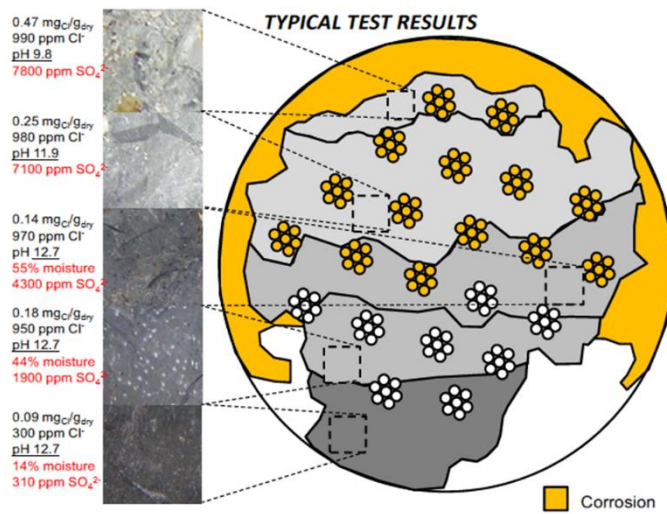
Figure 4. Post-Tension Tendon corrosion due to grout segregation. (Florida Department of Transportation)

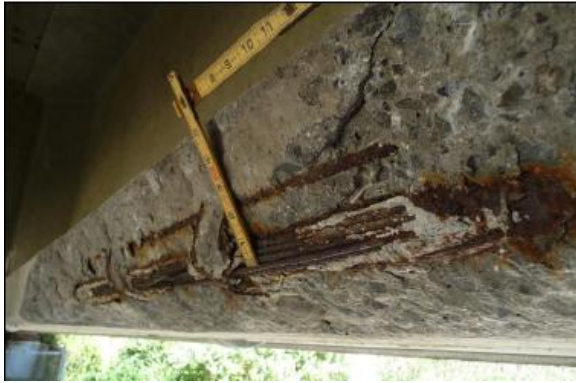
Figure 5. Voids between wires, high water cement ratio grout and presence of chlorides does not provide adequate corrosion protection to the PT tendon.

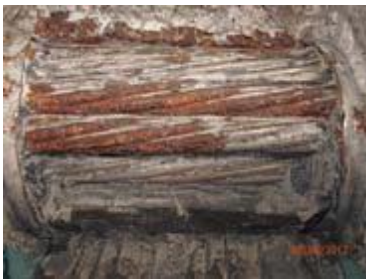
Figure 7. Corrosion of post-tension tendons in soft grout (Florida Department of Transportation 2013)

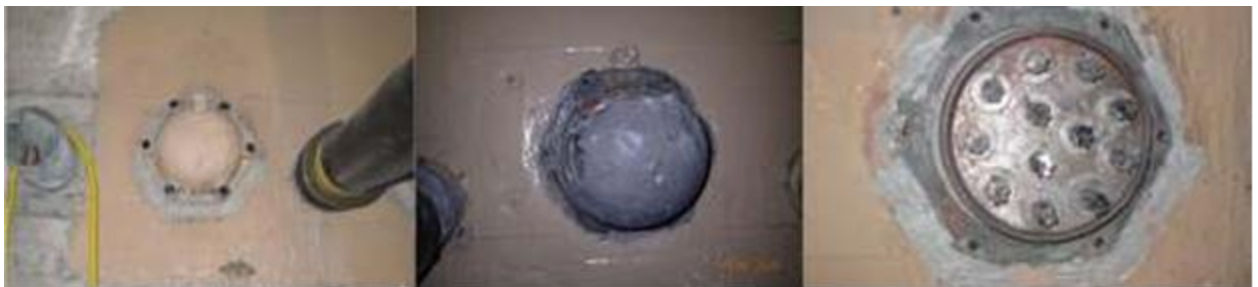
Figure 19. From Left to Right: Before removal of anchor cap, view of grout at anchorage after anchor cap was removed, and exposed anchor plate and strand ends after removal of grout

A number of tendons were impregnated from the end anchorage location. In order to complete this work, the grout caps and grout within the cap was removed to expose the anchor plate and the end of the 1/2" diameter strands. After the strand ends were exposed, the caps were re-installed and used for impregnation.

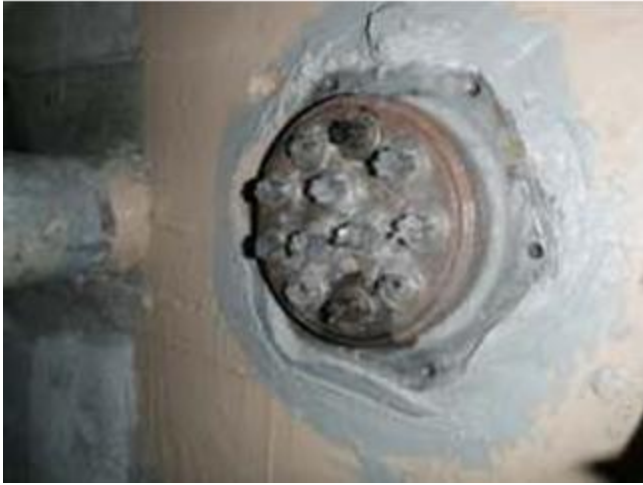
Figure 21. Post-Tension Impregnation Material leaking from the far end of 2 strands of a tendon (255 ft from point of impregnation)

Impregnation was initiated and low pressure was maintained until impregnation material appeared at the far end of the tendon, 255 ft. (78m) from the point of impregnation.

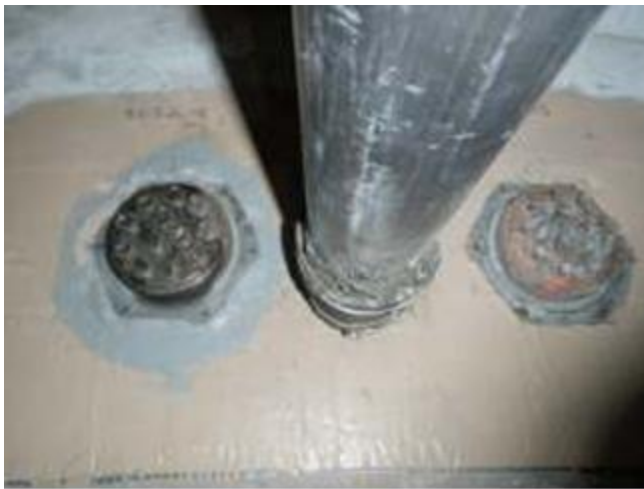
Figure 22. Post-Tension Impregnation Material present at far end of tendon on left. No impregnation material present on adjacent tendon (right).

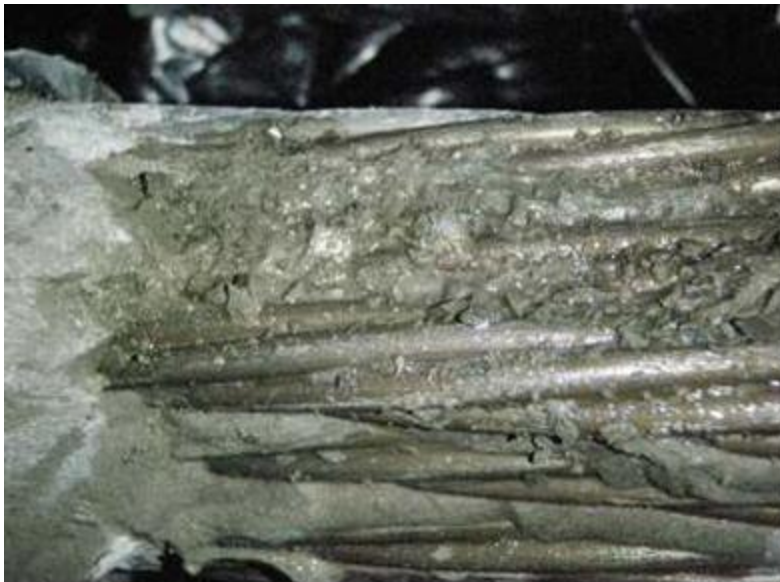
Figure 25. Post-Tension Impregnation material clearly visible in the strands as well as in the surrounding grout
