The Lions' Gate Bridge Suspended Span Replacement

Darryl Matson, P.Eng., Buckland & Taylor Ltd.

of the 2009 Annual Conference of the  
Transportation Association of Canada  
Vancouver, British Columbia

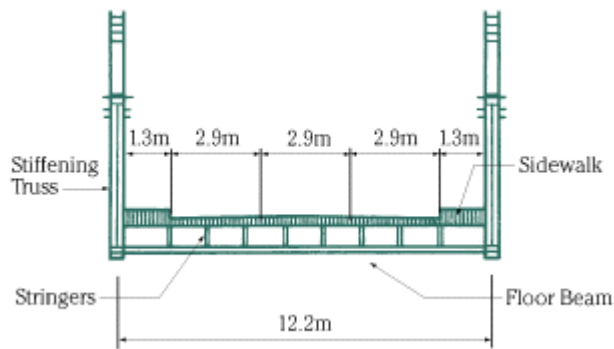
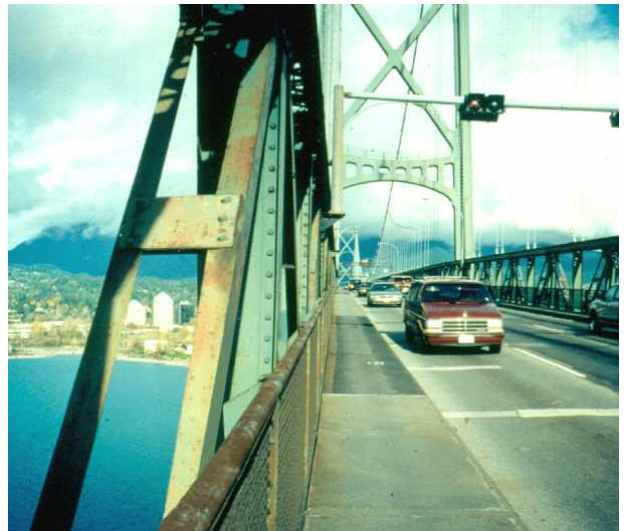
Figure 2: Old Cross Section and Old Sidewalk Photo

The design of the original stiffening trusses, floorbeams, stringers, concrete filled tee-grid deck, and steel sidewalks produced a relatively light suspended structure. Though the new deck is approximately 35% wider, with almost 45% more usable width than the original deck, the weight was kept to that of the original bridge. This was important as it meant that the towers, main cables, and main cable anchorages did not need to be upgraded to carry any additional load. Maintaining the same light weight was also critical to allow sequential replacement of the deck in sections without inducing unacceptably large deformations and stresses in the original or new structural components during construction.

B&T's design increased the width of the three traffic lanes from 2.9m to 3.6m, included traffic barriers to separate pedestrians and cyclists from the traffic (the original bridge has no barriers), and increased the width of the sidewalk width from 1.3m to 2.7m (2.0m clear at the hanger locations).

See Figures 2 and 3 for a comparison of the old and new cross sections.

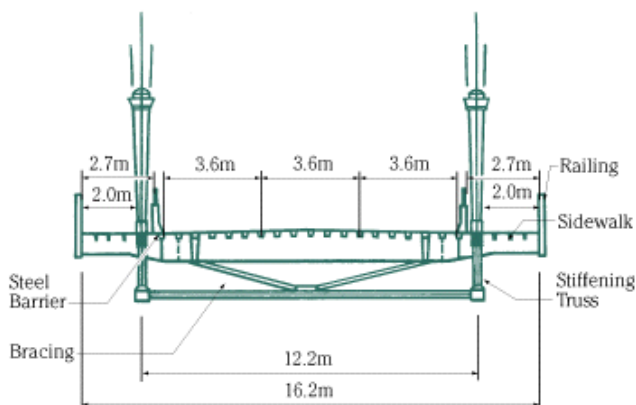
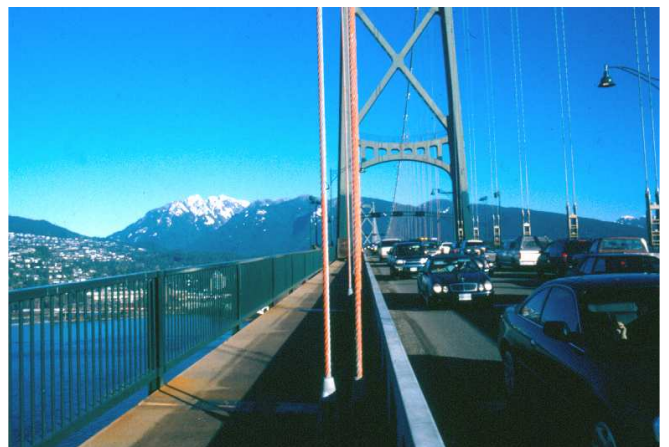
Figure 3: New Cross Section and New Sidewalk Photo

The new longitudinal stiffening trusses are composite with the orthotropic deck, and unlike the original trusses, the new ones are placed under the deck.

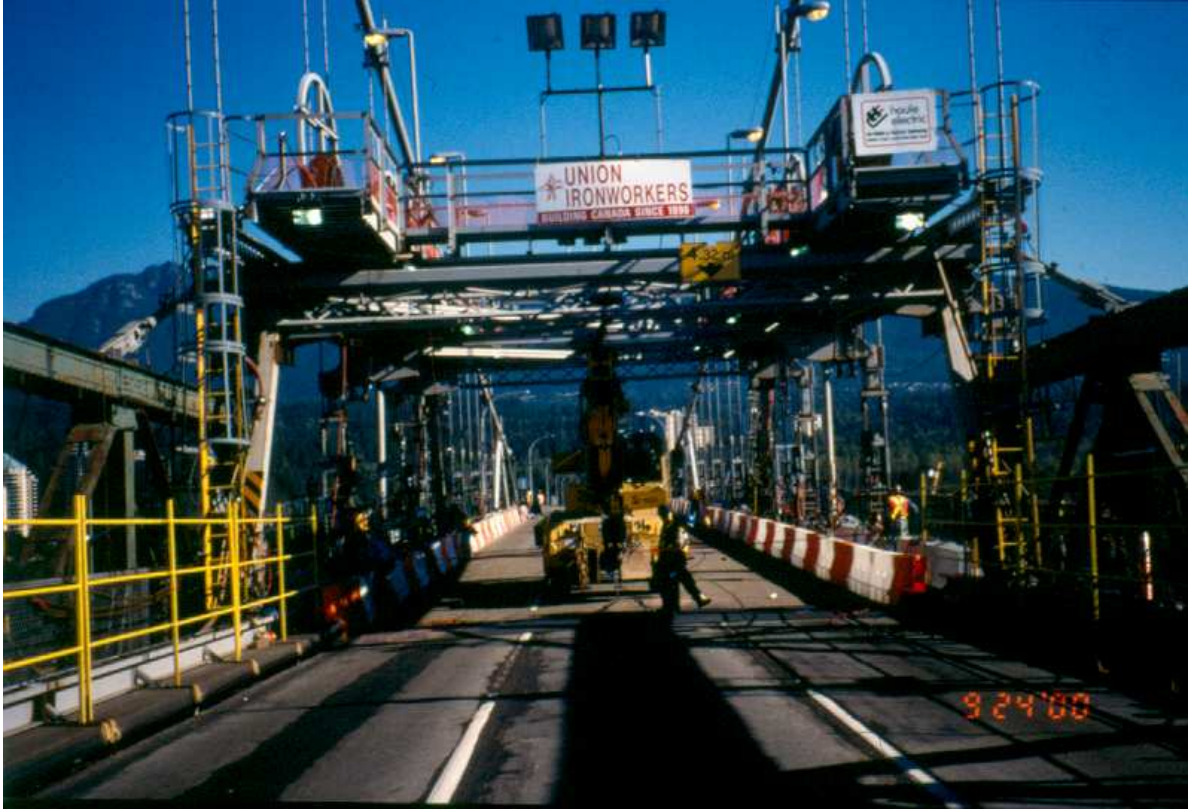
Figure 4: Contractors Jacking Traveler

The main components of the Contractor's construction equipment were a "jacking traveler" (see Figure 4), which supported four 60 tonne capacity strand jacks, and a "continuity link" (see Figure 5), which provided the vertical and lateral connection between the new and old deck sections at the erection front. The jacking traveler was a steel frame that weighed approximately 55 tonnes and was the support structure for lifting and lowering deck sections. The jacking traveler was designed to be supported on the original hangers when lowering and lifting sections and to be supported on the deck when the jacking traveler was moved.

The replacement of a typical deck section began by positioning the jacking traveler over the section to be removed (this was typically done during the day while traffic was using the bridge). At the start of a night closure, the bridge was closed to traffic and the continuity link was disconnected and moved to the next location. The old truss, old deck and the original hanger lug plates were cut (see Figure 6), thereby releasing a 20m section of the existing deck from the bridge onto the strand jacks. The old section was lowered (see Figure 7) and disconnected from the strand jacks. The new deck section was attached to the strand jacks and raised into place (see Figure 8). The geometry of the new section, in relation to the previously erected new sections, was established and bolts were installed and torqued in the trusses and the orthotropic deck troughs (see Figure 9). Temporary adjustable hanger extensions were installed between the original hangers and the new deck then the continuity link was connected. The strand jacks were disconnected and the adjustable hanger extensions were set to their correct lengths to distribute the loads between hangers to avoid overloading the structure. Temporary deck plates and temporary traffic barriers were installed and the bridge was reopened to traffic.

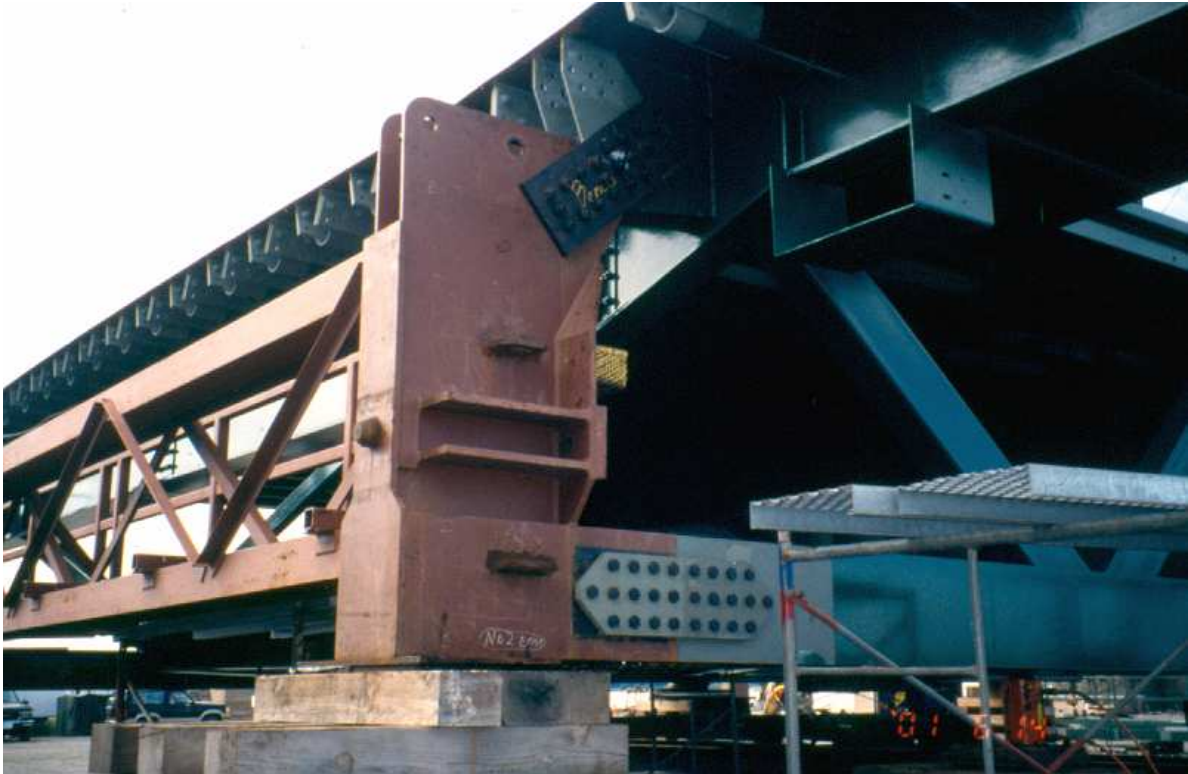
Figure 5: Contractors Continuity Link (Mates with Section Attached to Old Bridge)

The continuity link, which weighed approximately 20 tonnes, was needed whenever traffic was using the bridge. It connected the new and old sections together at the

erection front and, therefore, maintained the continuity of the roadway surface. At the beginning of a night closure, the continuity link was disconnected and moved, on the existing maintenance traveler rails, to the next location. After the deck section was replaced, the continuity link was re-connected prior to allowing traffic to use the bridge.

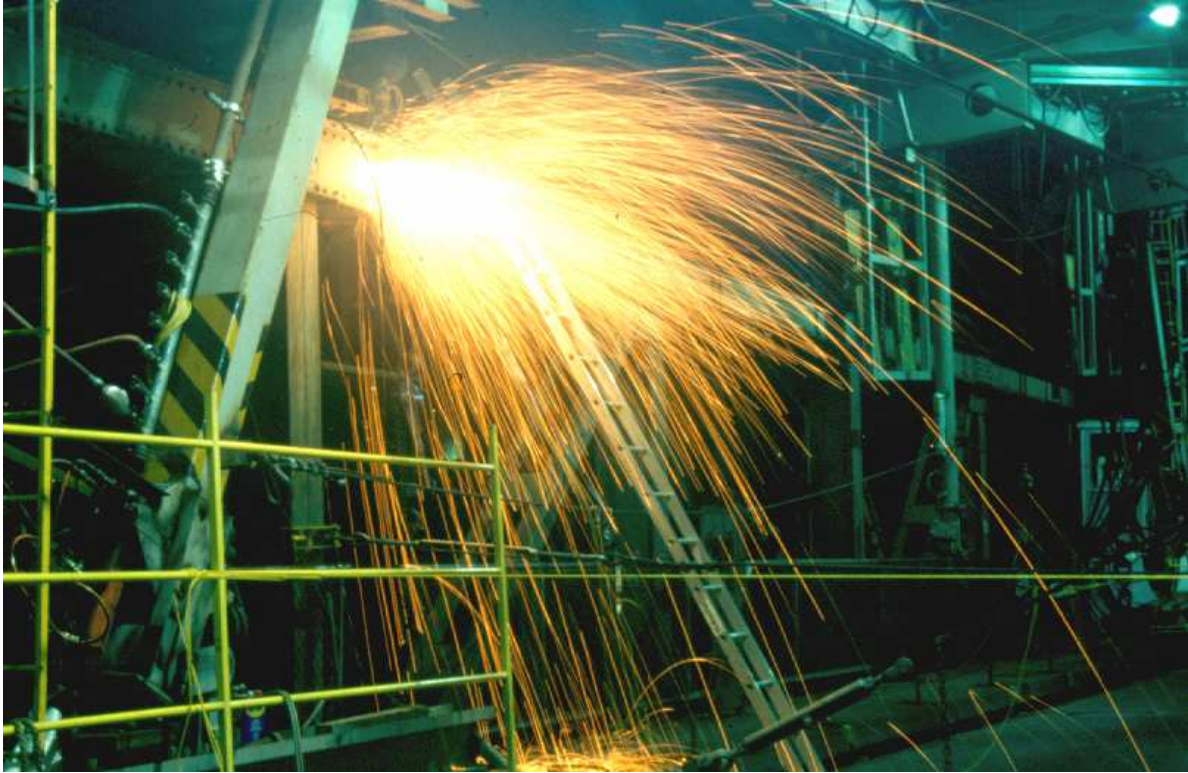
Figure 6: Cutting Old Deck Section Free

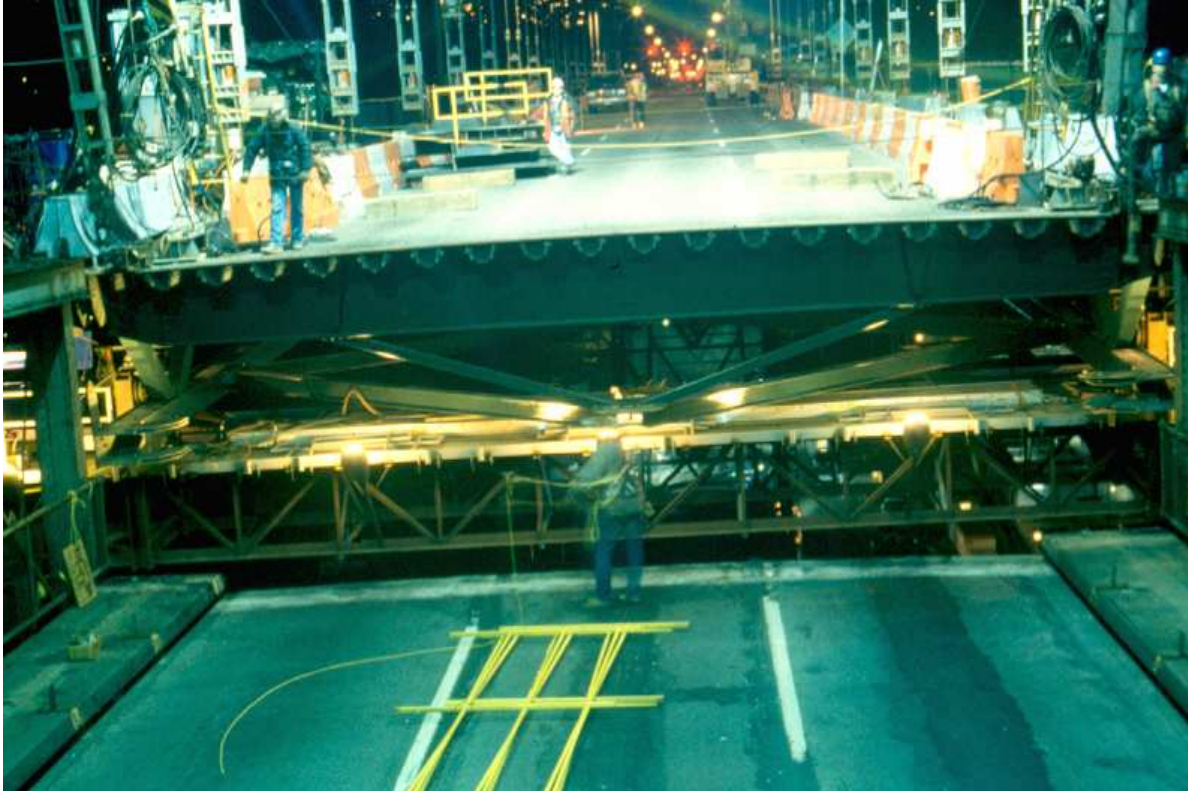
Figure 7: Lowering Old Deck Section

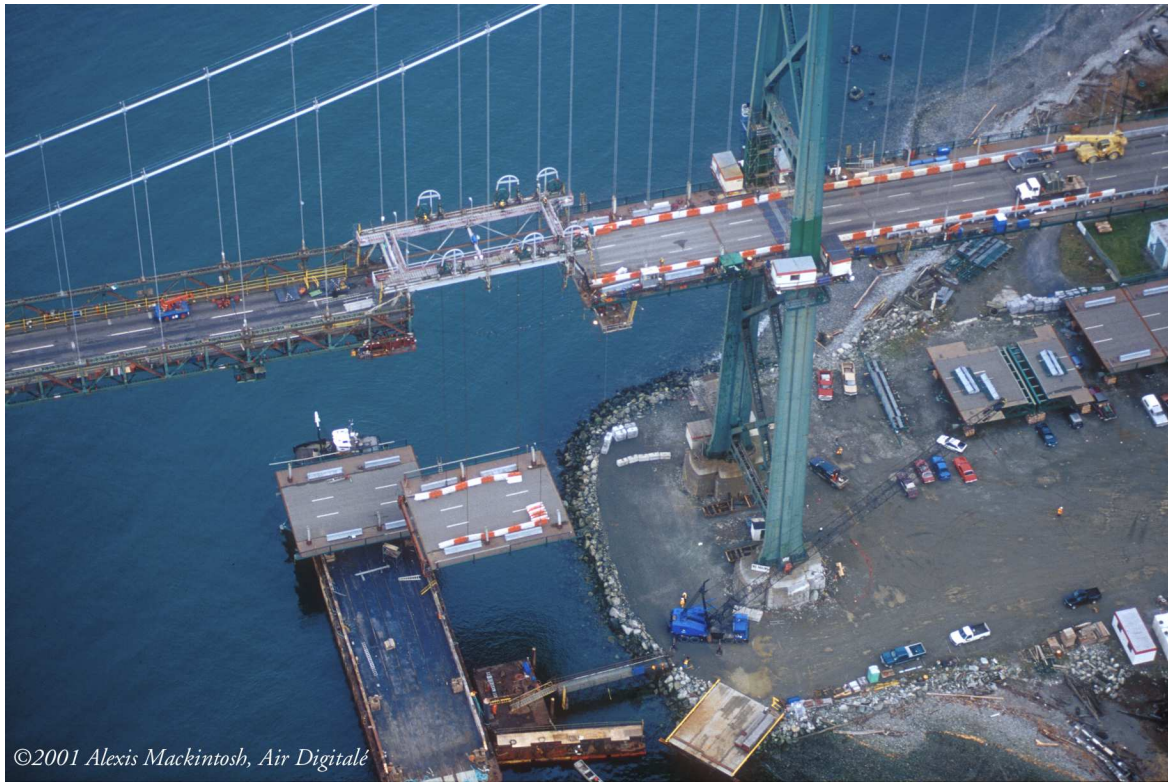
Figure 8: New Deck Section Being Raised

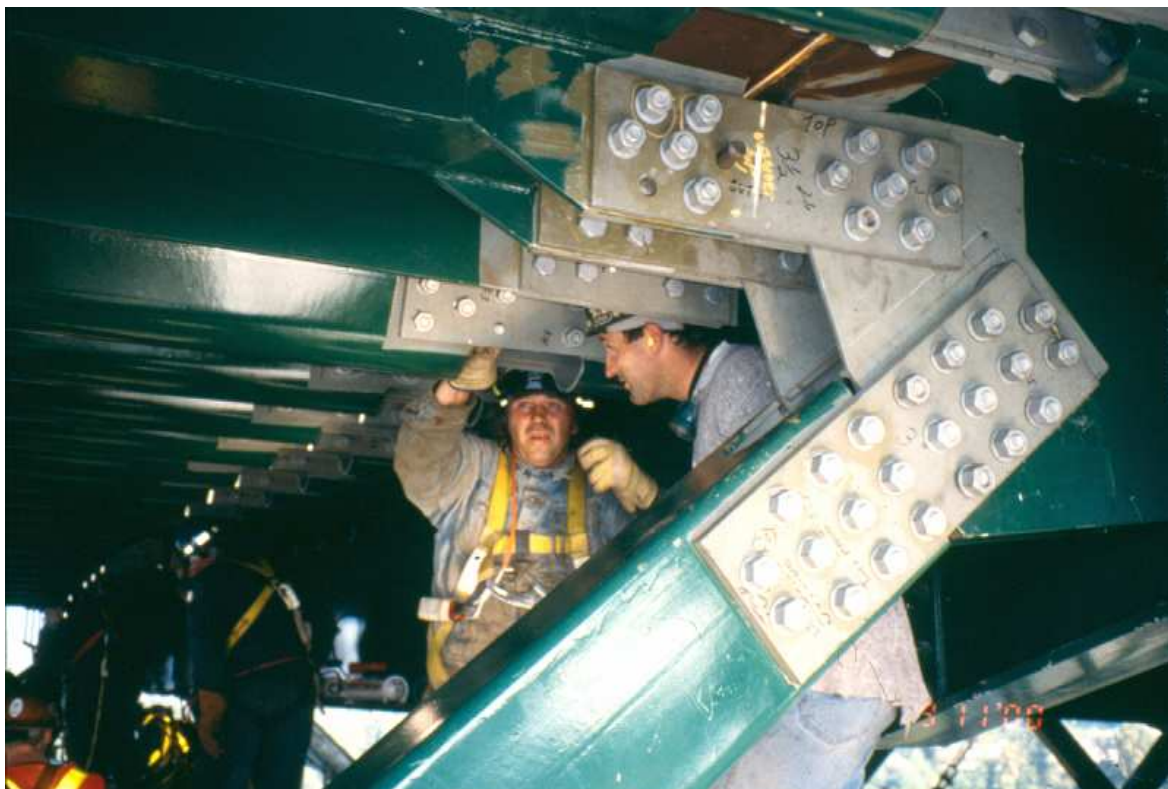
Figure 9: New Section Being Bolted to Previously Erected Section

Design details were developed that considered the constructibility issues that arose due to the short duration of the bridge closures. The design anticipated 47 new deck sections, typically 20m in length weighing 106 tonnes, progressively erected from north to south. The field splices were located to allow the newly erected deck section to be raised with little interference from the previously erected section. All the splicing of the stiffening trusses and deck troughs used bolted connections rather than field welding, to allow for alignment and quicker completion of the splice.

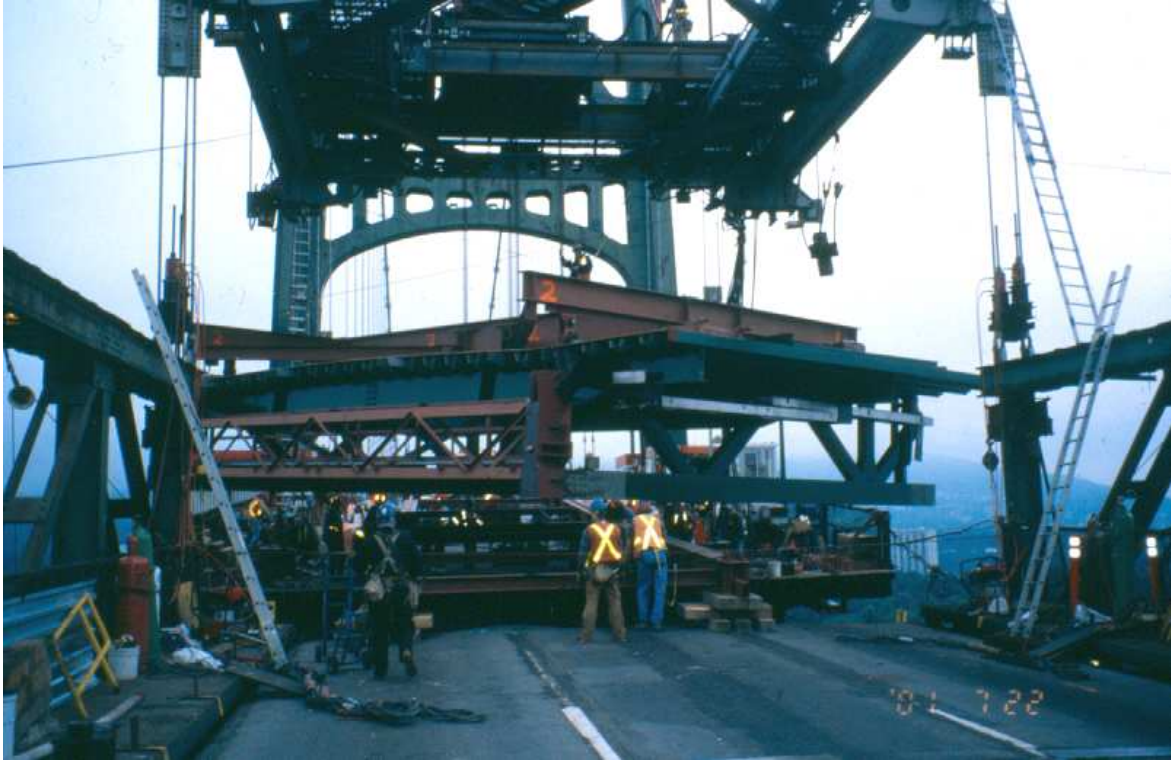
Figure 10: Modified Jacking Traveler Rotating South Side Span Section

The Contractor elected to replace the south side span in 10m sections. This change in procedure allowed the Contractor to eliminate the need for an elaborate ramp system on the steep slope below the side span that was anticipated during the design. It also resulted in a total of 54 deck sections for the bridge instead of the 47 shown on the design drawings. The jacking traveler was modified to allow the sections to be driven to the erection front on the new deck (i.e. from the north), lifted by the jacking traveler, rotated 90 degrees (see Figure 10), and lowered into place.

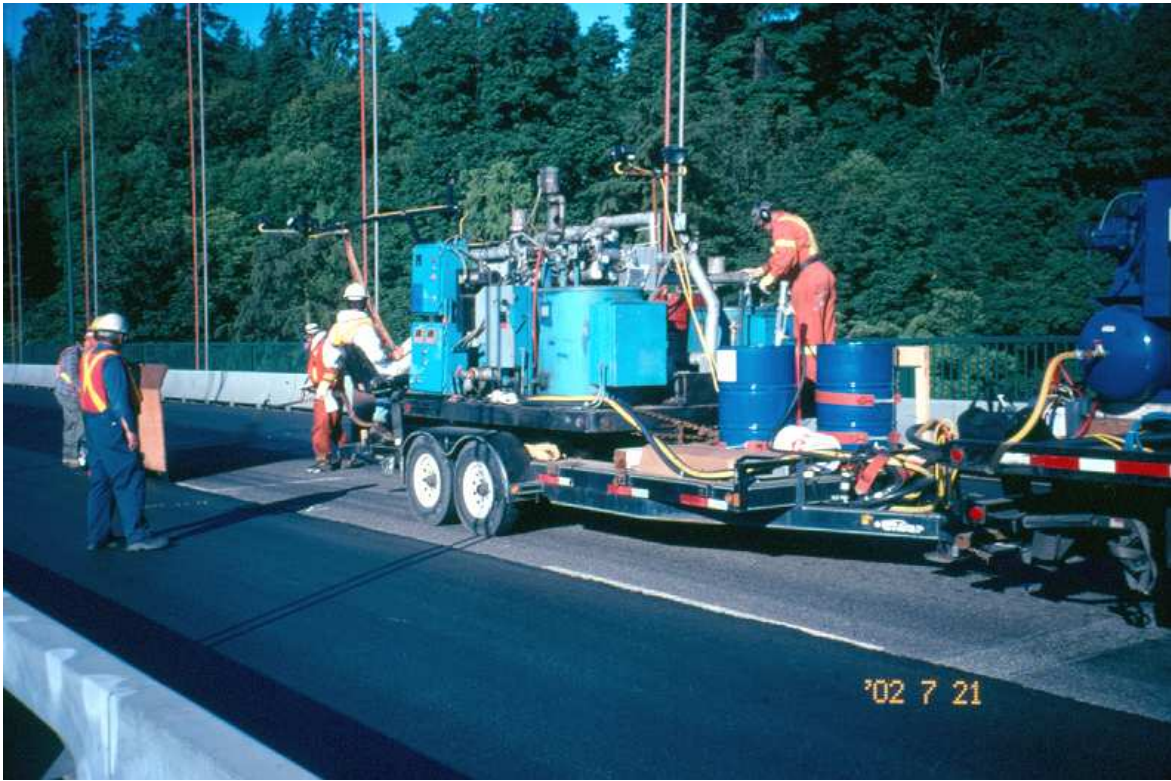
Figure 11: Final Paving Being Applied

The deck erection started at the north end and progressed south. The first deck section was installed in September 2000 and the last one a year later in September 2001. Following installation of the deck sections, the original cable suspenders were replaced. Due to minimum temperature requirements, the final lift of epoxy asphalt was installed in the summer of 2002 (see Figure 11).
