**Settlement Mitigation by Using Cellular Concrete
at Nepewassi River Bridge, Ontario**

A Case Study

**Paper prepared for presentation
at the ROADS AND EMBANKMENTS -- CASE STUDIES AND LESSONS LEARNED session**

of the 2016 Conference of the
Transportation Association of Canada
Toronto, ON

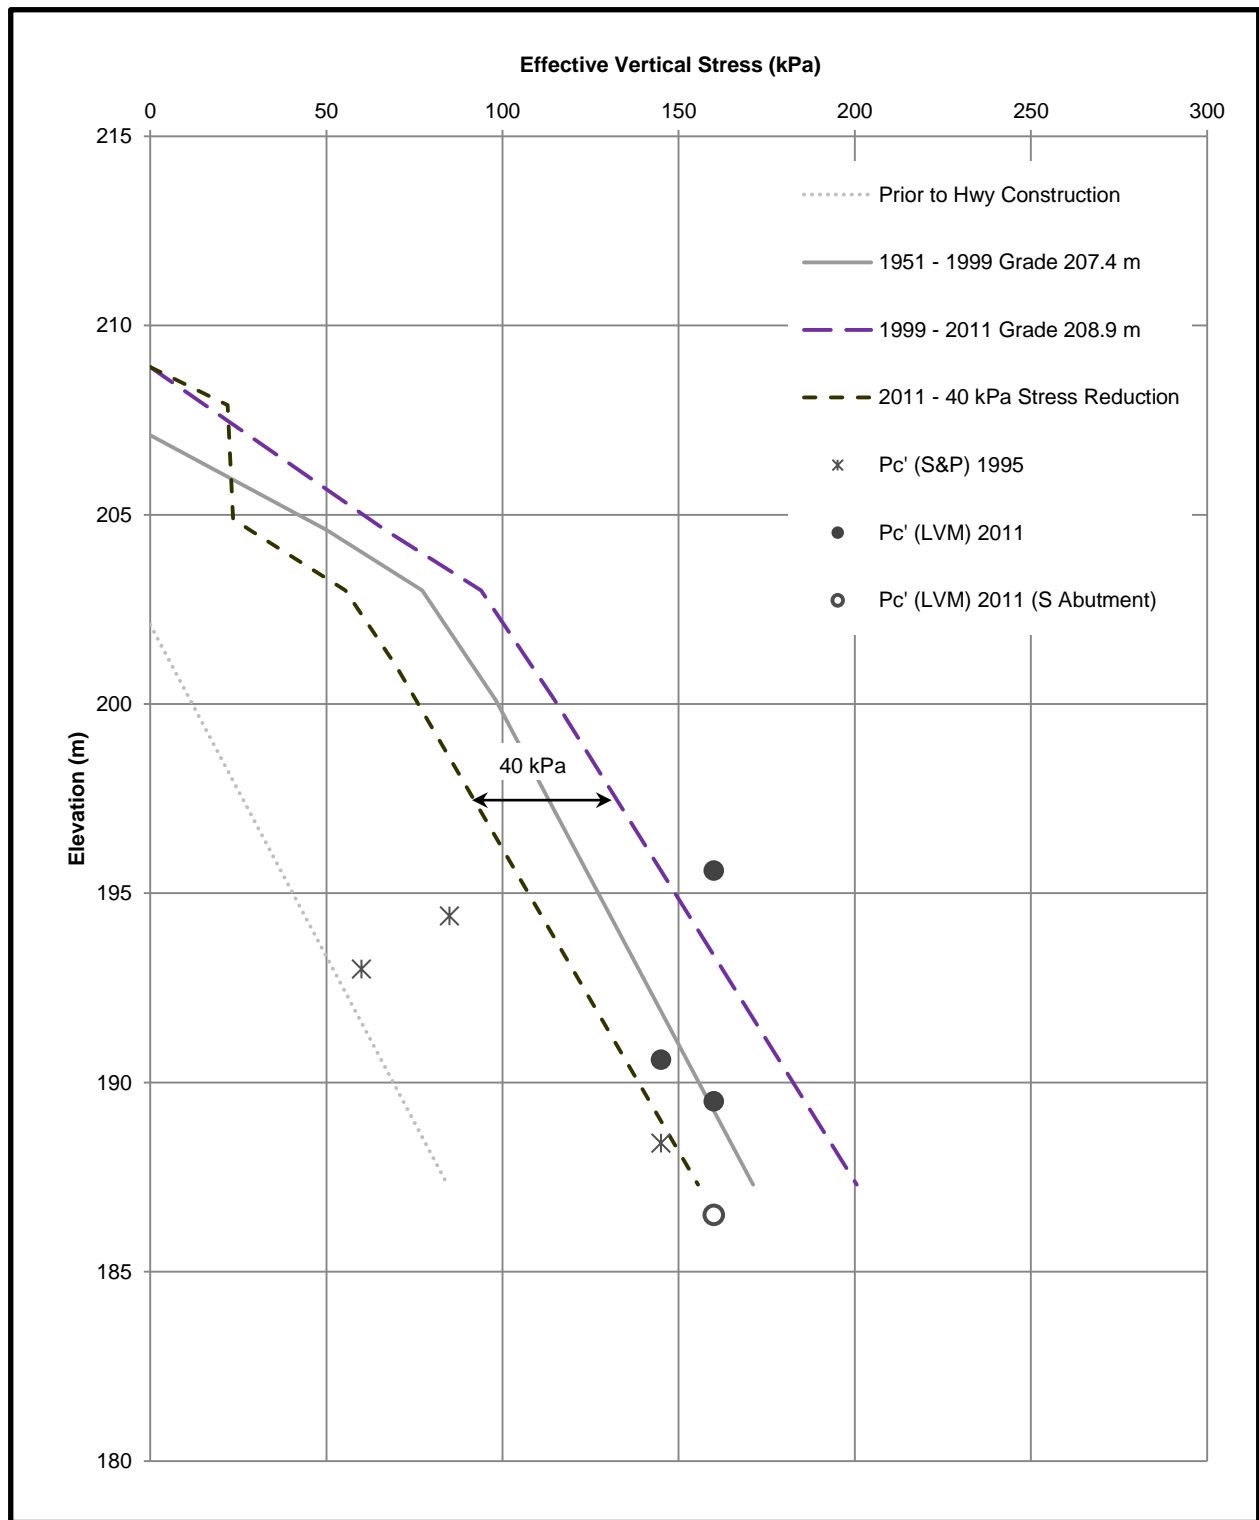
Figure 2 – Stress History of Northern Embankment

An investigation was commissioned to assess the embankment performance for both embankment stability and settlement. Consolidation testing, compiled during a 2011 study, indicated that the effective stress on the underlying soft clay exceeded the preconsolidation (pc') values for the underlying clay deposit. As such, it was concluded that consolidation settlement would continue. To control future settlement of the approach fill, to within tolerable limits, the effective stress directly behind the abutments for a 10 m length (below approach slab) needed to be reduced to a value estimated to be less than the preconsolidation pressure of the underlying clay stratum. The relationship between the historical and existing effective overburden pressure and the estimated preconsolidation pressures, developed during the 2011 study, are shown as the Stress History plots for the south and north embankments on Figures 2 and 3.

At the south embankment, where the clay deposit is thicker, it was necessary to reduce the vertical effective stress by 50 kN/m^2 to achieve a stress level less than the preconsolidation level of the clay stratum. Likewise, at the north embankment, a reduction of 40 kN/m^2 was required.

The reason for the continuing, although reduced and annually decreasing, settlement of the approach embankment fill is due to the effective stress on the underlying clays exceeding the preconsolidation pressure of the deposit. The Stress History plots, evaluated during the 2011 Foundation Investigation indicate that at the south abutment the planned effective vertical stress reduction of 50 kPa was only slightly lower at some 4 kPa than the estimated preconsolidation pressure evaluated for the sample from elevation 190.5 m. The river level limited the depth of excavation and therefore restricted achieving a greater reduction in effective vertical stress at the south abutment. At the north abutment the planned stress reduction of 40 kPa was some 10 kPa lower than the preconsolidation pressure evaluated for the sample from elevation 190.5 m. All other preconsolidation values, estimated during the 2011 Foundation Investigation, exceeded the stress reduction value(s) by an amount greater than those referenced above for the sample at elevation 190.5 m.

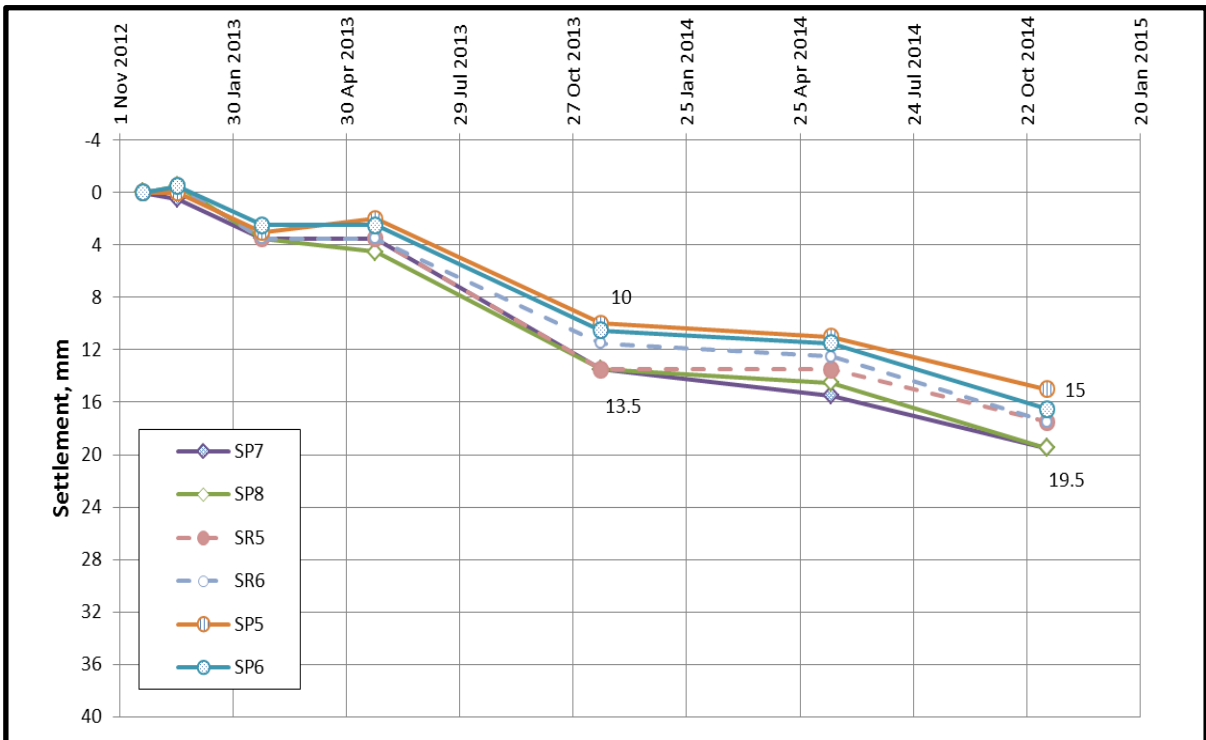
Figure 6 – Settlement of North Embankment

Post construction settlement monitoring comprised of settlement rods (SR) and settlement monitoring points (SP). Four settlement points and two settlement rods were installed in the new cellular concrete embankment, at both the north and south approaches. In addition, two settlement rods (SR No.1 and SR No.2) were installed within the embankment that was not “treated” with cellular concrete; this stretch of embankment was used as a control embankment. The Settlement Rods (SR) were designed to record vertical movement at the base on the cellular concrete whereas the Settlement Points (SP) were founded in the upper final lift of the cellular concrete and were intended to measure vertical movement of the surface materials. The vertical movement of the Settlement Rods (SR) and Settlement Points (SP) are presented graphically on the attached settlement data plots, Figures 5 and 6

The vertical movement of the south and north embankments are shown on Figures 5 and 6 respectively. As can be seen from the settlement data plots of both the SR's and SP's there is a distinct difference in the slope(s) of the settlement plots for the winter period (November to May) versus the summer periods (May to November). During the winter period of November 2013 to May 2014, the SR readings indicate 0 to +1 mm of settlement, in the area of the cellular concrete fill. This is considered to indicate essentially zero movement in the area of the cellular concrete. The SP's also returned very low movement values varying from +2 to -1 mm over the winter months. However, over the summer periods, May to November 2013 and May to November 2014, the data indicates downward settlement varying initially from 8 to 10 mm (summer 2013) decreasing to 3 to 4 mm (summer 2014) at the SR's located in the area of the cellular concrete. The data for the settlement points (SP) also indicates that the settlement recorded during the summer of 2014 was at a decreased rate relative to the settlement recorded during the previous summer of 2013, similar to the data at the settlement rods, Figure No. 6.

In the areas beyond the lightweight (cellular concrete) fill treatment, represented by SR 1 and SR 2, settlement has occurred during both the summer and winter periods however at a distinctly lower rate during the winter as indicated by the settlement plots SR 1 and SR 2. The relationship between the movement of the deep seated SR's and the adjacent shallow seated SP's has been plotted on Figure 5 and 6. This data indicates that at all four locations where SR's were located adjacent to SP's the movement of the rods was equal to or only slightly exceeded the downward movement of the points. This difference generally varied between 0 to 2 mm except at the location of SR5 where the difference was a maximum of 3.5 mm on November 2013 reading.

The settlement data plots, taken over a twenty-four (24) month monitoring period, indicate that the magnitude of settlement of the cellular concrete approach slab fills is essentially zero during the winter months. However, settlement still occurs during the summer months, albeit at a decreasing rate. The data also indicates that the deep seated SR's are settling slightly more than the shallow seated SP's.

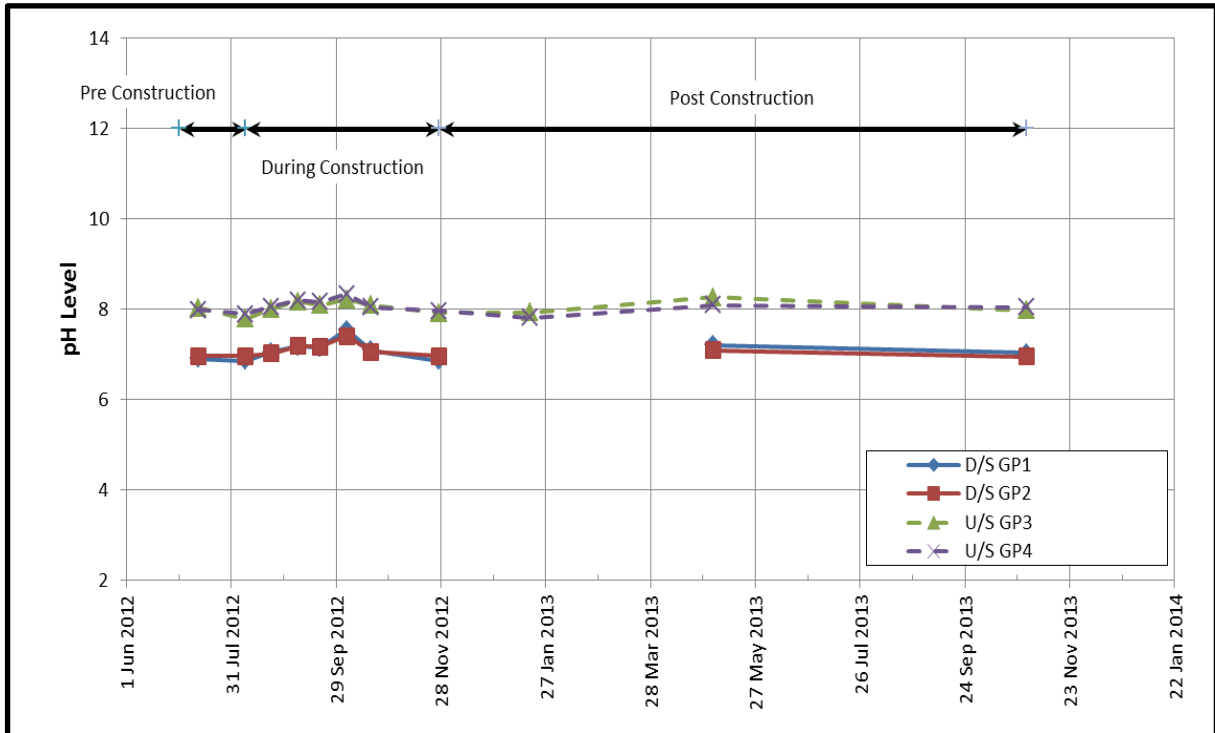
**Figure 7 – pH of Groundwater
Upstream (U/S) & Downstream (D/S) of Embankment**

A set of water samples was collected from the four standpipes (monitoring wells) and two surface water locations for the six month post-construction phase of the water quality monitoring. Surface water locations, upstream and downstream of the north bridge approach were named as SW 1 and SW 2. The odour and color of the water at each groundwater monitoring well was observed and recorded. Sampling and testing of groundwater was undertaken throughout the construction and the results of some key parameters are shown on Figures 7 to 10.

It is interesting to note that the concentration of chloride and total dissolved solids, and the alkalinity of the water increased during the construction period, and eventually returned to pre-construction levels. This is characteristic of all measured chemical content of the river water.

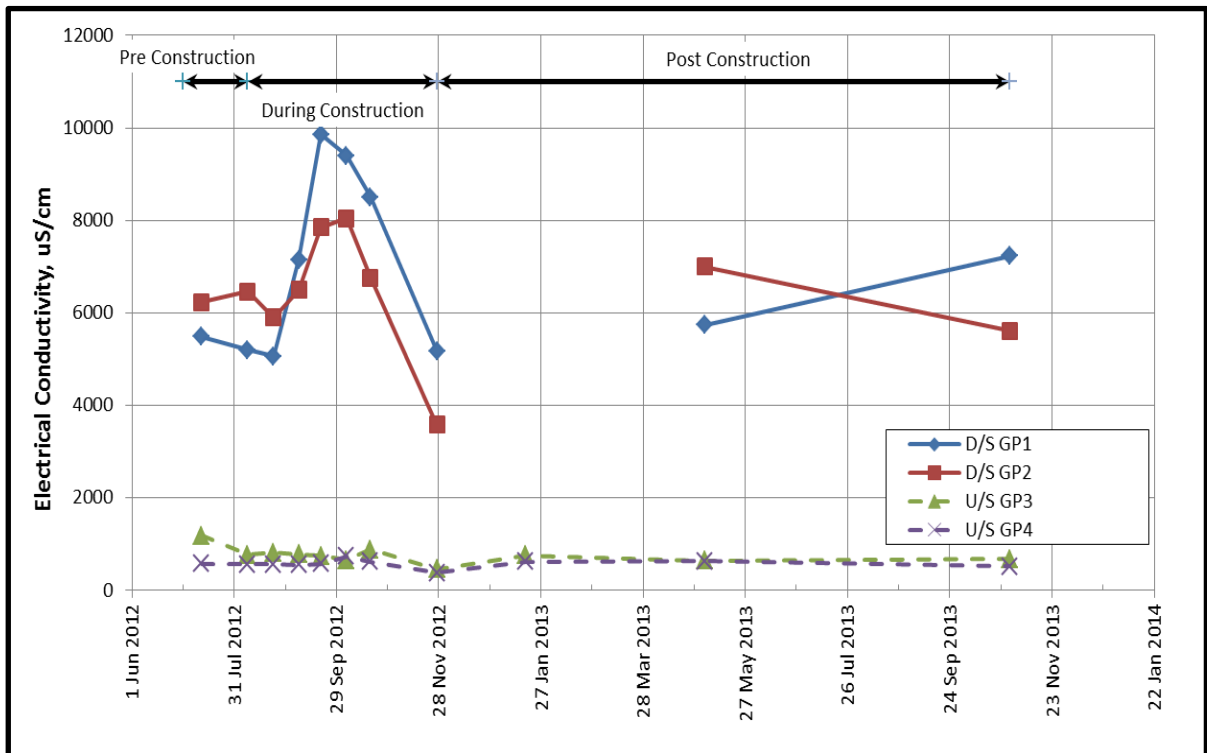
**Figure 8 – Electrical Conductivity of Groundwater
Upstream (U/S) & Downstream (D/S) of Embankment**

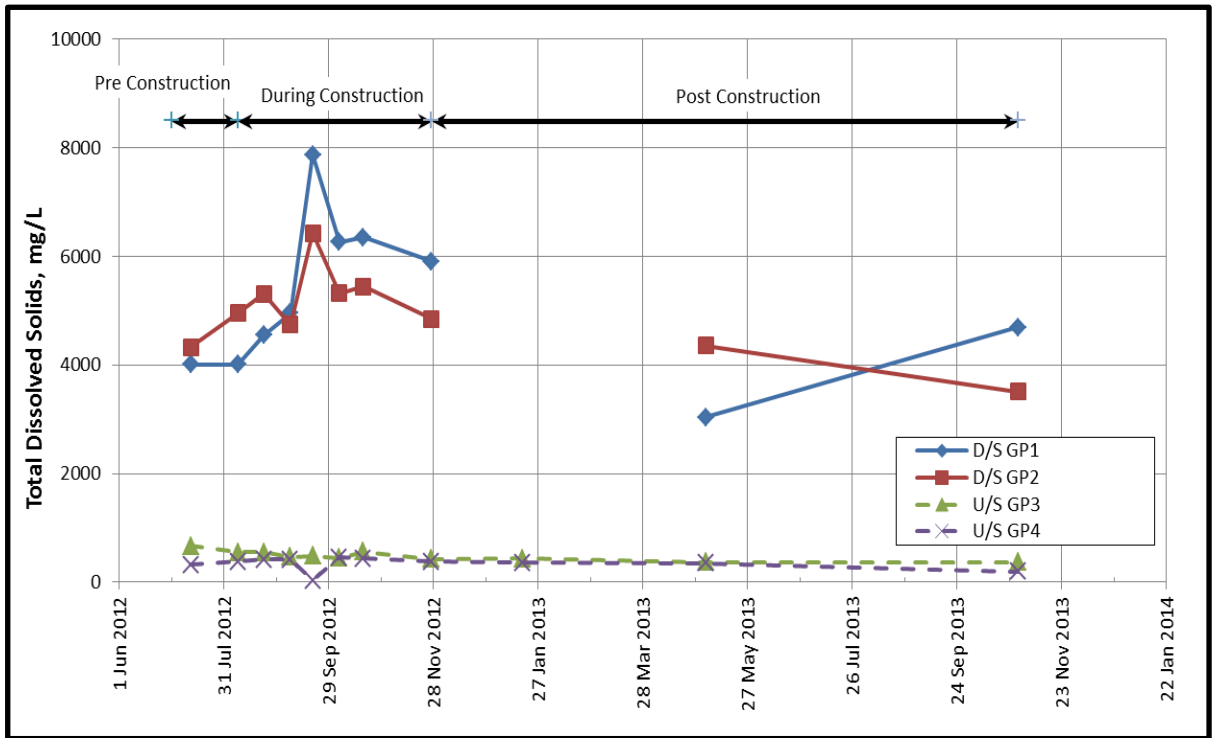
Figure 9 – Electrical Conductivity of Groundwater Upstream (U/S) & Downstream (D/S) of Embankment

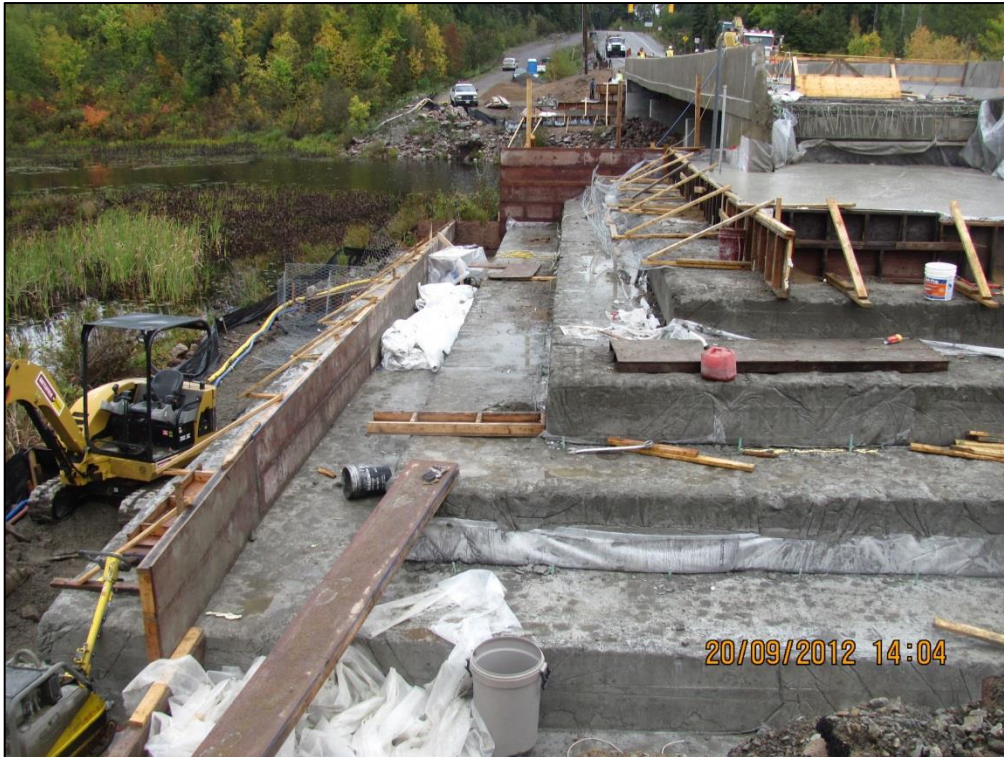
Photo 1 – Construction of southern embankment. Lighter formwork was used due to the lower unit weight of cellular concrete. Wire mesh was used as part of tie-down system using gabion blocks.

To cater for buoyancy forces on the cellular concrete, counterweights were used. Gabion baskets were placed at the toe of the future embankment slope, and after the initial curing, each lift of cellular concrete fill was strapped to the gabion baskets.

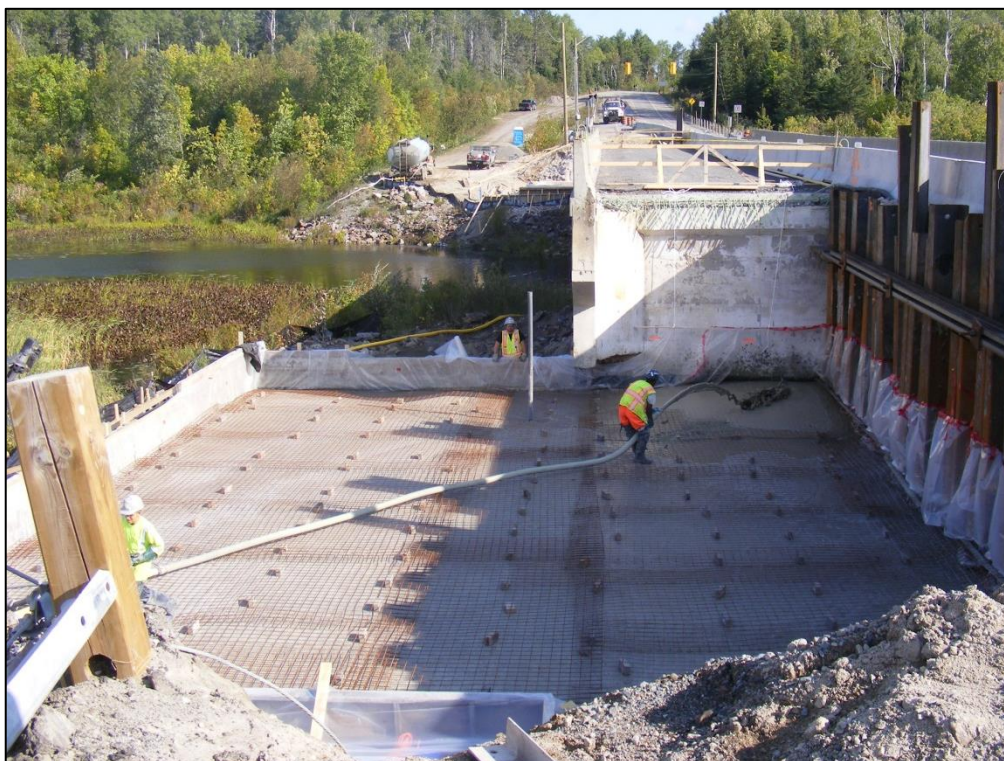
Photo 2 – Placement of cellular concrete. Plastic sheets were used to make the forms impermeable and secondary containment was installed to guard against unplanned concrete discharge or spills

Sheet piling was installed down the centreline at the approaches in order to maintain traffic across the bridge (see Photo 2).

Cellular concrete was placed in lifts ranging in thickness from 500 to 650mm. Plywood formwork lined with polyethylene sheets was used to contain the cellular concrete where

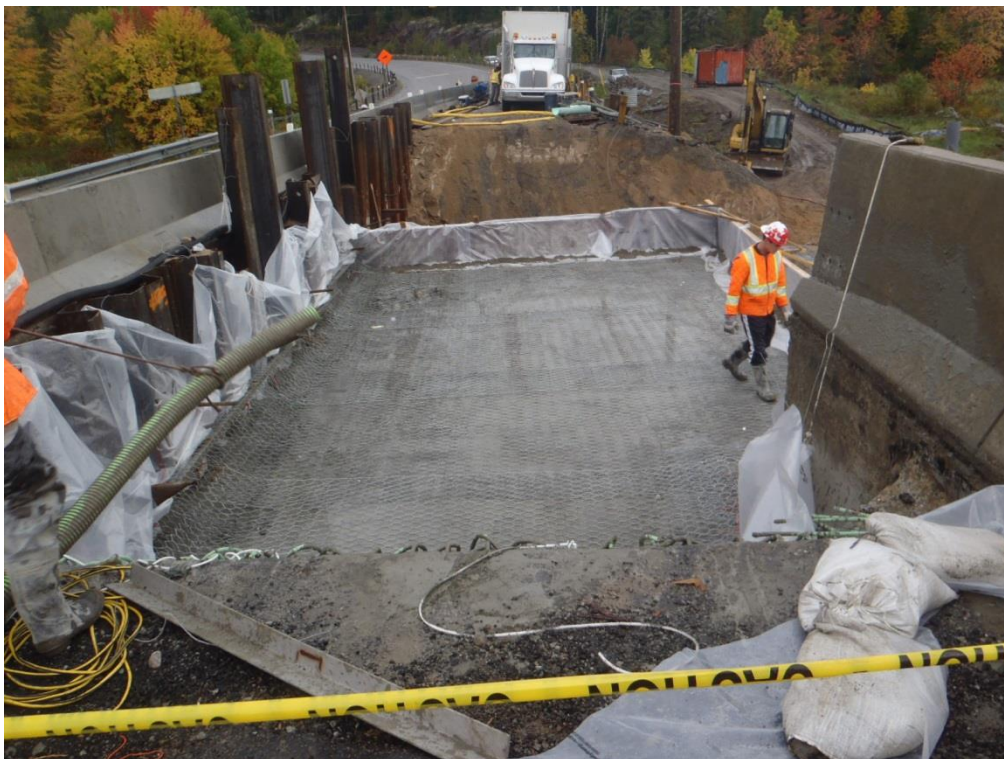
Photo 4 – Staged Construction of Embankment. Exposed subsoil of slag fill seen on the background
