Remote Monitoring System  
PTH 83 Shell River Landslide  
Russell, Manitoba

Paper prepared for presentation at the  
Innovation in Geotechnical and Materials Engineering Session

of the 2017 Conference of the  
Transportation Association of Canada  
St. John's, NL

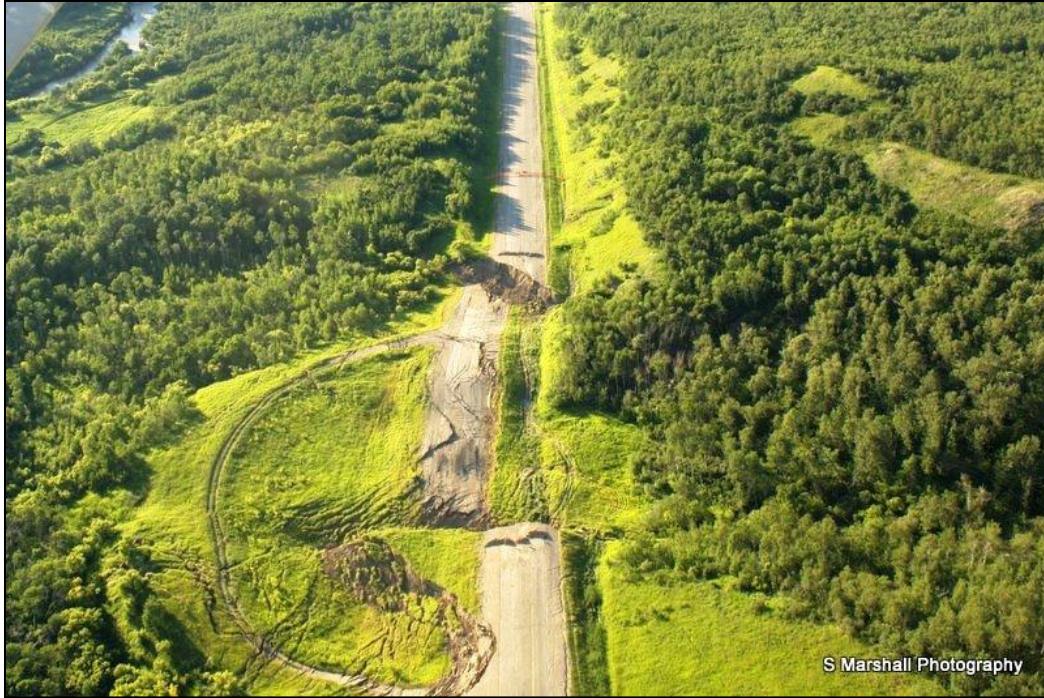
Photo 1: Aerial view of PTH 83 Shell River Landslide July 2012  
(courtesy of Shelia Marshall)

The 2012 landslide was about 20 Ha in area engaging about 4M m<sup>3</sup> of earth (Photos 1 and 2). Over a period of a few days the highway had moved about 10 m vertically and 20 m horizontally. No one was hurt but the highway was closed for 6 months while it was reconstructed at a cost of about \$3M. The repairs primarily involved rebuilding the damaged road embankment. The repairs were strictly focused on getting the highway back into service. No stabilization works to prevent a re-occurrence of the slide were implemented.

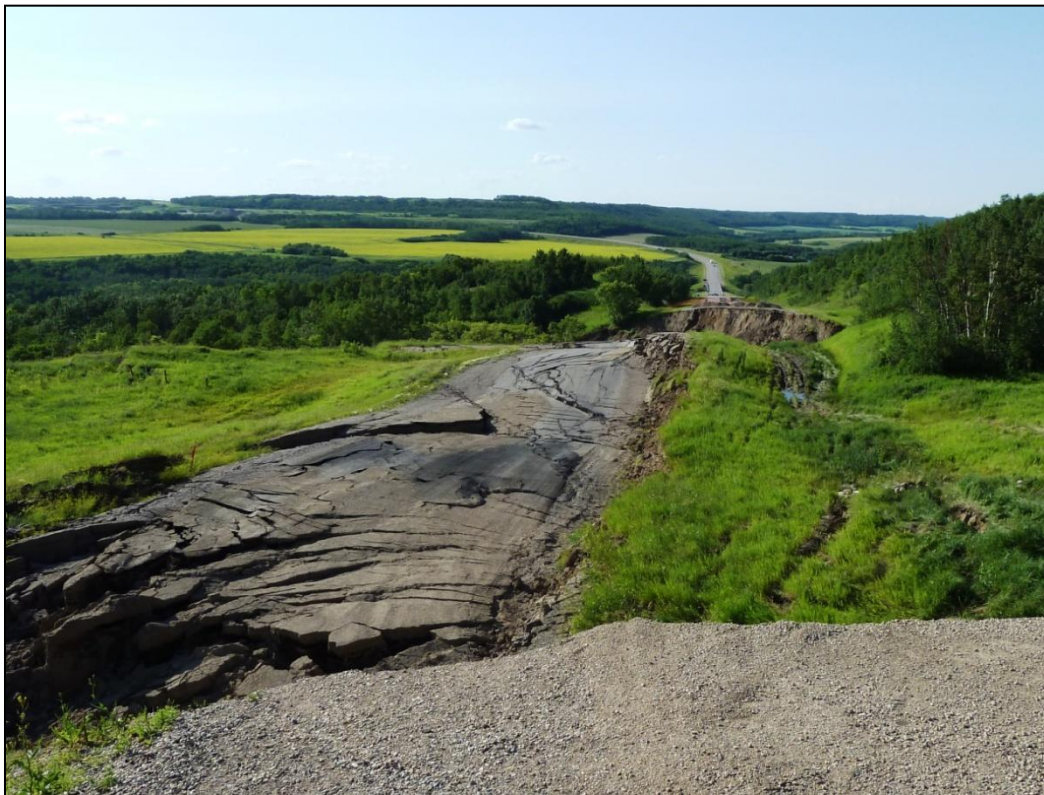
Photo 2: Damage to PTH 83 after the 2012 landslide

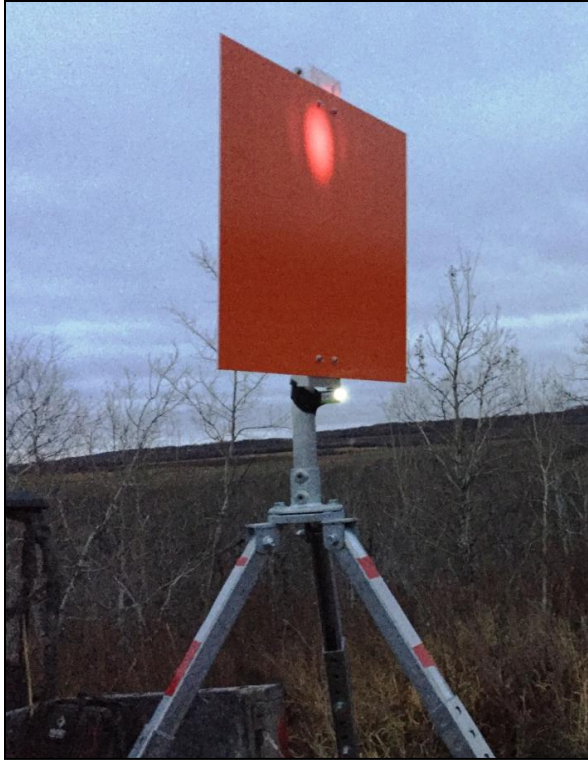
Photo 3: Target

The LDMs are fixed on the top of the escarpment outside of the active landslide and measure the distances to targets installed in the active part of the landslide (Figure 1, Photos 3 and 4). The targets (0.6 m x 0.6 m) are approximately 233 and 281 meters from their respective LDM. The SAA is installed about midway between the two targets and measures movement in three dimensions to a depth of 24 m. The three measuring devices provide adequate coverage of movements that could affect the highway. Ground surface measurements at the SAA can be compared to movements detected by the lasers. The VW piezometers are used to measure groundwater pressures at various depths in the soil.

Each LDM and target (Photo 3) is mounted on a steel tripod with adjustable height. Each tripod is bolted to three wooden 6"x6" posts that were installed 3 m into the ground. The LDMs sit on an anchor plate that can be adjusted up or down to change the angle of the laser. Sunlight

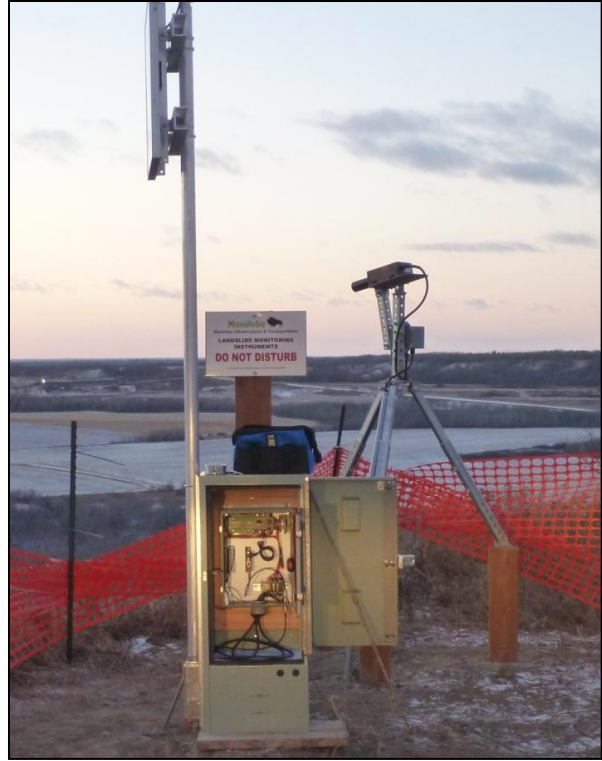
Photo 4: LDM Station 2

Data obtained from the LDMs, SAA, and VW piezometers are recorded by a Campbell CR6 data logger located next to each measuring device (Photo 4). The data from each instrument location is sent through an onsite wireless network to a cellular modem. Once per hour the cellular modem sends all the site data to a laptop located in the department's geotechnical office where it is automatically processed and uploaded to a website for viewing (Figure 5). The website can be customized to meet the needs of the viewer.

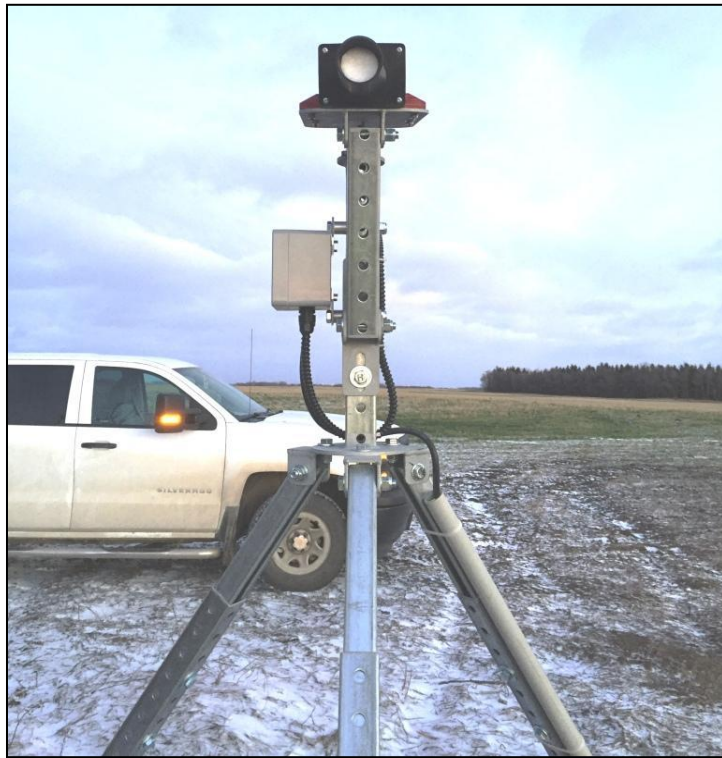
Photo 5: LDM with snow in lens

Weather Related Problems: Small amounts of snow can accumulate on the lens of the LDMs (Photo 5) and hinder laser measurements. It is possible that some of the zero LDM readings can be attributed to snow. Department maintenance staff regularly clean the snow off the lenses but access to the laser devices is across an unplowed field for several hundred meters. Having to inspect the LDMs frequently for snow is not a practical solution and effective snow shields or deflectors are needed. It has not been possible to determine if weather played a part in some of the other on site hardware problems.

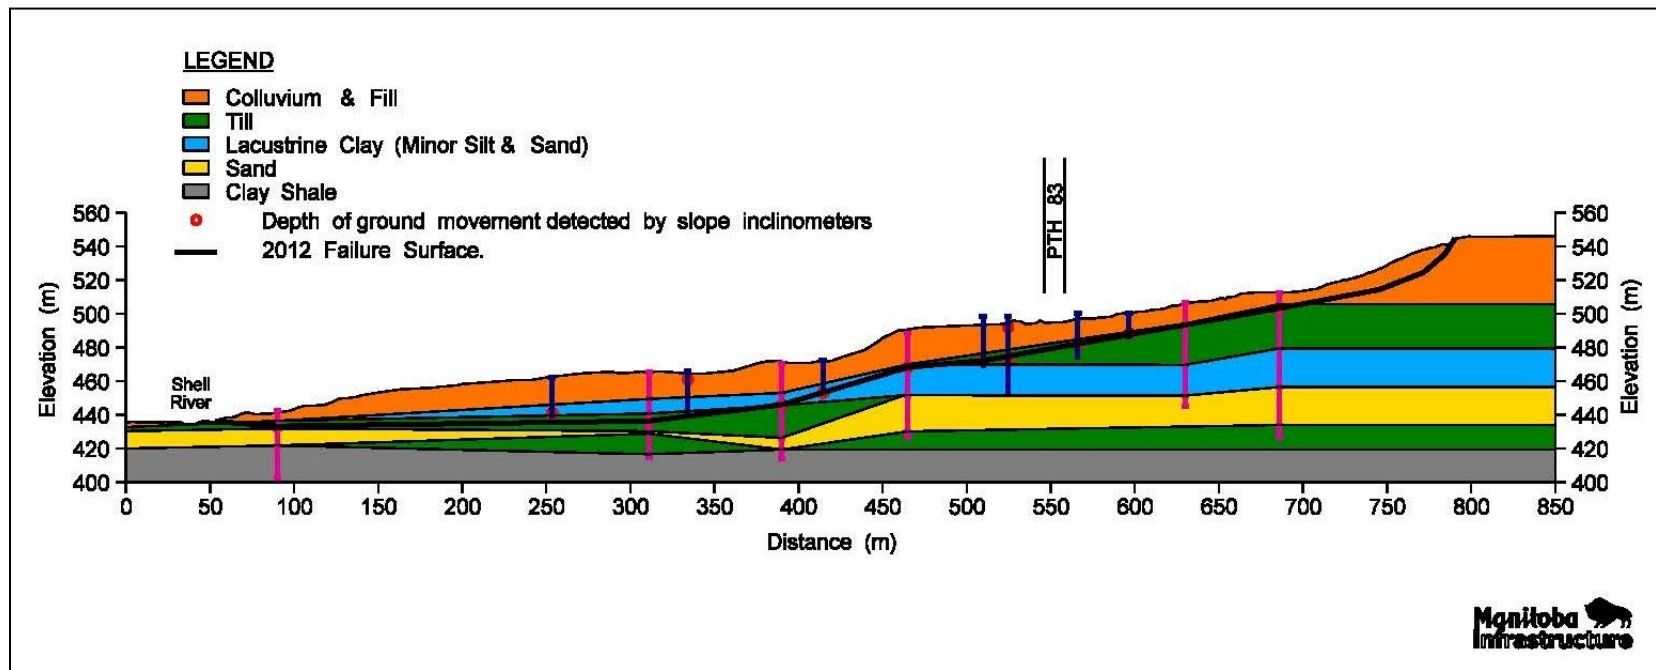
Figure 2: PTH 83 Shell River Landslide Cross Section B-B – Showing geology and failure surface

Figures 1 and 2 are a site plan and cross section of the landslide. The valley slopes are formed by soils deposited by ice and melt water during multiple glacial and inter-glacial periods. The landslide extends to depths of up to 24 m. The slip surface passes through a layer of lacustrine clay and silt below the lower slopes. The upper part of the slide is comprised of highly disturbed soils of clay, silt, sand and road fills (the colluvium unit on the cross section).

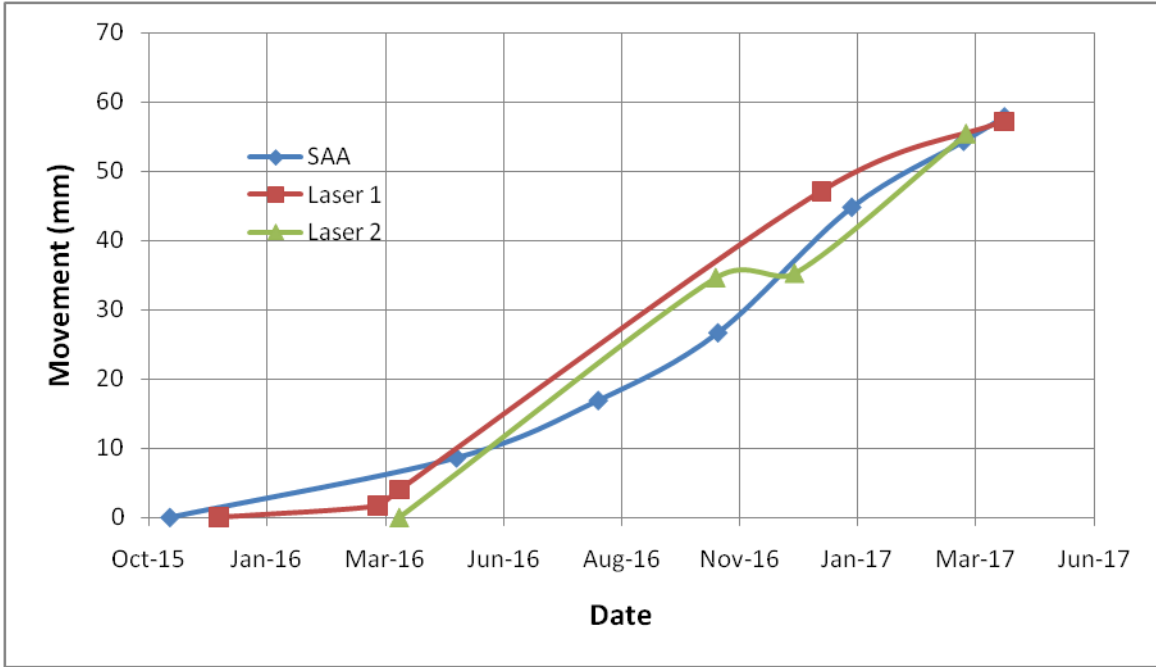
Figure 6: Total Movements Measured by LDMs and SAA  
(LDM data has been “smoothed” to eliminate scatter)

The results collected from the SAA and LDMs are summarized in Figure 6. Due to the high degree of scatter in the laser distance measurements, 4-day averages were calculated for each point plotted. The SAA measurements appear to be highly repeatable with negligible scatter so selected data points were plotted without any averaging.

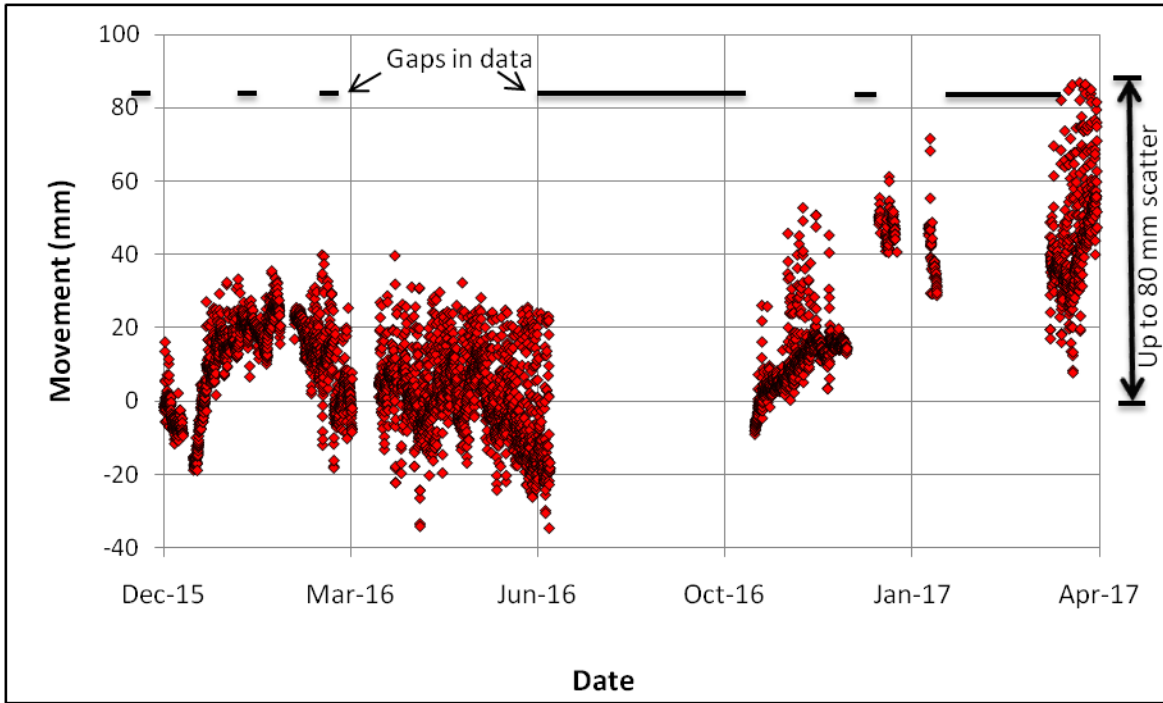
Figure 7: Movement measured by LDM 1 showing scatter and gaps in measurements

Laser Distance Measurement Results: Figure 7 shows the high degree of scatter in the laser data. The scatter of up to 80 mm is more than the total landslide movement since the lasers were installed. Negative measurements of landslide movement are clearly erroneous.

Figure 7 also shows a number of extended periods of missing laser measurement data. As with the SAA data, laser data was lost due to malfunctions of the communications components of the system. However, unlike the SAA the laser devices themselves failed to take readings for periods of time.

Missed Measurement Readings: The laser measuring devices have missed a considerable number of readings, evident by recording zero distances. See Figure 7 for the gaps in readings. The LDMs are programmed to take ten distance measurements every hour. Often the LDMs miss some or all of the ten readings and sometimes the lasers shut down entirely for hours or days missing readings for extended periods of time. The cause of the problem has not been determined although the supplier has been trouble shooting the problem resulting in fewer missed readings recently.
