## **Challenges in Designing Pavements for Bus Rapid Transit Projects Experience in York Region, Ontario**

**Paper prepared for presentation**

**of the 2011 Annual Conference of the  
Transportation Association of Canada  
Edmonton, Alberta**

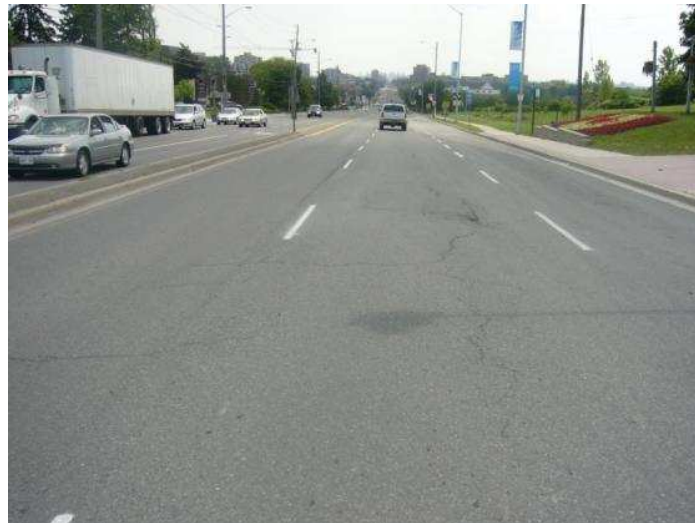
Figure 1 – Overview of Yonge Street looking at the southbound lanes. Note the transverse cracks and the mid lane crack in Lane 2.

The field investigation consisted of a visual pavement condition survey, FWD testing, GPR survey, and coring and drilling about 140 boreholes. Figure 1 shows a typical pavement condition on Yonge Street.

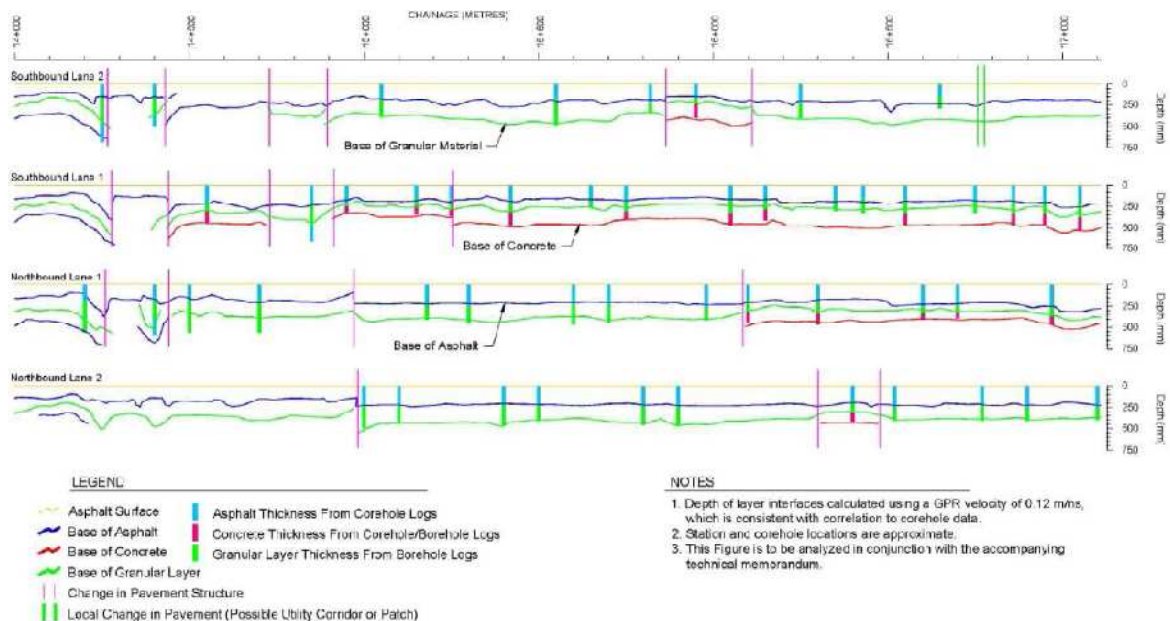
Figure 2 – GPR Profiles From a Section of Yonge Street

On this project, the sequencing of the field program was important to maximize the benefits from the different investigation techniques. The GPR survey was performed first using two ground coupled Sensors and Software systems with antenna centre frequencies of 500 MHz and 1000 MHz, respectively. A quick analysis of the results from the GPR survey was carried out to identify the sections with buried concrete and those with thinner or thicker pavement structures than the average or typical road section. The thinner pavement sections could have insufficient structural capacity while locations with thicker asphalt could be areas where past problems had been addressed by placing an additional overlay, or by localized patching. Figure 2 shows the GPR profile from a section of Yonge Street.

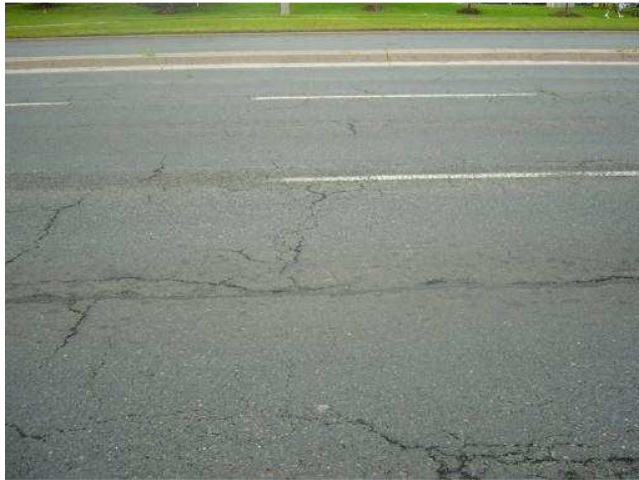
Figure 3 - Section of Highway 7 showing typical distresses; transverse, longitudinal and pavement edge cracks, ravelling and rutting.

The visual condition survey identified the main forms of pavement distresses to be intermittent, slight to moderate longitudinal, transverse, pavement edge, map and alligator cracking; extensive, slight wheel track rutting; slight to moderate ravelling; intermittent slight flushing, and shoving, distortion and potholes at a few locations (Figure 3).

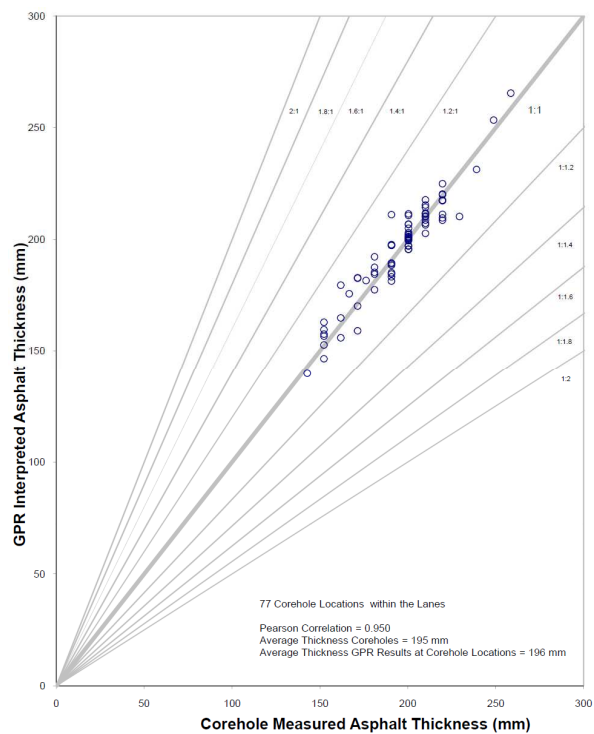
Figure 4 – Correlation: Thickness of Asphalt Cores and GPR inferred Thickness at the same Locations

The borehole investigation indicated that the pavement structure along Highway 7 was a relatively uniform flexible pavement, with about 190 mm of asphalt overlying about 200 mm of granular base and 500 mm of sandy subbase. The GPR survey results indicated an average asphalt thickness of about 200 mm but the inferred total granular thickness was much less at 450 mm. This is probably due to the high moisture content of the granular materials, and the GPR survey results being sensitive to significant variations in moisture. Figure 4 shows the excellent correlation between the thickness of the asphalt cores and the asphalt thickness inferred from the GPR survey at the same location. As shown on the figure, the average thickness of the cores and the GPR results at the same location were 195 and 196 mm, respectively while the thicknesses of the individual cores and GPR data at the corresponding location were generally within 15 percent.

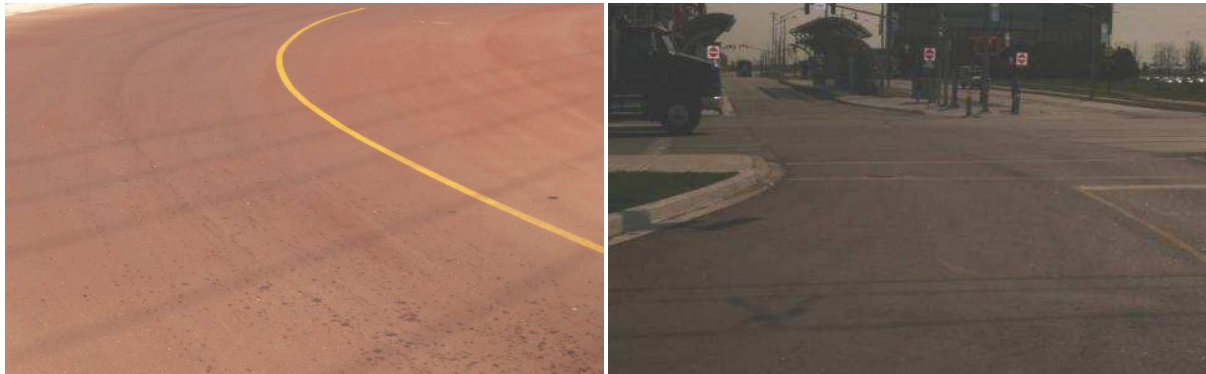
Figure 5 – Red Asphalt surface looking away from the Sun (left) and in the direction of the Sun (right)

Figure 5 shows that the red asphalt surface is clearly visible when travelling away from the sun (left photograph) but is not as clear when travelling in the direction of the sun (right photograph). The other option that is being trialed is brick pavers, shown on Figure 6. The brick pavers were more visible when viewed in the direction of the sun as seen on the photograph to the right on Figure 6.

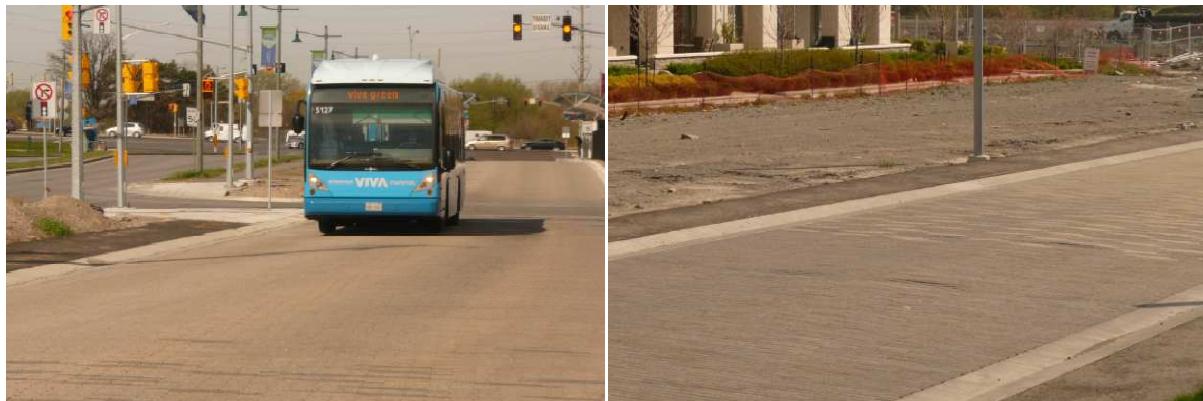
Figure 6 – Surface with Paving Bricks looking away from the Sun (left) and in the direction of the Sun (right)
