Maintenance Equipment Testing on Accelerated Clogged Permeable Interlocking Concrete Pavements

Prepared for: Interlocking Concrete Pavement Institute Foundation for Education and
Research

Jennifer Drake, Ph.D., P.Eng.
Tahmineh Sarabian, M.A.Sc., P.Eng
Jody Scott Ph.D. Student
4-1-2020

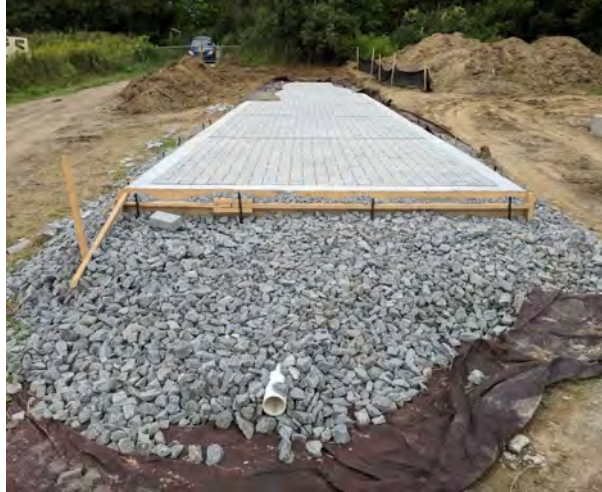
Figure 2-2: Test pad following construction (Aug 18th, 2017).

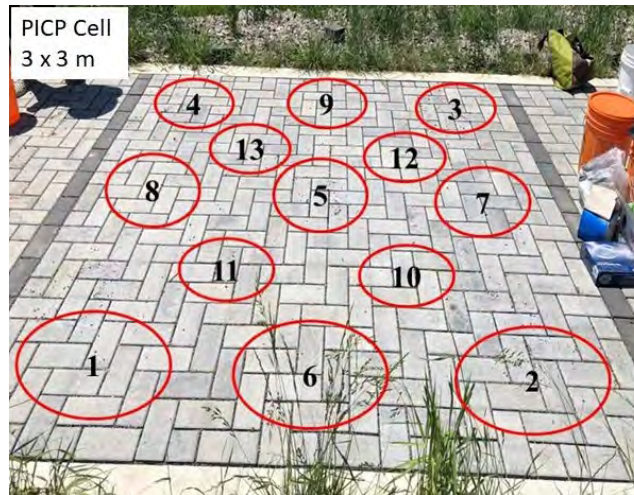
Figure 3-1: Surface infiltration test locations in each cell.

On each cell, surface infiltration was measured at five locations (Locations 1 – 5, Figure 3-1) after construction in November 2017 and re-checked in July 2018 before starting the accelerated clogging.

SIR was measured at Locations 1 – 5 following each application of clogging materials. Four additional tests (locations 6 – 9, Figure 3-1) were performed on each cell to assess the overall SIR of the cells better and to evaluate if the repeated SIR tests collected during the accelerated clogging had created any localized effects on SIR measurements.

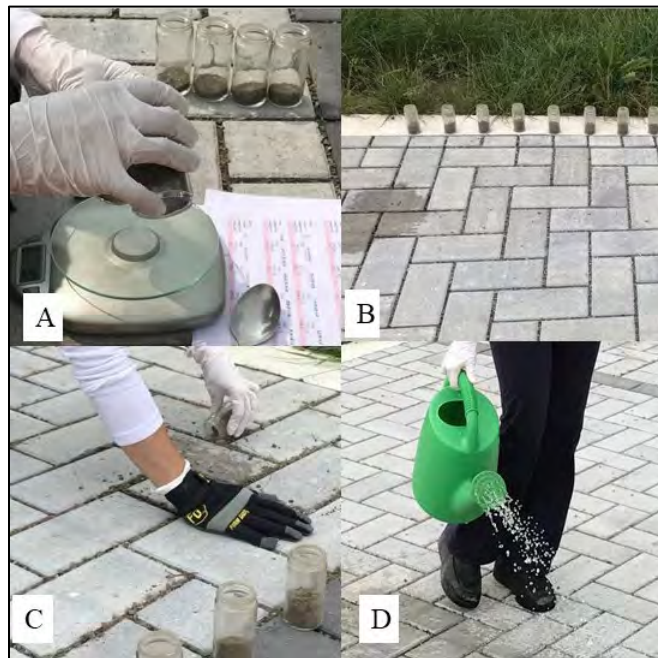
Figure 3-4: Clogging procedure: A) pre-weighing sediment before application; B) pre-weighed sediment for every row and column; C) application of sediment over joints; D) application of water to move sediment into the joints.

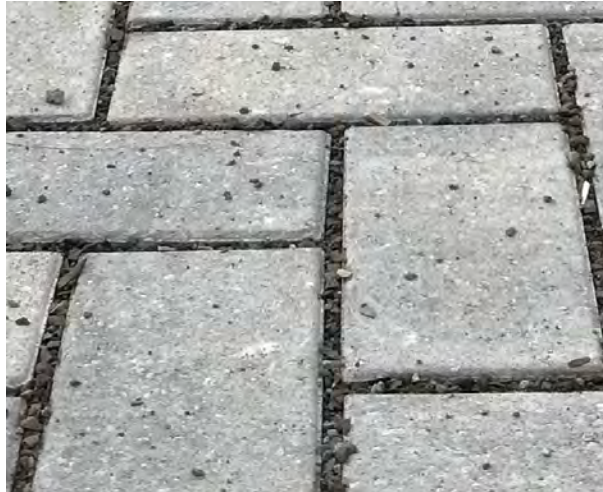
Figure 3-5: Visual inspection of the PICP joints after the third round of clogging before compaction

The final target SIR for the test pad was 250 mm/hr, as this is when restorative maintenance is recommended by ICPI. SIRs were measured 24 hours following each application of sediment. Appendix C summarizes the pavement synthetic clogging schedule. After three applications of sediment, it was observed that sediment was spilling out of the joints and onto the pavers (Figure

3-5). Since the target SIR had not yet been reached, a lightweight plate compactor was applied over the pavement to consolidate the sediment further into the joints. Immediately after, water was applied to facilitate the movement of sediment further down into the joints. SIRs were measured again before the next application of sediment.

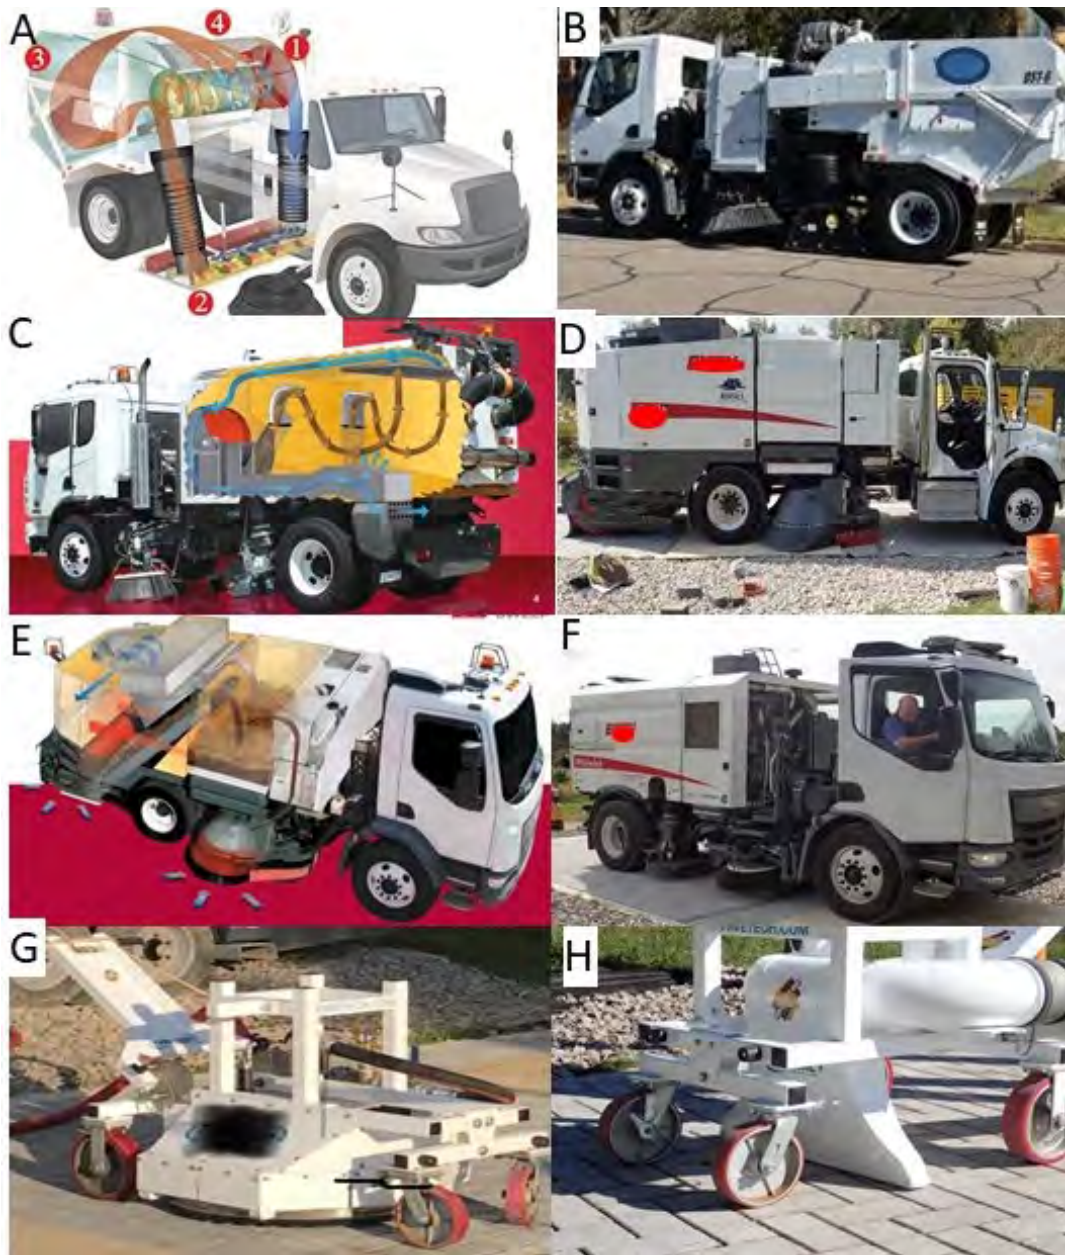
Figure 3-6: Street sweepers (A, B) Tymco® DST 6 regenerative air (Tymco Inc., 2019), (C, D) Elgin® Whirlwind vacuum (Elgin Sweeper Co., 2017), (E, F) Elgin® Waterless Eagle mechanical (Elgin Sweeper Co., 2019) and (G, H) Pavetech Typhoon and PaveVac.

Each PICP cell was treated by a different maintenance technique including three types of street sweepers: a regenerative air sweeper (Tymco DST-6®), a vacuum sweeper (Elgin WhirlWind®), a mechanical sweeper (Elgin Waterless Eagle®), pressure washing followed by manual vacuuming and specialized two-piece high pressurized-air and vacuum system (Typhoon® and Pavevac®). The Tymco DST-6® is a regenerative air street sweeper that operates by forcing pressurized-air to the pavement on one side and recycling the air through a suction head (2.2 m) on the other side. Tymco DST-6® has a 132 cm sweep path. The Elgin WhirlWind® is a vacuum street sweeper with a suction head (0.81 m) and a trailing arm broom on each side and has a sweep path of up to 366 cm. The Elgin Waterless Eagle® is a dry mechanical sweeper that includes two gutter brooms on each side and the main broom mounted at the rear of the vehicle. The sweeper has a conveyor belt as the primary collection mechanism and has a sweep path of 305 cm. The Typhoon® and Pavevac® are designed for the maintenance of PICP that consisted of a specialized blower head (0.61 m) and a vacuum head (0.71 m), that is connected to a trailered air compressor (200 psi) and a vacuum truck respectively. Figure 3-6 includes a picture of each maintenance technique, and Table 3-3 summarizes the tested maintenance techniques. During each test, adjacent cells were covered with plywood for protection. Only one pass was allowed for each technique.

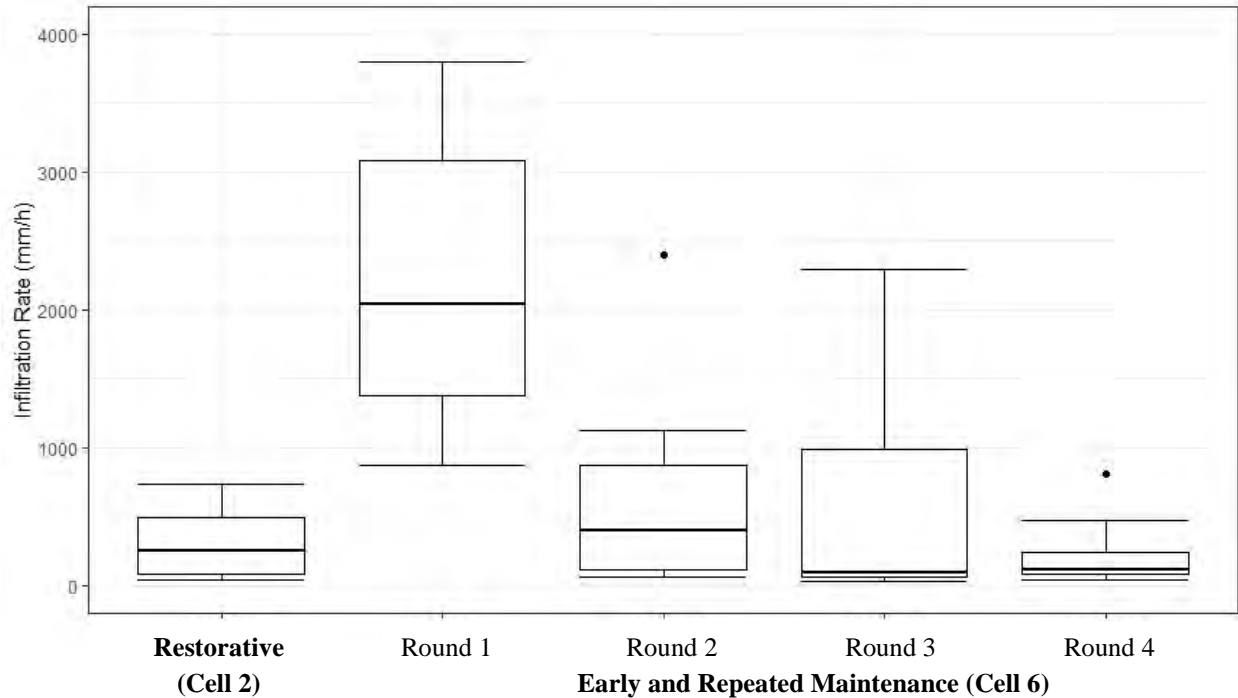
Figure 4-2: Pre-maintenance surface infiltration rates box plots of restorative (Cell 2) and early and repeated test cells (Cell 6)

Table 4-2 and Figure 4-2 present descriptive statistics and boxplots of the pavement’s pre-maintenance SIR, respectively. The benefits of early and repeated maintenance were evident in the test cell’s pre-maintenance surface infiltration data. Cell 2, which simulated restorative maintenance, was fully-clogged (i.e. average SIR ≤ 250 mm/hr) following the application of 9.3 kg of street sweepings. **In contrast, Cell 6, which had the benefit of early and repeated maintenance, only became fully-clogged after the application of 18.5 kg of street sweepings, a doubling of the total amount of clogging materials applied to the PICP surface.**

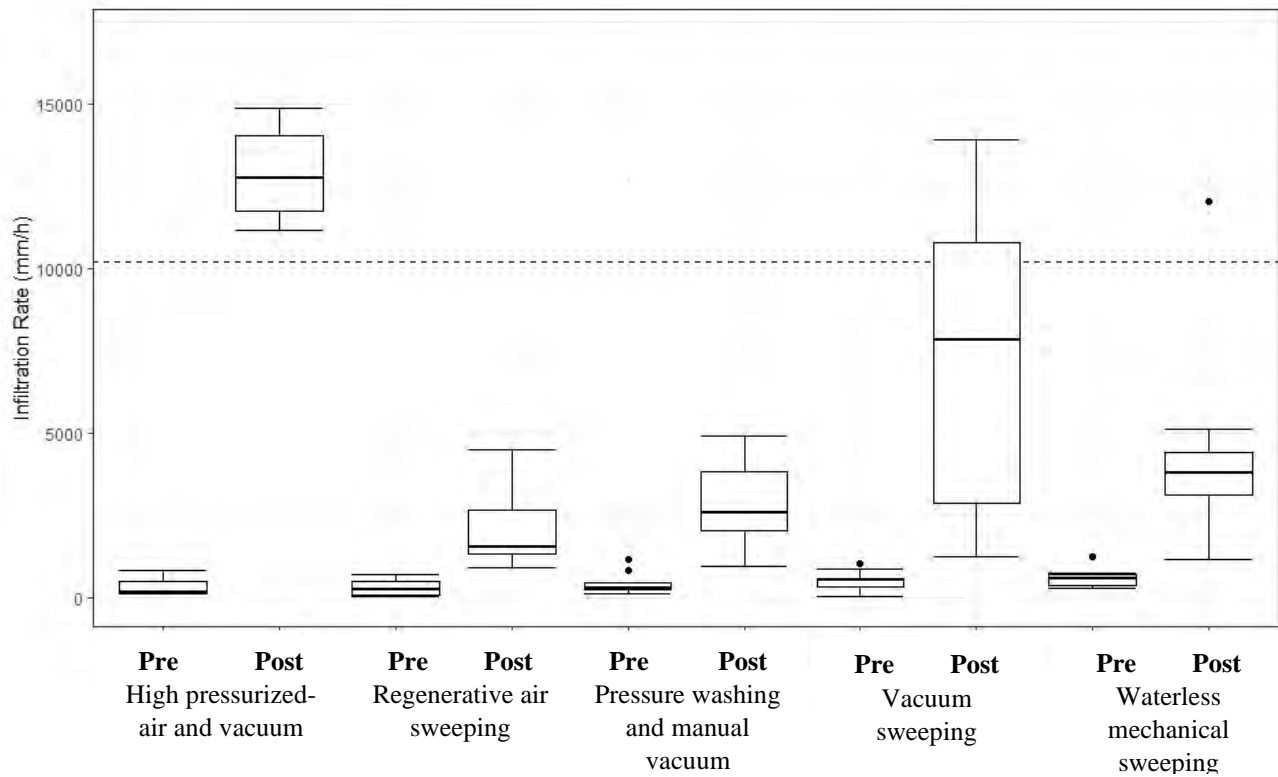
Figure 4-3: Box-plot presentation of the pre and post-maintenance surface infiltration rate for each surface treatment method.

Dashed line (---) indicated baseline conditions, average surface infiltration rate prior to clogging.

All maintenance techniques significantly restored the pavement's surface infiltration capacity even when limited to a single pass over the pavement. All post-maintenance SIR test results are provided in Appendix F. Table 4-3 and Figure 4-3 present post-maintenance descriptive statistics and boxplots, respectively. Statistical tests reported in Table 4-4 found that:

1. The high pressurized-air vacuuming provided the highest increase to PICP surface infiltration capacity than the other tested techniques;
2. Vacuum street sweeping provided a more significant increase to PICP surface infiltration capacity than the regenerative air street sweeper and the mechanical street sweeper;
3. Manual pressure washing followed by vacuuming provided similar levels of treatment as the regenerative air street sweeper and the waterless mechanical street sweeper;
4. And, the mechanical and vacuum street sweepers provided similar levels of treatment.

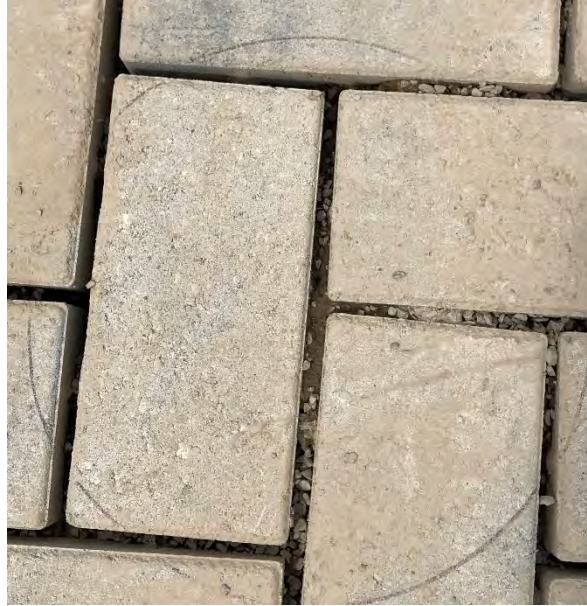
Figure 4-6: Example of sub-surface clay agglomerate left following maintenance

Joint penetration depths (Table 4-7) were statistically similar for both cells treated with the high pressurized-air and vacuum system. **Thus, joint penetration depth was not a good indicator for maintenance effectiveness when comparing pavement’s clogged with different source materials.** The addition of clayey soils to the clogging mixture allowed for compacted agglomerate to form within the joints. As shown in Figure 4-6, these clumps of sediments were very tightly adhered to the pavers and sometimes formed several millimetres below the pavement surface.

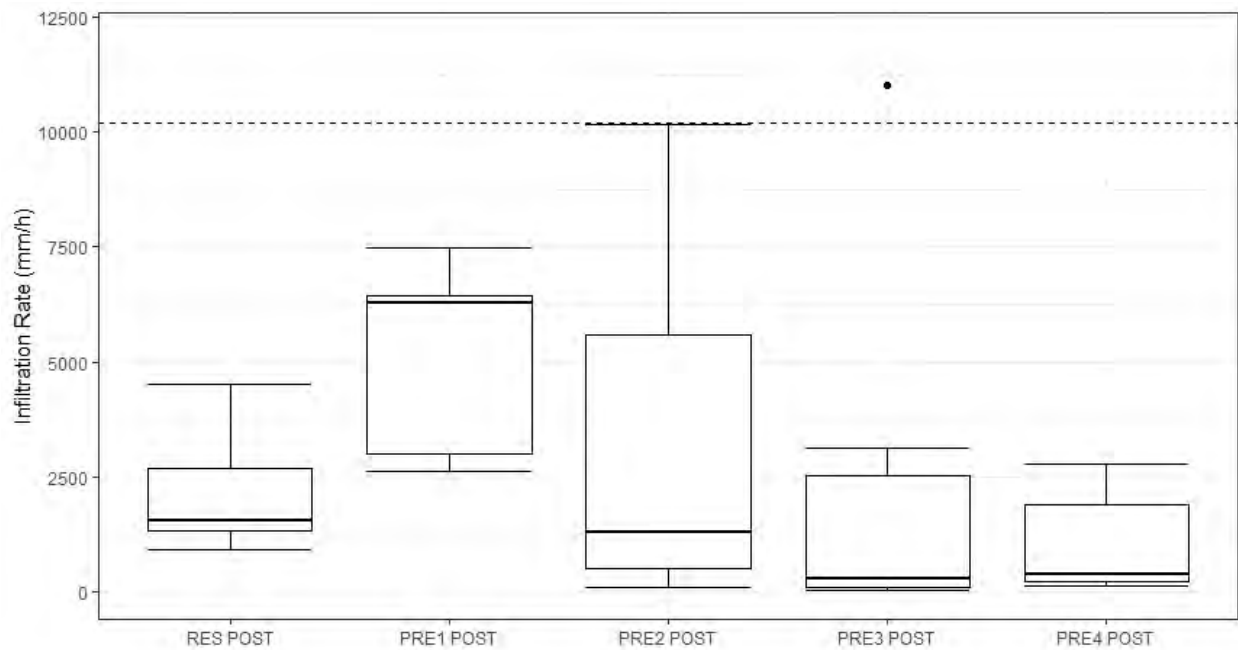
Figure 4-7: Post-maintenance surface infiltration capacity following restorative and early and repeated maintenance with a regenerative air street sweeper.

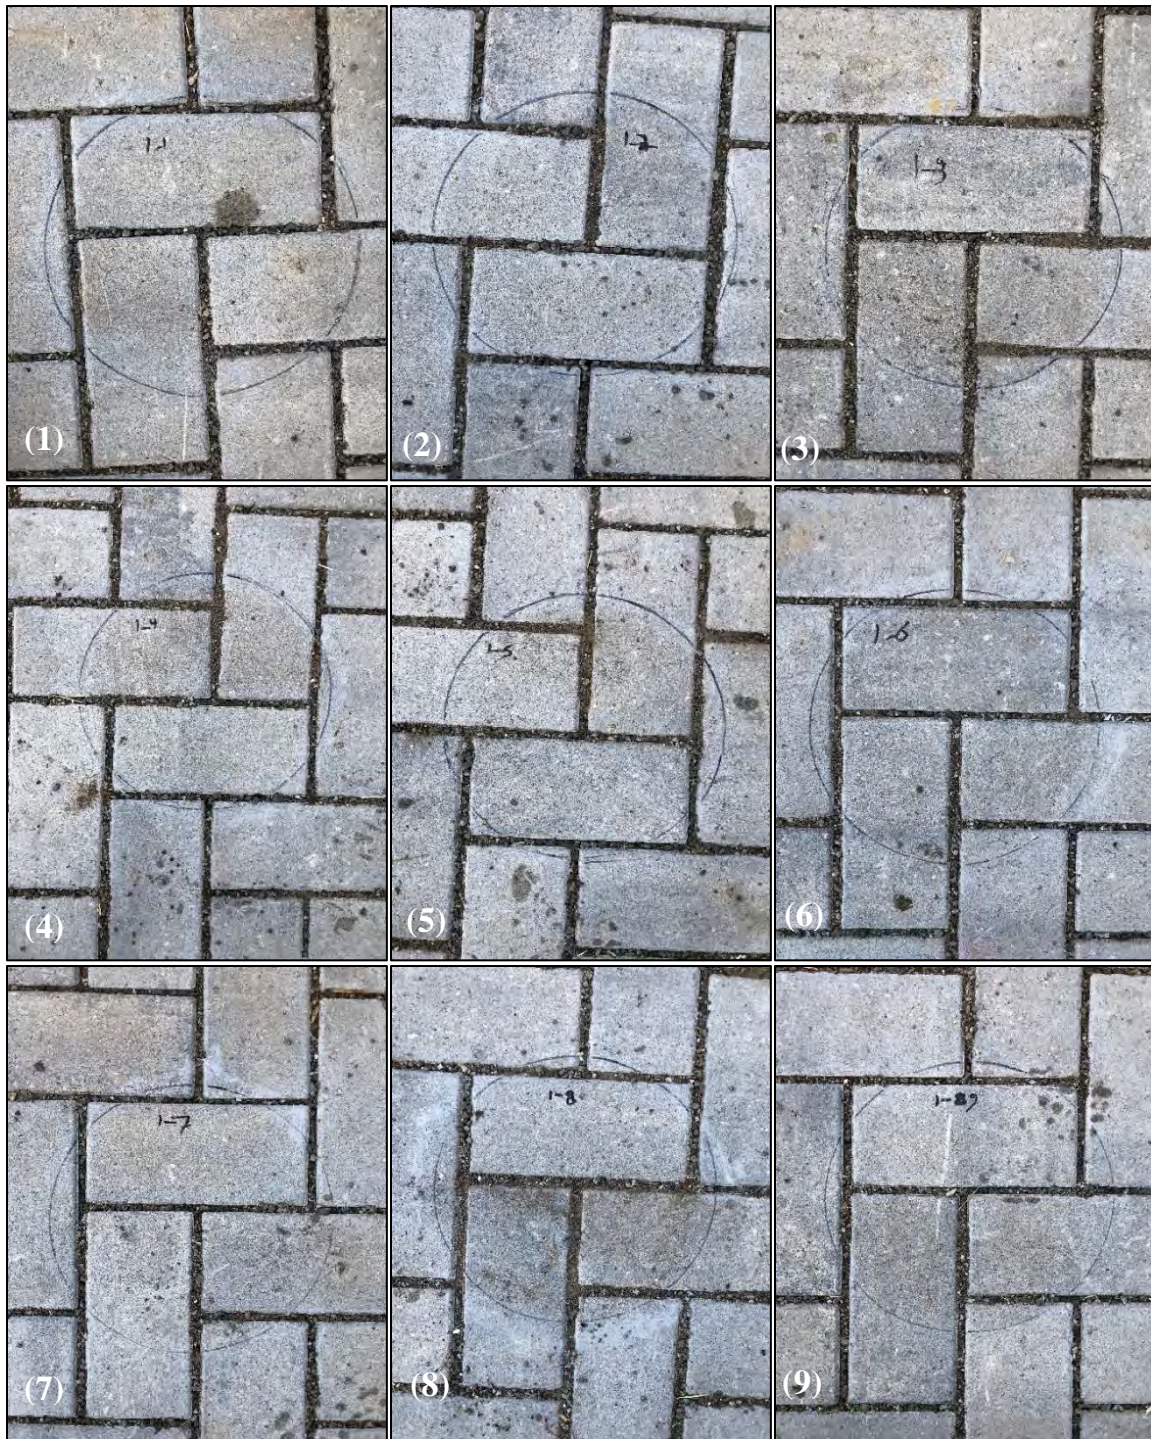
Figure I1: Pre-maintenance photos of infiltration measurement locations (1-9) on Cell 1 (Pave-Tech Typhoon® and Pavevac®).

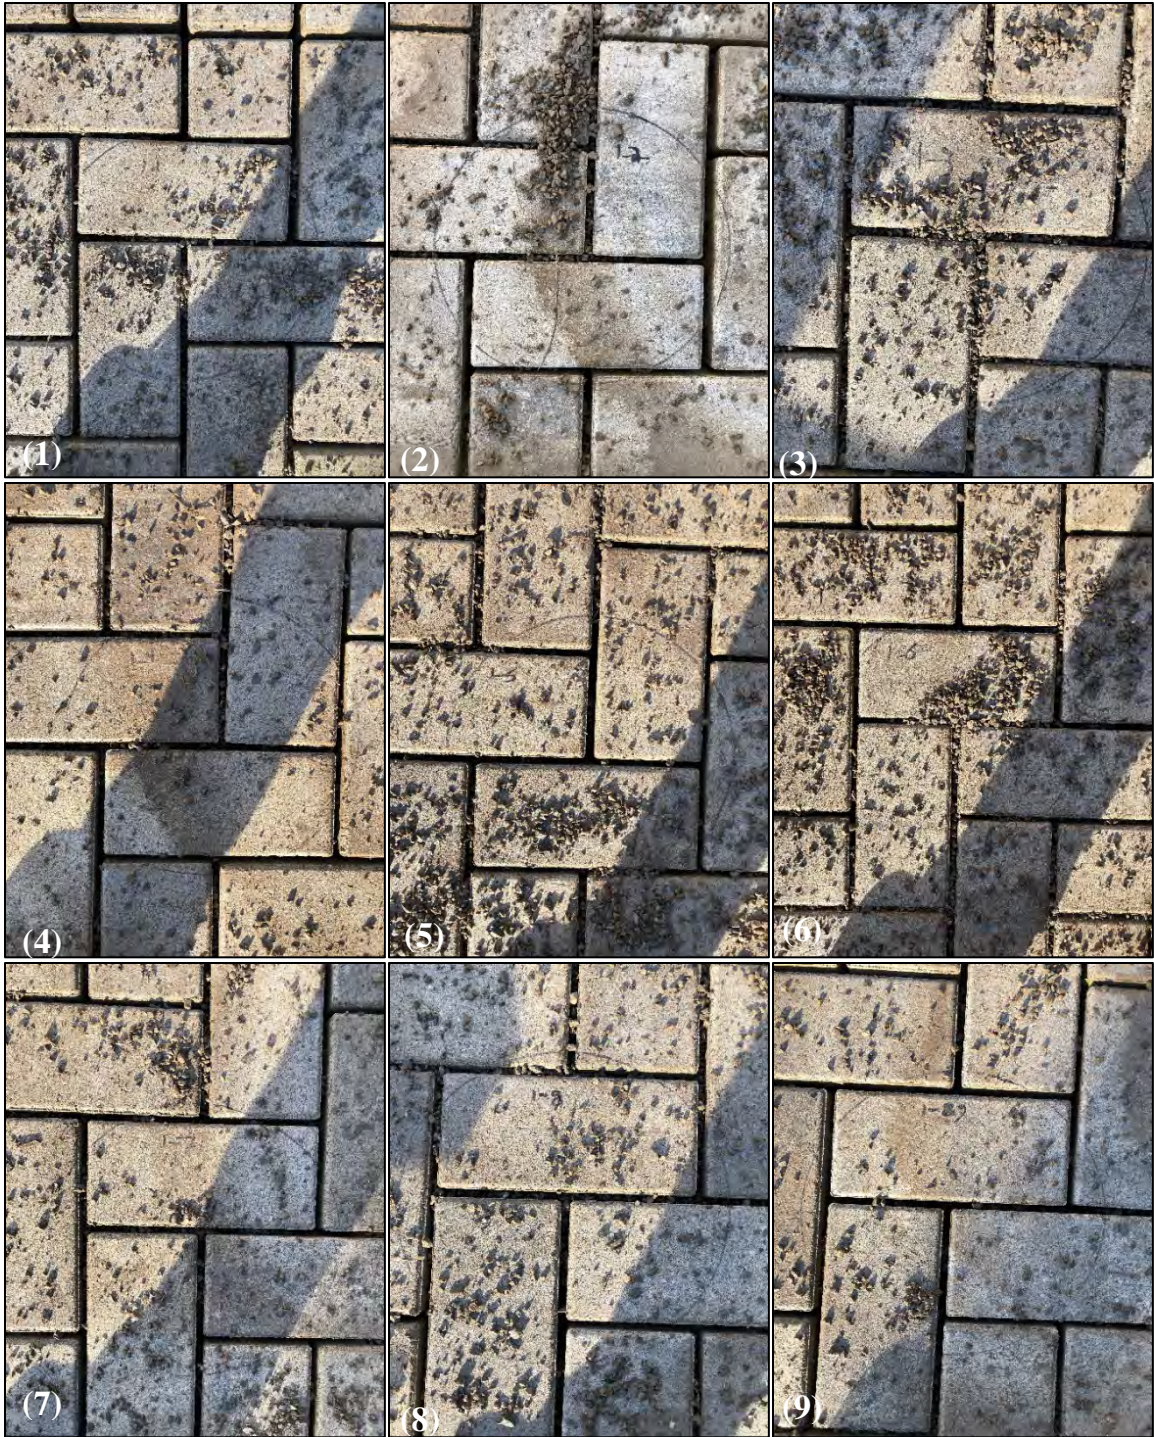
Figure I2: Post-maintenance photos of infiltration measurement locations (1-9) following high pressurized-air system on Cell 1 (Pave-Tech Typhoon®).

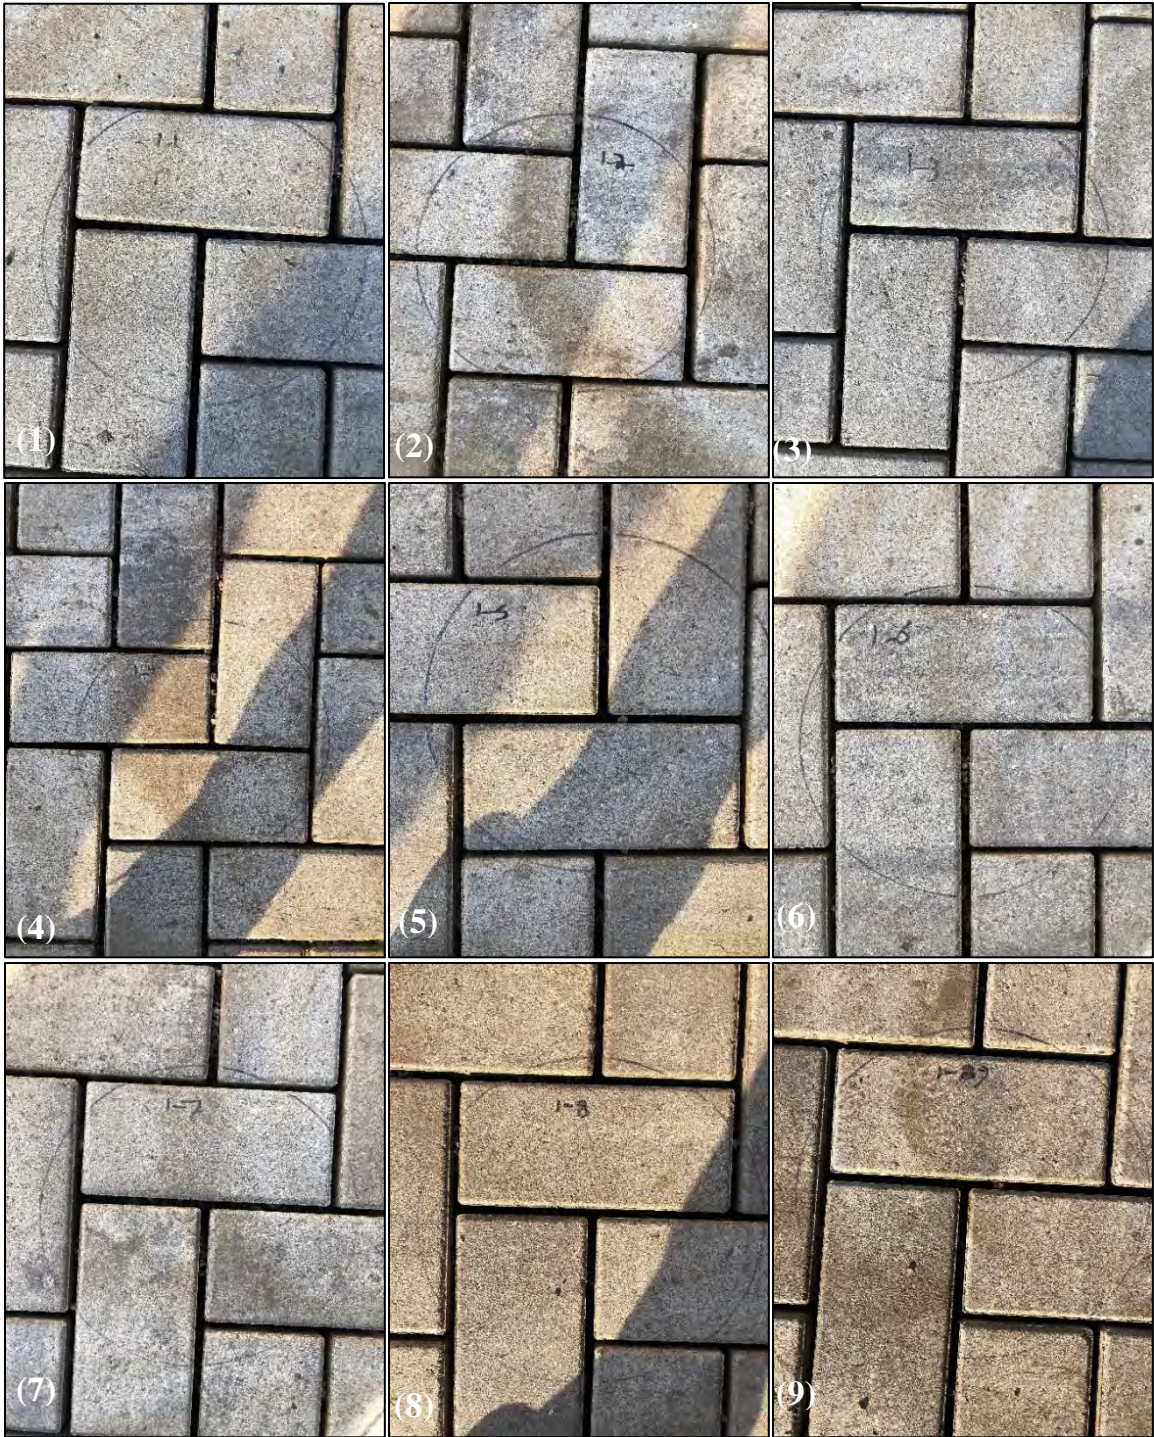
Figure I3. Post-maintenance photos of infiltration measurement locations (1-9) following a vacuum system on Cell 1 (Pavevac®).

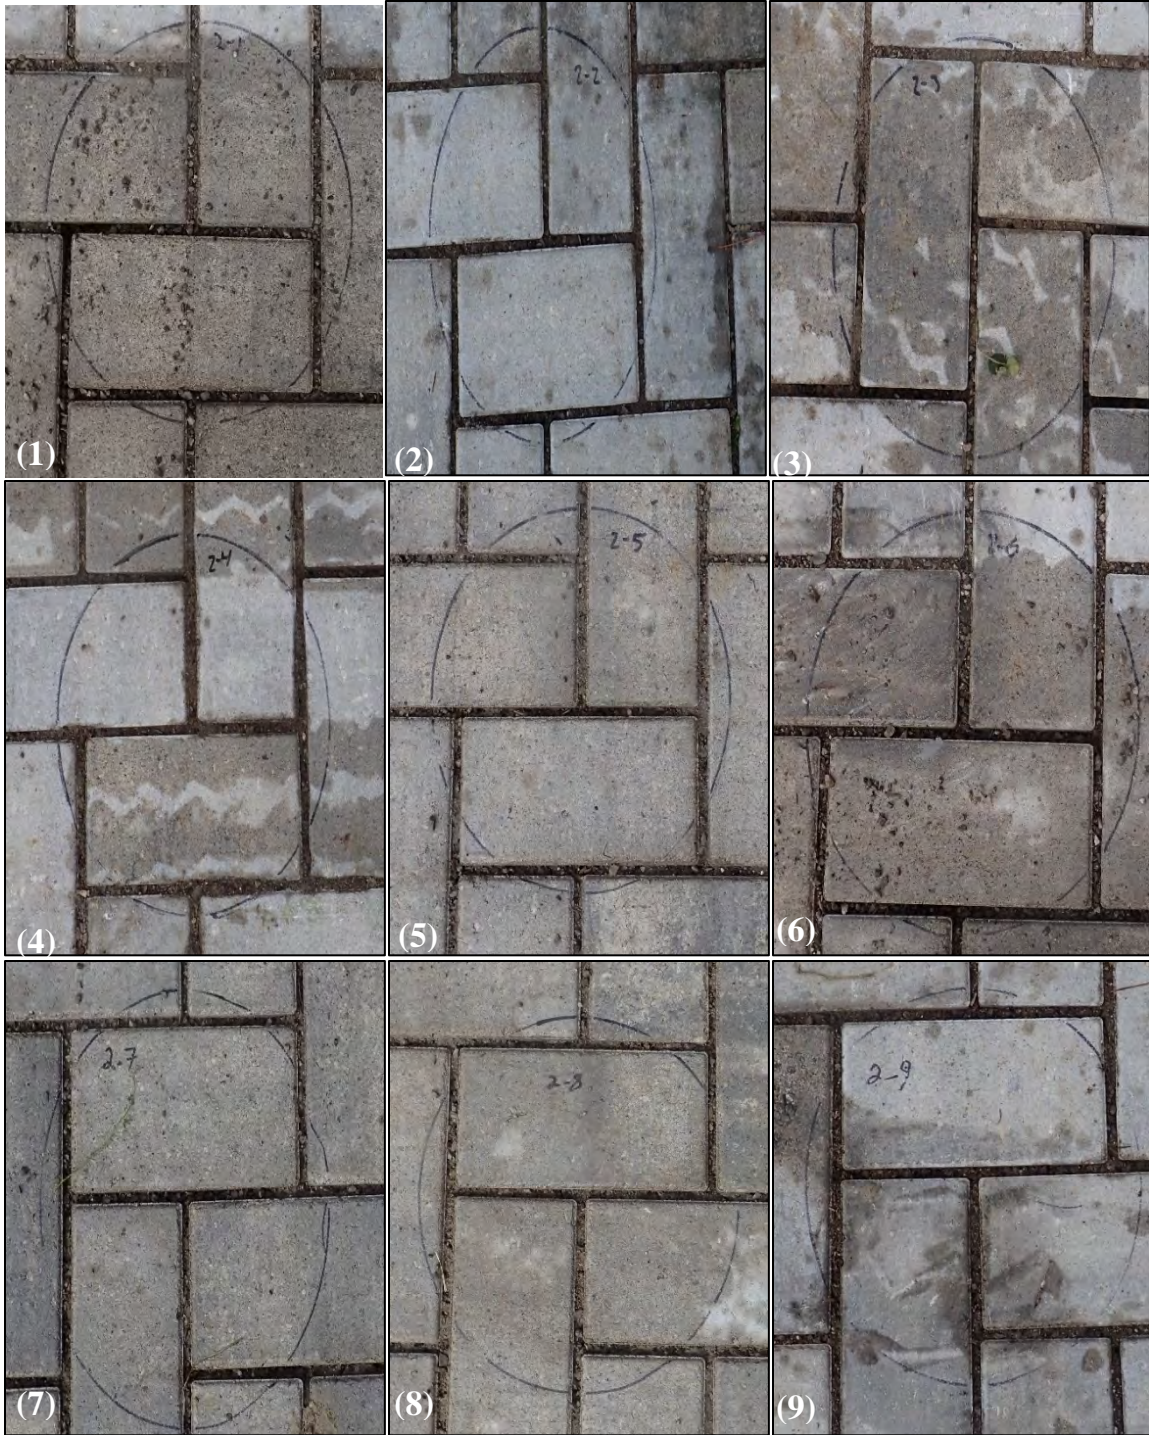
Figure I4. Post-maintenance photos of infiltration measurement locations (1-9) following a regenerative air street sweeper on Cell 2 (TYMCO DST-6®).

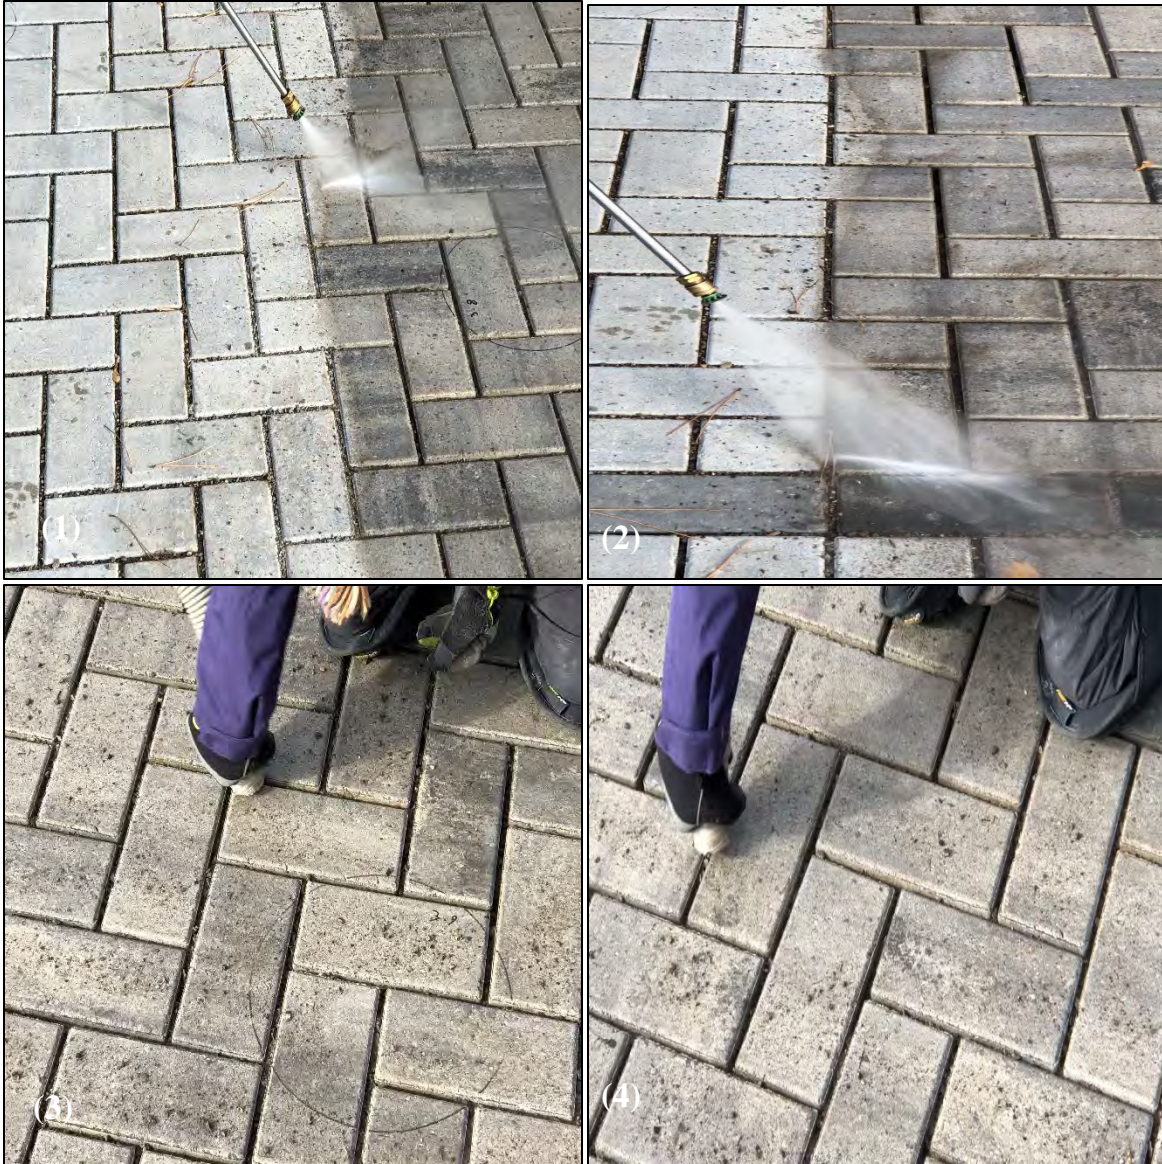
Figure I5. Pre- and post-maintenance following pressure washing (1,2) and vacuuming (3,4) on Cell 3.

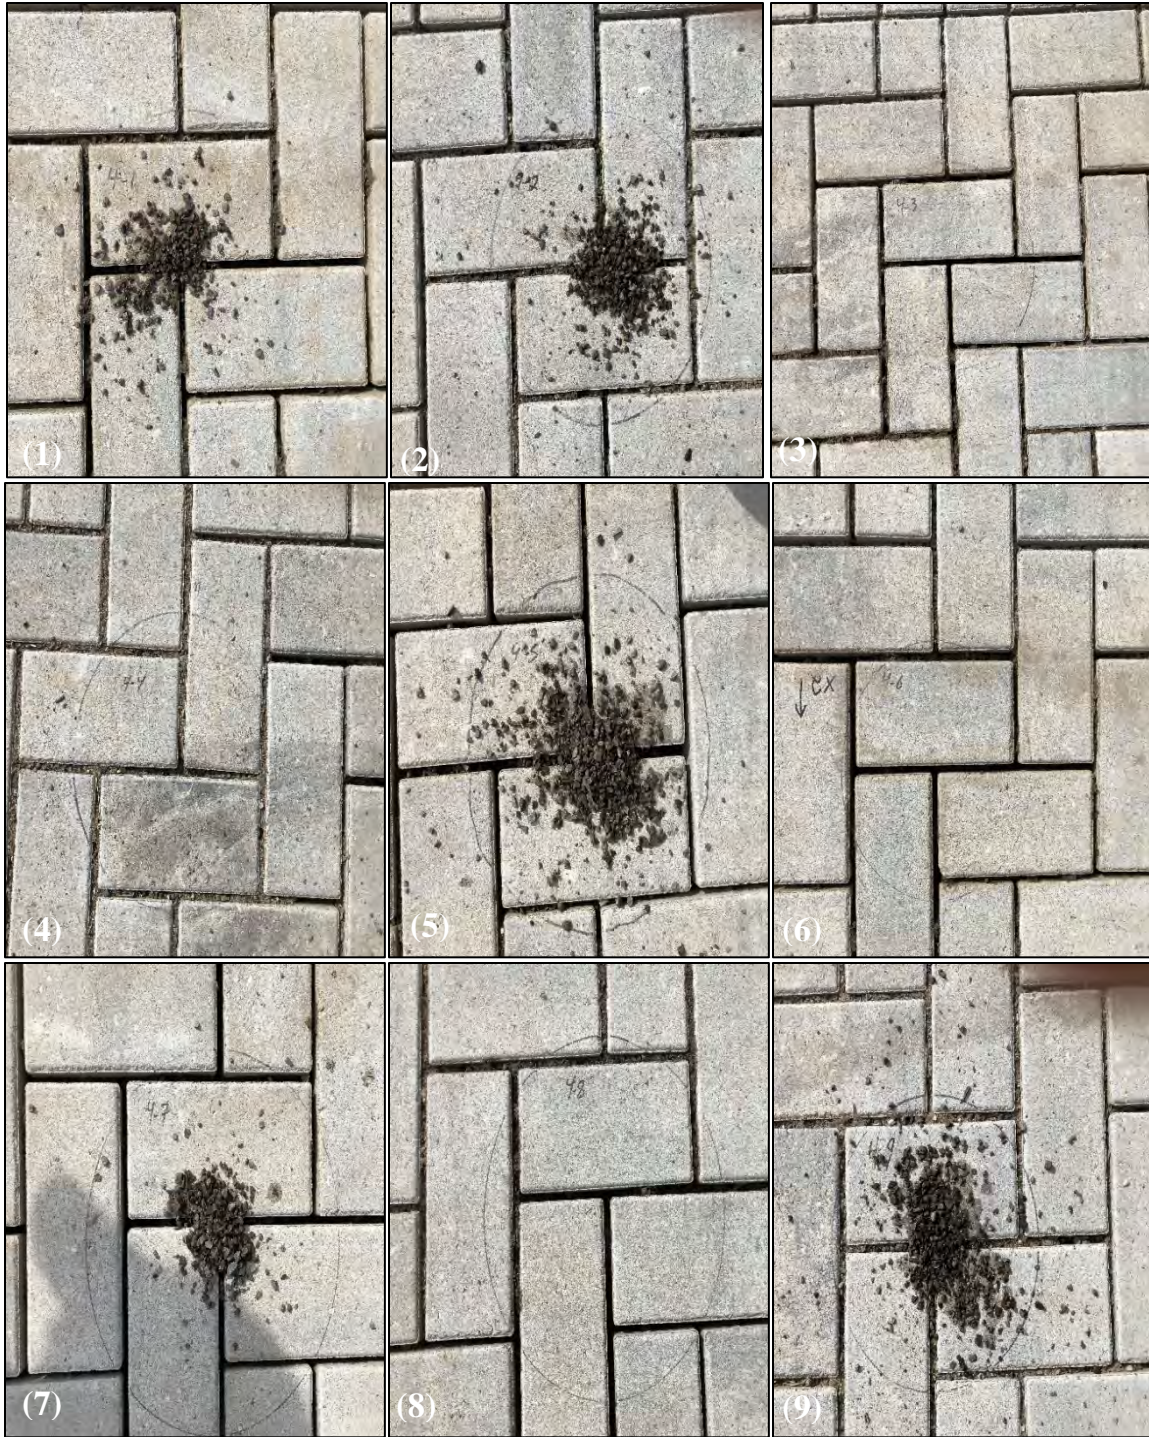
Figure I6. Post-maintenance photos of infiltration measurement locations (1-9) following a vacuum street sweeper on Cell 4 (Elgin Whirlwind).

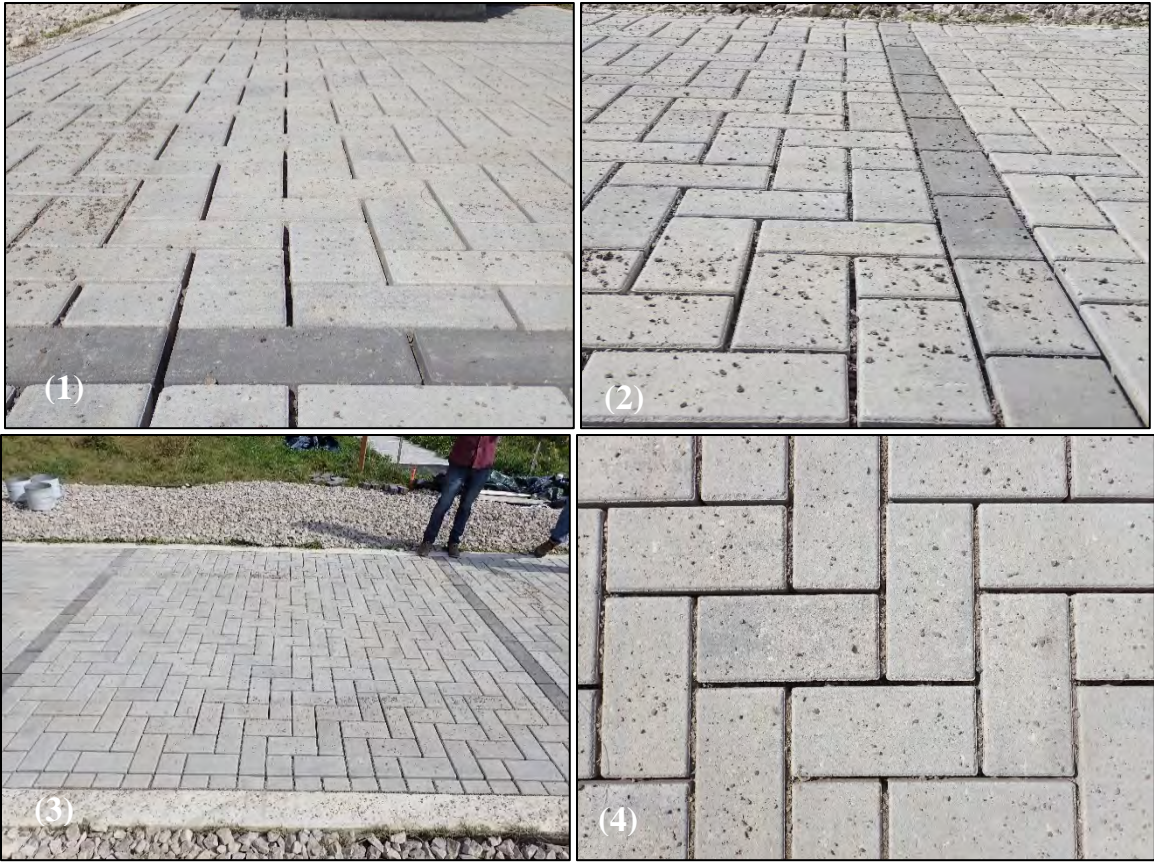
Figure I7. Post maintenance photos following a waterless mechanical sweeper on Cell 5 (Elgin Sweepers Water Less Eagle[®]), where (1) and (2) are parallel and perpendicular to travel path respectively. (3) is an overview of the plot and (4) is a close up of parallel and perpendicular sediment removal.

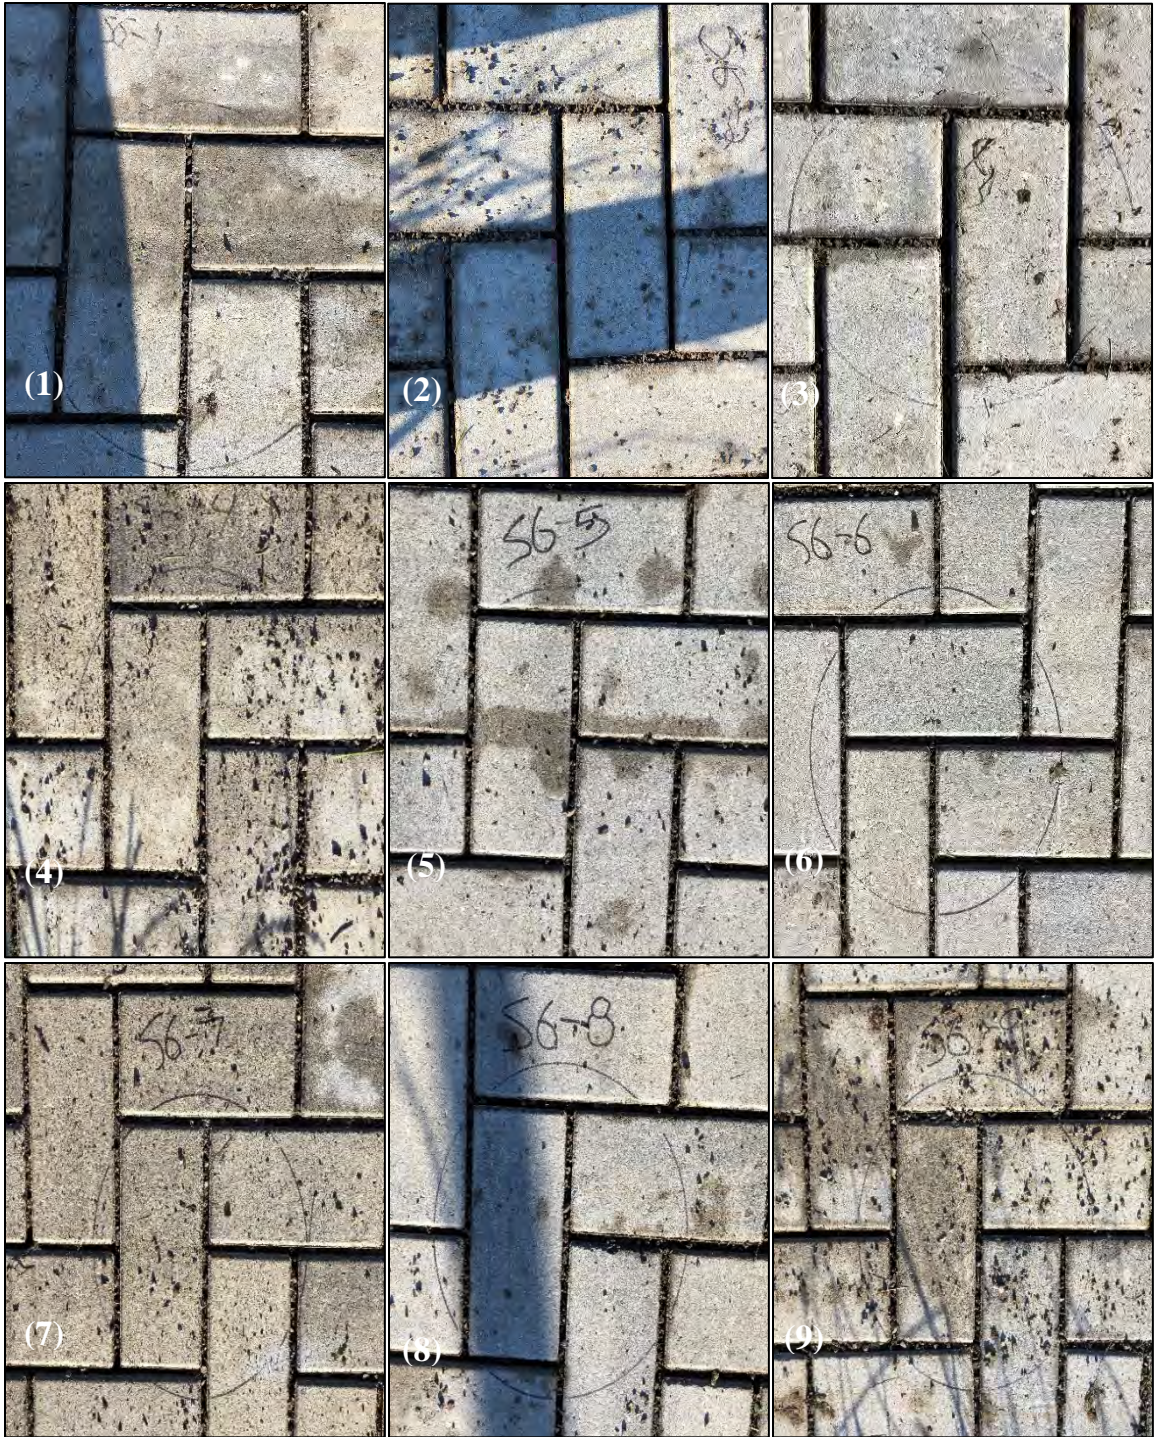
Figure J2. Post-maintenance photos of infiltration measurement locations (1-9) following a regenerative air street sweeper on Cell 6 for first early and repeated maintenance (TYMCO DST-6®).

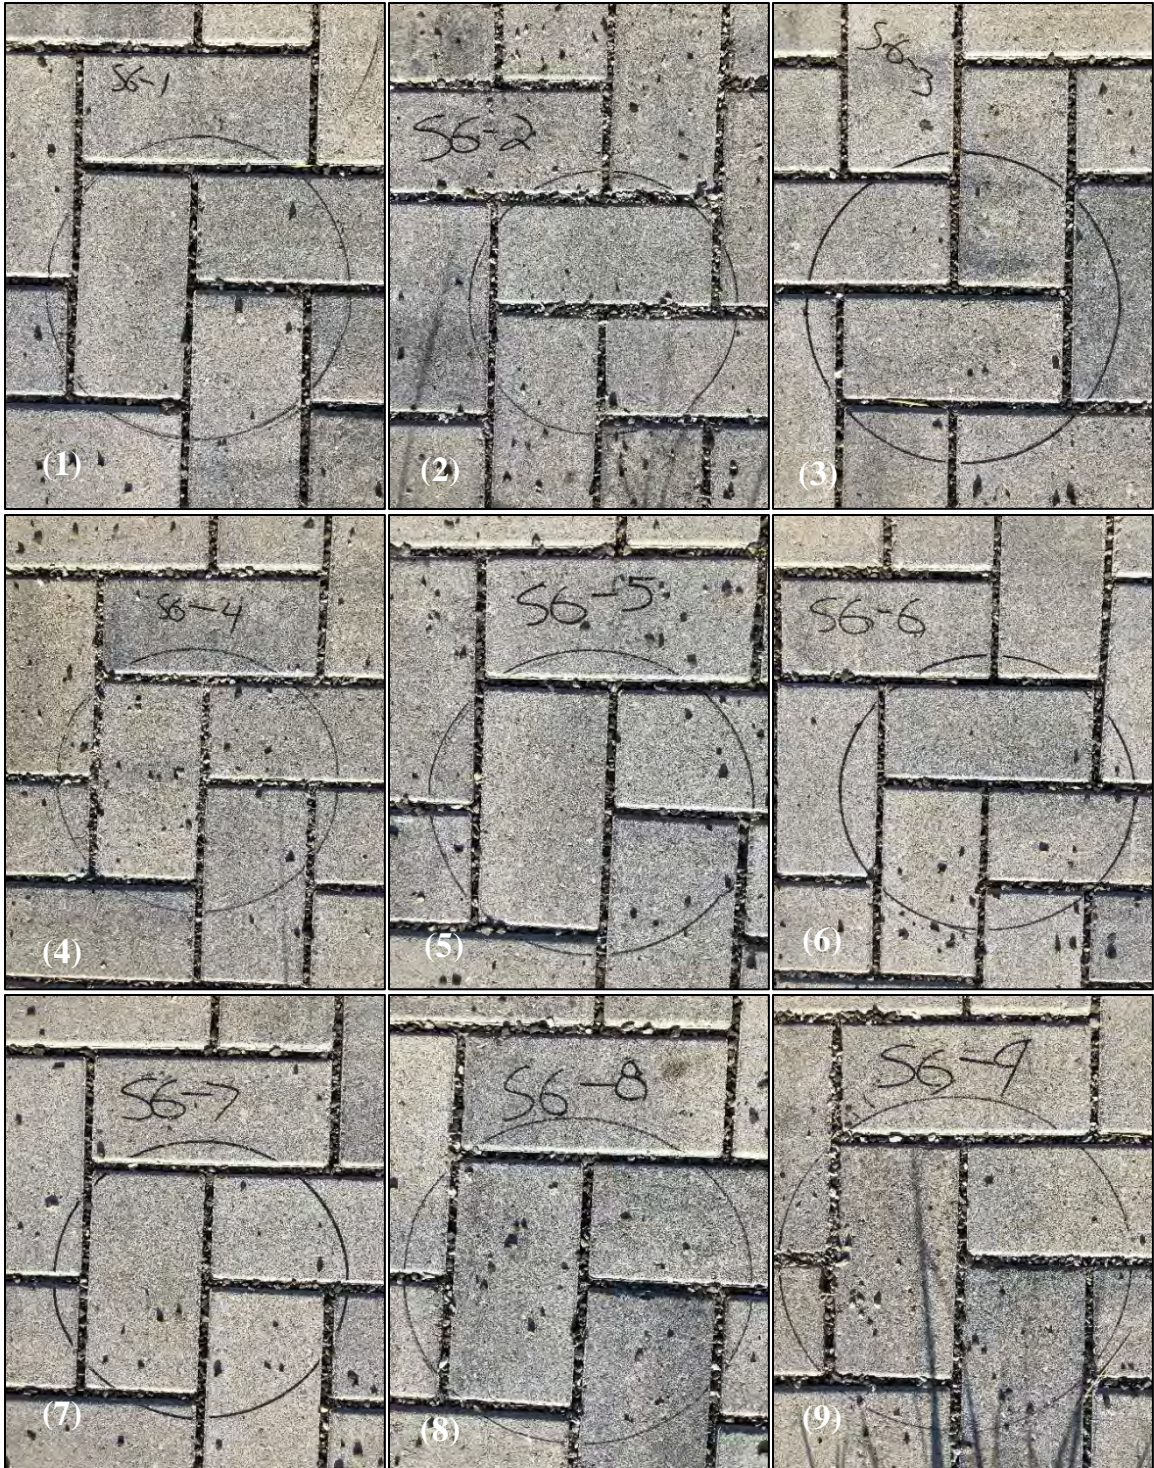
Figure J3. Pre-maintenance photos of infiltration measurement locations (1-9) on Cell 6 after first early and repeated maintenance (TYMCO DST-6®).
