Maintenance Equipment Testing on Accelerated Clogged Permeable Interlocking Concrete Pavements

Prepared for: Interlocking Concrete Pavement Institute Foundation for Education and
Research

Jennifer Drake, Ph.D., P.Eng.
Tahmineh Sarabian, M.A.Sc., P.Eng
Jody Scott Ph.D. Student
4-1-2020

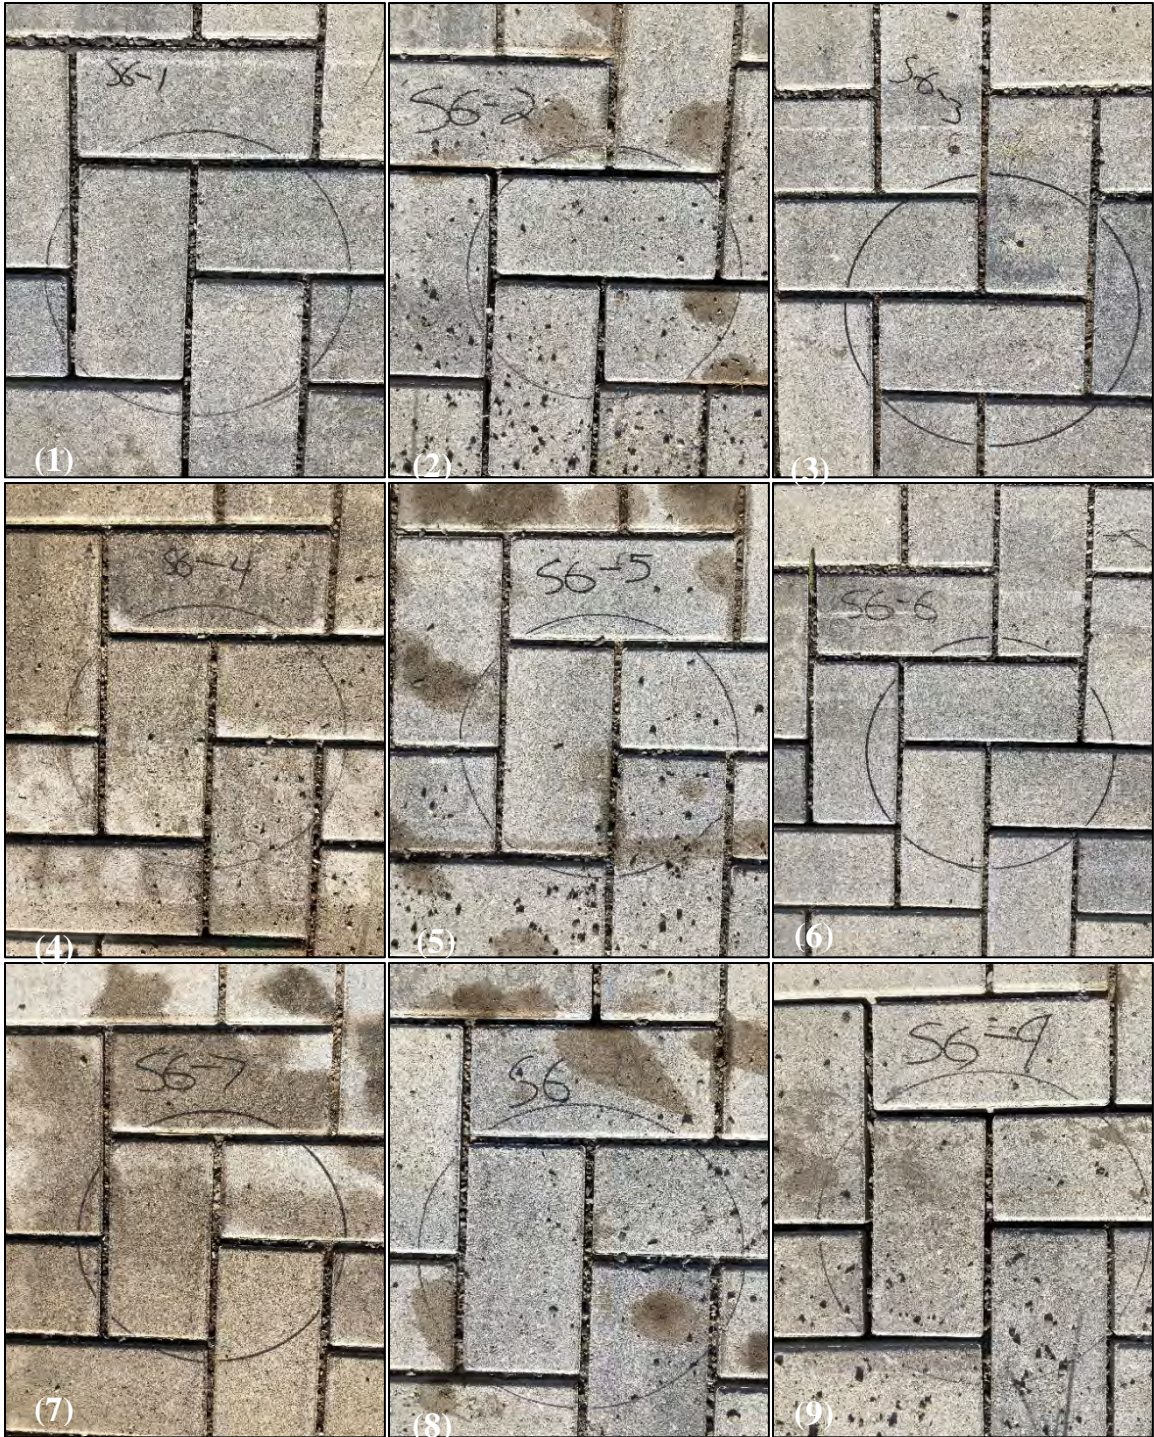
Figure J4. Post-maintenance photos of infiltration measurement locations (1-9) following a regenerative air street sweeper on Cell 6 for second early and repeated maintenance (TYMCO DST-6®).

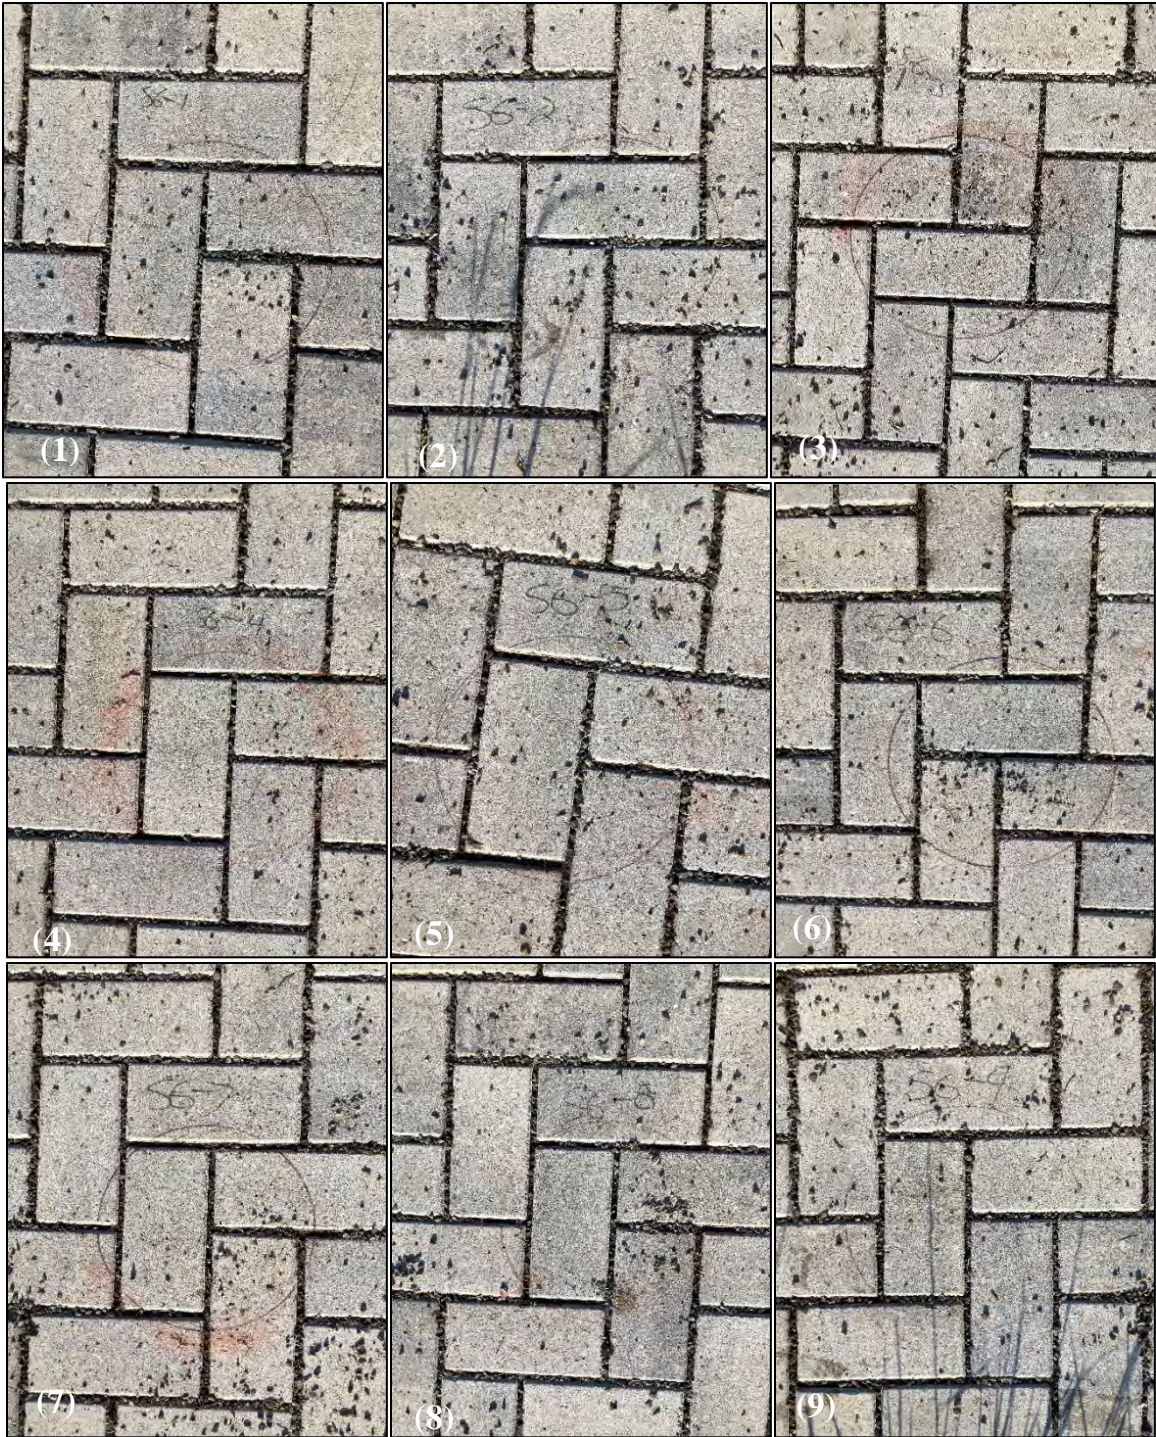
Figure J5. Pre-maintenance photos of infiltration measurement locations (1-9) on Cell 6 after second early and repeated maintenance (TYMCO DST-6®).

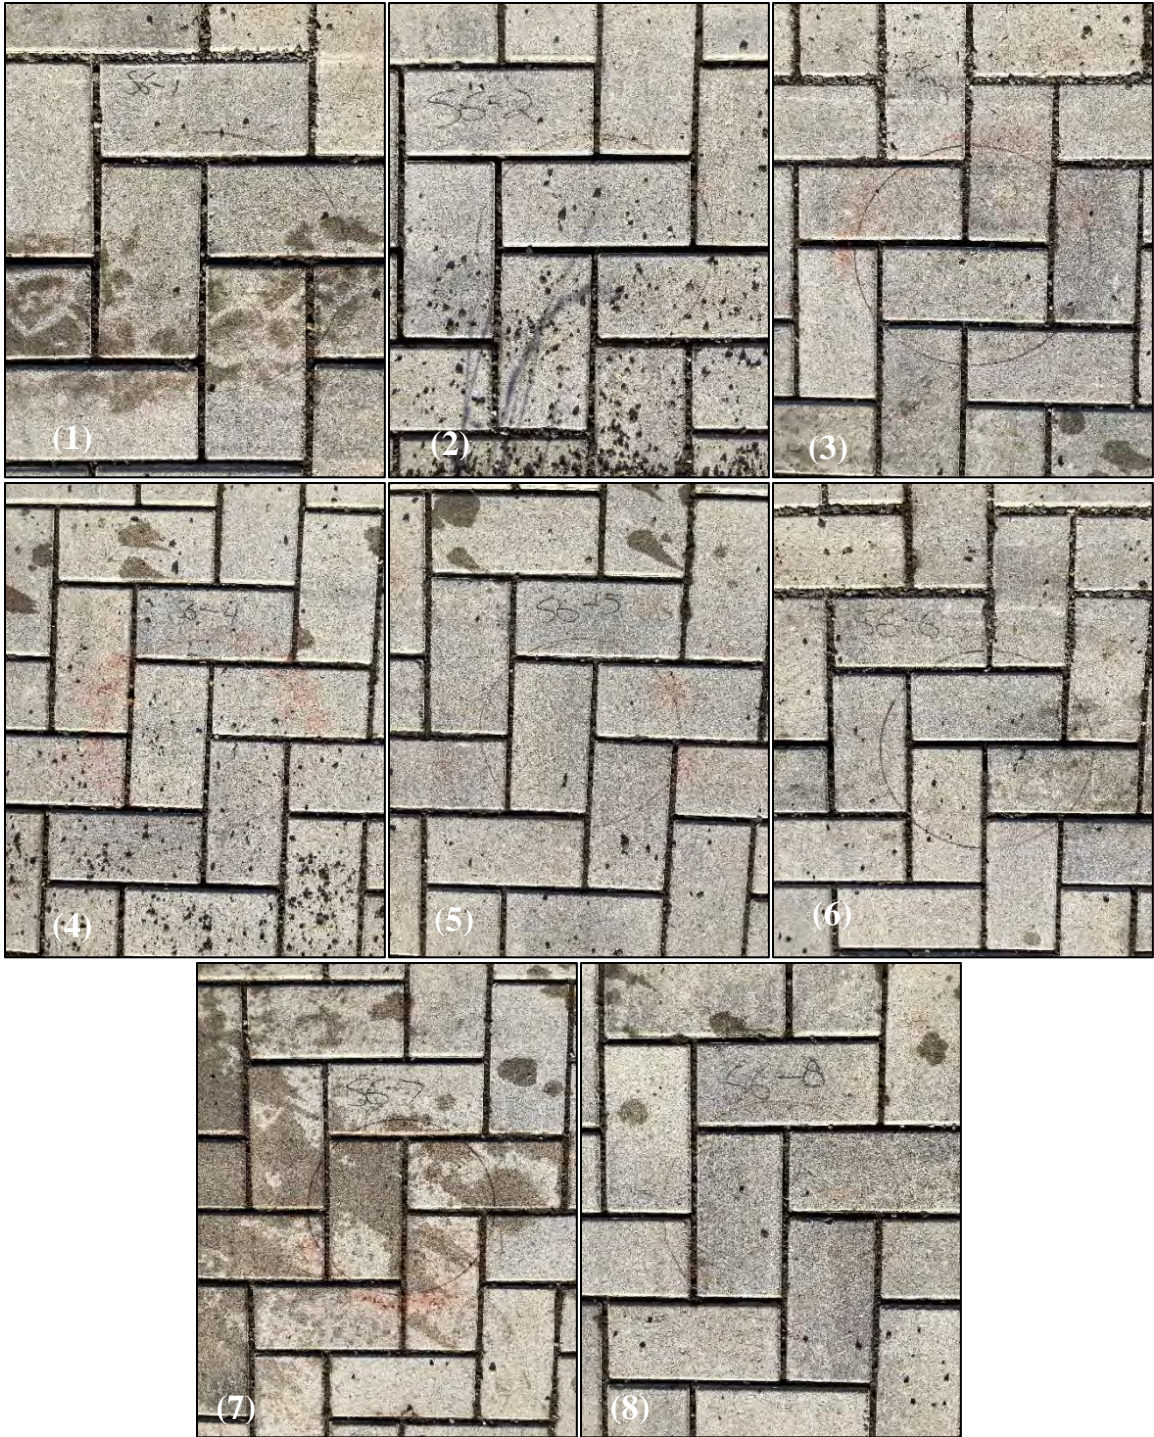
Figure J6. Post-maintenance photos of infiltration measurement locations (1-8) following a regenerative air street sweeper on Cell 6 for third early and repeated maintenance (TYMCO DST-6®).

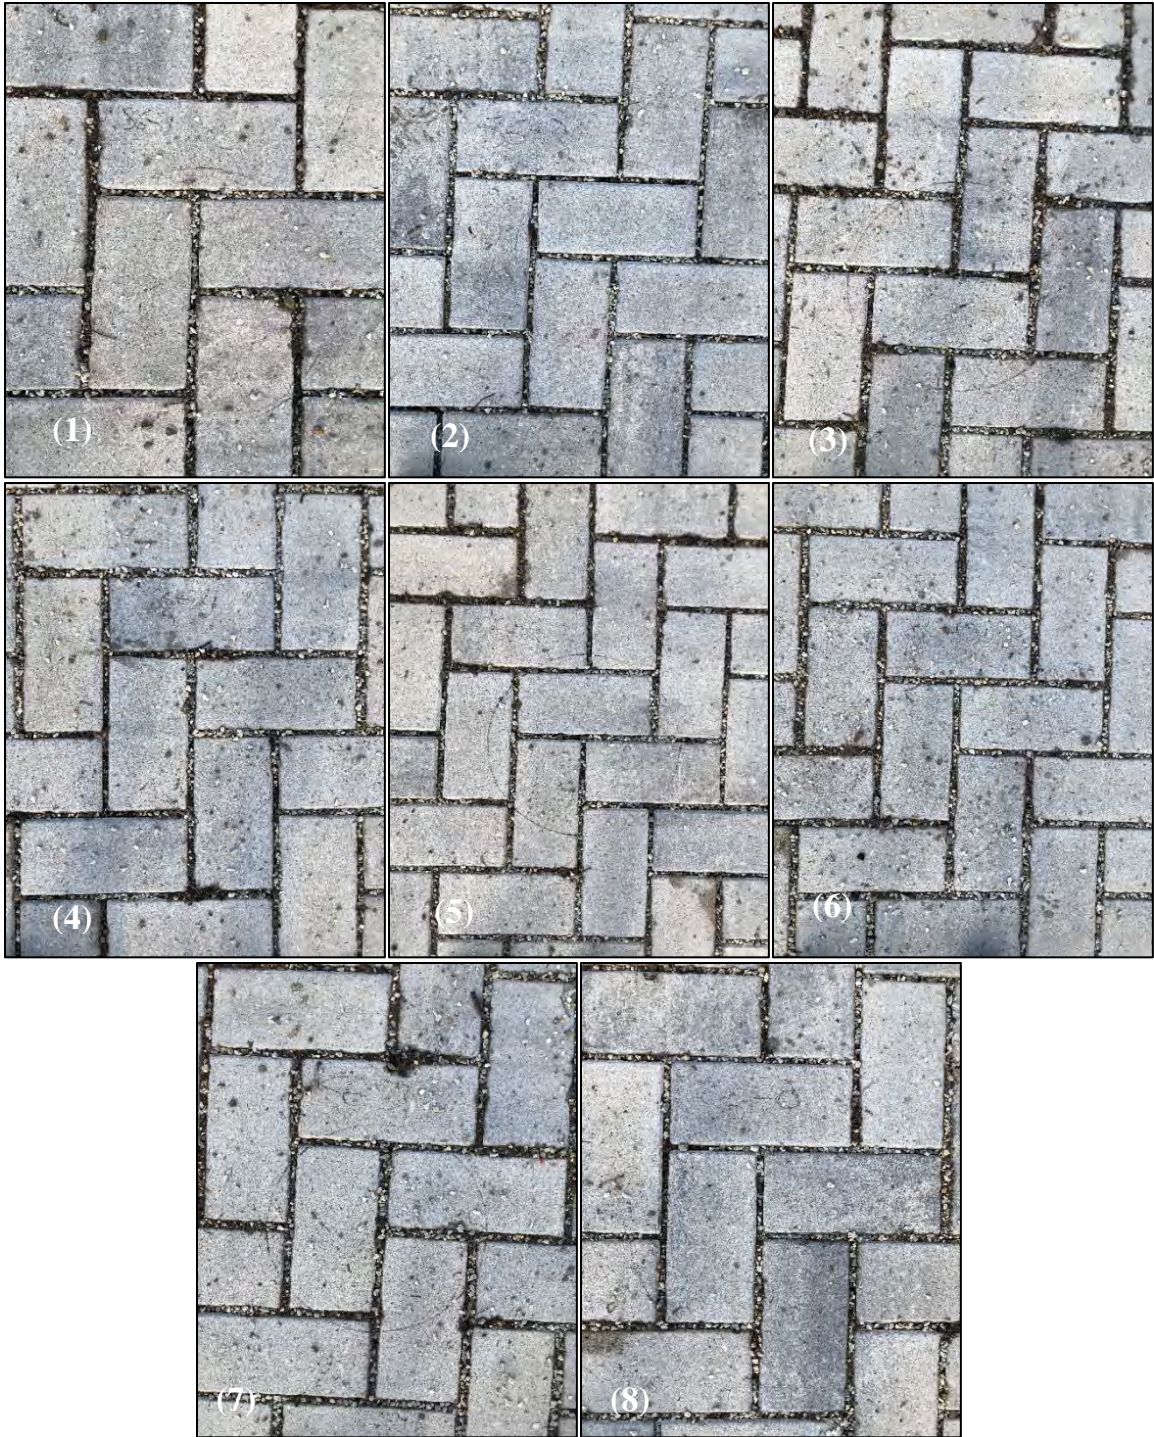
Figure J7. Pre-maintenance photos of infiltration measurement locations (1-8) on Cell 6 after third early and repeated maintenance (TYMCO DST-6®).

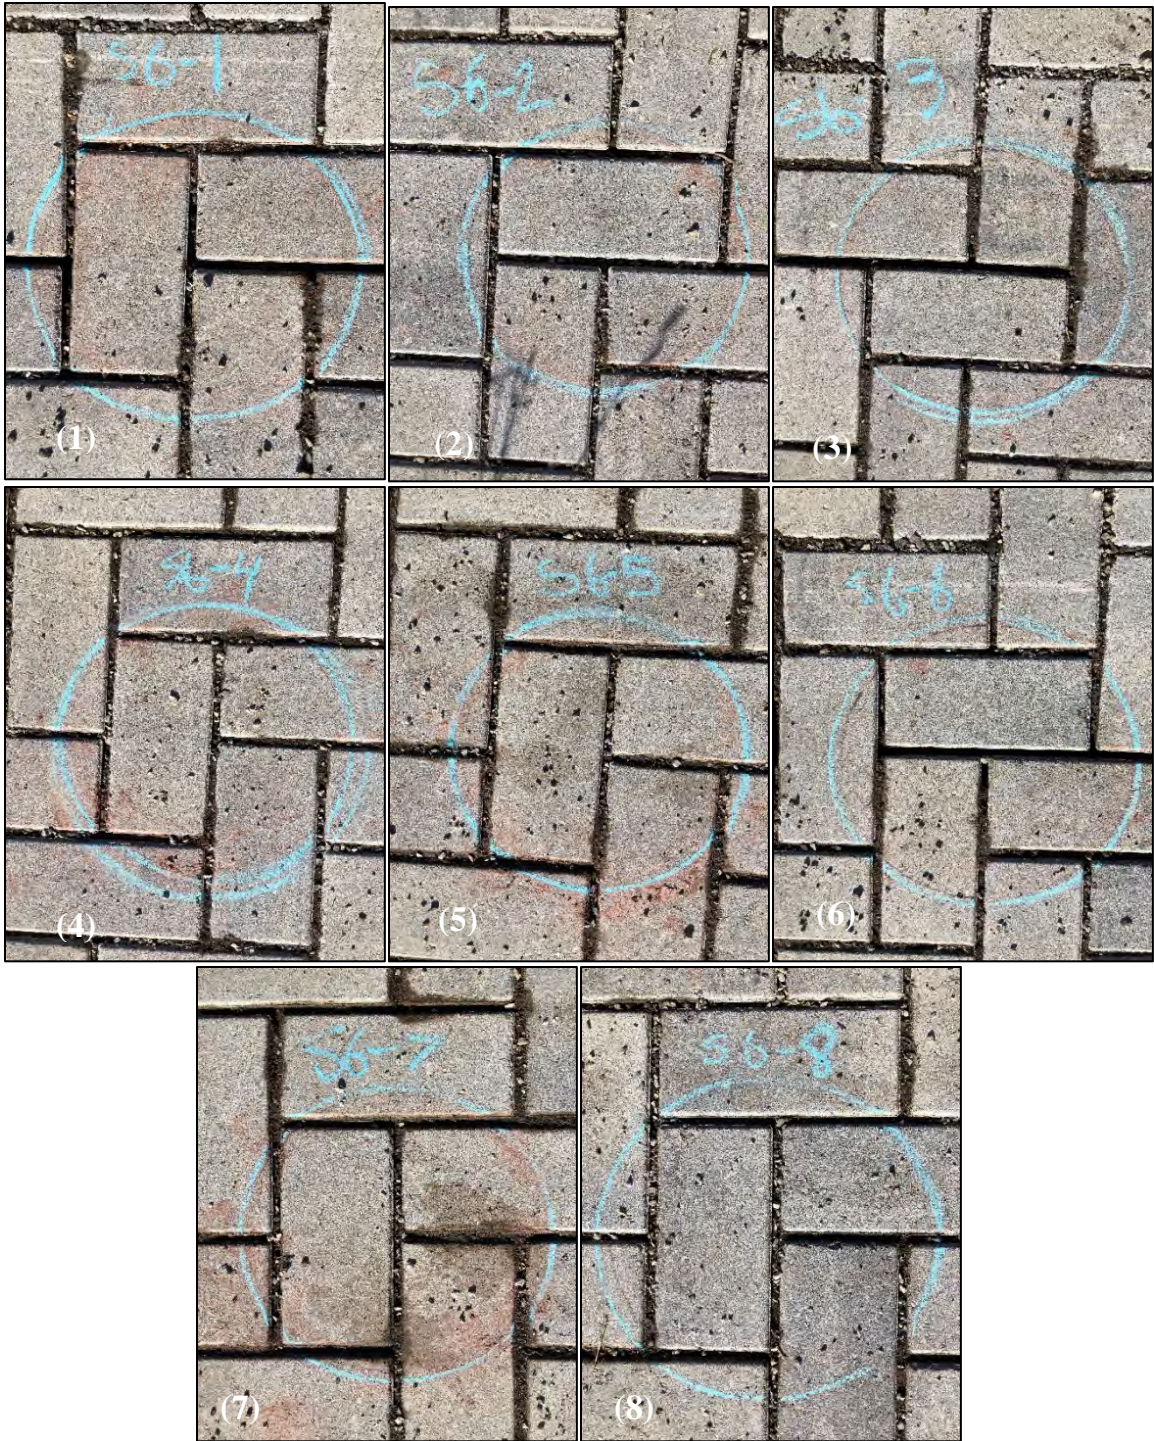
Figure J8. Post-maintenance photos of infiltration measurement locations (1-8) following a regenerative air street sweeper on Cell 6 for fourth early and repeated maintenance (TYMCO DST-6®).

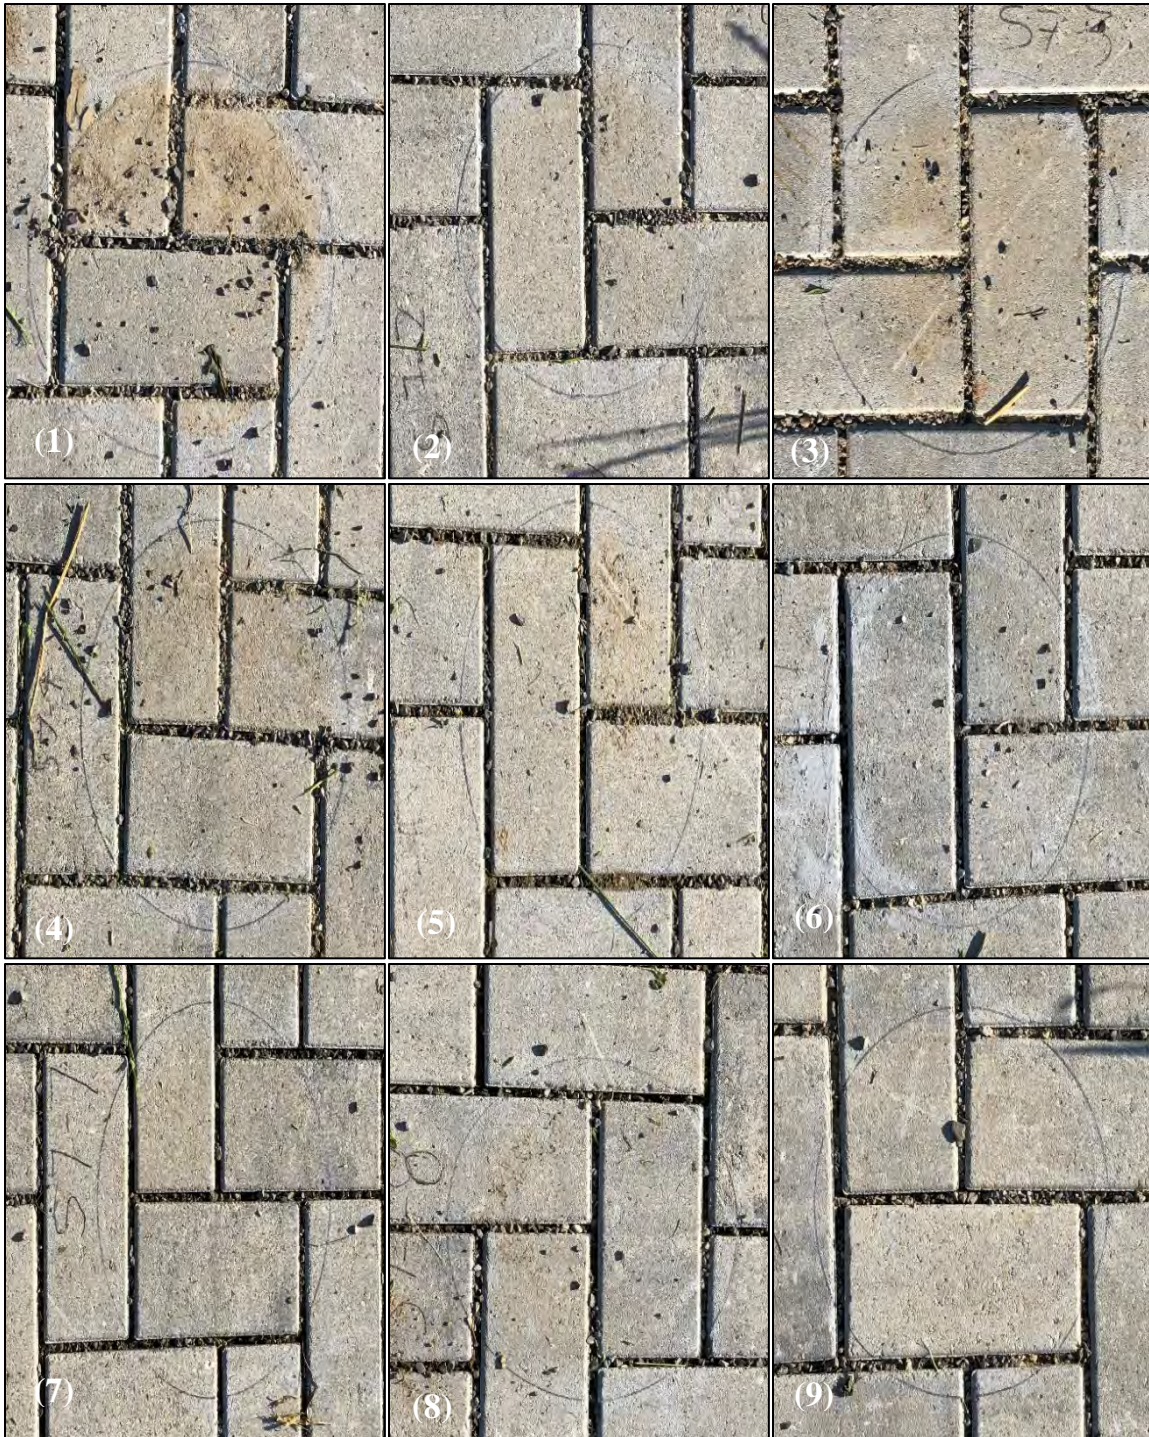
Figure K1. Pre-maintenance photos of infiltration measurement locations (1-9) on Cell 7 (Pave-Tech Typhoon® and Pavevac®).

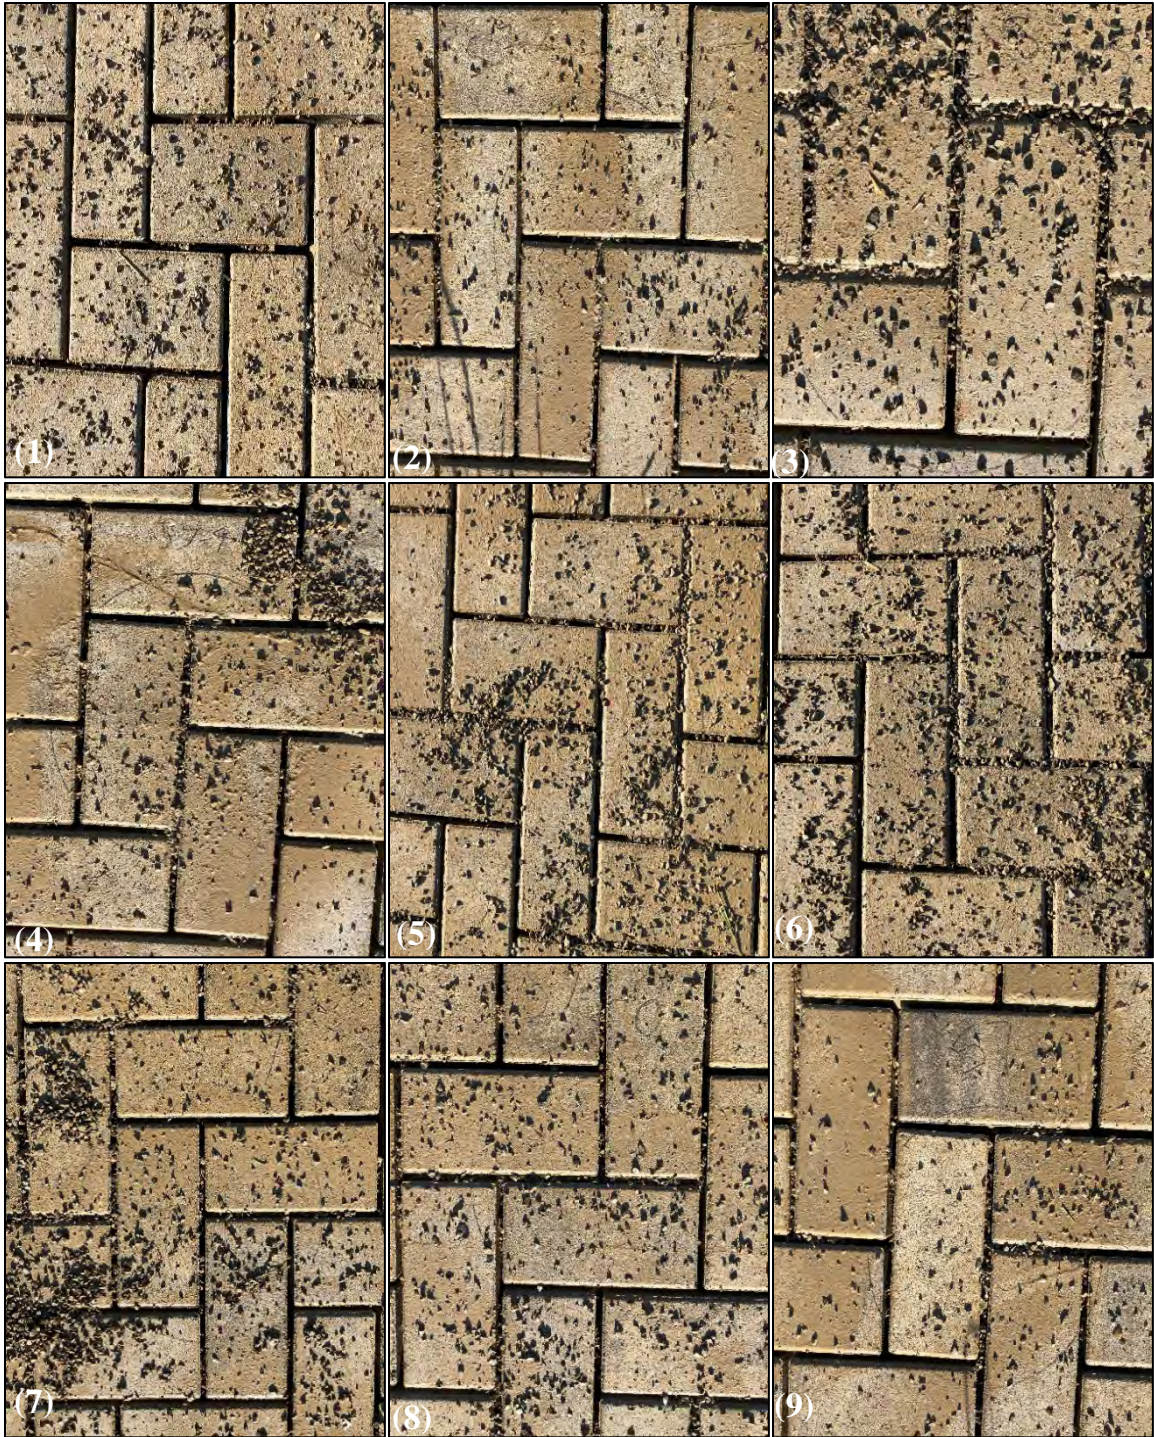
Figure K2. Post-maintenance photos of infiltration measurement locations (1-9) following high pressurized-air system on Cell 7 (Pave-Tech Typhoon®).

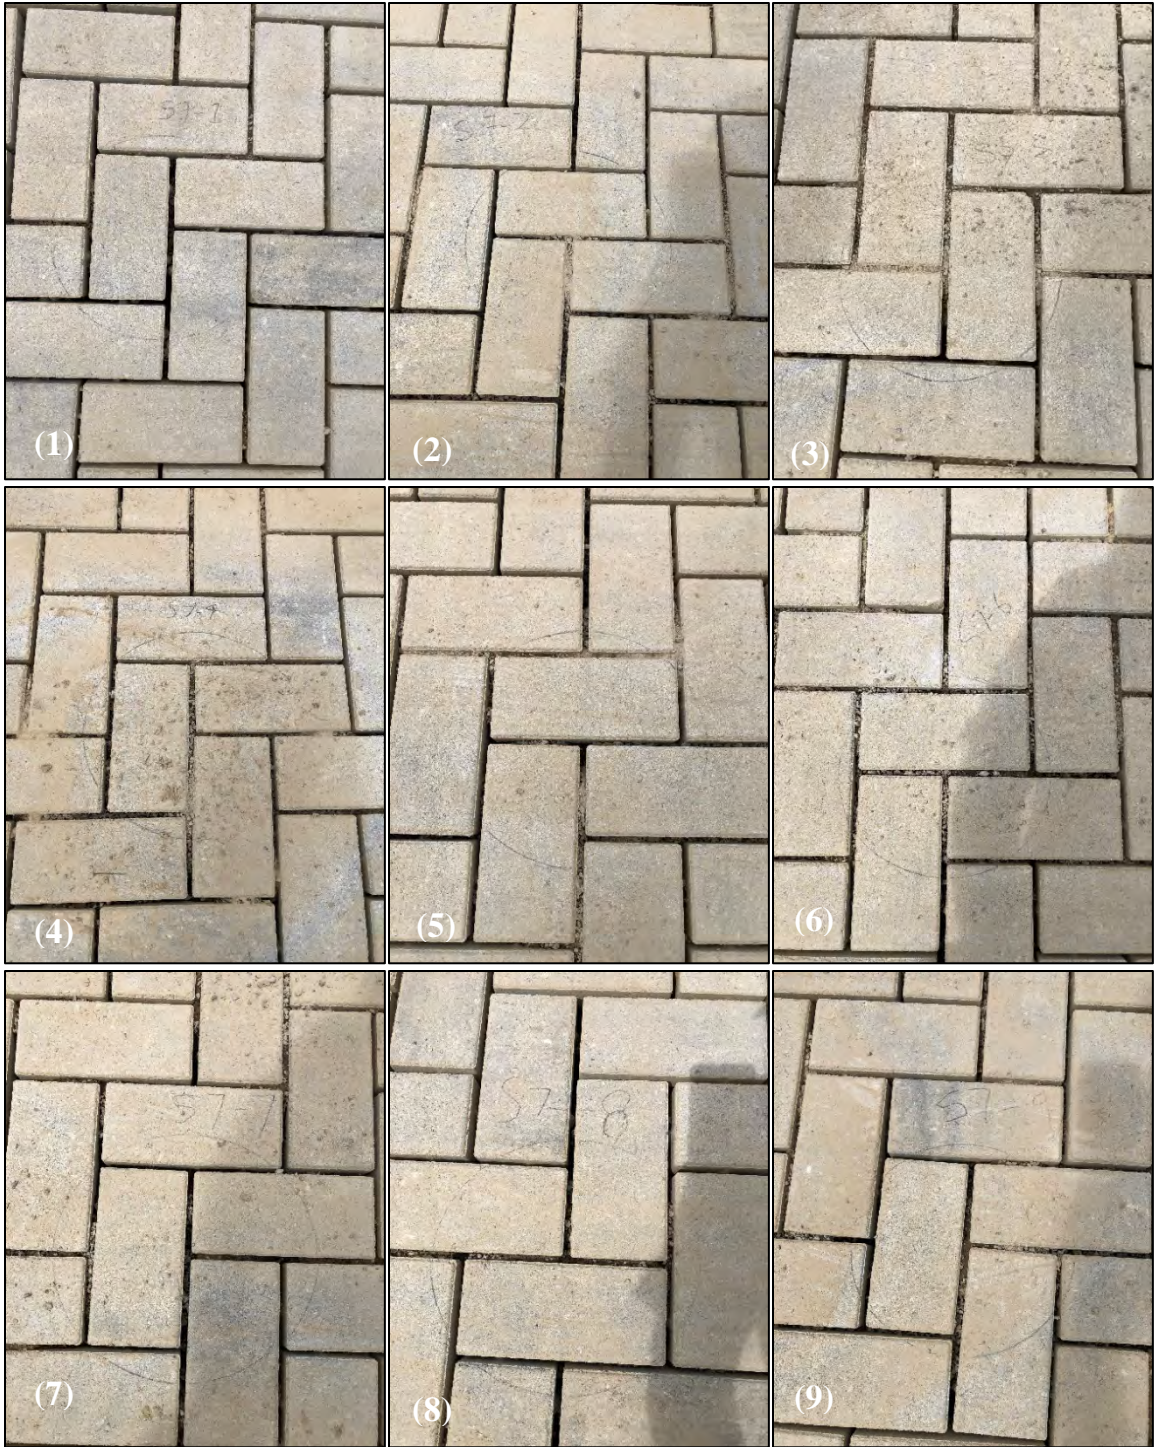
Figure K3. Post-maintenance photos of infiltration measurement locations (1-9) following a vacuum system on Cell 7 (Pavevac®).
