Evaluation of a Skid Resistant Material at High Incident Intersection Locations

Mohammad Karim, M.A.Sc., P. Eng., Pavement Engineer, City of Calgary
Joe Chyc-Cies, P.Eng., Materials and Research Engineer, City of Calgary
Brian Hartman, C.E.T., Manager, Transportation and Urban Development, City of St. Albert
Dean Schick, C.E.T., Transportation Coordinator, Engineering Services, City of St. Albert
Chris Dechkoff, E.I.T., Technical Manager, Lafrentz Road Marking

Paper prepared for presentation at the
“Giving the Edge to Pedestrians” Session
of the 2012 Conference of the
Transportation Association of Canada
Fredericton, New Brunswick

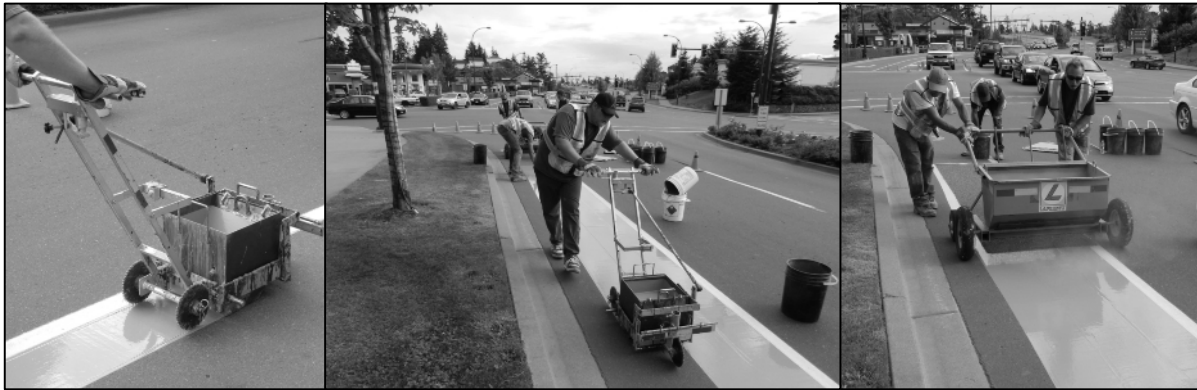
Photo I: First steps of application process of Lafrentz SRM MMA and bauxite

The MMA/bauxite skid resistant treatment is installed by Lafrentz Road Marking crews by first preparing the asphalt surface scuffing up the surface. At intersections near the stop bar oils and other vehicular remnants seem to accumulate. Surface preparation is important to remove any of the contaminated asphalt and to ensure proper adherence and longevity of the material. Next a base layer of methyl methacrylate (MMA) is applied to the road surface at a thickness of 1-1.5mm as seen in Photo I. Calcinated bauxite is then spread evenly over the surface of the uncured MMA, embedding itself into the wet material, becoming bonded to the MMA once cured. After curing, the excess bauxite is then swept off and the surface is blown to remove any remaining dust. Finally, a thin layer of MMA resin is rolled over the bauxite, effectively sealing the surface. This works well as the nature of a MMA can create a monolithic repair bonding back to itself. Photo I and Photo II depict the installation process.

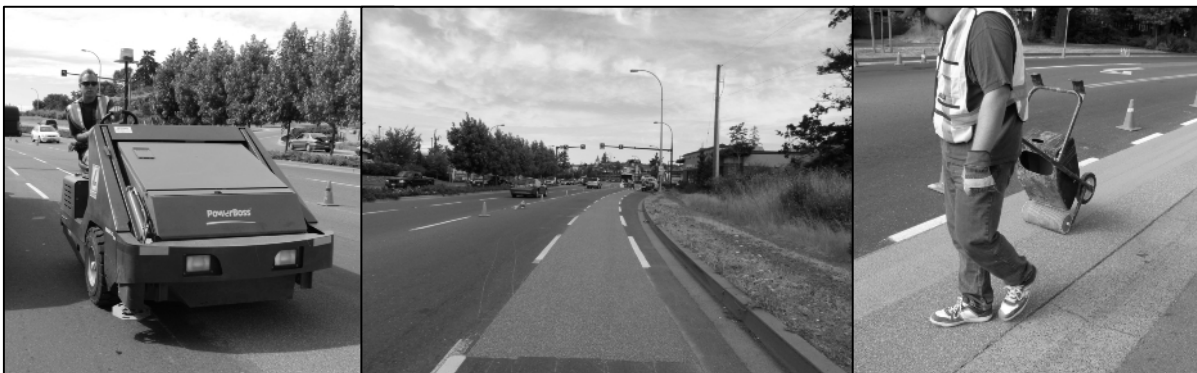
Photo II: Second steps removing excess bauxite and sealing surface with MMA resin

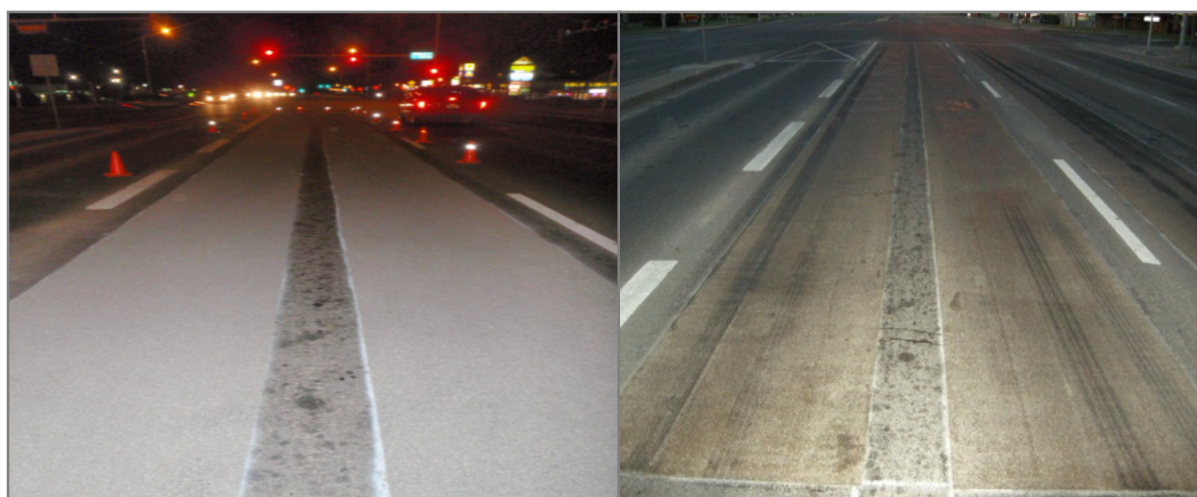
Photo III: Post Installation Photo

Each of the intersection locations that received this installation had three driving lanes in each direction on St. Albert Trail. The first location was placed in early June of 2010 on asphalt that was approximately one year old. The work was scheduled for night due to the extremely high volumes of traffic at these locations and was back in service by the morning. The following two locations were installed later in the 2010 season in October once paving operations had been completed. Photo III shows the material just after completion on the left and the following morning on the right. Skid marks can be seen in the second photo demonstrating the material was put to test right after installation.

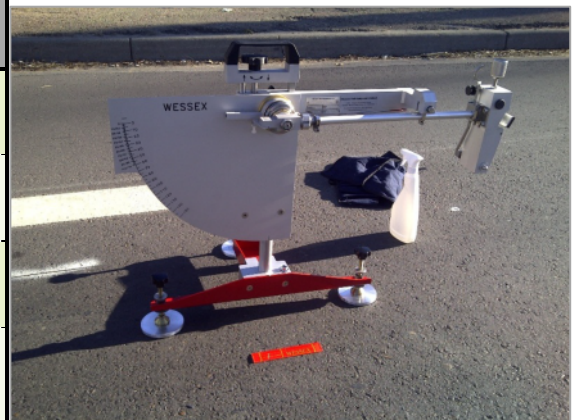
Photo IV: Wessex Skid Tester S885

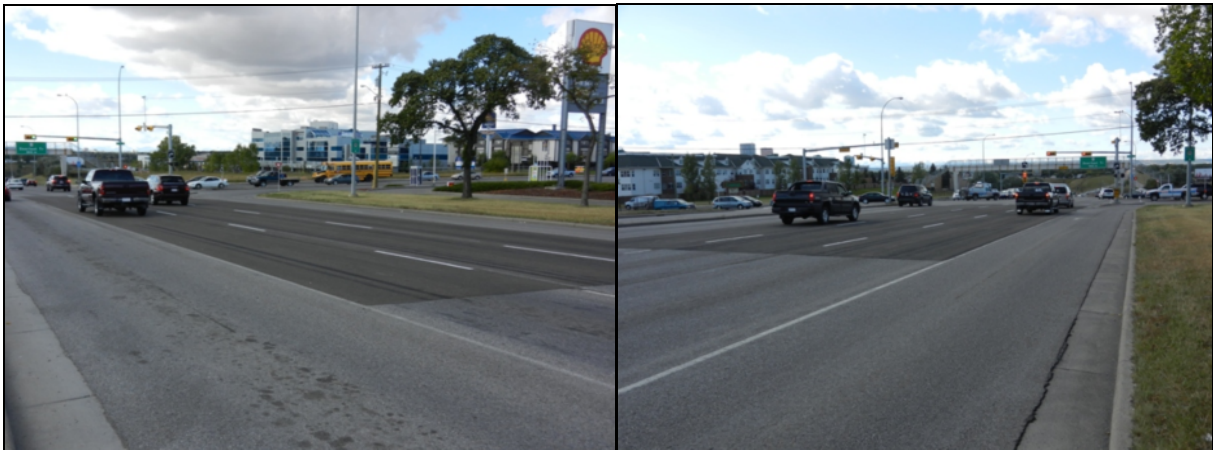
Photo V: Solid Laneway Application of SRM

The City of Calgary decided to go with a solid laneway application, as seen in Figure III, in the three straight through lanes for this location. The City was more concerned with coverage and long term durability over the extra cost of material for full coverage. Lafrentz Road Marking installed the SRM application during the nights so as not to disrupt the travelling public at this high traffic intersection. In service use of the SRM in Photo V shows the solid laneway application and skid marks from use.

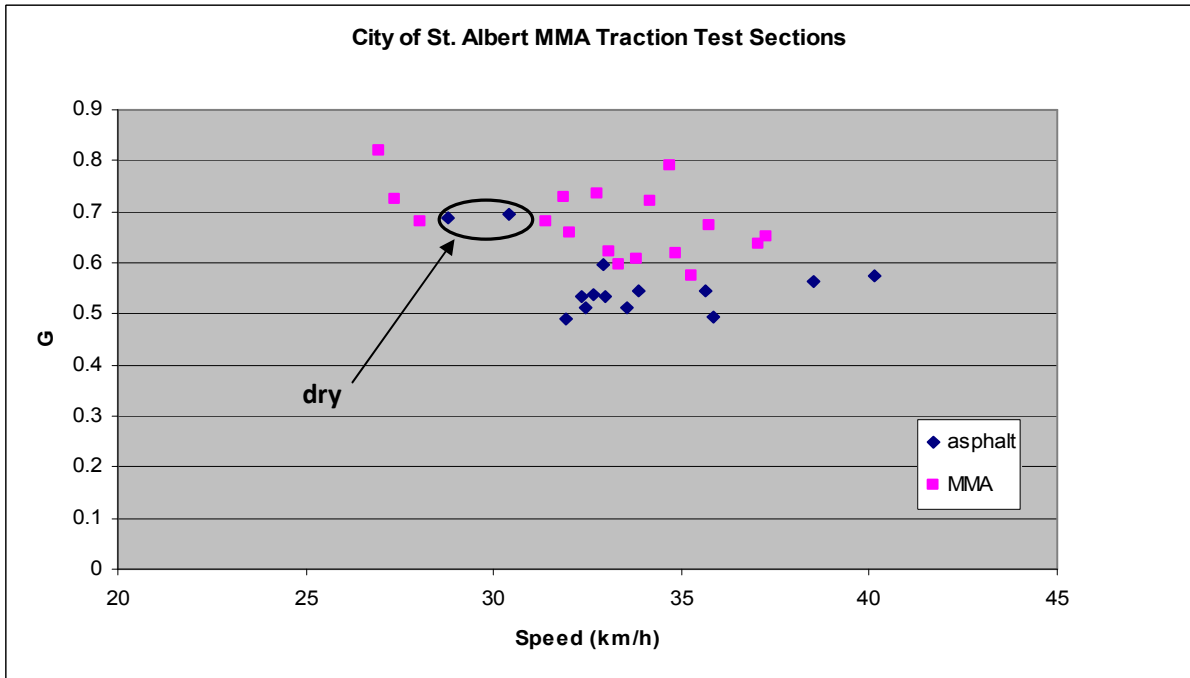
Graph I: Coefficients of Friction generated braking on asphalt and MMA test sections

On March 15, 2011 The City of St. Albert, with the help of the City of Edmonton conducted traction tests along St. Albert Trail on the three MMA/bauxite surface treatment test sections. In performing the tests a Vericom VC4000 accelerometer was used to collect the following information: Average G, Peak G, stopping distance, stopping time, and vehicle speed. The target velocities for this testing were 30 km/h utilizing a Dodge Dakota with all-season radial tires and an anti-lock braking system. Traction data was collected on the new asphalt and on the MMA/bauxite anti-skid treatment. Appendix B Graph I demonstrates the differences between the coefficients of friction (G) generated on the MMA/bauxite test sections and on regular asphalt. Two of the asphalt data points were collected on a dry surface, the rest of the asphalt data and MMA/bauxite were on a wet surface. The coefficients of friction are seen to be higher for the MMA/bauxite over the asphalt. Table II below and Graph II in Appendix B show the differences in stopping distance on the MMA/bauxite compared to regular asphalt. On average, the MMA produced a 1.5m shorter stopping distance when braking at 30km/h over regular asphalt. Braking on the MMA generated higher coefficients of friction (higher G), and resulted in shorter stopping distances than regular asphalt under wet conditions. Overall, the MMA test sections provided better frictional properties than regular asphalt.

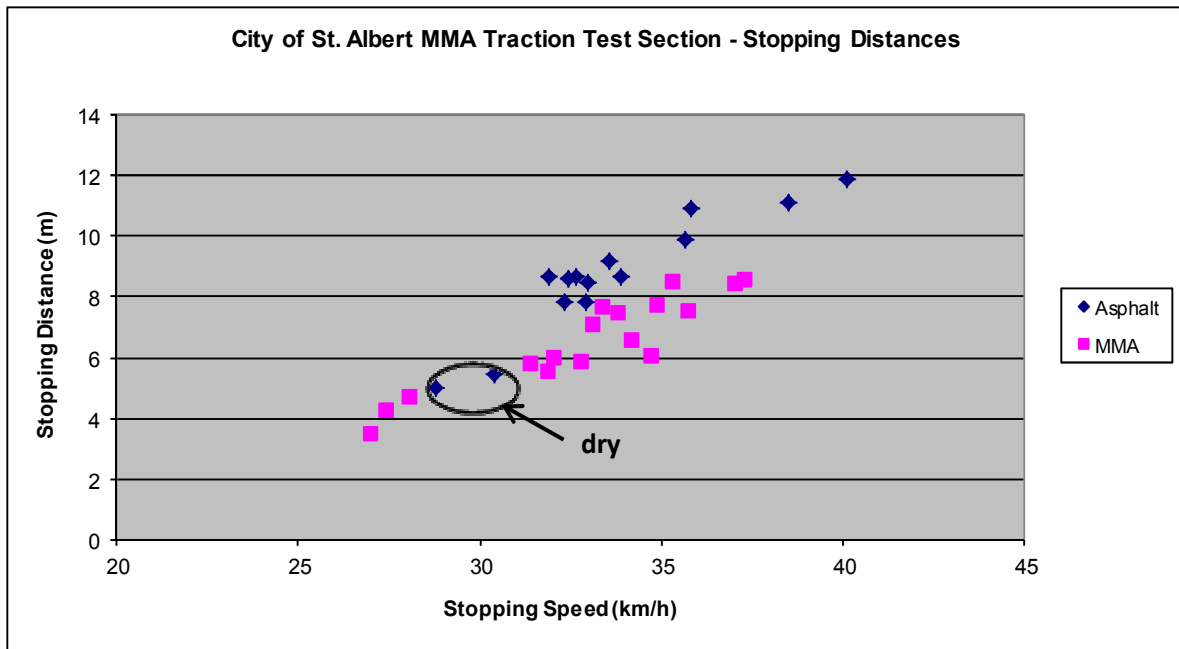
Graph II: Stopping distances as a function of stopping speed, on MMA and Asphalt
