# Rehabilitation of the Armdale Rotary

Mark Lenters, P. E., P.Eng. President  
Ourston Roundabout Engineering  
Toronto, Canada  
and Madison, Wisconsin  
[www.ourston.com](http://www.ourston.com)

2010 Annual Conference of the  
Transportation Association of Canada  
Halifax, Nova Scotia

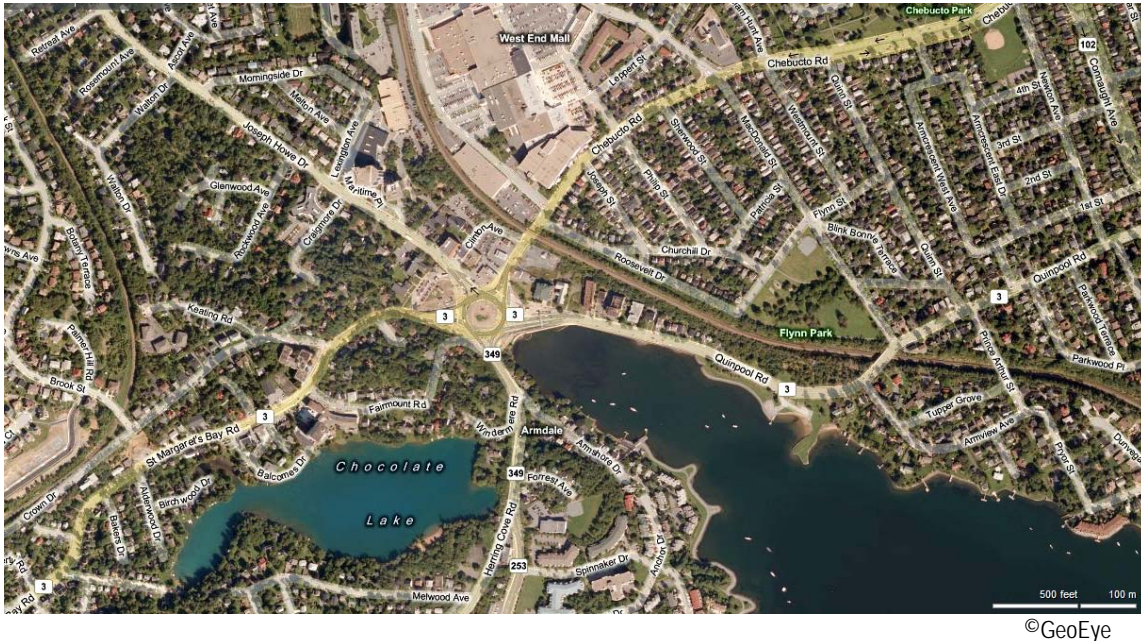
The study area with the rotary at the center of the image is shown above. The traffic circle receives vehicles from five different directions: Chebucto Road and Quinpool Road on the Halifax Peninsula, Herring Cove Road and St. Margaret's Bay Road on the Chebucto Peninsula, and Joseph Howe Drive, which runs along the isthmus of the Halifax Peninsula. It currently handles approximately 60,000 vehicles on weekdays. Historically, the intersection predates modern automobile traffic, but was designed as the Armdale Rotary during the post-war period to handle 5,000-20,000 vehicles.

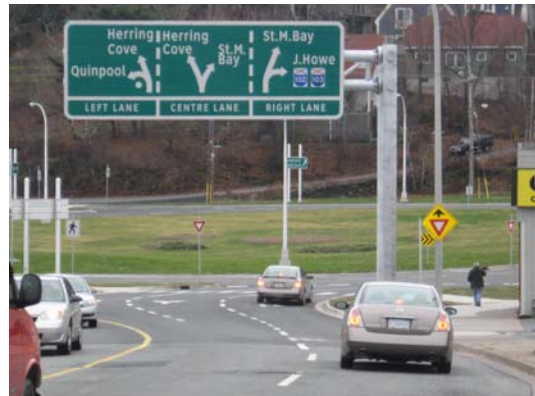
- On the Armdale Rotary, overhead signs were originally to be added only to the three lane entries: Quinpool Road and Chebucto Road. In the final design overhead signs were added to the other three entries.
