LINK SLAB DECK JOINTS

Edmund Ho, P.Eng., MMM Group Limited
Jim Lukashenko, P.Eng., MMM Group Limited

Paper prepared for presentation at the Session
Bridges – Successes: Let's Build on Them
of the 2011 Annual Conference of the
Transportation Association of Canada
Edmonton, Alberta

Bow River / CPR Overpass (Westbound) Bridge at km 23.0 TransCanada Highway, Banff, Alberta, Canada

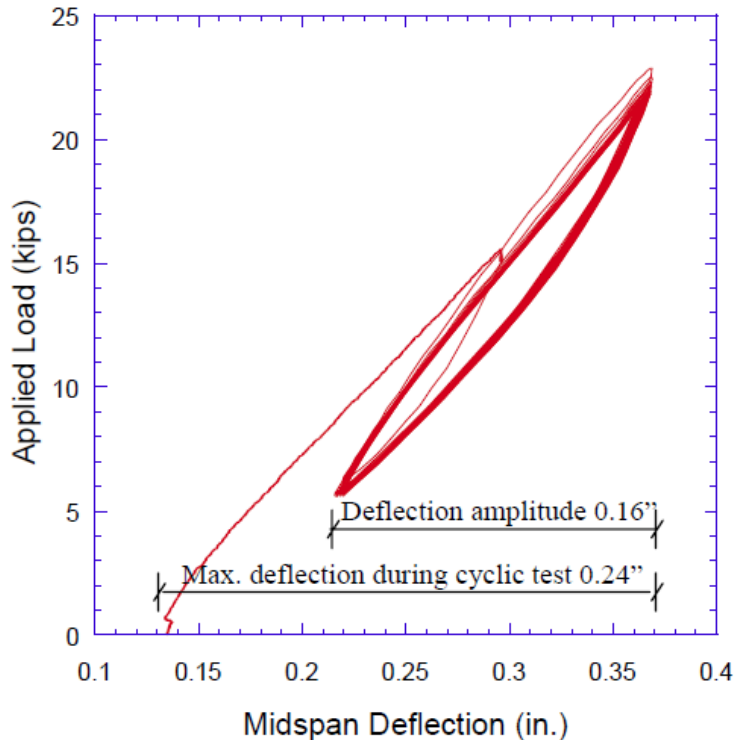
Figure 6) Graph illustrating cyclic loading of ECC link slab [4]

The following figure illustrates the midspan deflection resulting from cyclic loading of a 28" wide by 128" long link slab between inflection points loaded from 26kN to 103kN. After 10,000 cycles, the specimen did not show any changes in stiffness and no damage was evident (see Figure 6).

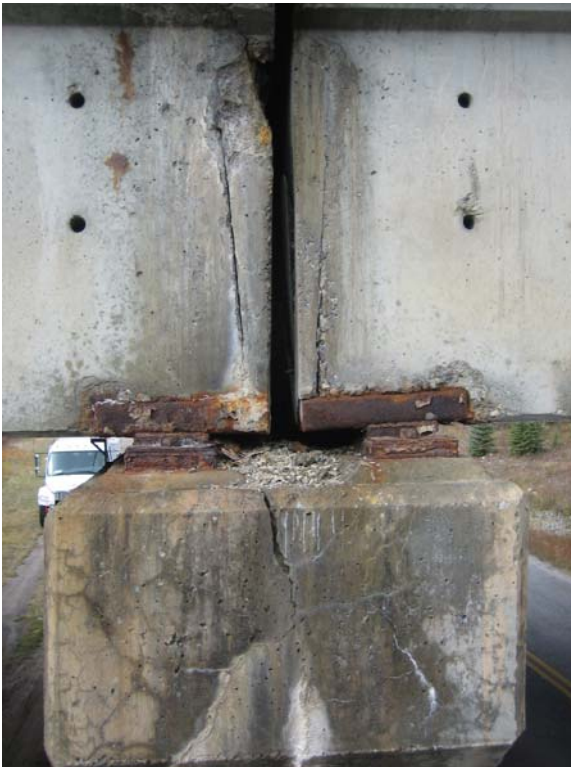
Figure 8) Cracked pier cap with severe corrosion of steel rocker bearings

A condition assessment inspection performed by MMM Group Limited in 2007 determined that the pier caps had reduced load-carrying capacity due to severe corrosion of the reinforcement and heavy spalling of the concrete. Also the girder diaphragms adjacent to the expansion joints were observed to have cracking and spalling. The steel rocker bearings were noted as having fair to serious corrosion and possibly seized in some locations (see Figure 8).

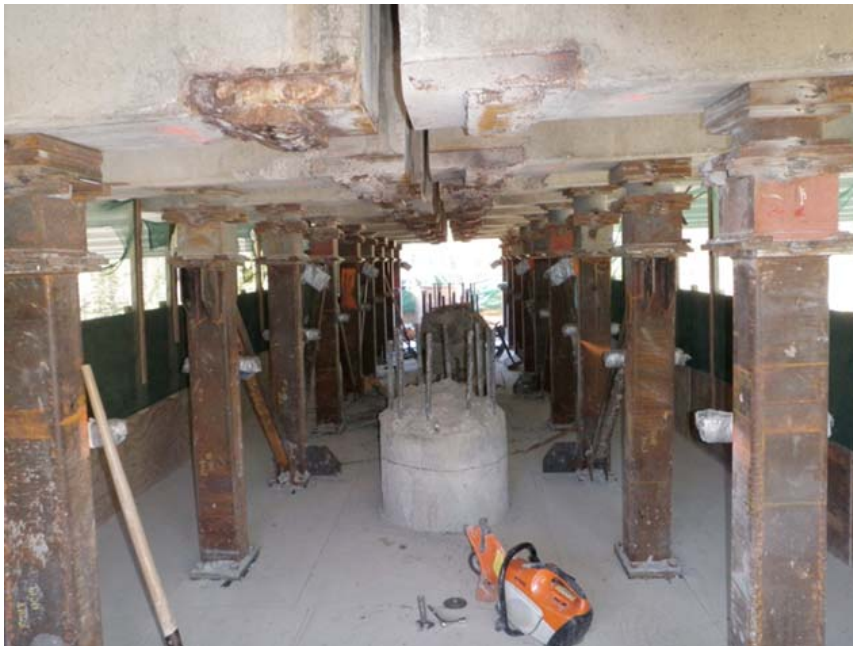
Figure 10) Support system beneath jacked girders during reconstruction of pier cap

An adjacent eastbound bridge structure enabled the vehicular traffic to be diverted during construction, and allowing full closure of the westbound bridge. The pier caps were first demolished and reconstructed. This involved jacking up the entire bridge in sections with hydraulic jacks. The jacks supported the deck while the existing concrete was chipped away, the bearings were removed and the existing shoe plates were sandblasted and metalized (see Figures 10 and 11). Sacrificial zinc anodes were installed between the salvaged pier column reinforcement and the new pier cap reinforcement to prevent new corrosion activity in the reinforcement. A distributed anode system was also applied to the concrete jacketing of the abutment face which exhibited sections of spalling and concrete delamination.

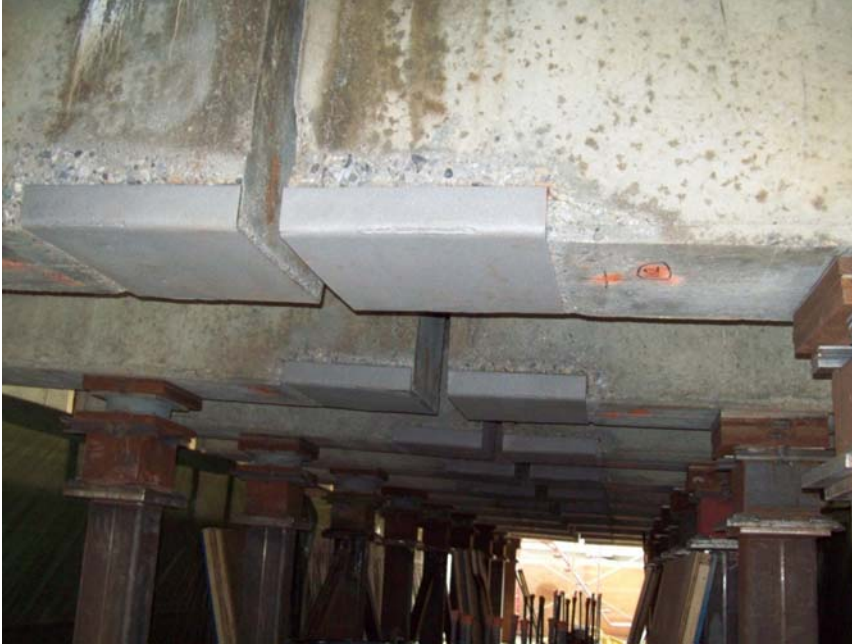
Figure 11) Existing sole plates sandblasted and metalized for use with new bearings

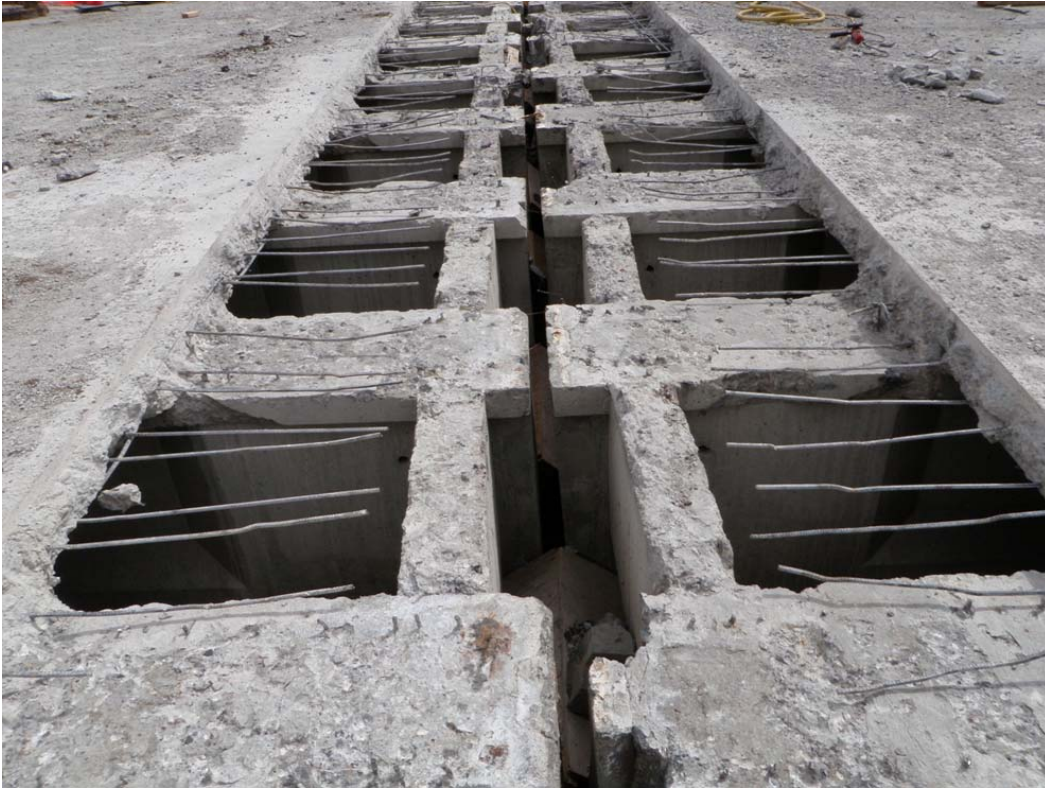
Figure 12) Link slab after chipping away of existing deck

A problem encountered was that the concrete diaphragms of the structure were within the debond zone and during the chipping process to remove the deck, the poor condition of the diaphragms caused the diaphragms to crack and spall. The top portion of the diaphragm therefore had to be reconstructed prior to the installation of the poly sheeting and link slab (see Figure 13). Further complications arose when the deck was measured to be less thick than anticipated. The deck thickness was measured to be approximately 200mm thick, and with the link slab designed to be 152mm with 86mm of asphalt topping, this proved to be inadequate. Alternatives were to reduce the asphalt topping to

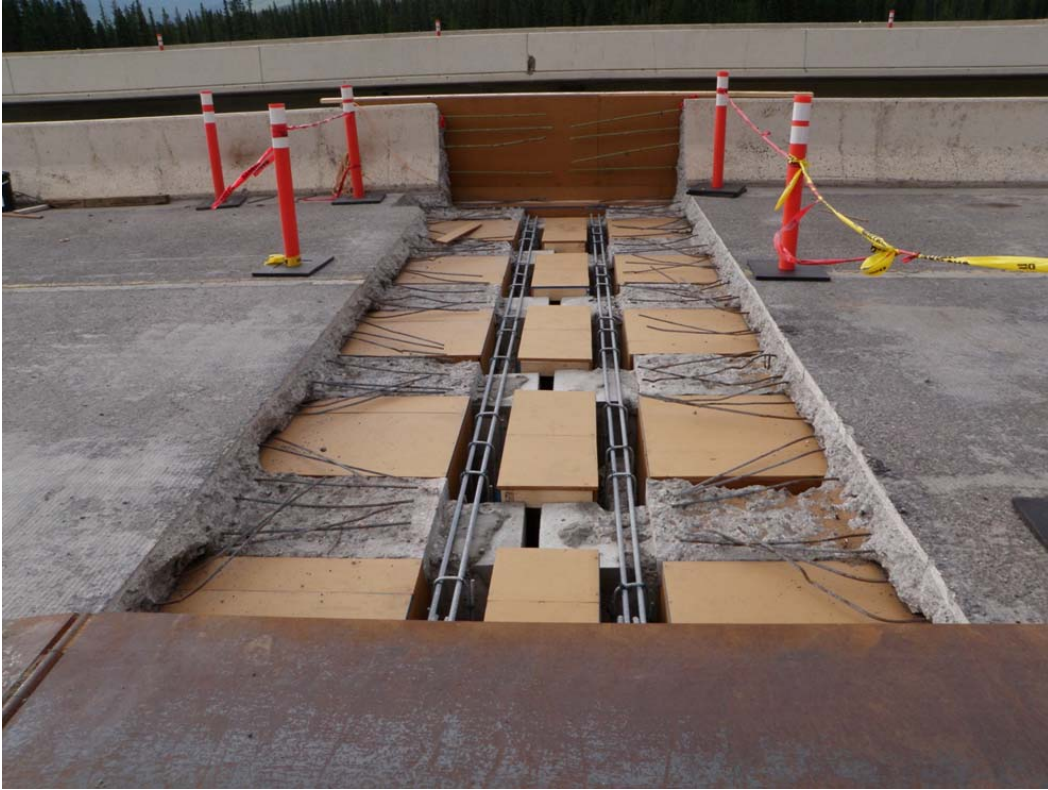
Figure 13) Formwork in place for the concrete diaphragms and link slab deck

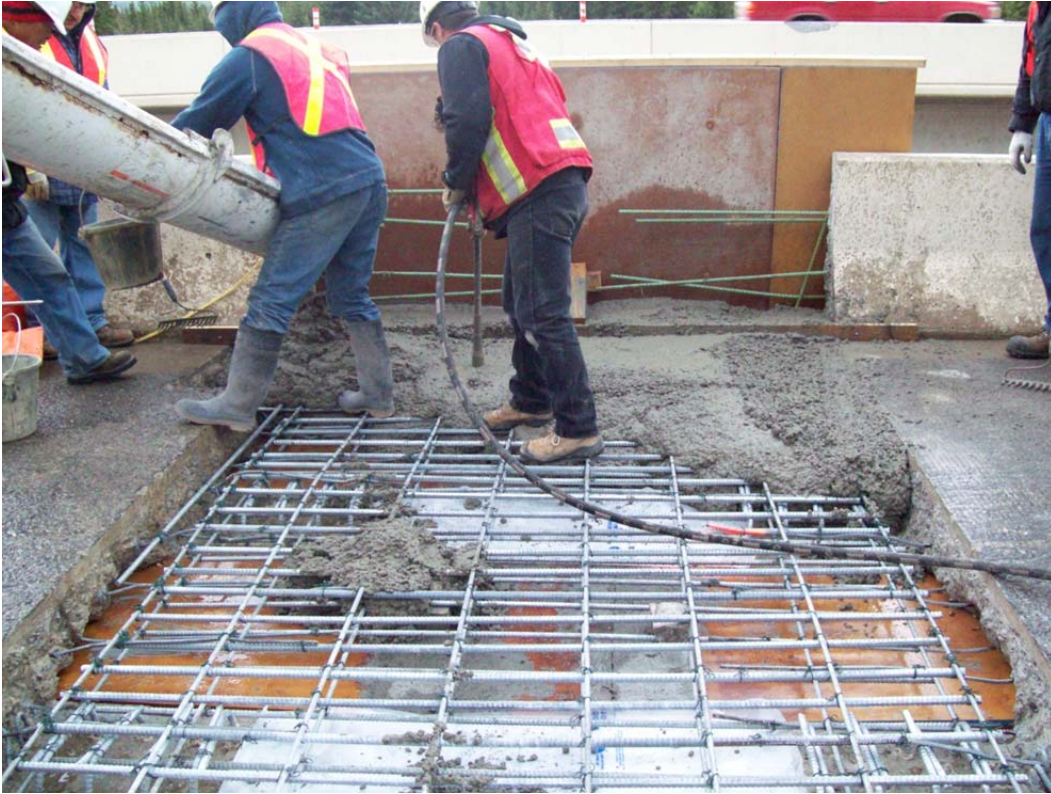
Figure 14) Pouring of link slab.

The link slab was poured followed by the barriers (see Figure 14), with the finished link slab shown in Figure 15.

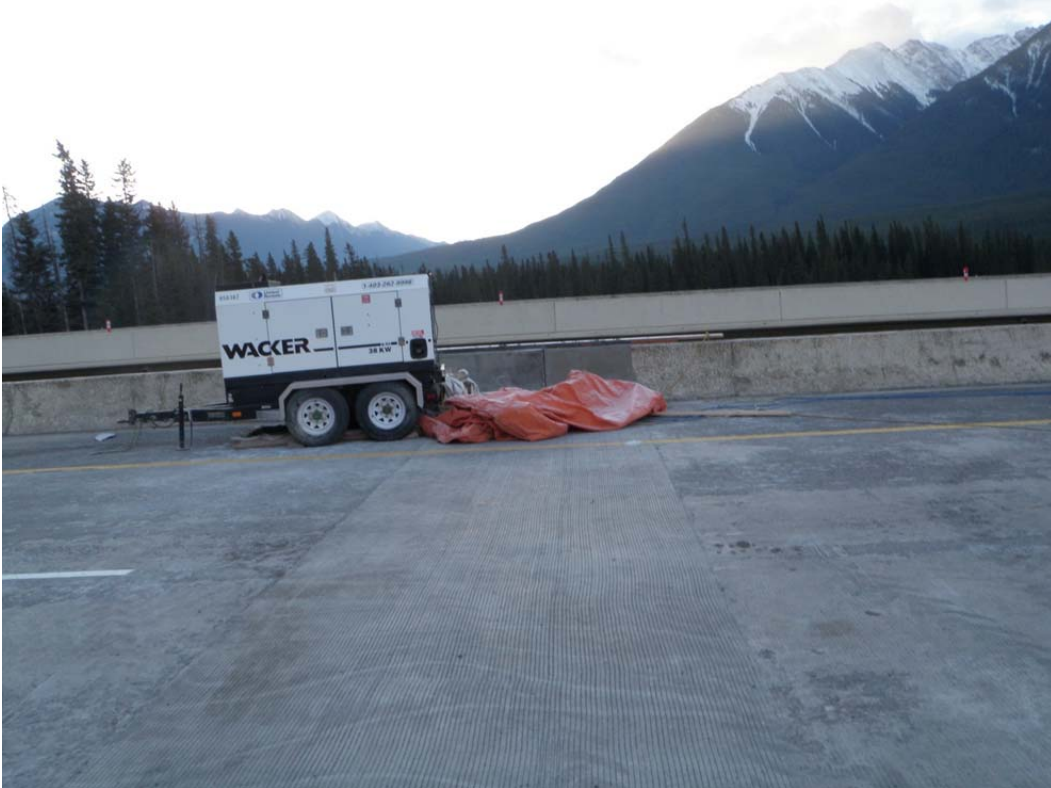
Figure 15) Finished link slab.
