Application of Passive Infrared Thermography for the Detection of Defects in Concrete Bridge Elements

Paper prepared for presentation
at the Structures Session
of the 2016 Conference of the
Transportation Association of Canada
Toronto, ON

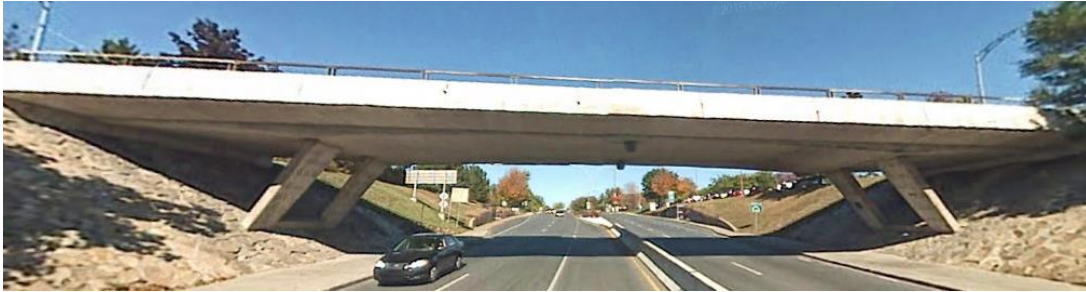
Field testing was conducted in this study on an in-service reinforced concrete bridge located in the province of Quebec, Canada and scheduled, by the Ministry of transportation of Quebec for rehabilitation. Delamination, corrosion and high chloride ion content were recently indicated through a condition survey of the bridge. Therefore, the bridge was considered as a good candidate for evaluation study using thermal IR to detect subsurface anomalies within the bridge deck and soffit. The bridge was constructed in 1969, and the critical characteristics of the deck include a total length of 147 ft with a transverse width of 29.53 ft, which translates into 26.25 ft of drivable surface (supports one lane of traffic in each direction) with one side shoulder. **Figure 1** shows the surveyed bridge in this study.

Figure 1: Illustration of the surveyed concrete bridge.

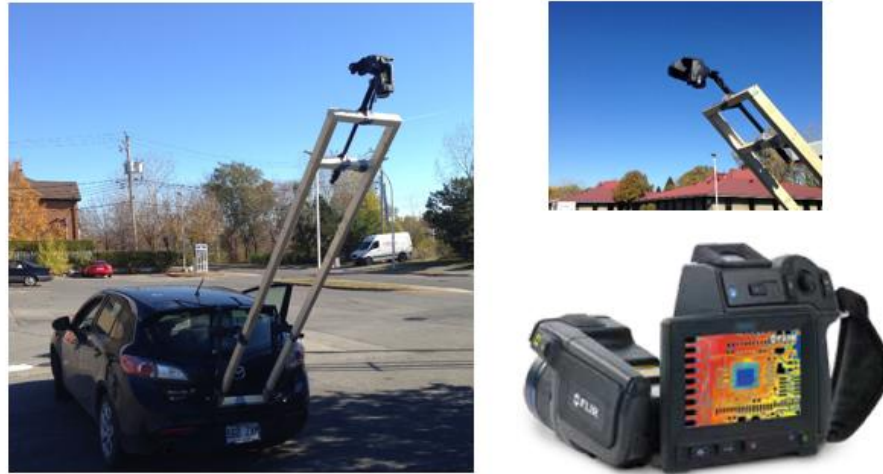
The most important parameters that must be considered before choosing an IR camera include the spectral range, spatial resolution, temperature range and frame rate. For observing objects at ambient temperature, a long wave length band (7.5–14 μm) are preferable to detect small thermal contrasts. The spatial resolution of an IR camera primarily depends on the object-to-camera distance, lens system and detector size. An advanced infrared thermal camera, FLIR T650sc, was utilized in this survey. The camera has uncooled microbolometer detector, 5 MP built-in digital camera, and displays thermal images with a resolution of 640 x 480 pixels. The thermal IR camera was mounted on a vehicle at a height of 8.5 ft oriented facing straight-down to the concrete deck surface. A calibrated 13.1 mm focal lens (45° wide lens) was utilized. This allowed a 7 ft x 5.3 ft field of view (FOV) for each image and to survey each single lane with only two paths. The vehicle was driven at low speed over the center of each pass of the bridge deck. The images were taken every 3 ft and hence, a total of 392 thermal and digital images were collected, which covers the entire bridge deck. The survey was conducted on October 27th, 2015 at 1 PM, 6 hours after sunrise. During the survey indicated, the ambient temperature was 56° F, relative humidity was 26%, and wind speed was 5 mph. Bridge deck dryness was considered during data collection since surface moisture can reduce the thermal contrast on the thermal IR images. Sun direction was also considered to avoid shadows on images. The total time of data collection was about two hours. The Matlab image acquisition toolbox was utilized to initialize acquisition and storage of the IR data.

to separate patches and surface defects from subsurface anomalies. **Figure 2** illustrates the utilized camera and the vehicle mounted setup to survey the bridge deck.

Figure 2: Illustration of the FLIR T650sc IR camera and vehicle mounted setup system.

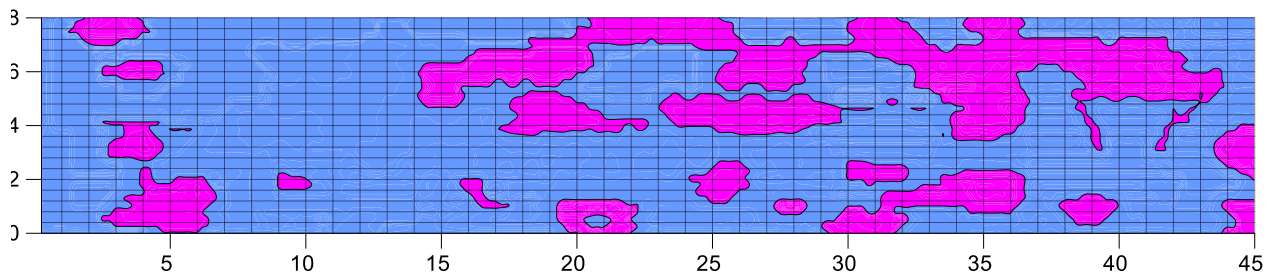
Thresholding classification using the saved temperature values was implemented in the present study to identify the defective areas in the concrete deck. Firstly, the thermal contrasts were calculated from the temperature values of the mosaicked thermogram. The max thermal contrast of the recorded data was 7.7°C . It was then necessary to select a threshold value for the calculated thermal contrasts that could indicate where delamination was likely to be detectable. A 1°C threshold was selected for two reasons: (1) it is 20 times higher than the sensitivity of the utilized camera such that much smaller variations in surface temperature were easily detectable; (2) it is twice the ASTM D4788-03 requirement (0.5°C minimum contrast between sound concrete and a defect). The pixels with a higher temperature than this threshold value were highlighted because delaminations appear with a higher temperature. Finally, the temperature values were grouped and a condition map was plotted using a commercial mapping software to construct a high contrast image, accurately delineating the location of subsurface defects. **Figure 3** illustrates the created map of the surveyed bridge deck.

Figure 3: Map of the surveyed bridge deck indicating delaminated areas.

Hammer sounding was conducted on the bridge deck and soffit by the bridge inspector, before conducting the IR survey. The created IR delamination map of the bridge deck

was compared with the hammer sounding results. It was found that the two methods provided very similar sizes and shapes of defects in the deck. The surveyed bridge was also GPR scanned on September, 2015 by a specialized consultant, as part of condition survey program. GPR evaluates the condition of concrete bridge decks based on the difference between reflection amplitudes of top rebar layer where strong reflection indicates sound concrete, while the area with high amplitude attenuation is commonly associated with concrete corrosion. The analysis of the GPR profiles identified the areas which have potential corrosion. **Table 3** compares the results of the conducted IRT survey and the records of both hammer sounding and GPR scanning in terms of the percentage of the subsurface defects. The hammer sounding results showed 39% total delaminated areas on the bridge deck, whereas the total delaminated area calculated from the thermal infrared imagery survey was 36% of the total bridge deck area (36% of the total delaminations is common between these two surveys). Similarly, 32% and 28% total delaminated areas on the bridge soffit were identified by the hammer sounding and IRT, respectively. The GPR results indicate 24% total areas that have potential corrosion. This complies with the findings of Washer *et al.*, (2013) who reported that not all delamination can be observed in GPR images and that GPR and IRT should be combined for accurate identification of anomalies in highway bridges. Thus, the IR survey and analysis in the present study identified the delaminated areas with superior degree of agreement with GPR and hammer sounding.

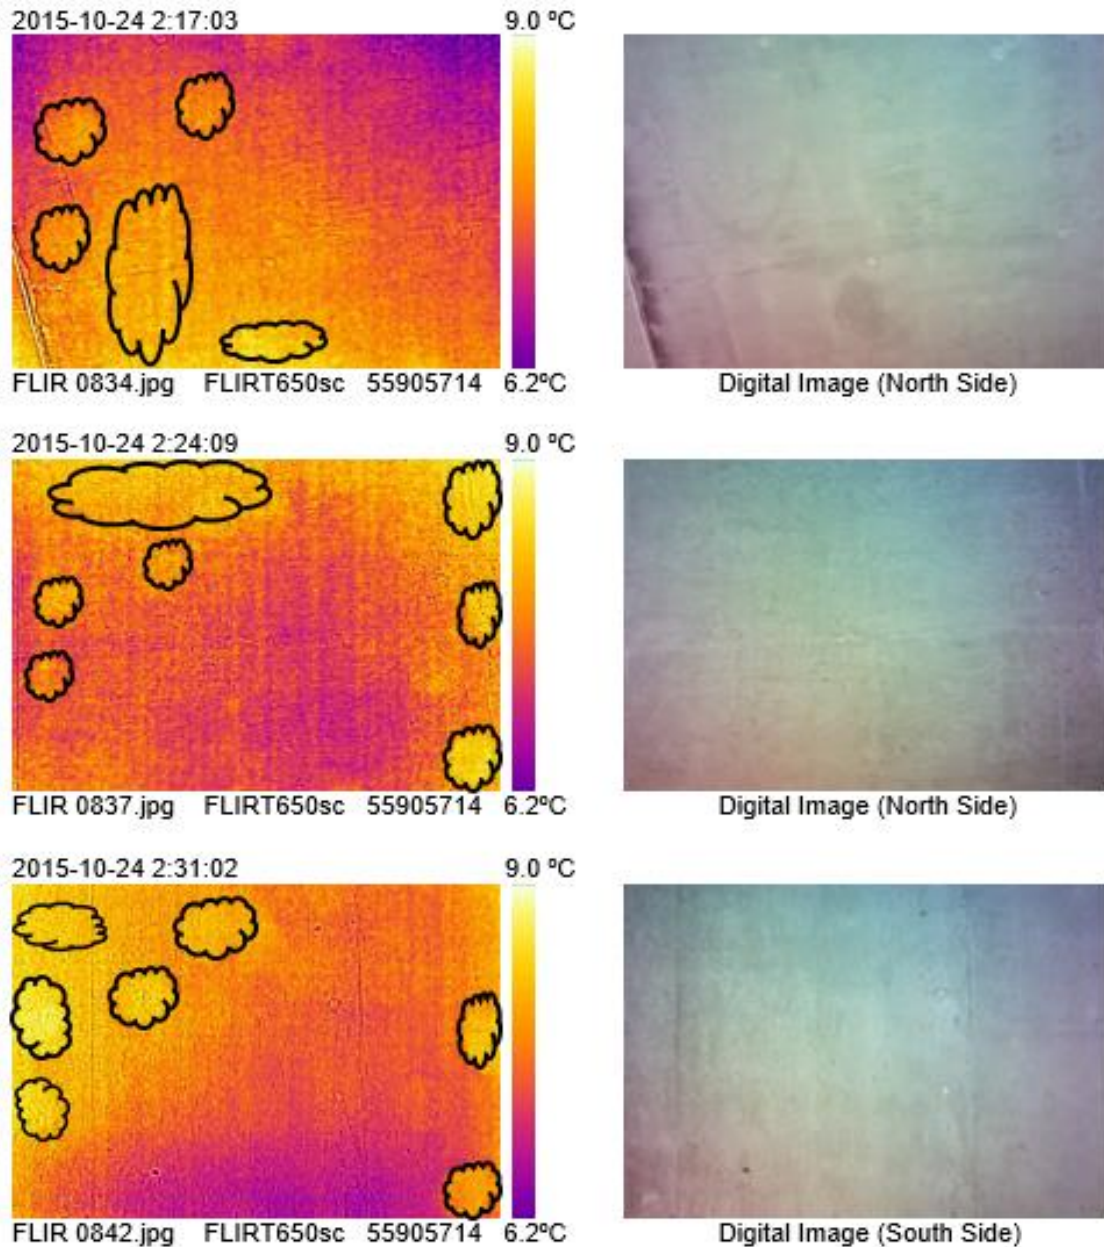
delaminated areas in each image. Having a camera with a larger field of view can solve this issue to some extent, and having less images on the overall bridge soffit can make the data procedure faster and more practical. However, caution must be taken in using the wide-angle lens for the thermal IR camera as the edges of the thermal IR images may be distorted and become not viable for calculating the number of pixels and area of delamination. **Figure 4** displays a subset of thermal and related digital images, which were captured by the infrared camera on the bridge soffit, delineating the potential delaminated areas.

Figure 4: Thermal and digital images of potential delaminated areas in the bridge soffit.
