**Scona Road Case Study:
Challenges and Opportunities for the Widening of an
Existing Major Arterial Into the City of Edmonton's
Downtown Core**

Aleksandra Turcza, P. Eng., City of Edmonton

Paper prepared for presentation
at the
Geometric Design Technical Paper
How Much is Enough? – Optimizing Right-of-Way Use Session

of the 2012 Conference of the
Transportation Association of Canada
Fredericton, New Brunswick

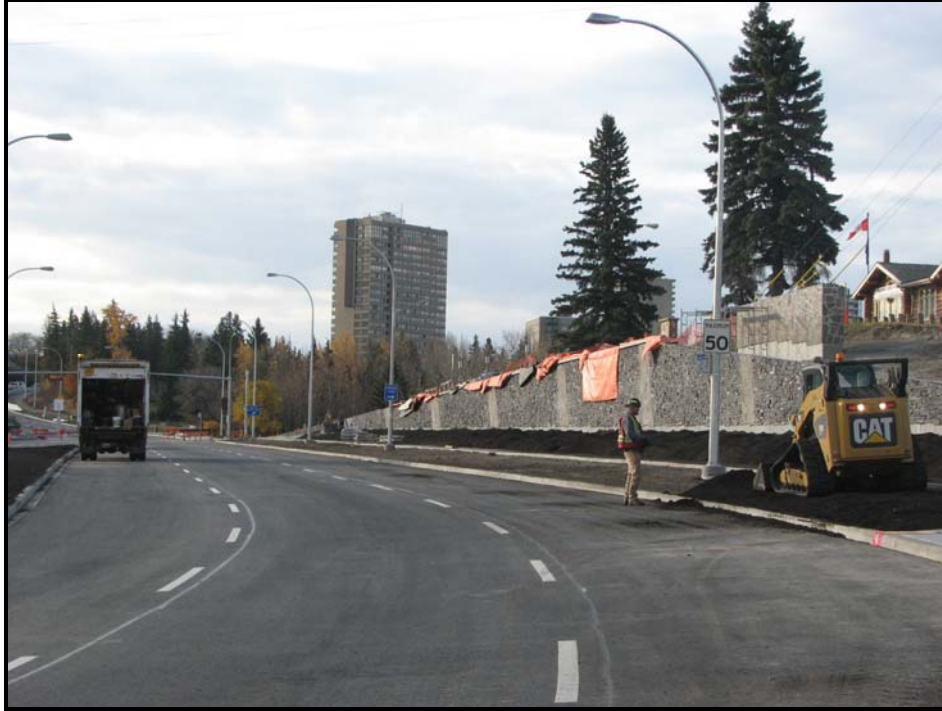
Figure 3: Retaining Wall 1 and Guy Wire Structure

The geometric restrictions and aesthetic possibilities ended up being the deciding factors in deciding the wall type. East of an alleyway immediately adjacent to the Old Timers Cabin, were tall wooden poles which carried overhead power lines that crossed the North Saskatchewan River and continued further east. The wooden poles were stabilized by guy wires which ran across the alley and down to an area in the grassed boulevard which was only a few meters from the edge of where the new roadway curb face was designed. Utility requirements dictated

that the poles could not be removed. The guy wires would have to be relocated to an already narrow boulevard which would now become even smaller due to the addition of a lane. The major challenge this issue posed was that the guy wires had to maintain an approximately equivalent existing angle from the top of the pole to the ground to provide sufficient clearance from the wires to the alleyway underneath them. Geometric constraints of the addition of the lane and the resulting need of the retaining wall along this section of land, did not allow for the wires to maintain this angle and not conflict with the retaining wall to reach the ground. The constraint caused by the confining geometric elements was able to be resolved through a creative and unique idea by Epcor, the utility owner. A solution to this problem involving the construction of a structure strictly for the purpose of supporting the guy wires at the required height was proposed. The guy wire structure was constructed approximately four meters behind the new retaining wall at a height that provided the required vertical clearance of the wires to the alleyway. The guy wire structure and associated relocation of the wires had to be completed before the construction of the noisewall. With the guy wire structure now situated four meters away from the retaining wall location, construction methods of the retaining wall had to be considered in respect to the new structure. The retaining wall which was ultimately selected for construction at this location was a cast in place, retaining wall on piles. Although taking a significant amount of time to construct, this wall provided small impact to the adjacent area as well as provided numerous possibilities for aesthetic finishes. The 165 meter wall ended up requiring 66 concrete piles, with each pile diameter approximately 90 centimeters. To obtain an aesthetic finish, the retaining wall included a rundle stone finish in an effort to maintain a 'natural' theme through the River Valley area. The two structures and their rundle stone finishings are shown in Figure 3: Retaining Wall 1 and Guy Wire Structure.

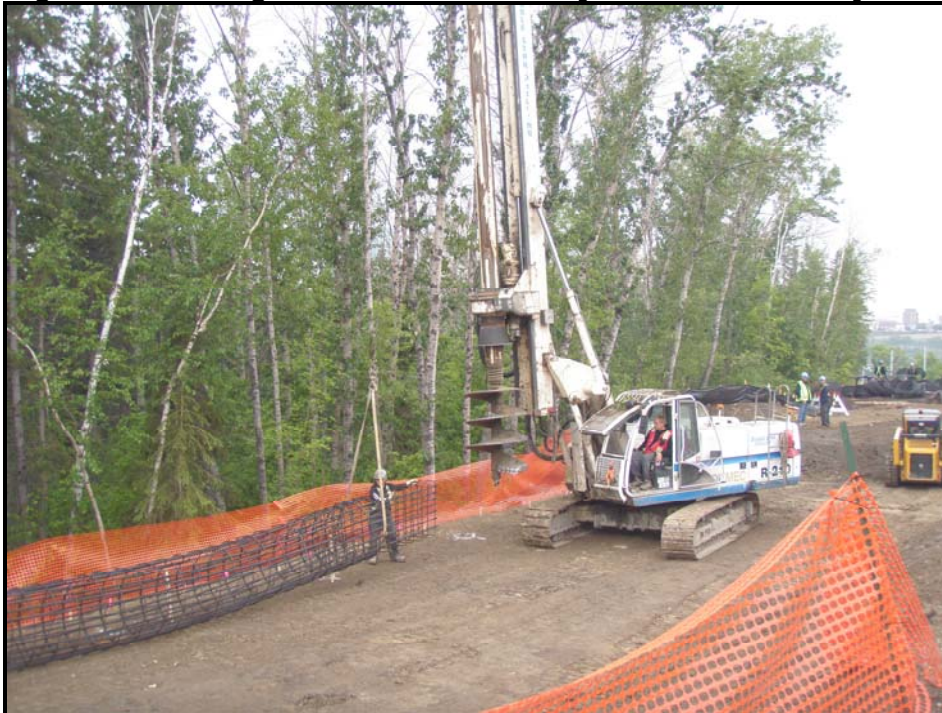
Figure 4: Retaining Wall 2 Construction Adjacent to River Valley

The new retaining wall was designed to accommodate the new roadway lane as well as to replace a shared use pathway running along the roadway which tied into the River Valley trail system, south of the Old Timers Cabin. The retaining wall design took careful consideration of the inclusion of the shared use path. The shared use path was to match the width of its adjoining three meter path in the river valley. Ideal conditions would call for a three meter boulevard width to separate the path from the edge of roadway. Any space offsets in this area would provide a greater impact to the River Valley, which would call for the requirement of removing trees. Both the path and the roadway experienced heavy traffic and a separation of the different modes was required to provide a sense of safety. As a compromise, to separate the cyclists and pedestrians using the pathway from the heavy vehicular traffic, a jersey barrier with a handrail was installed until the geometrics allowed for the pathway to be shifted away from the roadway. The jersey barrier provided a complementary benefit of shielding vehicles from the natural slope into the River Valley. In an effort to mitigate the negative effect of creating a vertical obstruction which pedestrians and cyclists would tend to shy away from, an additional sixty centimeters was added to the path width, which the City felt was an acceptable compromise between providing pathway users with an acceptable walking/cycling surface, versus mitigating the impact to the natural area. This retaining wall design resulted in a seventy eight meter long retaining wall on 1.2 meter wide piles, nine meters deep. Construction of this retaining wall is shown in Figure 4: Retaining Wall 2 Construction Adjacent to River Valley.

The face of the wall faces the River Valley and for the most part is covered behind the natural growth of the natural area and is not visible to passerbys. This allowed for little attention to be paid to the aesthetic finishing of the wall, which was left in plain concrete.
