## Circle Drive Widening

Jim Zacaruk P.Eng., Stantec Consulting Ltd.  
Mike Gutek P.Eng., City of City of Saskatoon

Paper prepared for presentation

of the 2008 Annual Conference of the  
Transportation Association of Canada  
Toronto, Ontario

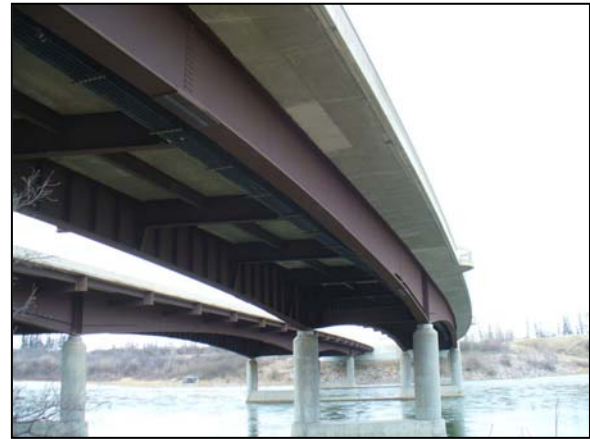
Figure 1.2 – Circle Drive Bridge

The Circle Drive Bridge is one of 5 major river crossings in the City of Saskatoon. The structure configuration consists of twin 5 span steel girder structures with a total span length of 275

metres supporting 2 lanes of traffic plus a sidewalk in each direction, Figures 1.2 and 1.3. In 1983, future capacity improvements had been expected and had been included in the original design by providing additional pier and abutment elements plus connection points between the two structures to permit in-filling of the space as shown in Figure 1.4.

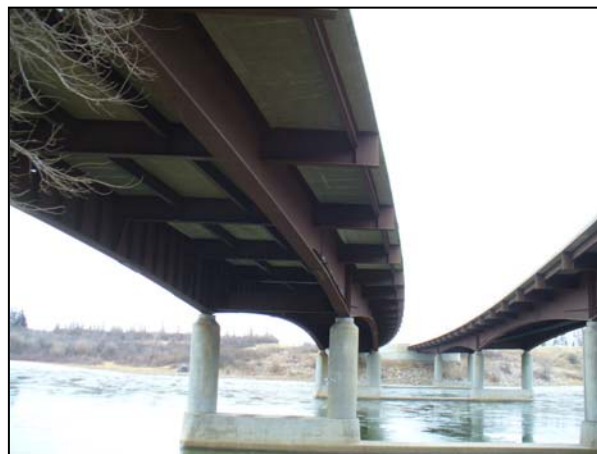
Figure 2.1 – Existing Condition

Detailed visual inspections covered all accessible portions of the structure but focused on areas adjacent to the proposed expansion, that is, the space between the two structures. Visual inspection results painted a picture of a structure showing early signs of deterioration consistent with the age and design of the structure that included:

- White stained cracks on the deck soffit in the negative bending moment regions;
- Extensive delaminations on the traffic barriers and curbs;
- Misaligned deck joints;
- Expansion joint trip seals split and torn in many locations;
- Teflon sliding surfaces debonded on the eastbound structure pier bearings at Pier 1 South Bearing and Pier 3 North Bearing; and
- Regular transverse asphalt cracks evident in the shoulders.

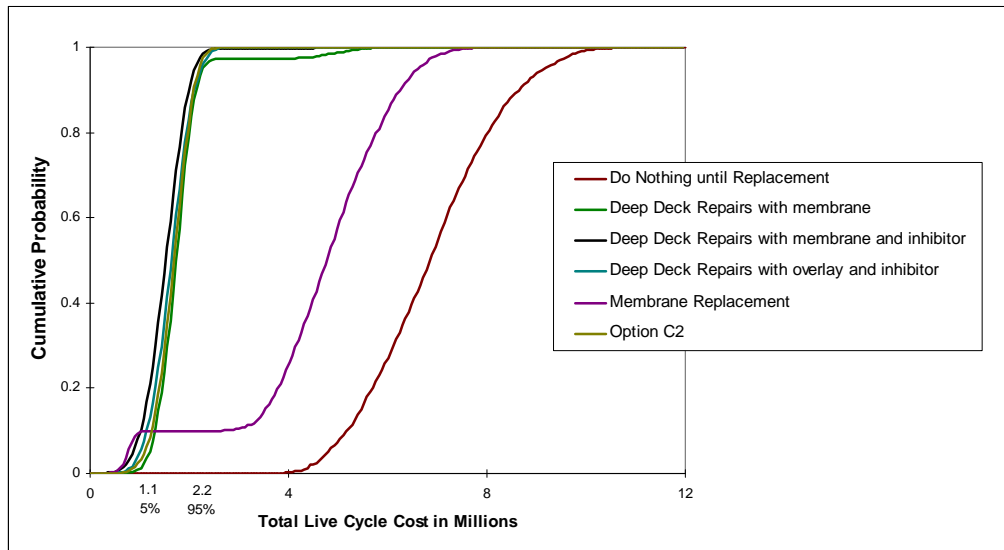
Figure 2.2 – Monte Carlo Simulation Results for Widening Rehabilitation Scenarios

Timing and cost ranges developed were then input into a life cycle costing model linked to a Monte Carlo simulation environment. This simulation process allowed multiple combinations of service life and cost to be combined in a probabilistic manner thereby allowing relative risk to be assessed between options over a wide range of scenarios. Simulations included calculations for 5,000 different combinations of cost, timing, and repair quantity with analytical results graphically presented below in the form of a cumulative probability distribution curve. Analysis conclusions suggest the widening project would not significantly change the rehabilitation strategy for the bridge which currently identified a major membrane replacement and deck rehabilitation for 2014.

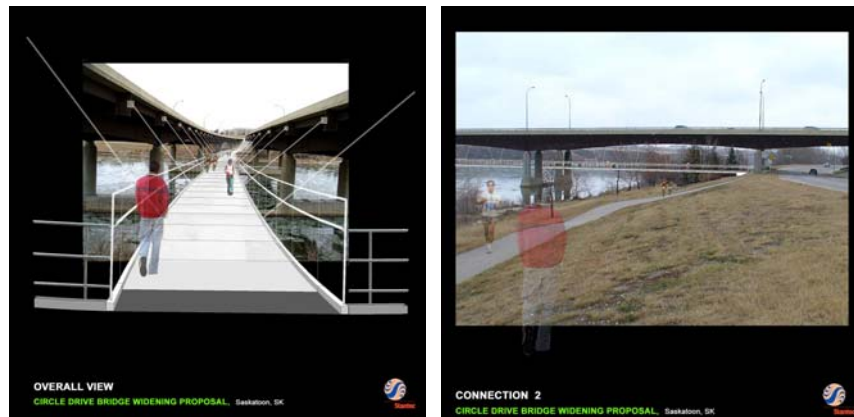
Figure 2.7 – Preliminary Pedestrian Bridge Renderings

Before any significant engineering work was completed a preliminary rendering showing the walkway at a level below the roadway was produced that outlined the proposed geometry and aesthetic requirements of the structure, Figure 2.7. This rendering was used as the basis for discussion with the City and other regulatory groups in order to generate feedback related to the look and feel of the pedestrian bridge. The development of this rendering was considered fundamental to the development of the proposed bridge as previous experience had demonstrated the value this presentation material provided when describing a complex project to non-technical groups.

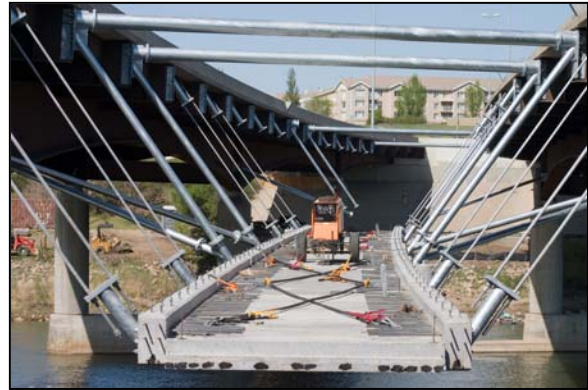
Figure 2.8 – Pedestrian Bridge Support at Pier

These challenges were overcome with the use of three rigidly supported panels at each pier location combined with adjustable hanger rods between the piers, Figures 2.8 and 2.9. Once set, the three starting points provided a solid base from which one end of each subsequent panel could be placed. The opposite end could then be suspended from adjustable hangers spaced at approximately 10 metre intervals from the adjacent structure, Figure 2.10. Since the hangers were adjustable, each panel could be positioned vertically and horizontally to permit the best position for the new panels which

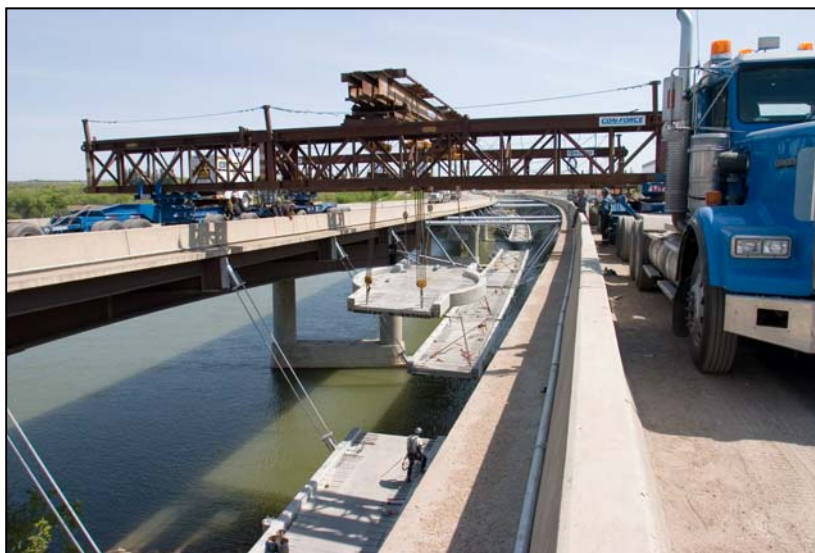
Figure 3.2 – Pedway Construction

The pedestrian bridge installation proceeded smoothly based on the design concept developed during the preliminary and detailed design phases. Erection of each sidewalk unit was attained using a moveable work bridge which spanned between each structure while suspending each new sidewalk panel, Figure 3.2. The selection of modular units during the design phase combined with the use of a work bridge allowed for minimal impact to the traveling public as lane closures were held to a minimum during off-peak hours.
