## Sikanni Bridge Fire - Triaging an Emergency Response

Paper prepared for the session ST - Transportation Structures  
2024 Transportation Association of Canada (TAC) Conference & Exhibition  
Vancouver, British Columbia

In August 2022, a transport tanker carrying a highly flammable liquid crashed into the south approach barriers at the Sikanni Chief River Bridge resulting in a full closure of the Alaska Highway (Highway 97) in northern BC. The fire generated intense heat that resulted in extensive structural damage and brought forward severe concerns for weakening of the bridge load carrying members. As a critical link to Northern Canada and then to Alaska, USA, there was extreme pressure to get this highway safely re-opened as quickly as possible. An emergency response was initiated immediately with a rapid damage assessment that enabled light vehicle traffic to be restored shortly after the incident. The emergency response and structural assessment continued until full unrestricted truck traffic was restored on the bridge. While the primary focus was forensic review and structural evaluation of the residual load carrying capacity, several concurrent bridge engineering teams w

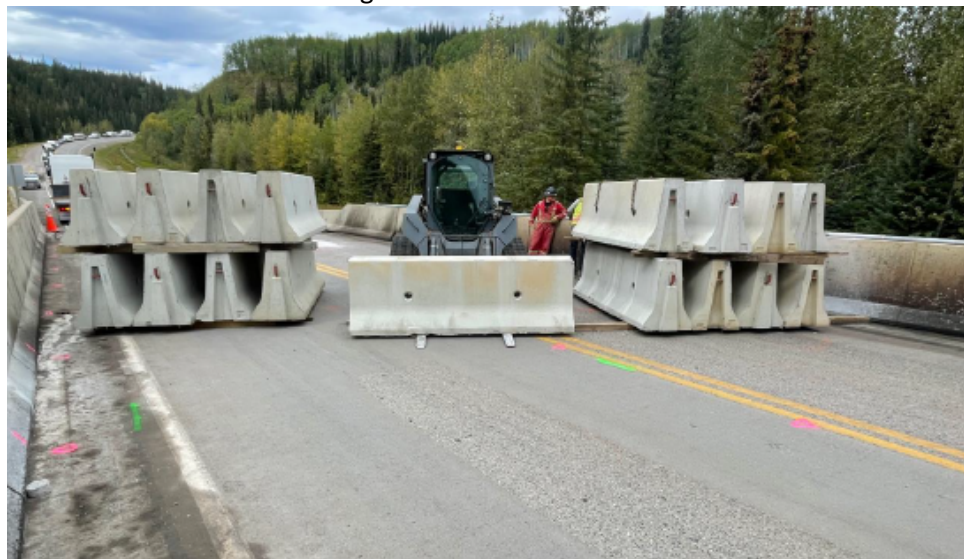
Figure 10. Static load test

For the static load test, 17 precast concrete barricades were precisely placed at midspan of each span along with a skid steer. The objective behind the static load test was to provide insight into how the in-situ deflection of the structure compared with the theoretical deflection from the finite element model.

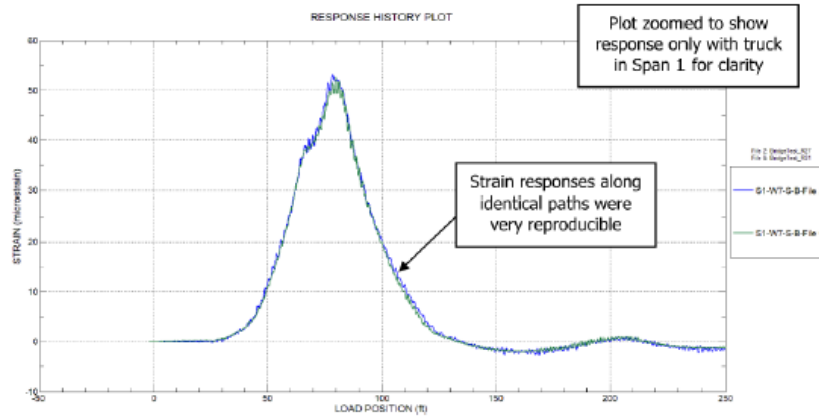
Figure 2. Example of data quality

All field data was examined graphically to provide a qualitative assessment of the structure's live load response and data quality. In general, the response data was found to be of good quality and typical magnitudes/shapes for prestressed girder bridges.
