The Old Skeena River Bridge Rehabilitation and Recoating of a 100-Year-Old Steel Truss

Paper prepared for the session Transportation Structures
2024 Transportation Association of Canada (TAC) Conference and Exhibition
Vancouver, British Columbia

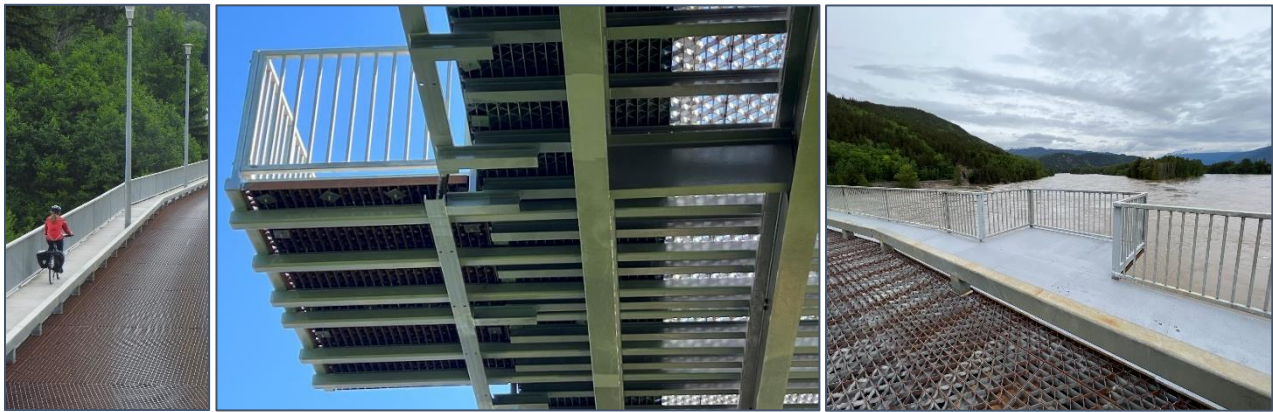
Figure 12: Sidewalk Refuge Bays with Existing Narrow Sidewalk (left), Support Beams (centre) and Finished Bay (right)

As a late addition to the design, 5' x 10' (1.5 m x 3.0 m) refuge bays were included at six locations along the sidewalk to facilitate passing along the existing narrow 4' (1.2 m) wide sidewalk. These bays were supported by cantilevered beams which were inserted between the first two deck stringers and the existing decking (see Figure 12).

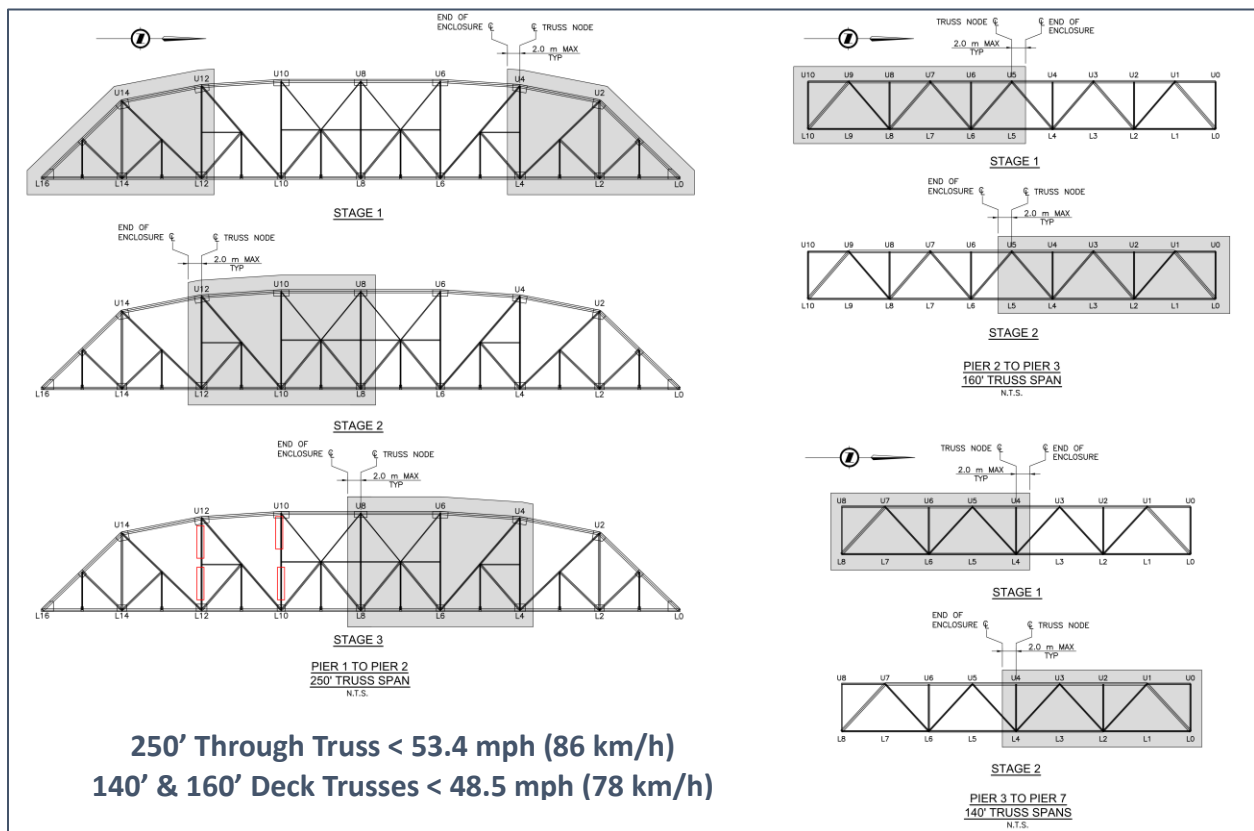
Figure 15: Coating Staging for the Various Truss Spans and Allowable Wind Speeds During Construction

The analysis determined that the structure was only able to accommodate partial enclosures and put limits on the maximum wind velocities that could be permitted during the enclosure. The 140' and 160' deck truss spans could only be half-enclosed, and the 250' through truss span could only be roughly one-third enclosed (see Figure 15) and required temporary bracing to help distribute the lateral loads (see Figure 16). The analysis assumed that the member repairs to the truss horizontal bracing were performed prior to the full enclosure taking place. Work could be (and was) performed concurrently on adjacent spans which allowed the contractor to accelerate their schedule (see Figure 17).

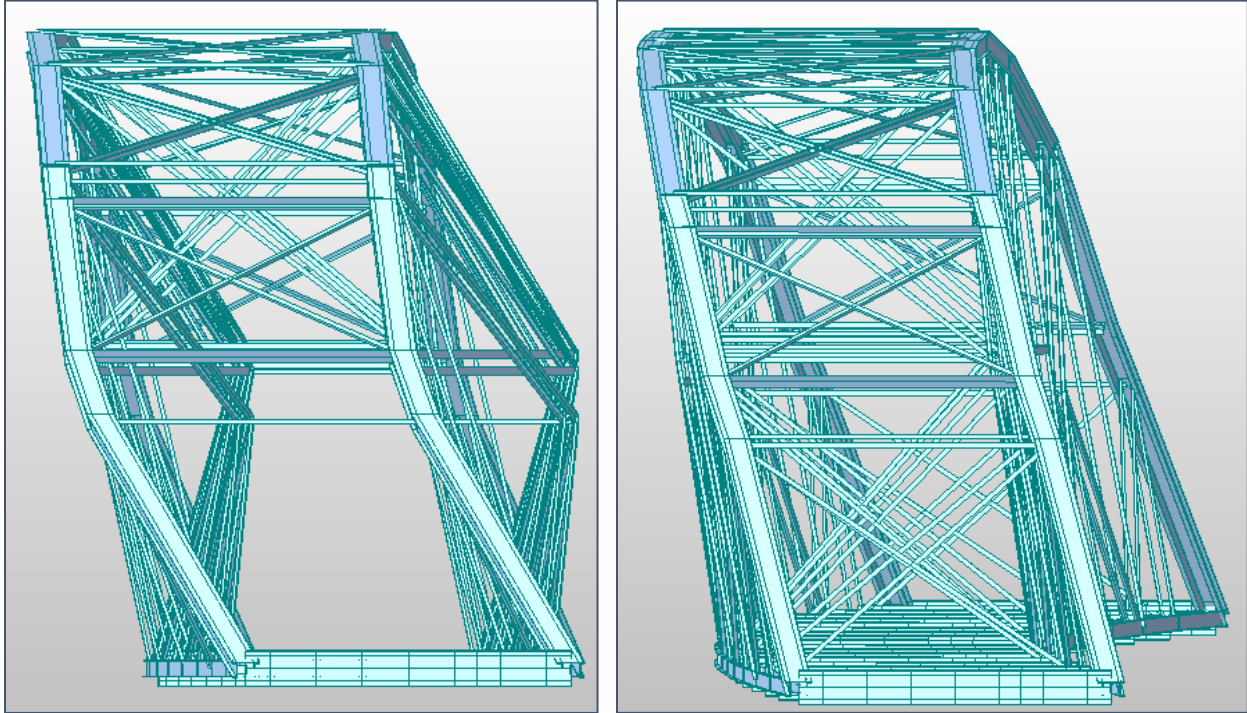
Figure 16: 250' Through Truss without Temporary Bracing (left) and with Temporary Bracing (right).
(Truss Deflections are Exaggerated to Illustrate Deflected Shape)

Due to the presence of lead paint and the ambient requirements for coating work, the bridge was required to be fully enclosed for containment of debris, temperature controls and humidity controls. The original trusses were not designed to carry the wind loading resulting from being fully enclosed. A 3D model of the structure was prepared and analysed for wind loads to determine the extent of enclosure permitted on each truss span.

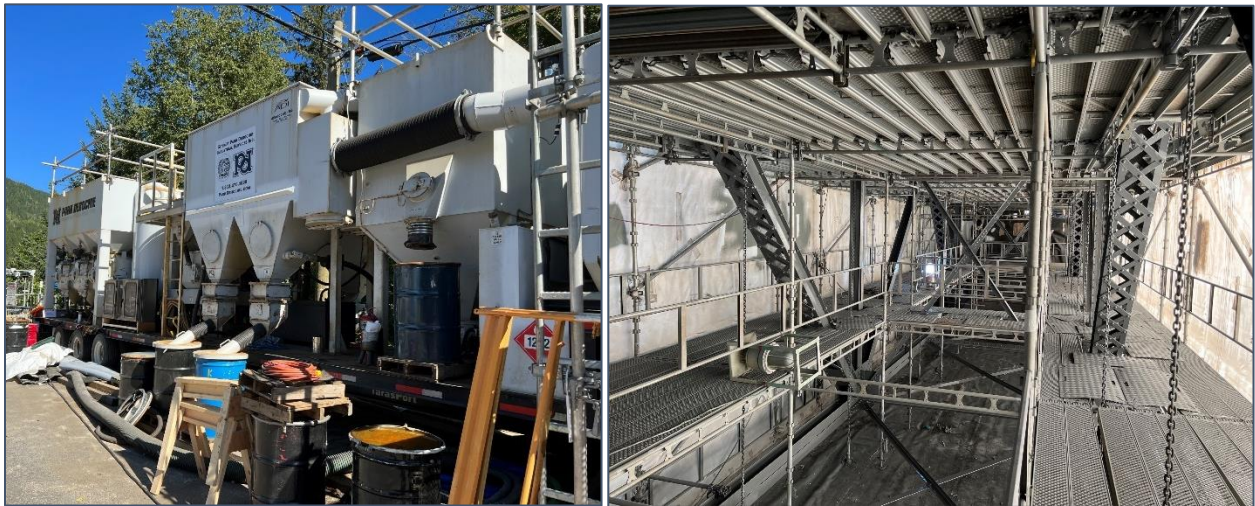
Figure 18: Steel Shot Blast Recycling Equipment (left) and Inside a Coatings Enclosure Following Top Coat Application (right)

- 2) The steel was blast cleaned to the stricter of SSPC-SP10⁴ or the manufacturer's requirements. Enclosures were utilized to contain the steel shot system and harmful wastes during the blasting process (see Figure 18).
- 3) The coating is applied consisting of penetrating sealer, primer, stripecoat, intermediate (mid) coat and topcoat with quality assurance inspections occurring at each stage (see Figure 14).
- 4) Caulking was applied to seal the larger gaps following application of the topcoat in order to avoid schedule delays while waiting for the caulking to cure and also since the caulking was a close match to the final colour of the structure.
- 5) The enclosure was cleaned of any remaining debris and removed.

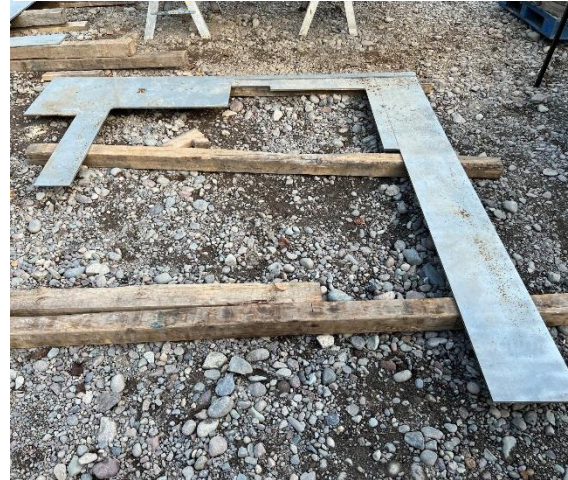
Figure 24: Steel Sheeting Cut On Site for Additional Member Repairs

Including to the Blast-Cleaning Reveals, the total quantity of steel repairs increased by over two times the originally estimated quantity. At the onset of construction, the contractor proposed to stockpile additional repair material in order to minimize potential supply delays during construction while waiting to perform the repairs. The design team worked with the contractor to develop repair details which utilized readily available plate thicknesses and common angles such that the plates could be cut and drilled on site to fit the specific repair location (see Figure 24).

Initially, the stockpiled material was galvanized in accordance with the project specifications, but after the initial stockpile had been exhausted, plain steel (primed) was permitted to be used because the repairs were going to be recoated with the entire bridge anyway, and it was preferable that the coating work was not delayed.
