Revitalizing Heritage Infrastructure: Preserving the Touchette Bridge's 70-Year Legacy

Paper prepared for the session Transportation Structures
2024 Transportation Association of Canada (TAC) Conference & Exhibition
Vancouver, British Columbia

Egis (formerly McIntosh Perry) was tasked with extending the service life of the 74-year-old Touchette Bridge over the South Nation River near Casselman, Ontario. The bridge was a 73 m long single-span Parker through truss bridge with a timber deck on steel stringers supported by steel floor beams.

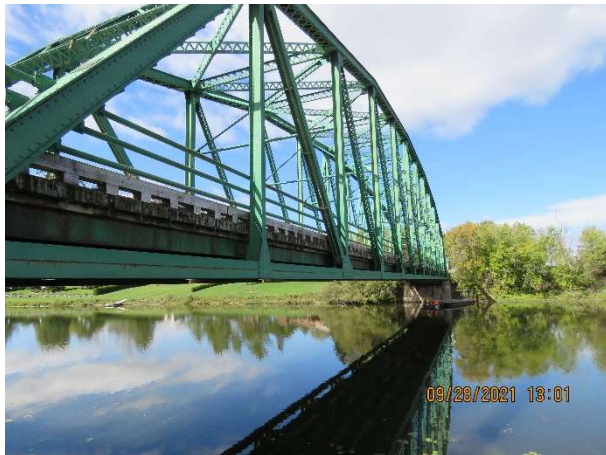
Figure 2. North Elevation View of Bridge

The superstructure was supported by concrete abutments founded on wooden piles driven to an unknown depth complete with expansion joints at each end. Cantilevered concrete wingwalls were provided at all quadrants. Photos of the bridge are included in Figure 2 and Figure 3.

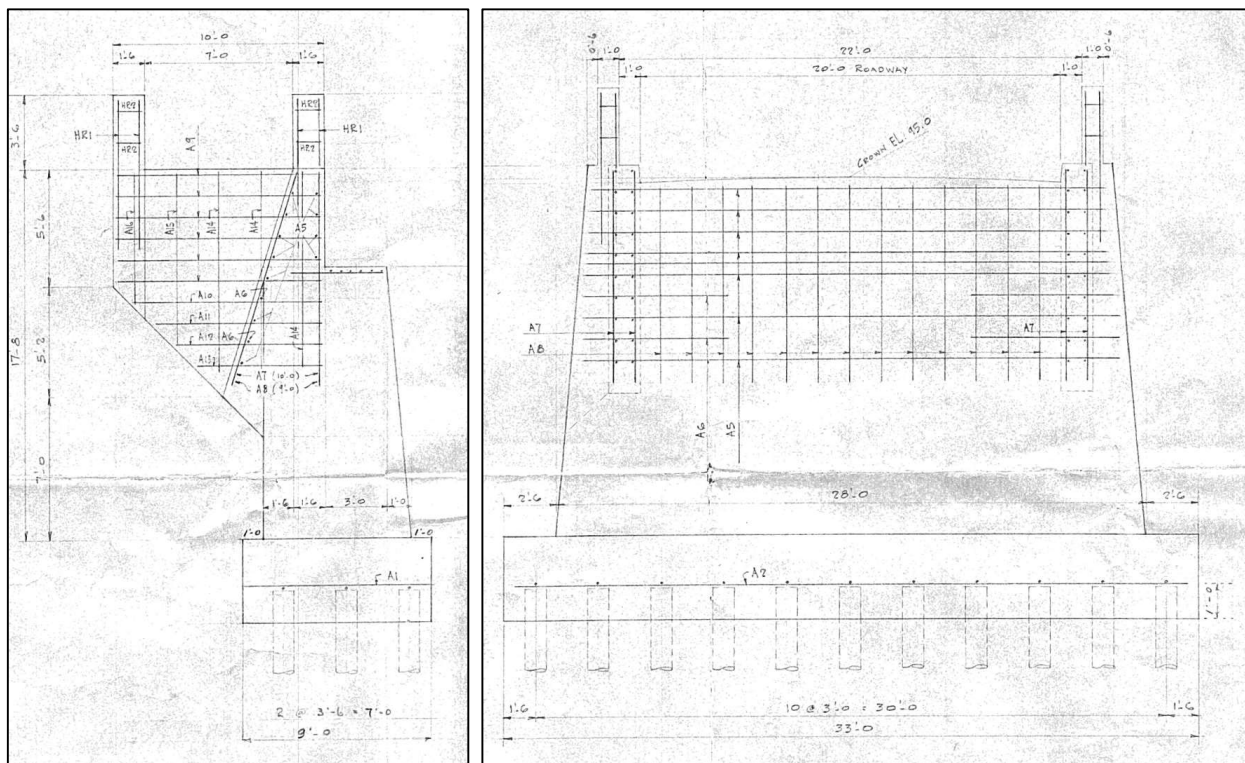
Figure 9. Abutment Configuration

Figures of the existing abutment drawings from the 1950's are provided in Figure 9. The drawings identified 3 rows of piles spaced at 1.07 m and 0.914 m in the transverse and longitudinal direction respectively. The size or type of pile was not identified on the drawings but based on the year of construction and scale, it has been assumed that it is 12" diameter timber piles driven to an unknown depth.

Based on these preliminary results, it was expected that the insufficient lateral capacity in the wall and piles is likely a primary factor for the south abutment movement. The team recommended to the Municipality that a dead man anchor system be installed to provide additional support.

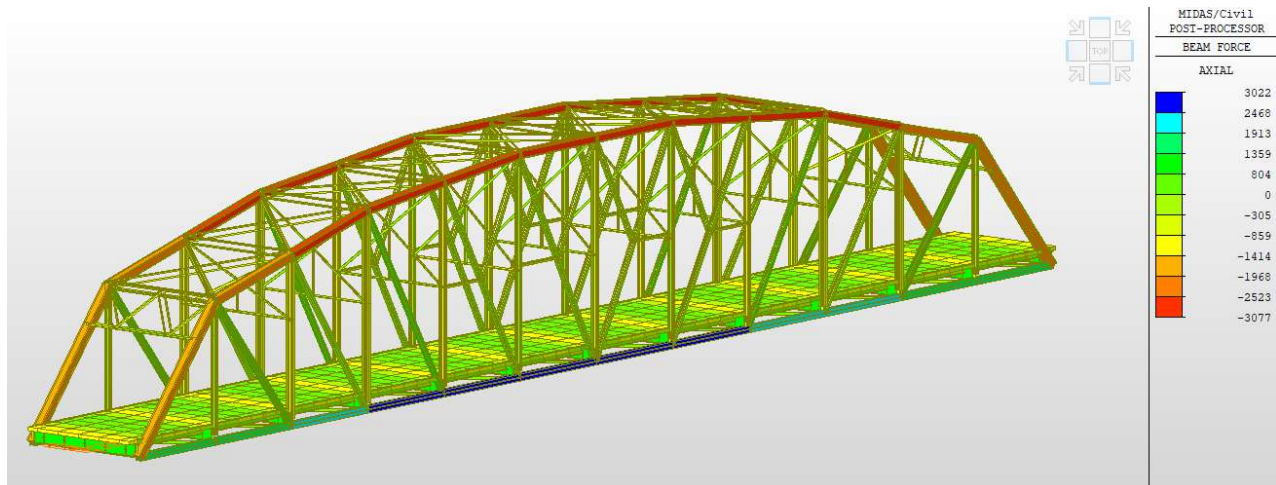
Figure 11. MIDAS Model of Truss with Axial Forces at ULS

An analysis of the existing loads on the truss was completed by developing a three dimensions model using Midas Civil (2021). The model, as shown in Figure 11, consists of frame elements that represent the truss and deck system.

The analysis indicated that the bridge could accommodate full CHBDC loading if it were reduced to a single lane and outfitted with a concrete riding surface.
