The Pattullo Bridge Emergency Repair

David Woolford, P.Eng., TransLink
Darryl Matson, P.Eng., Buckland & Taylor Ltd.

Paper prepared for presentation

of the 2009 Annual Conference of the
Transportation Association of Canada
Vancouver, British Columbia

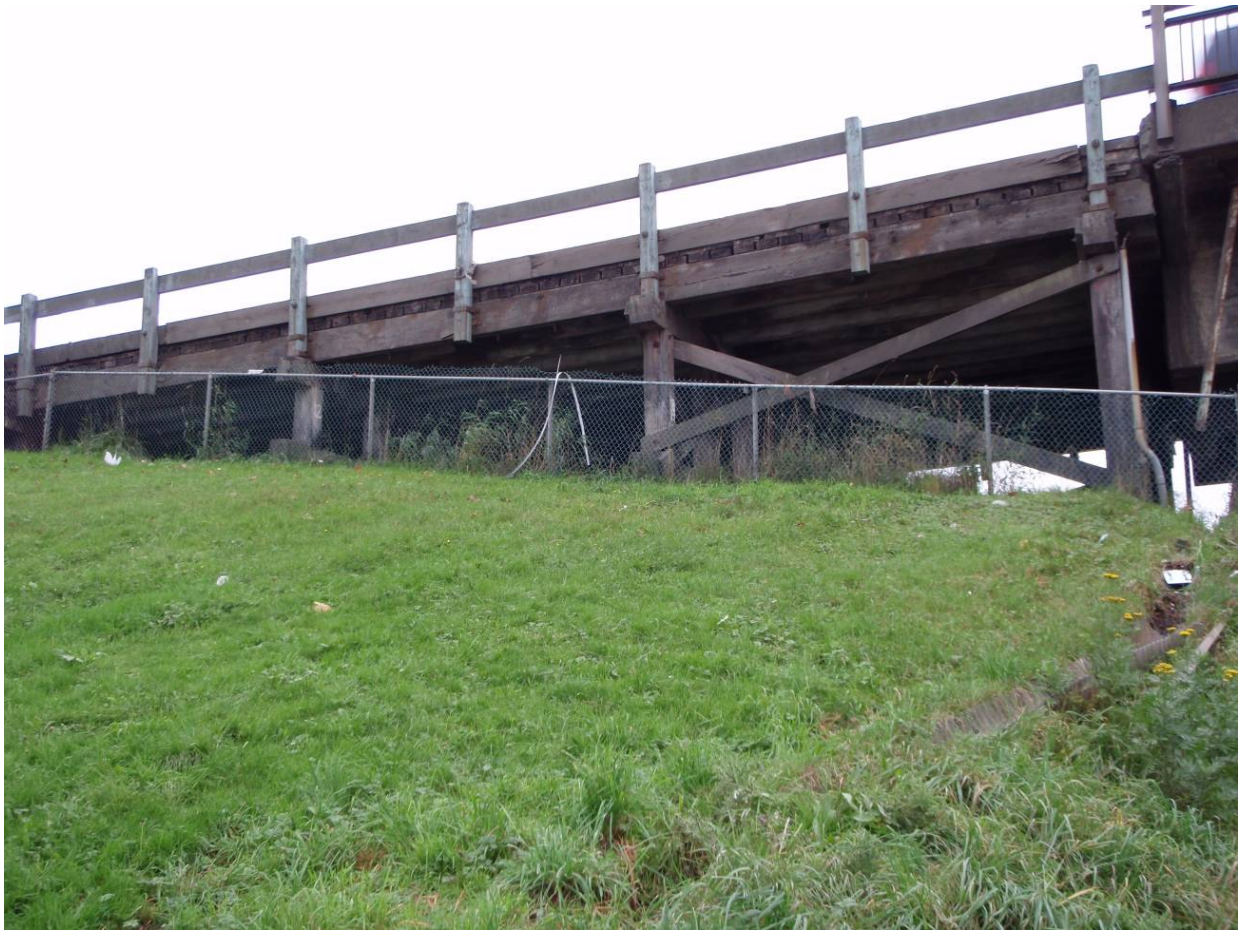
Figure 1. Undamaged Pattullo Bridge Timber Spans

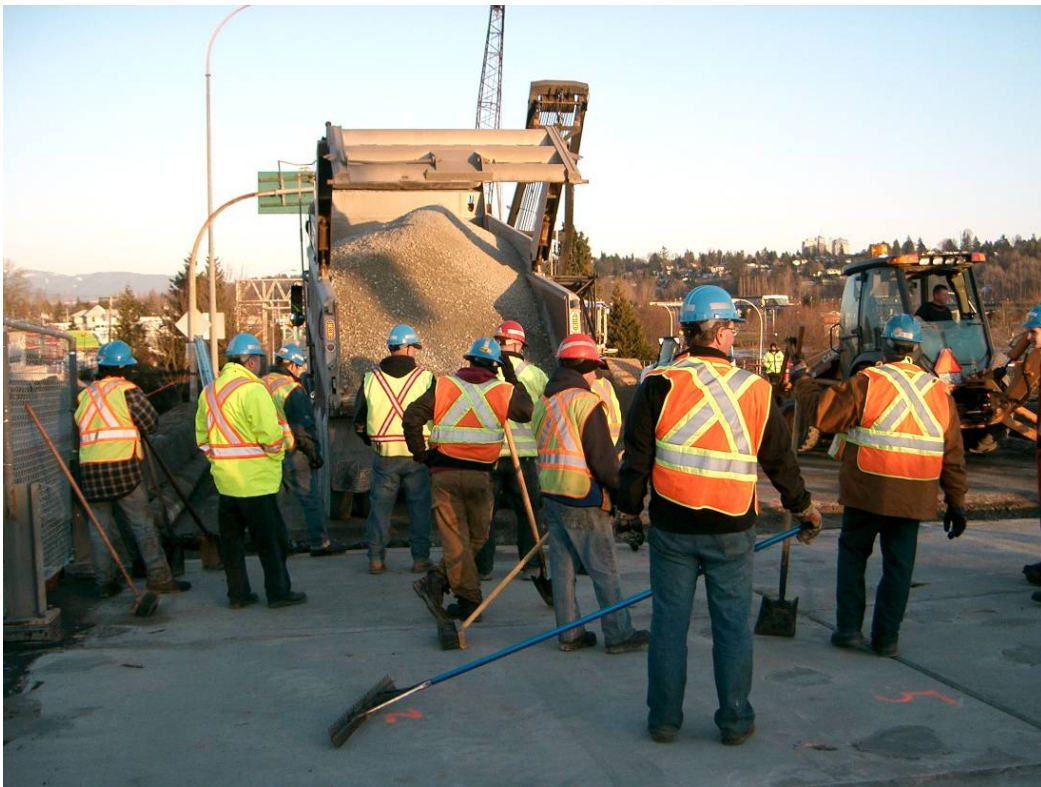
Figure 14. Backfilling and preparation for paving

By Sunday morning all of the major structure components were in place and the abutment backwall was installed. Backfilling commenced during the afternoon, along with the installation of railing posts (Figures 12 & 13). Once the backfilling was completed asphalt paving on the span commenced.

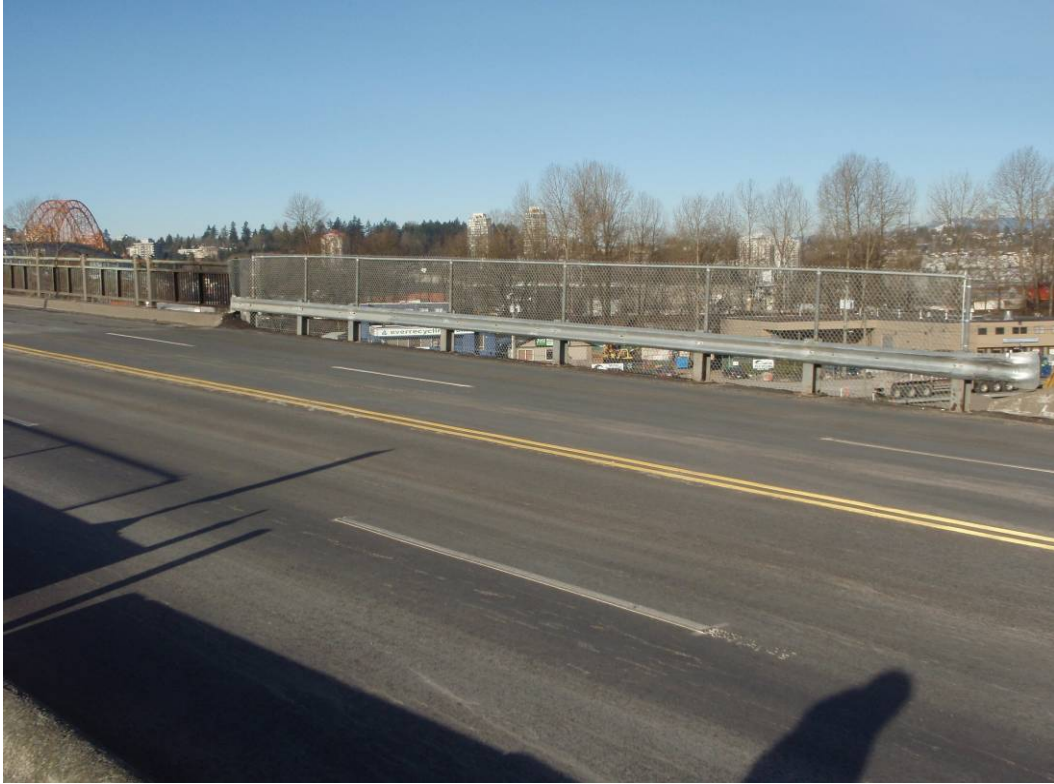
Figure 15. Completed Bridge Surface

After only 8 days, the bridge was open to all four lanes of traffic (Figures 14 & 15) at approximately 4:15am on Monday January 26, 2009, several weeks ahead of initial estimates.

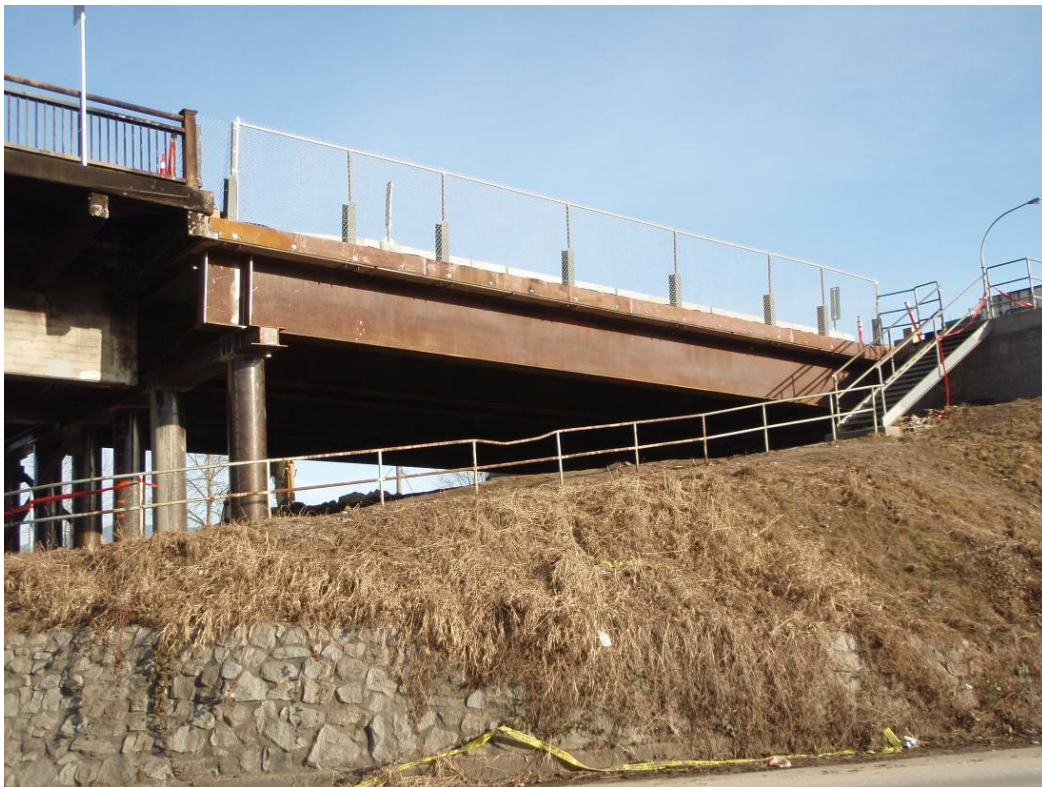
Figure 16. Completed Bridge
