Approach Channel Bridge Rehabilitation

Paper prepared for the session ST – Transportation Structures
2024 Transportation Association of Canada (TAC) Conference & Exhibition
Vancouver, British Columbia

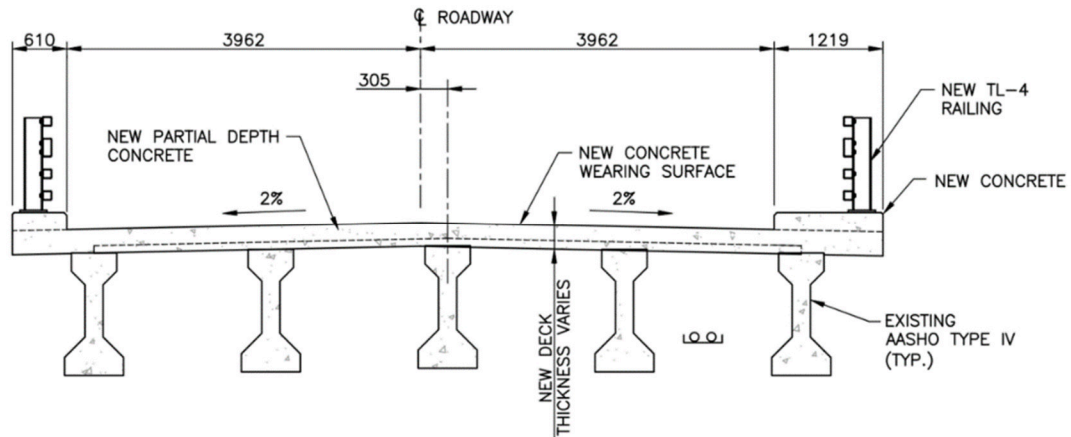
Figure 7. Proposed new deck cross section.

The post-rehabilitation roadway geometry of the bridge remains unchanged. However, the asphalt is replaced with an exposed concrete wearing surface to gain structural depth for the overhang and barrier anchorage (See Figure 7).

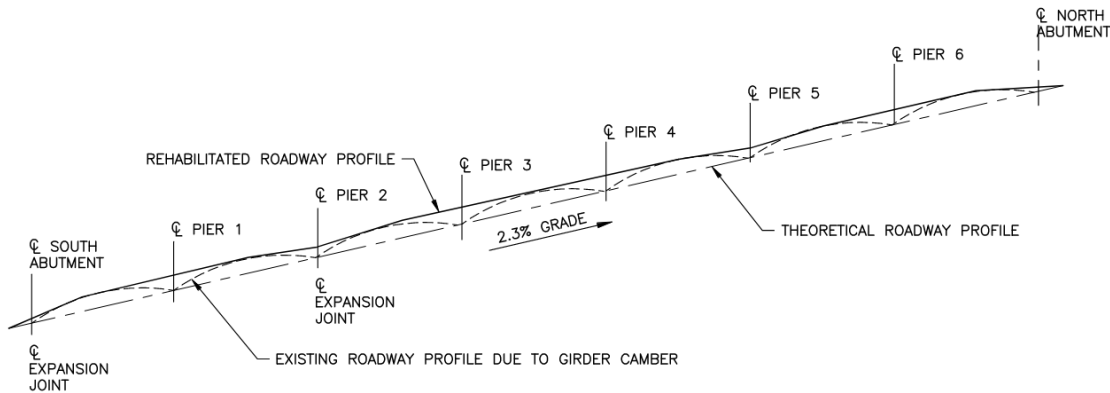
Figure 8. New (diagrammatic) longitudinal roadway profile

The existing deck also has a noticeable camber in each span which is suspected to be due in part to not having any haunches over the girders during original construction. The deck was inset 6 mm into the 178 mm thick deck at the centerline of bearings to compensate for erection camber. Any camber growth beyond that expected would have resulted in a significant reduction in deck thickness over the girders at mid-span. It is likely that the deck was placed to match the girder camber, which has resulted in a bridge with seven “humps.” By varying the deck thickness longitudinally and introducing continuity over the piers, the new deck profile will be much smoother (see Figure 8).

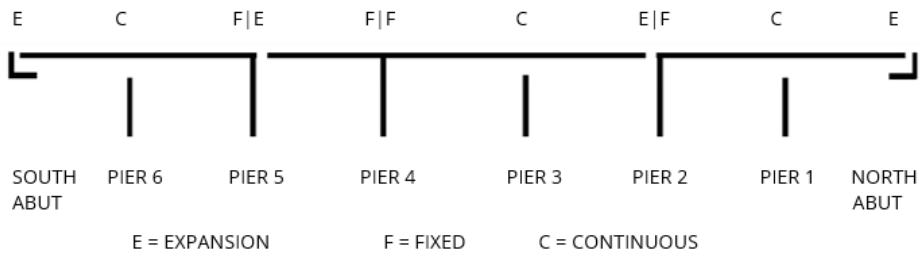
Figure 9. New Bridge Articulation

Recognizing that a thicker deck would increase the mid-span dead load moment in each girder, rearticulating the bridge to make it semi-continuous for live load was used to both redistribute mid-span moments and eliminate deck expansion joints. After investigating several options for providing longitudinal fixity and expansion at different supports, a two-span, three span, two span arrangement was found to provide the best geometric compatibility with the existing structure without requiring significant bearing and abutment reconfiguration to accommodate large restraint forces or large movement joints (see Figure 9).
