Red Lillooet River Bridge Deck Renewal

Paper prepared for the session **INFRASTRUCTURE & ASSET MANAGEMENT – Transportation Structures**
2024 Transportation Association of Canada (TAC) Conference & Exhibition
Vancouver, British Columbia

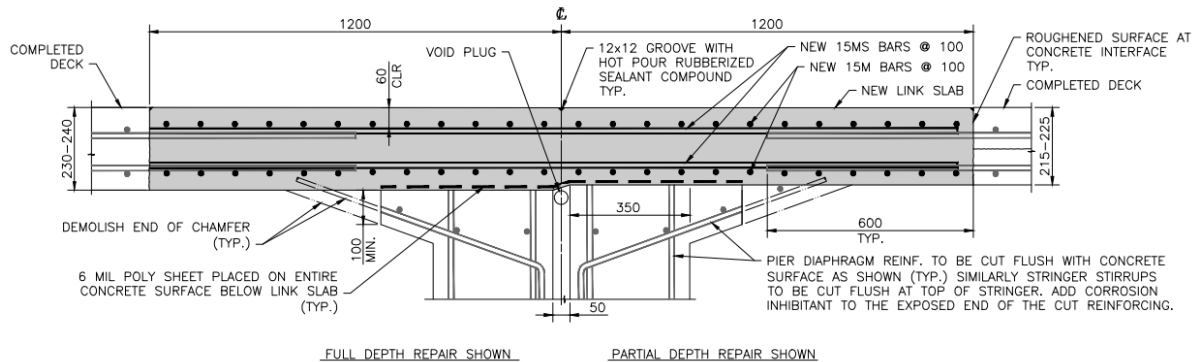
Figure 13 – Reinforcement design for link slab

The seals of the existing deck joints over the piers were degraded and the leakage from the joints contributed to the concrete deterioration and reinforcement corrosion in the girder ends and pier caps. To reduce the need for future maintenance, the deck joints were replaced by reinforced link slab with a poly sheet for debonding. The link slab was designed for the girder end rotation induced by the service live load on the bridge spans, in accordance with the Caner and Zia's method¹. In general, link slab will greatly improve rideability and user comfort compare to deck joints. *Figure 13* *Figure 11* shows the design details of the link slab.
