**CRASH PERFORMANCE OF ENERGY-ABSORBING
GUIDE RAIL TERMINALS**

Ryan W. Esligar, MScE, UNB Transportation Group
Eric D. Hildebrand, PhD, PEng, UNB Transportation Group

of the 2012 Conference of the
Transportation Association of Canada
Fredericton, New Brunswick

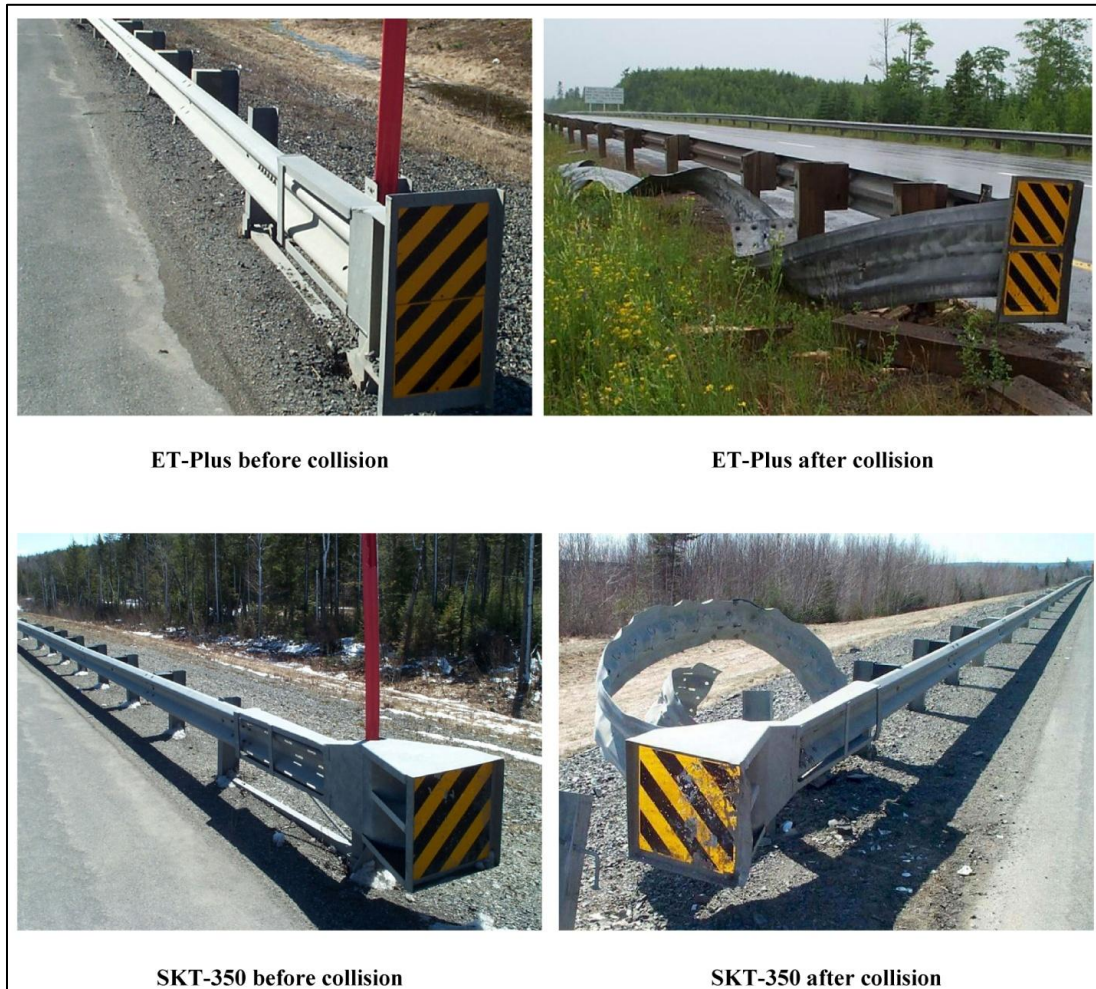
FIGURE 1: ET-Plus and SKT-350 before and after impact

There are currently two types of EAGRTs used in New Brunswick: the ET-Plus and the SKT-350. There are two obvious differences between the two systems. The ET-Plus has a tall and narrow terminal head, while the SKT-350 has a square terminal head. Secondly, guide rail extruded through the ET-Plus is completely flattened, while guide rail extruded through the SKT-350 has a kinked appearance, as shown in Figure 1.
