KICHI SIPI BRIDGE TO CROSS LAKE INNOVATIONS IN DEEP FOUNDATION DESIGN AND CONSTRUCTION

Paper prepared for presentation
at the Innovations in Bridge Engineering Session
of the 2005 Annual Conference of the
Transportation Association of Canada
Calgary, Alberta

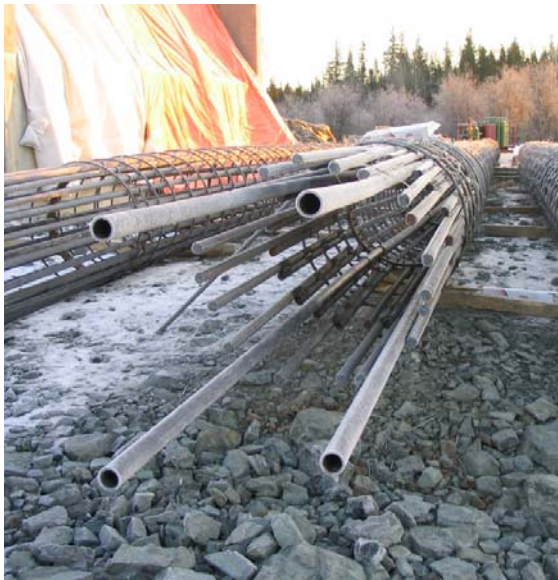
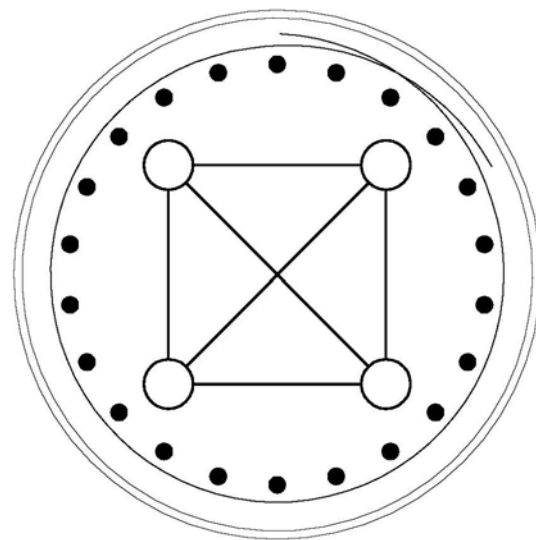
CSL testing is based on the theory that sound waves travel at different speeds through different media. Four steel tubes were cast into each caisson, as illustrated in the following photo and figure (Photo 9 and Figure 4). Variations in the apparent wave speeds between tube pairings identify potential anomalies in the caisson, or lower density concrete, which may be due to poor quality or excessively voided concrete.

Photo 9 & Figure 4: Typical view of the caisson reinforcing cage illustrating the steel tubes for Crosshole Sonic Log (CSL) testing. Note the conduit layout facilitated two diagonal and four perimeter scans between the four tubes.
