Forensic Pavement Study: Practical Methods, Analysis and Applications

Paper prepared for presentation

of the 2010 Annual Conference of the
Transportation Association of Canada
Halifax, Nova Scotia

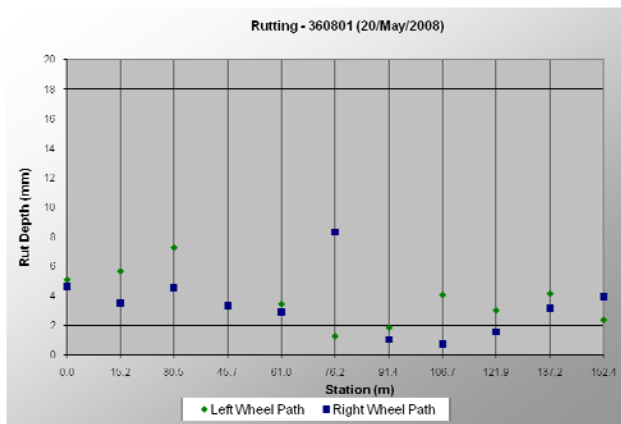
Figure 18: Rut Depth – Forensic testing (360801)

The historical trends in rut depth from the Dipstick® transverse profiles are provided in Figure 17. At 360801, these results indicate a very slight progression in rut depth over time with the left rut in most cases being slightly deeper than the right. Figure 18 shows the rut depth data collected during the May 20 forensic study over the full 152.4m section. The average rut depth for the survey on May 20, 2008 was 3.4mm in the right wheelpath and 3.8mm in the left wheelpath. Typically the rut formations in the right wheelpath are deeper than the left as there is less lateral support, but the differences are so small in this instance that they could be considered the same. The rut depth increased since the first survey in 1995 but not to any great extent. The results of the transverse profile survey would indicate that rutting is not an issue. At 360802, rutting appeared fairly early on this section and increased steadily up until the final survey. Figure 19 shows the rut depth data collected in May 20 over the full 152.4m section. The average rut depth for the final survey was 9.4mm in the right wheelpath and 3.9mm in the left wheelpath. The results of the transverse profile survey would indicate that rutting is higher than what would be expected based on the traffic volume and lack of commercial content.
