# **Cable Impregnation for Post-Tension Grouting Problems**

David Whitmore, P.Eng, FACI, FCSCE  
Vector Corrosion Technologies Ltd.  
Winnipeg, MB Canada

## **ABSTRACT**

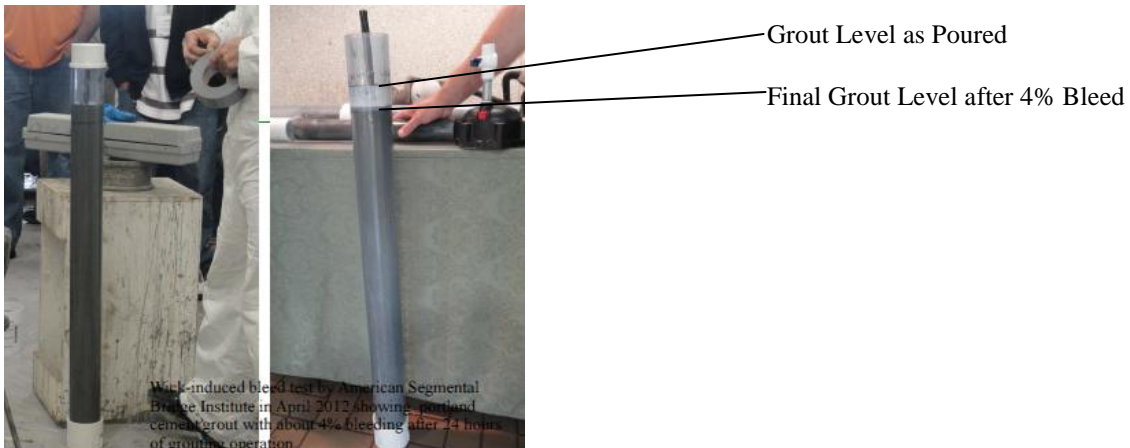
Prior to the early 2000's, conventional Portland cement grout was typically used for filling Post-Tension ducts. It is common to find voids in grouted tendons in bridges where conventional Portland cement grout was used. Typical Portland cement grout will experience 3 to 5% bleed (by volume) and the bleed water will rise to the high points of the grouted section. After the bleed water evaporates or is absorbed into the structure, voids will remain in the grouted section. For a 50m long tendon, 4% bleed will result in 2m of voids. Bleed water accumulation also results in very porous, poor quality cement grout with very high water/cement ratio material at the interface between the grout and the bleed water. Water soluble corrosive ions such as chloride and sulfate, dissolve in the bleed water resulting in higher chloride and sulfate concentrations in these localized areas. As a result, these areas will generally be the first sites of corrosion.

Figure 6. Comparison of non-bleed prepackaged grout (left) vs conventional Portland cement grout (right) with about 4% bleed.

Voids due to grout bleed have been greatly reduced as a result of the development and introduction of prepackaged thixotropic grouts. These grouts are less sensitive to bleed compared to conventional Portland cement grout but they can segregate and in some cases bleed. Prepackaged grouts can also produce pockets of soft grout (grout that does not harden and remains soft). The presence of segregated and soft grout has been reported in localized areas, such as anchor zones, tendon high points and between strands. Florida Department of Transportation defined soft grout as grout which can be penetrated by more than 1/16" by an awl with 10 to 15 pounds of force (Florida Department of Transportation 2013). Soft grout is often located adjacent to voids or in areas where there is a high probability of voids. It is often corrosive with high concentrations of sulfate, chloride and moisture (Figure 4). Significant corrosion has been found on post-tension strands which are in contact with soft grout (Figure 7).

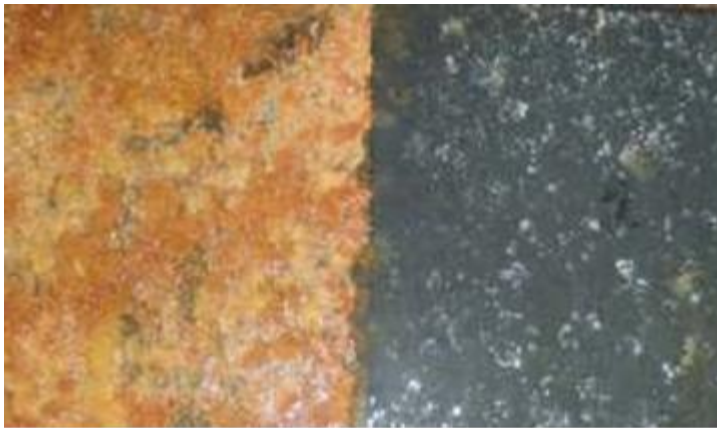
Untreated Control

Section treated with Impregnation  
Material

Figure 10. Steel plate after 30 day exposure to salt spray.

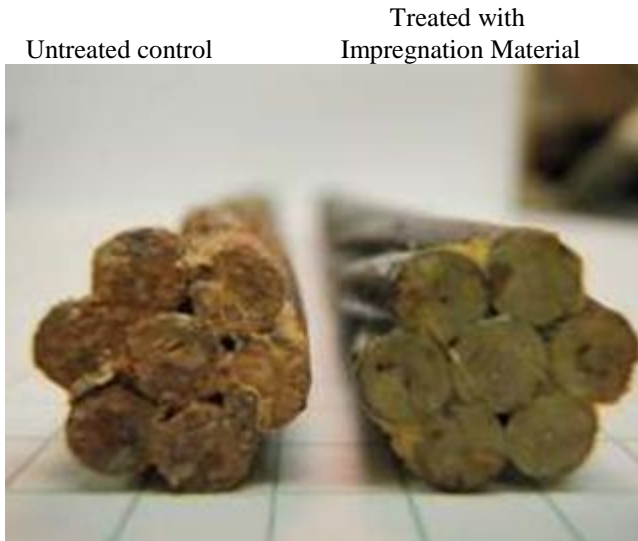
After successful completion the tests on steel plate samples, a similar test was completed using treated and untreated sections of post-tension strand samples. The figure below shows treated and untreated sections of post-tension strand after salt spray exposure. This test showed the treated strand to be much more resistant to corrosion.

Figure 11. Post-tension strand after exposure to salt spray test.

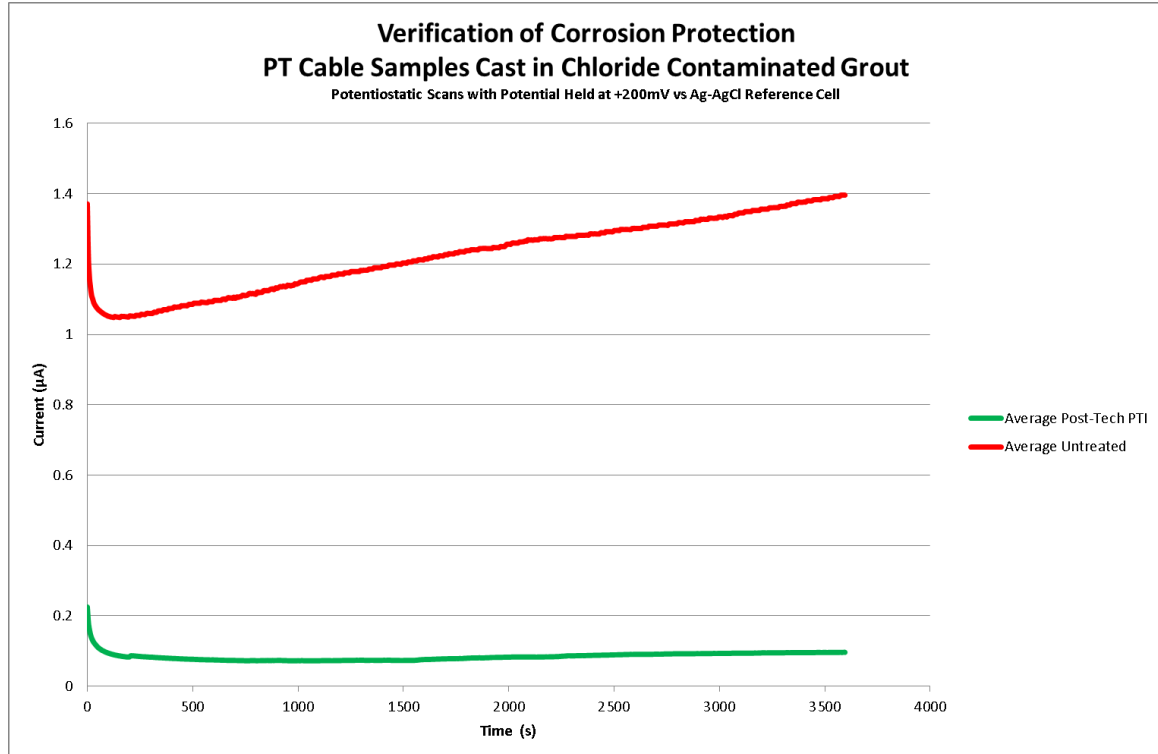
In addition to the above tests, samples with sections of strand embedded in pre-packaged post-tension grout were also prepared. These samples were exposed to potentiostatic testing to force the tendon sample to corrode by applying a voltage between the tendon sample and a counter-electrode. Impregnated and untreated samples were tested and the results were compared to each other. Figure 12 shows impregnated and untreated samples prior to potentiostatic testing. Figure 13 shows a sample undergoing potentiostatic testing and Figure 14 compares the performance of impregnated and untreated strand embedded in grout. Impregnation was extremely beneficial and reduced the current induced by the potentiostatic testing by over 90%.

Figure 14. Results of potentiostatic testing of impregnated and untreated post-tension strand samples.

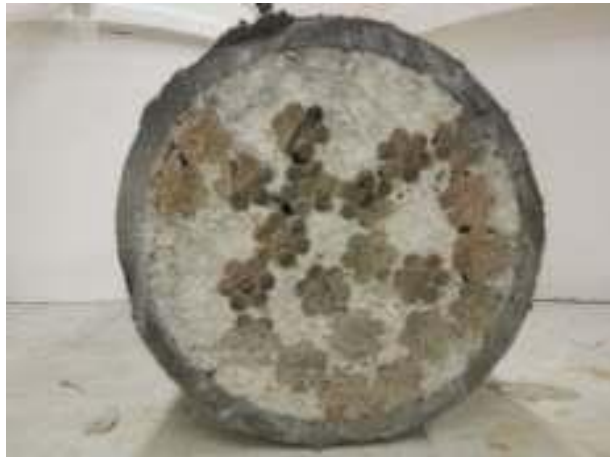
In addition to testing the ability of the impregnation material to mitigate corrosion, the ability of the impregnation process to impregnate bridge tendons was completed on bridge tendon specimens provided by FDOT. The tendon specimens provided to Vector were sections of external tendons which had been removed from a bridge in Florida. Each specimen was 4.5" diameter and contained nineteen, 0.5" diameter strands. The specimens were between 3 and 4 feet in length.

Figure 15. End view of one FDOT tendon specimen as received.

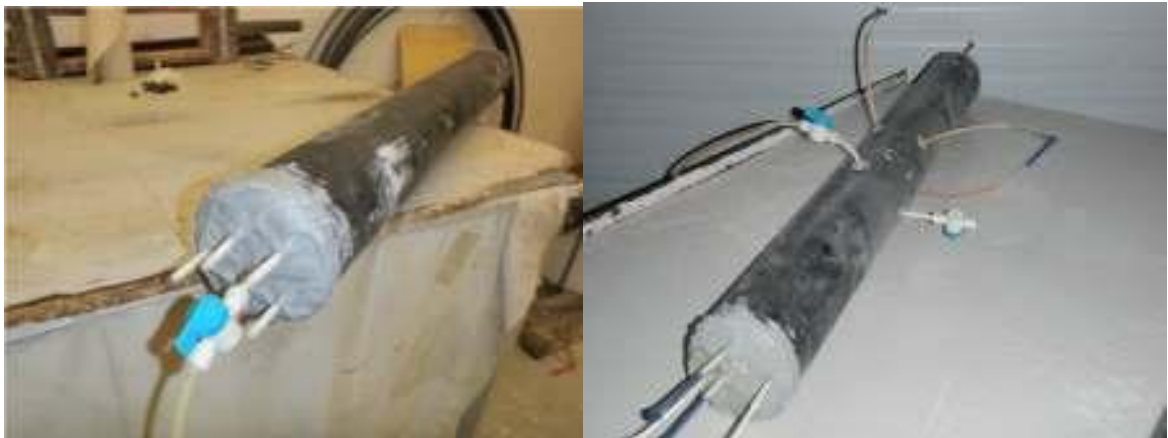
Figure 16.  
(Left) Impregnation being completed from the end of a prepared specimen.  
(Right) Impregnation being completed from the midpoint of a specimen.

The specimens were prepared and impregnated in the lab. Impregnation was completed from the end of one tendon specimen. The other specimen was impregnated from the midpoint.

Testing confirmed the ability of the impregnation material to travel along the length of the specimen, to soak into the grout surrounding the strands and to pass from strand to strand across the cross section of the tendon.

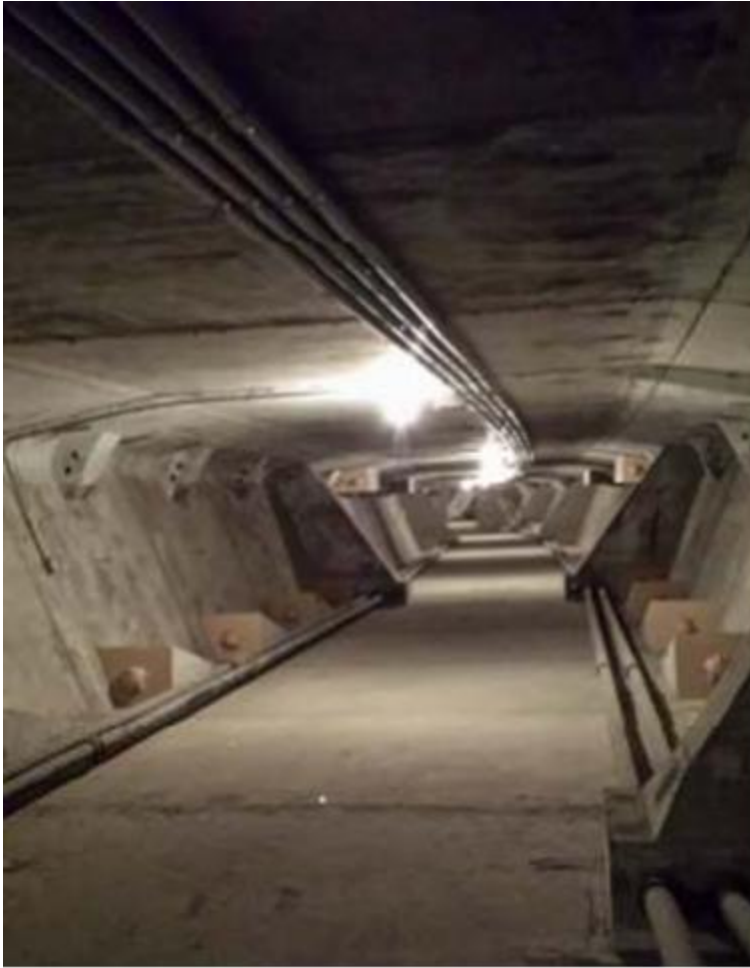
The post-tension impregnation field verification completed for Florida Department of Transportation was completed on post-tensioned tendons of a FDOT bridge in Jacksonville, FL. This bridge was chosen because “soft grout” had been found during inspection of some of the tendons. Tendons with and without soft grout were chosen to determine if the presence of soft grout would create any difficulties.

Figure 18. Interior view of FDOT bridge showing post-tensioned cables and anchorages

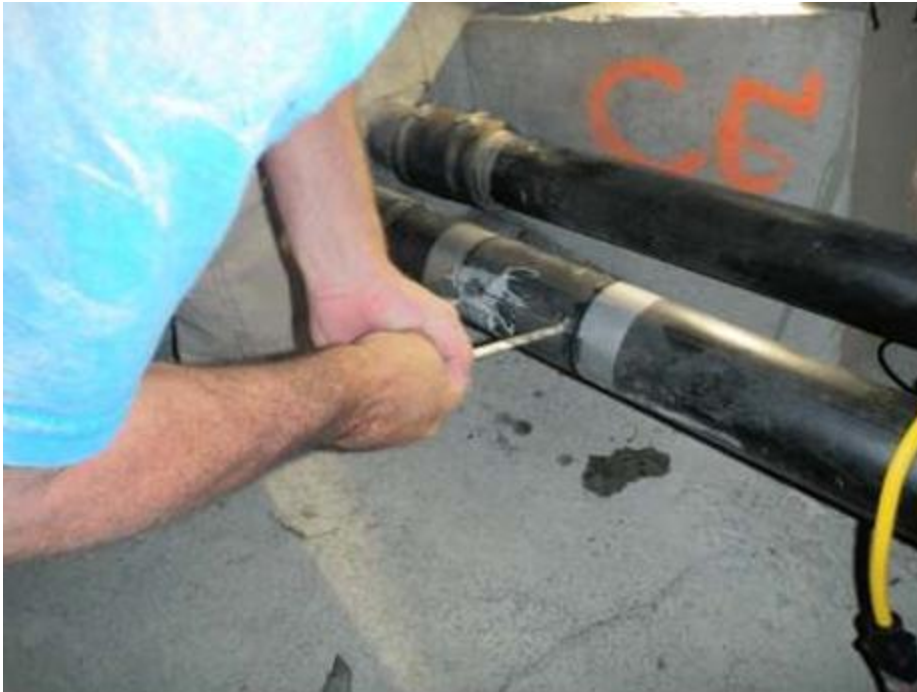
The plastic duct was cut and removed to expose the grout inside. A grinder was used to partially cut through the duct. Final cutting through the remaining thickness of the plastic duct was completed using a Dremel. The duct pieces were typically removed using a hammer and screwdriver.

Figure 23. Removal of plastic duct after cutting

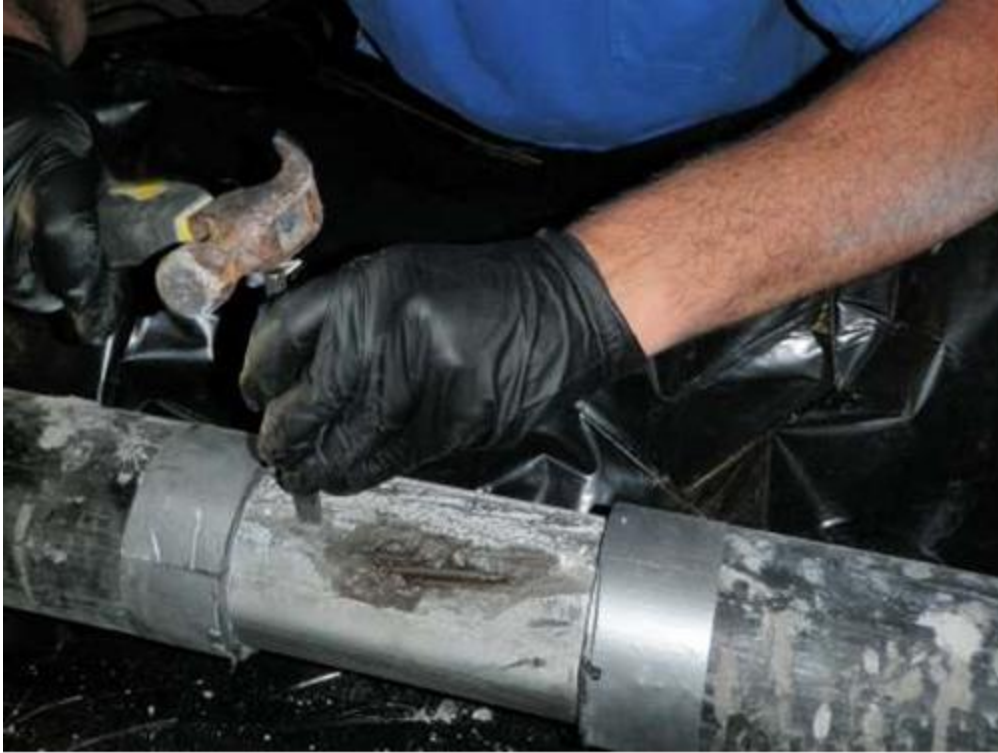
After the duct was removed, the grout was carefully removed using hand tools to expose the PT strands and to verify the strands were impregnated.

Figure 24. Chipping grout to expose strands and observe the level of saturation
