**Cost and Constructability of Permafrost Test Sections Along the
Alaska Highway, Yukon**

at the **Soil Stabilization for Changing Environments** Session

2009 Annual Conference
Transportation Association of Canada
Vancouver, British Columbia

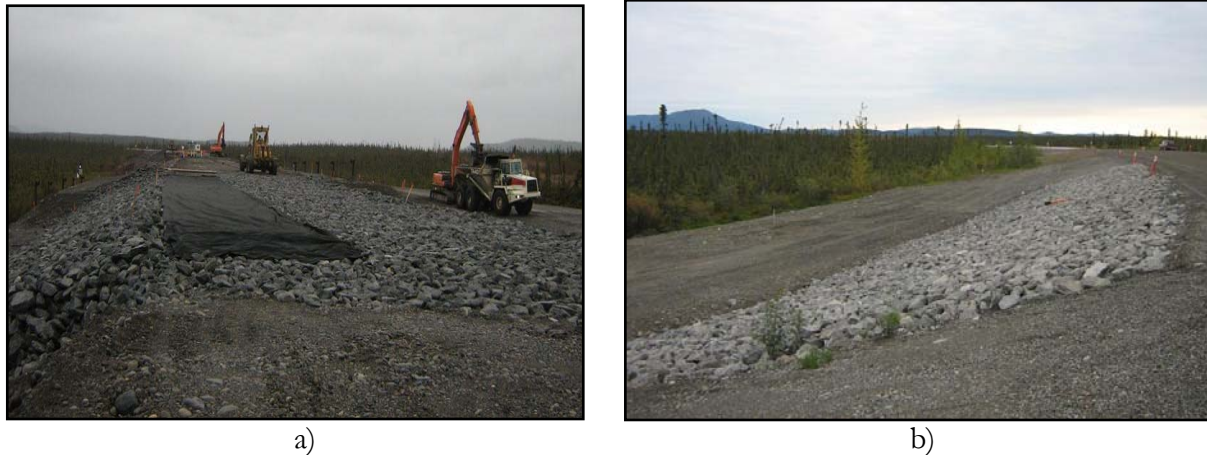
Figure 5: a) Full ACE embankment built; placing geotextile prior to base course. b) Finished uncovered ACE slopes section.

Each ACE area was excavated to within 70 cm of the ground water level. As soon as possible after the excavations were complete, they were backfilled with ACE rock. Due to the long haul involved in moving the rock to the construction site and the need to effectively use the equipment on site, some of the excavations were brought to 1 m above grade and left that way for several days, until enough rock was on site to begin a substantial portion of the backfill. In Figure 5, the full ACE embankment and uncovered ACE slopes sections have the entire rock fill in place.

serve as inlets and outlets for airflow. Before the organic layer was placed on this section and the full embankment sections, geotextile was laid out in order to prevent contamination of the ACE rock by the fine organic material.

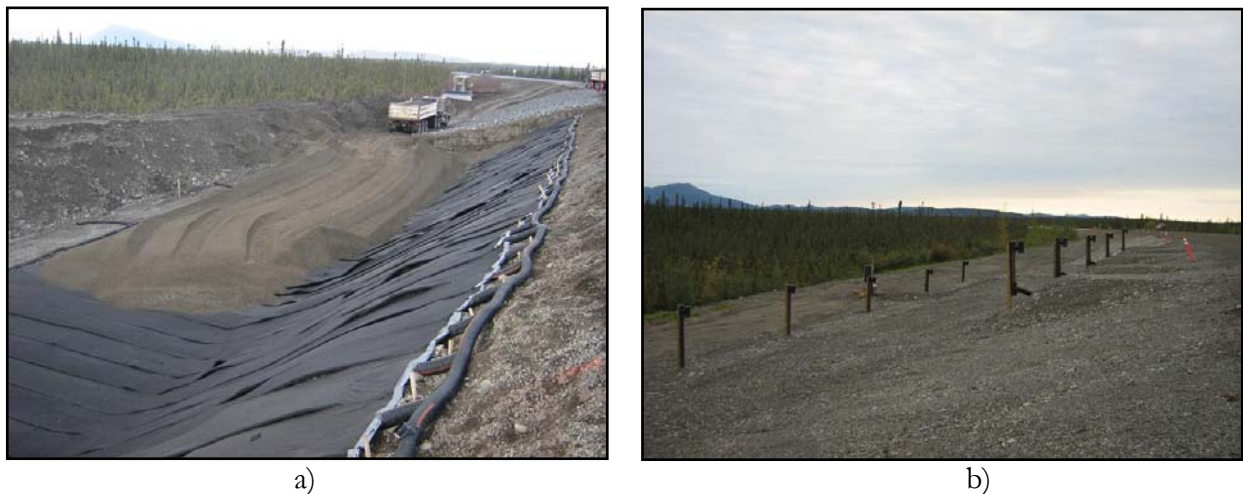
Figure 9: a) Backfilling over geocomposite on slope heat drain section. b) View of finished heat drains with insulation section.

Three different heat drains sections were constructed: one in the full embankment, one in the side slopes, and one in the side slopes also incorporating polystyrene insulation. The following is a list of the steps used to construct the heat drains test sections: excavate and stockpile existing embankment fill material, place a 20-30 cm lift of 20 mm aggregate, place geocomposite material, attach end fittings to geocomposite and build ventilation pipe system, backfill over geocomposite with 40 cm lift of 20 mm aggregate, continue backfilling with existing embankment material until grades achieved, and finish the ventilation pipe system by mounting the pipes to wooden posts. Figure 9 shows the backfill in progress followed by the finished section. The section that incorporated insulation had 120 cm x 240 cm x 5 cm insulation slabs placed on top of the 20 mm aggregate cover over the geocomposite. To limit breakage, the insulation was also covered with a lift of 20 mm aggregate.

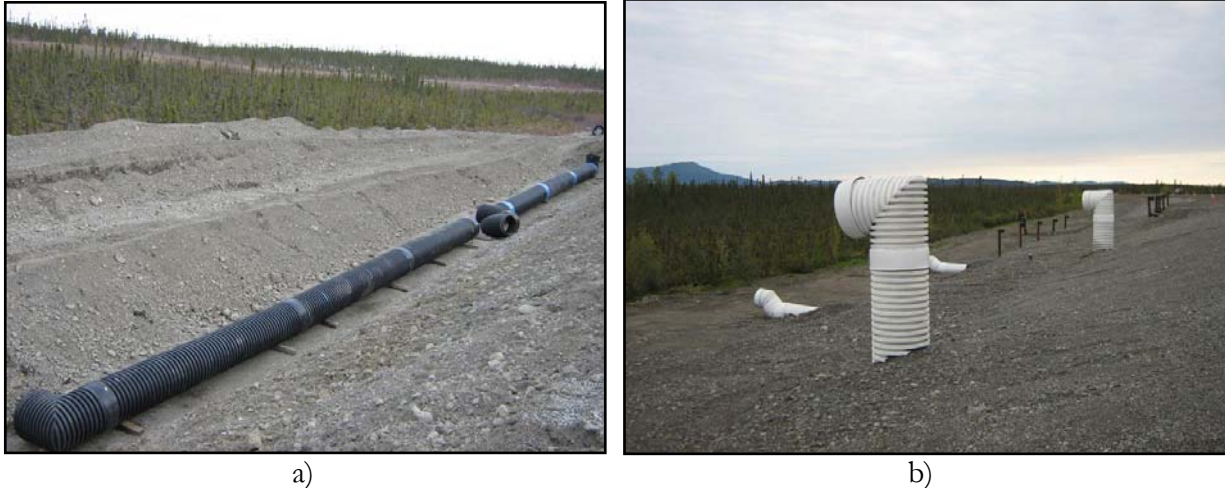
Figure 11: a) Longitudinal culverts placed in trench with some heat shrinking complete (blue joints) and prior to heat shrinking and backfill. b) Finished longitudinal culverts showing inlets (horizontal pipes) and outlets (upright pipes).

Trenches were excavated for the culverts. They were installed in a similar manner to regular culverts. A similar culvert technique has been tried in Alaska; however, ground water penetration of the culverts limited any benefits. Hence, care was taken to ensure the longitudinal culverts were not installed too deeply. However, placing the culverts deeper increases their effectiveness at cooling the embankment, so a balance had to be reached. Taking these factors into account, the culverts were installed approximately 0.7 m above ground water level. Figure 11 shows the longitudinal portions of the culverts as well as the inlets and outlets.

High-density polyethylene (HDPE) pipe was used for the culverts. The main advantage of using HDPE pipe was the ability to seal the joints. Every joint was gasketed and shrink-wrapped using the manufacturer's recommended product. Installation was fairly straightforward, with no notable difficulties. The skill of the crew in installing regular culverts was directly translatable to the longitudinal HDPE culverts.

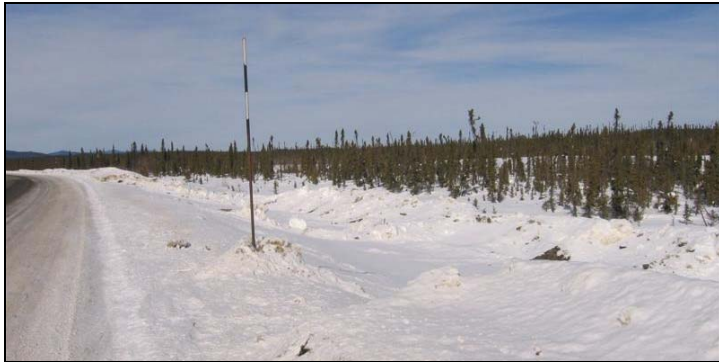
Figure 12: Test section a few days after snow clearing was performed.

In the snow clearing test section, the embankment was not modified. Rather, special maintenance techniques of clearing the snow from the entire side slopes are used throughout the winter to minimize the insulating effect of snow. Figure 12 shows the section where the snow had recently been cleared.

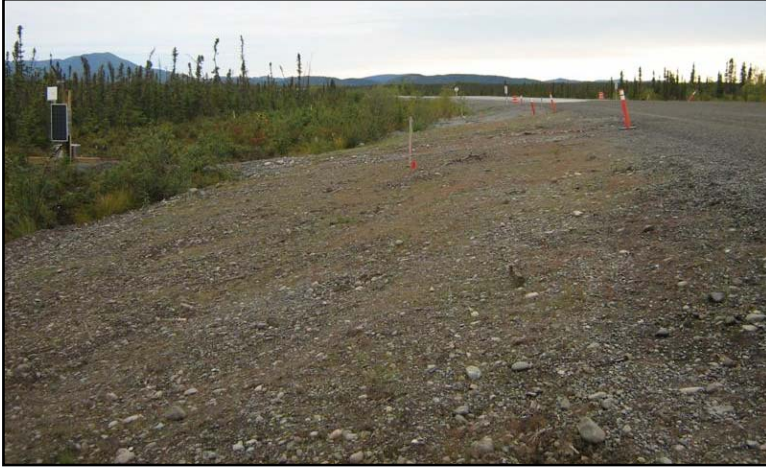
Figure 13: Grass-covered embankment side slopes.

Vegetation removal during road construction has a detrimental effect on underlying permafrost. Planting grass on the side slopes is an attempt to restore some of the natural insulation effect created by natural vegetation. For the test section, organic material was spread onto the side slopes of the embankment and a native grass seed mixture was planted. Figure 13 shows the grass beginning to grow on the side slopes.

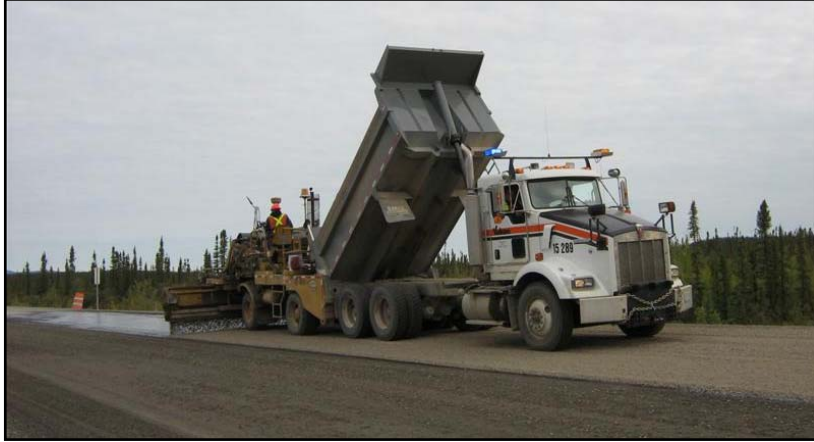
Figure 14: Placing the light-coloured BST.

As seen in Figure 14, the process and equipment used for applying the BST was the same as that used for normal road BST surfacing. The only difference was the use of a light-coloured aggregate instead of the typical darker-coloured aggregate.
