**Streamlining Culvert Inspection:  
A Tablet-based Comprehensive Inventory and Condition Inspection System  
for Asset Management**

Paper prepared for the presentation at the  
Emerging Asset Management Classes and Maturity Session of the  
2023 TAC Conference & Exhibition, Ottawa, ON

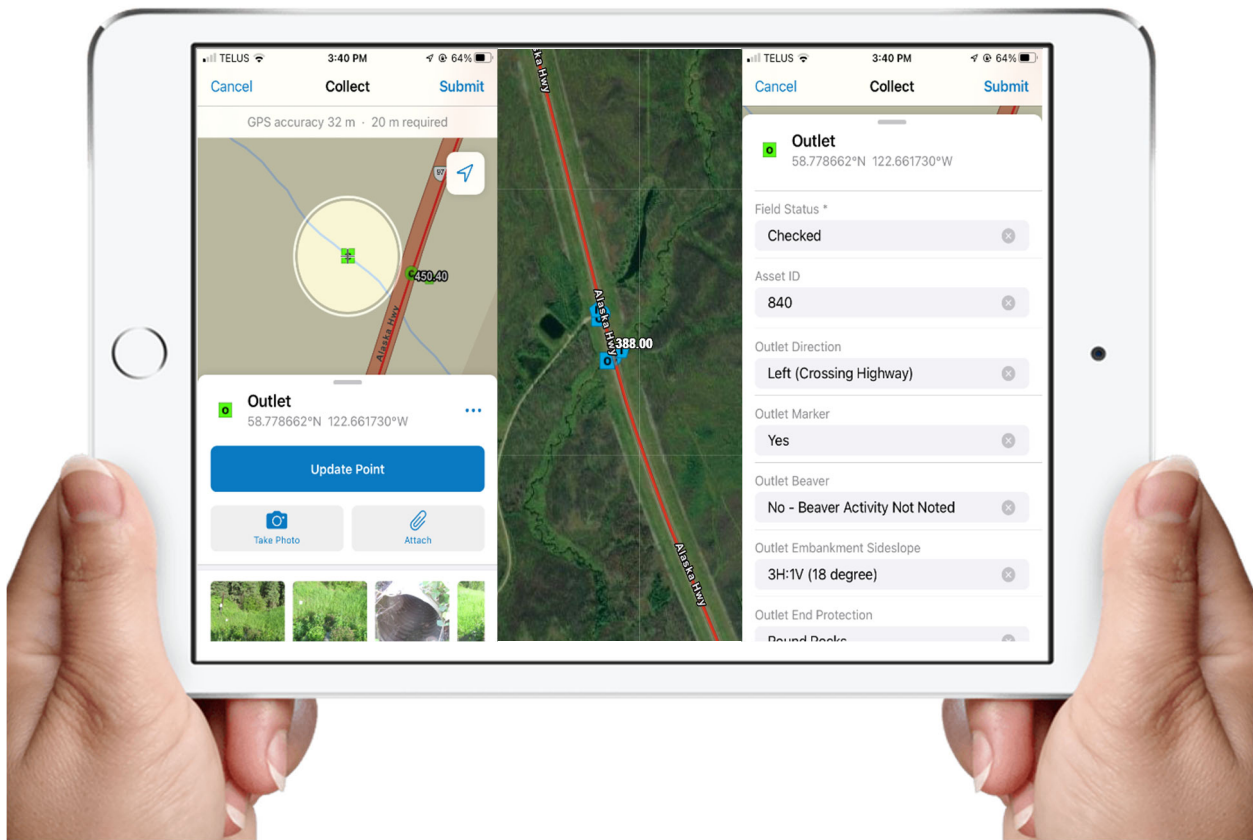
Figure 5: ArcGIS-based Field Maps™ Data Collection

Figure 5 shows the ArcGIS-based Field Maps™ data collection application used for the inspection.

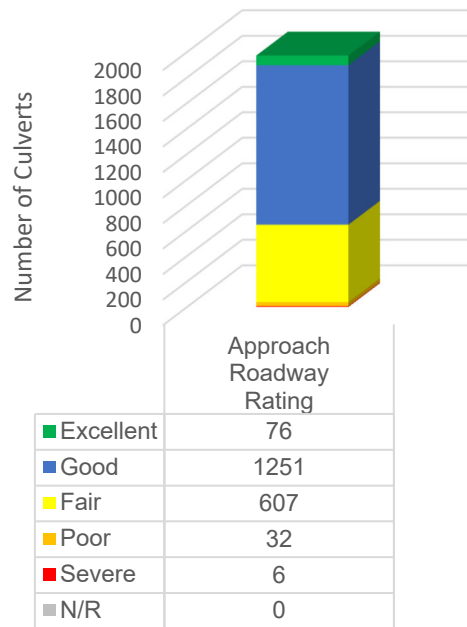
**Figure 6: Approach Roadway Condition**

Approach Roadway Condition was generally in good condition with 40 approach roadway components where at least one attribute among pavement, guardrail and shoulder was in poor or severe condition. Figure 6 shows the approach roadway condition.

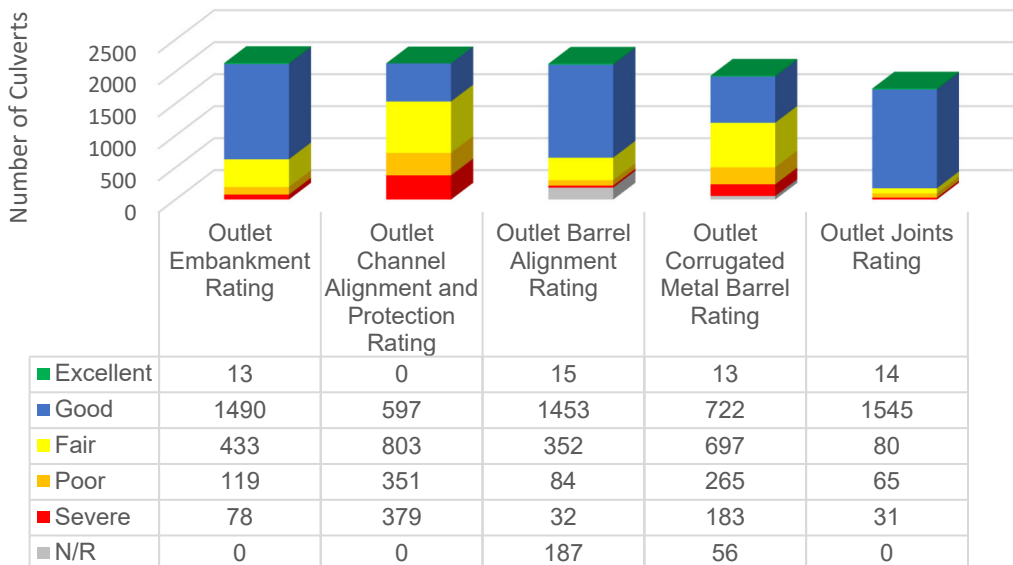
**Figure 7: Outlet Components Condition (Embankment, Channel Alignment and Protection, Barrel Alignment, Corrugated Metal Barrel, Outlet Joints)**

Select components were rated separately for outlets and inlets sides of the culvert. Figure 7 shows the outlet component condition. Overall, in terms of Poor and Severe condition, the outlet side channel alignment and protection, and metal barrel material is leading. It is also important to point out that three quarter of the inventory outlet channel alignment and protection was found to be in Fair condition or worst.

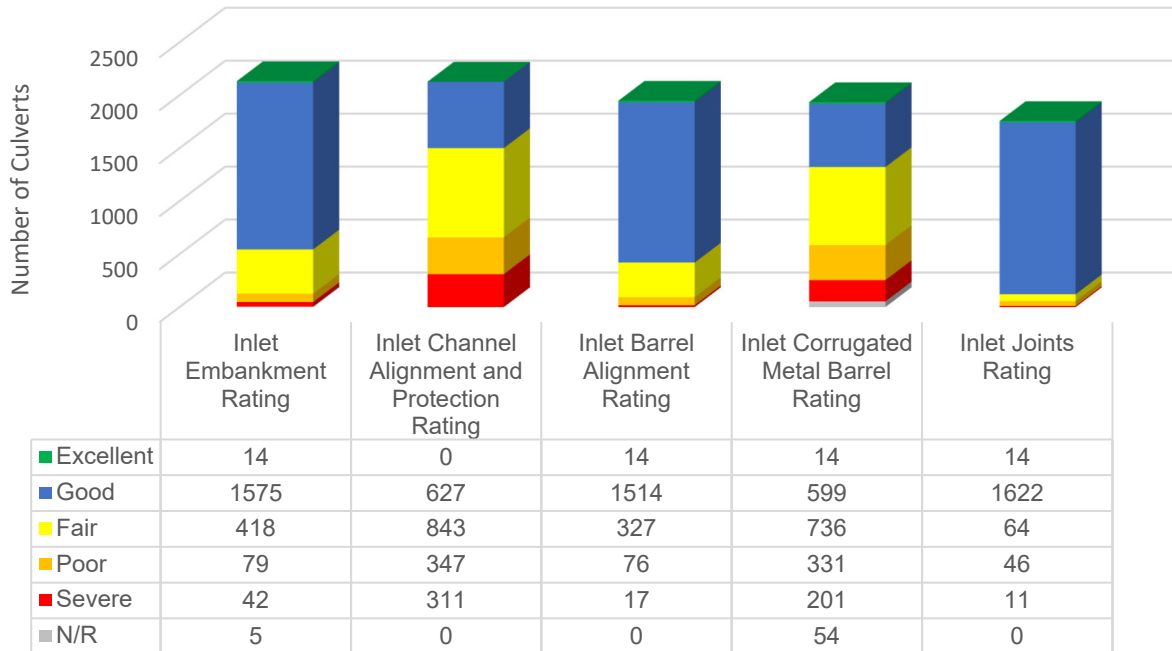
**Figure 8: Inlet Components Condition (Embankment, Channel Alignment and Protection, Barrel Alignment, Corrugated Metal Barrel, Outlet Joints)**

Figure 8 shows the inlet components condition (Embankment, Channel Alignment and Protection, Barrel Alignment, Corrugated Metal Barrel, Outlet Joints). The figure shows that the quarter of Channel Alignment and Protection, and Corrugated Metal Barrel components are in poor and very poor condition.

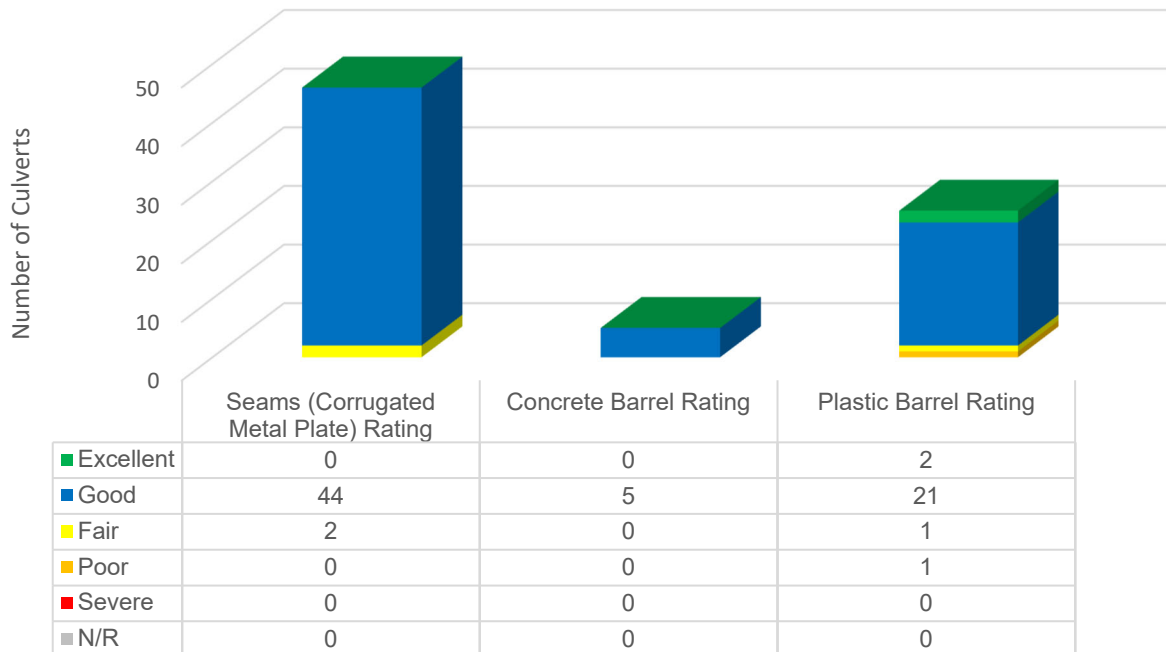
**Figure 9: Other Components Condition (Seams, Concrete Barrel, Timber Barrel)**

Figure 9 shows the other component rating such as seams, concrete barrel, plastic barrel, and timber barrel.

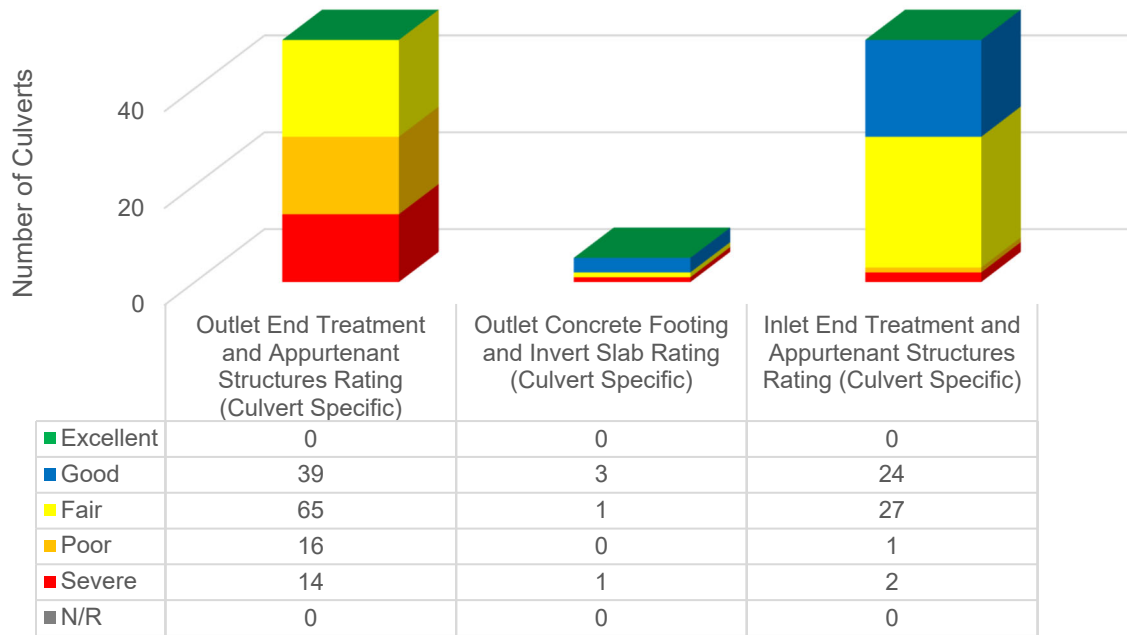
Figure 10: Culvert Specific Components Condition

Some components were only applicable when End Treatment and Appurtenant Structures and/or Concrete Footing and Invert Slab were present on the culverts. Figure 10 shows the culvert specific components condition.

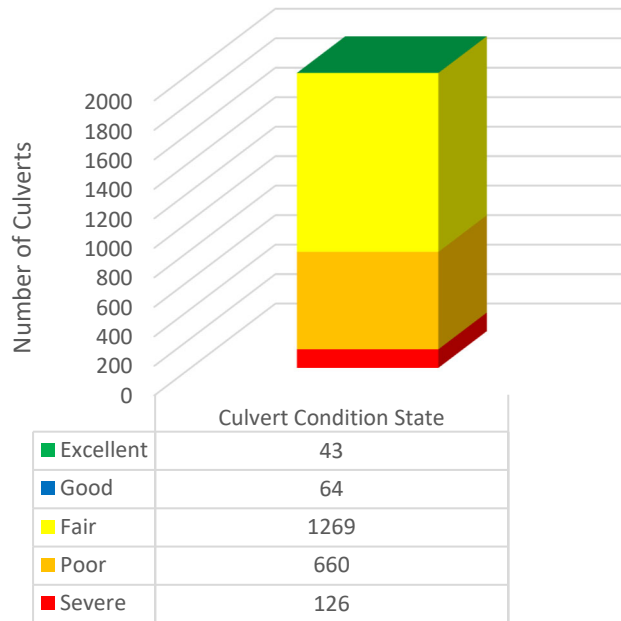
**Figure 12: Overall Culvert Condition**

The overall condition of the culvert was calculated using a regression equation based on the individual condition of the components which is based on the worst condition of all attributes representative of the component. Figure 12 shows the culvert components condition rating collected for the inventory.
