Modeling the *In Situ* Performance of Culvert Joints in a Pavement Structure

TAC 2013: Innovation in the Use of Instrumentation in Transportation Design & Construction

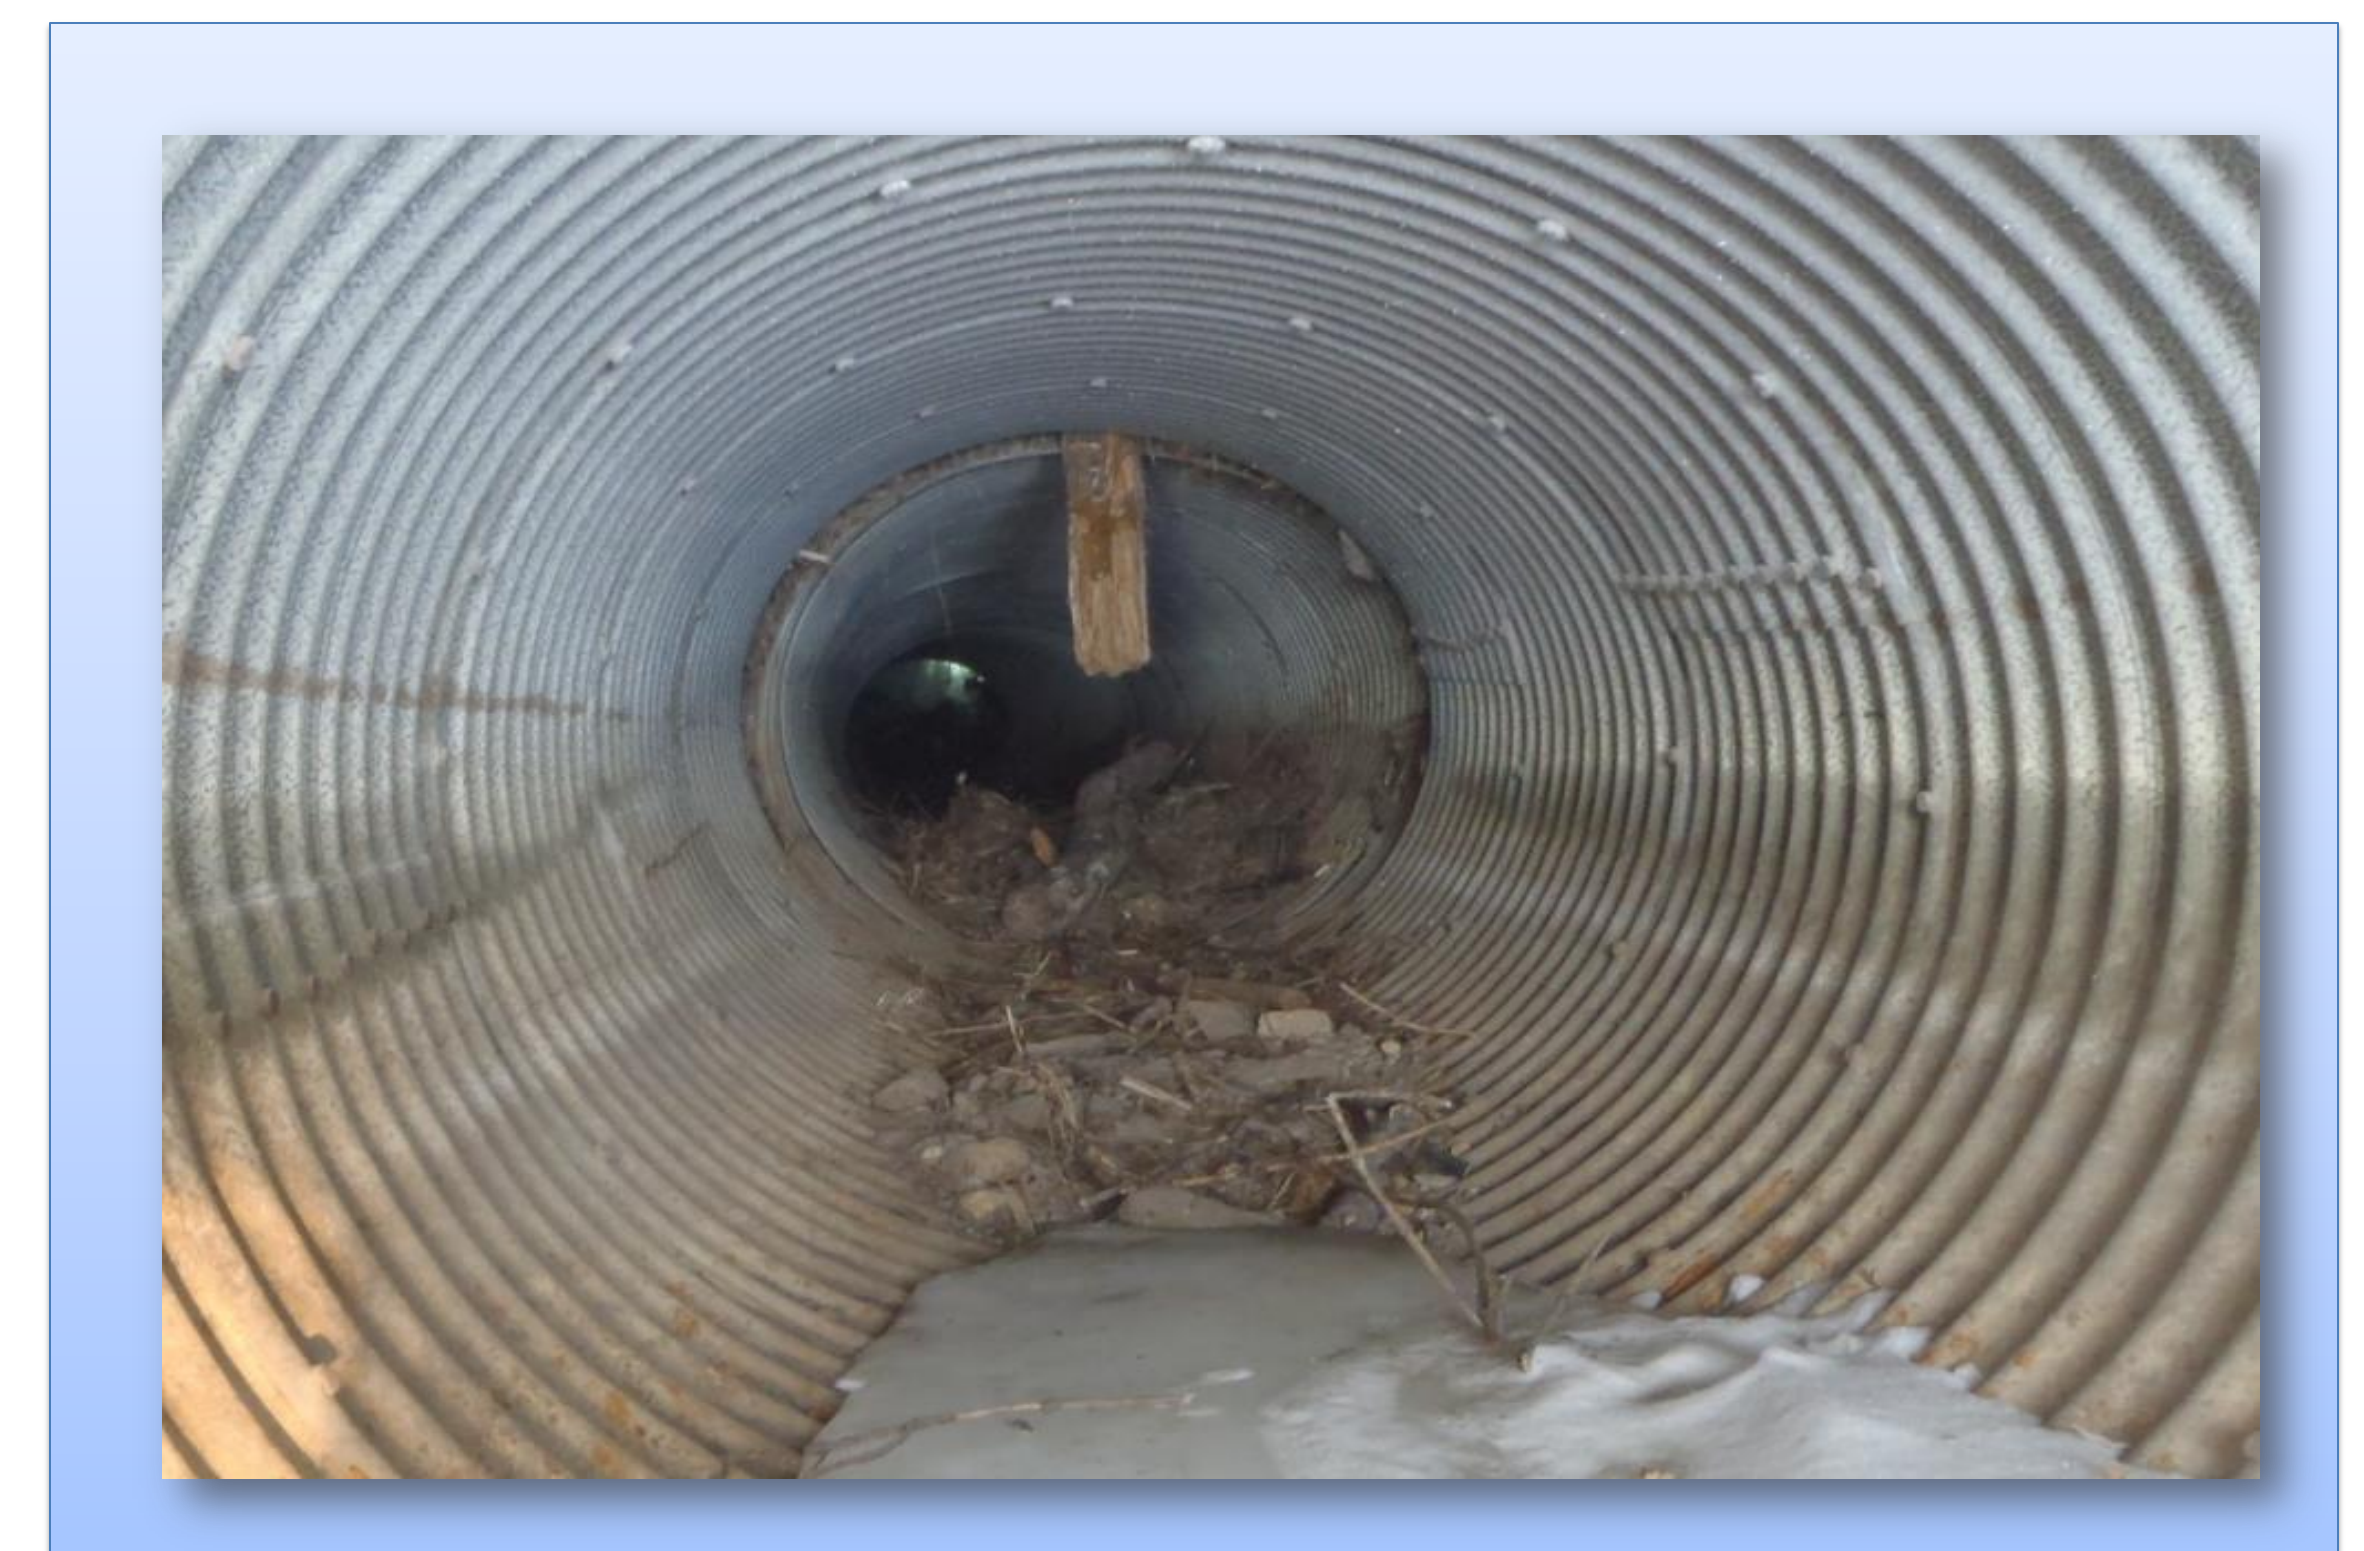
Mechanism of Joint Separation

- Climatic effects:
 - During freeze-thaw cycles, water can seep into culvert joints and freeze, causing joint separation.
 - When soil freezes, clay soils can swell and cause up-heaving as well as shear along the pipe.
 - Saskatchewan has silty and clayey subgrades subject to moisture issues and swelling.
- Culvert joints can pull apart due to differential settling in the surrounding soil.
 - As soil settles, loosens, or erodes around the culvert pipe, the fill material loses its lateral structural support capacity which alters the structural properties of the culvert and soil system.
 - Voids in the surrounding soil are created and pressures around the pipe are altered.
- It is hypothesized that tensile forces in the surrounding soil are reduced and result in culvert joints separating, or being pulled apart.

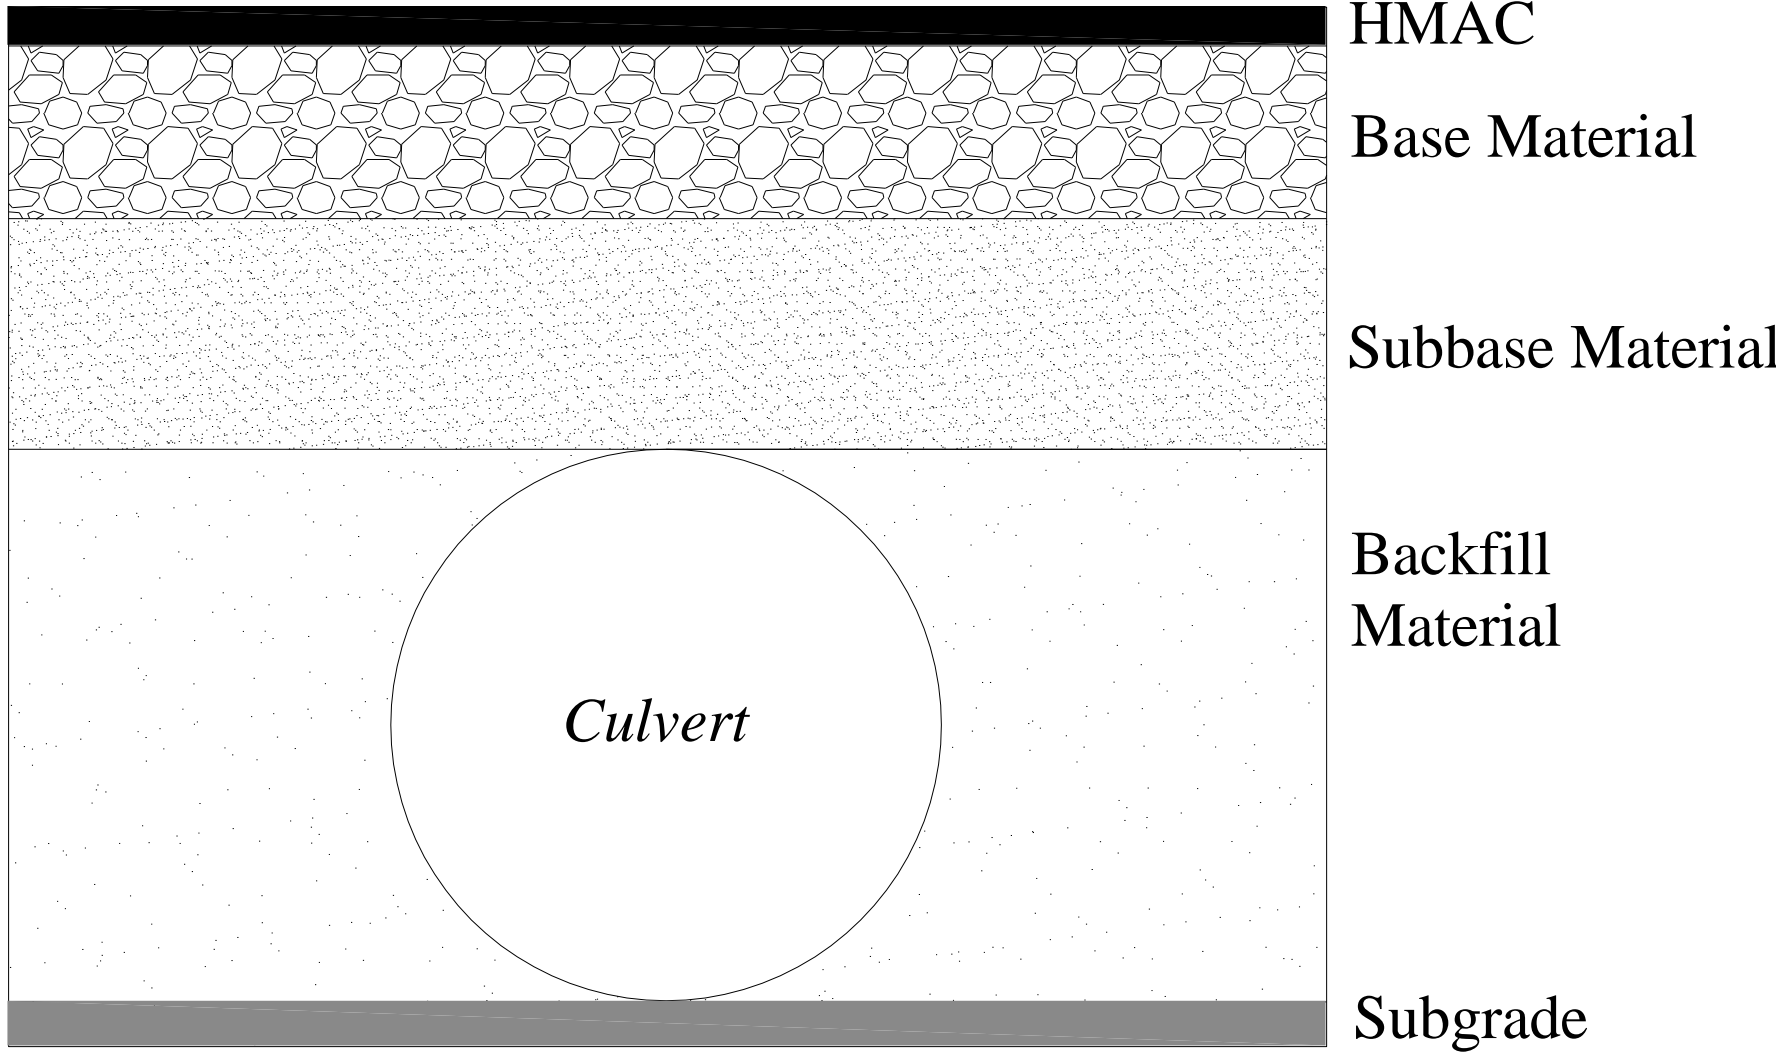
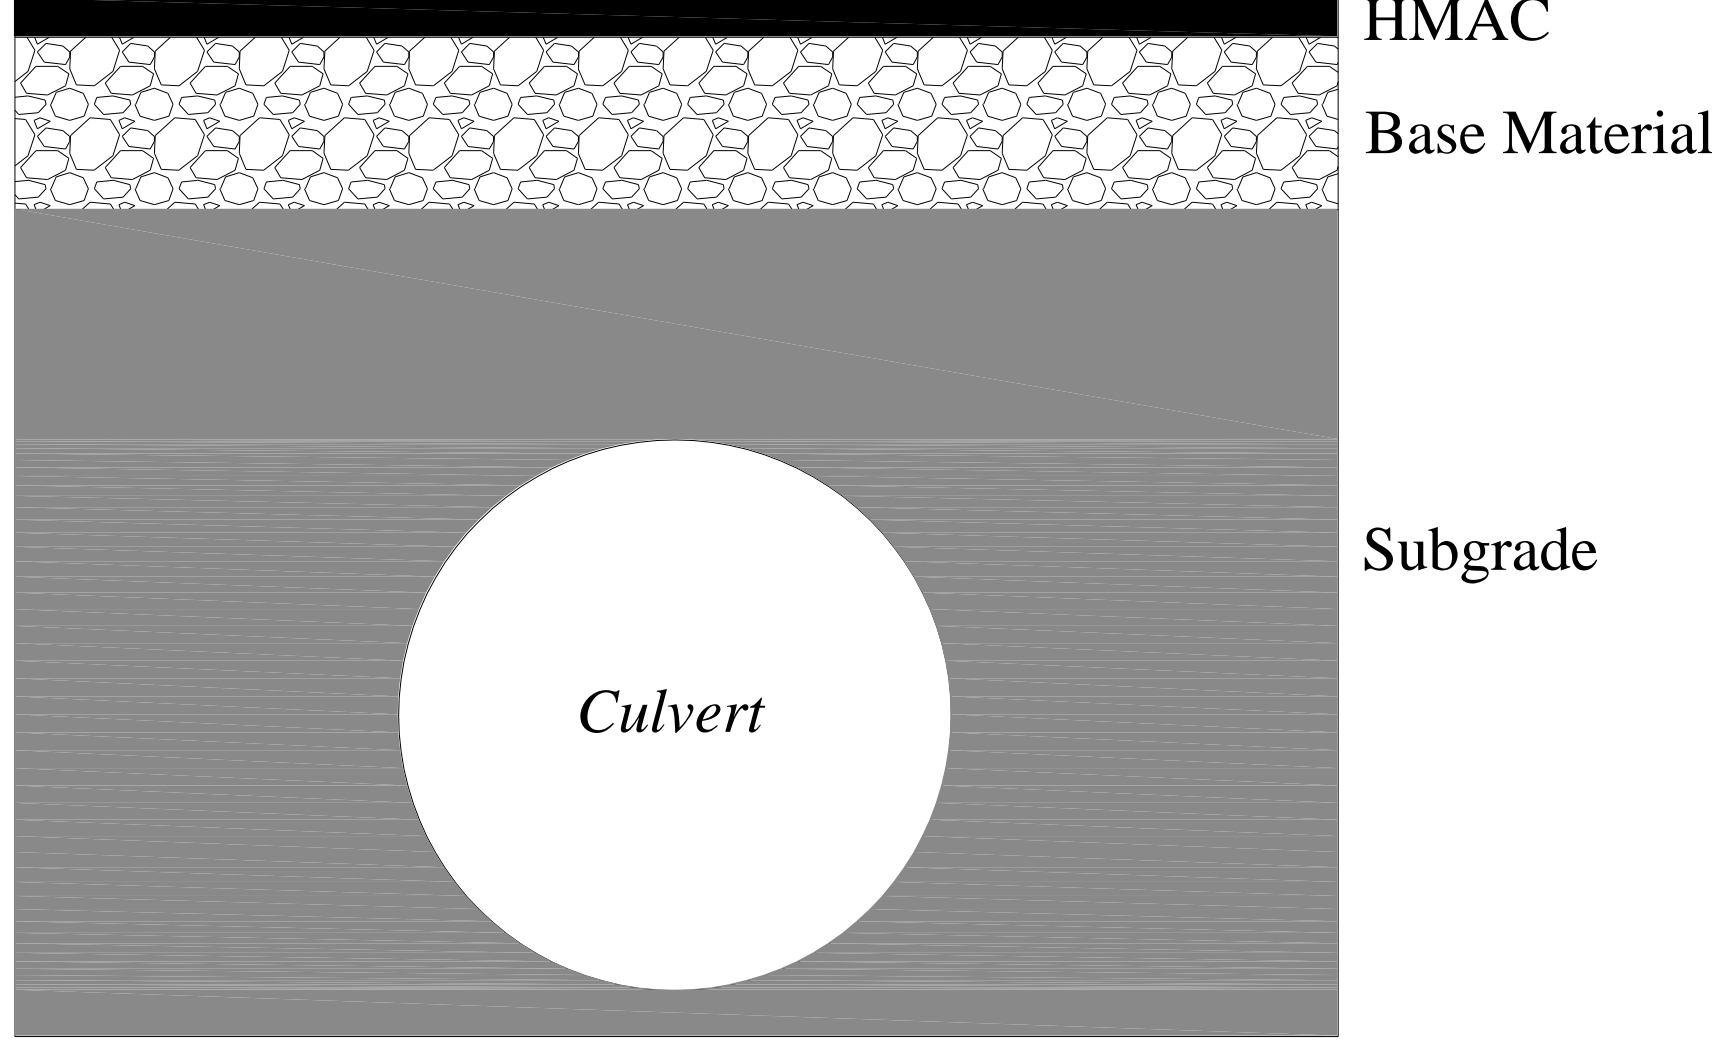
Primary Road Structure with CSP Culvert		Secondary Road Structure with CSP Culvert	
Cross Section

- The shear strains are greater in the secondary road structure because there is no subbase or backfill material surrounding the culvert.
- Overall, the secondary road structure with a wet moisture condition state had overall higher magnitudes of shear and horizontal strains compared to the other road structures and condition states.

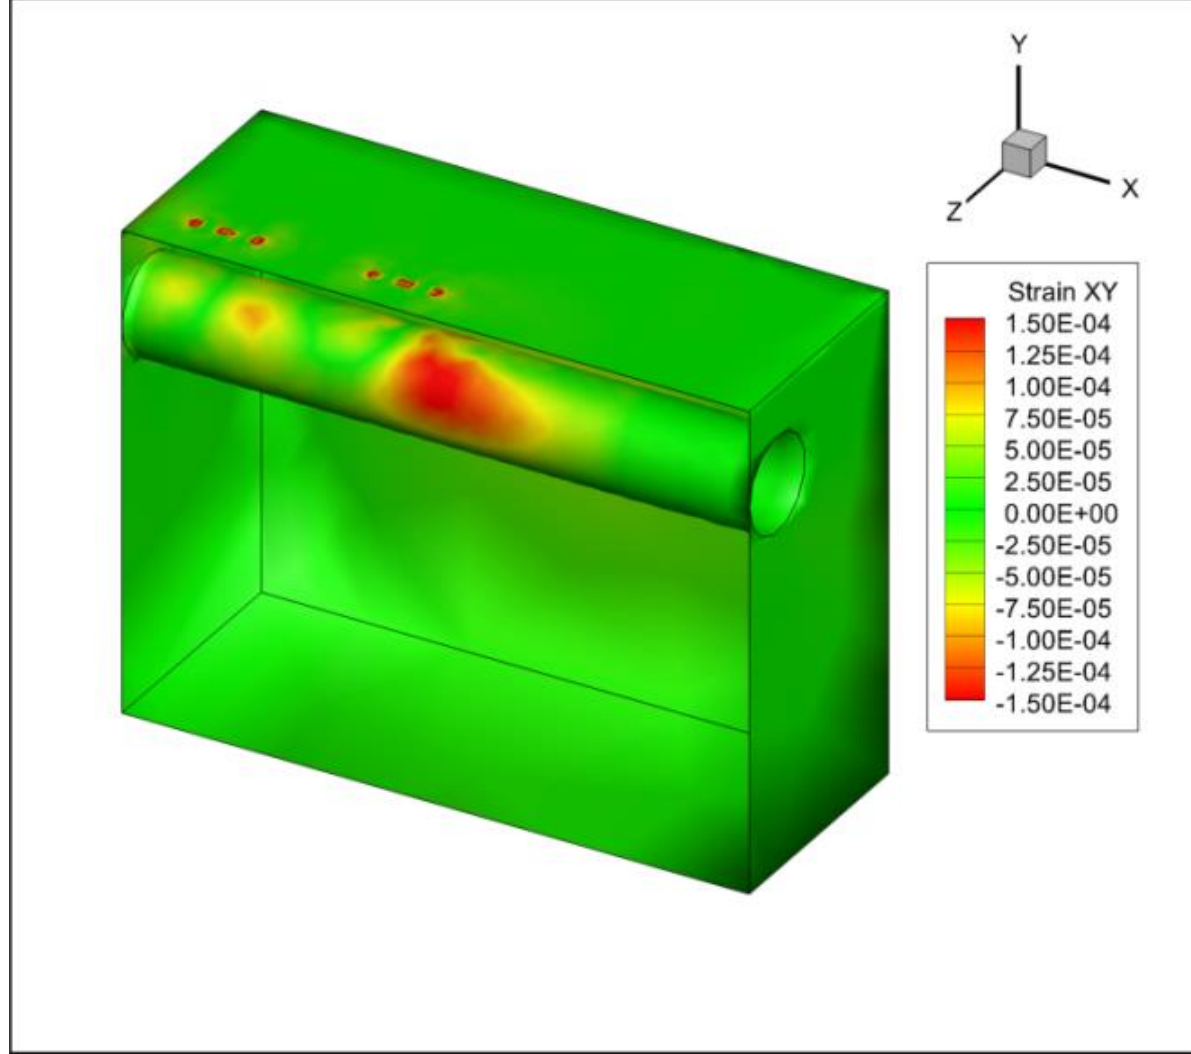
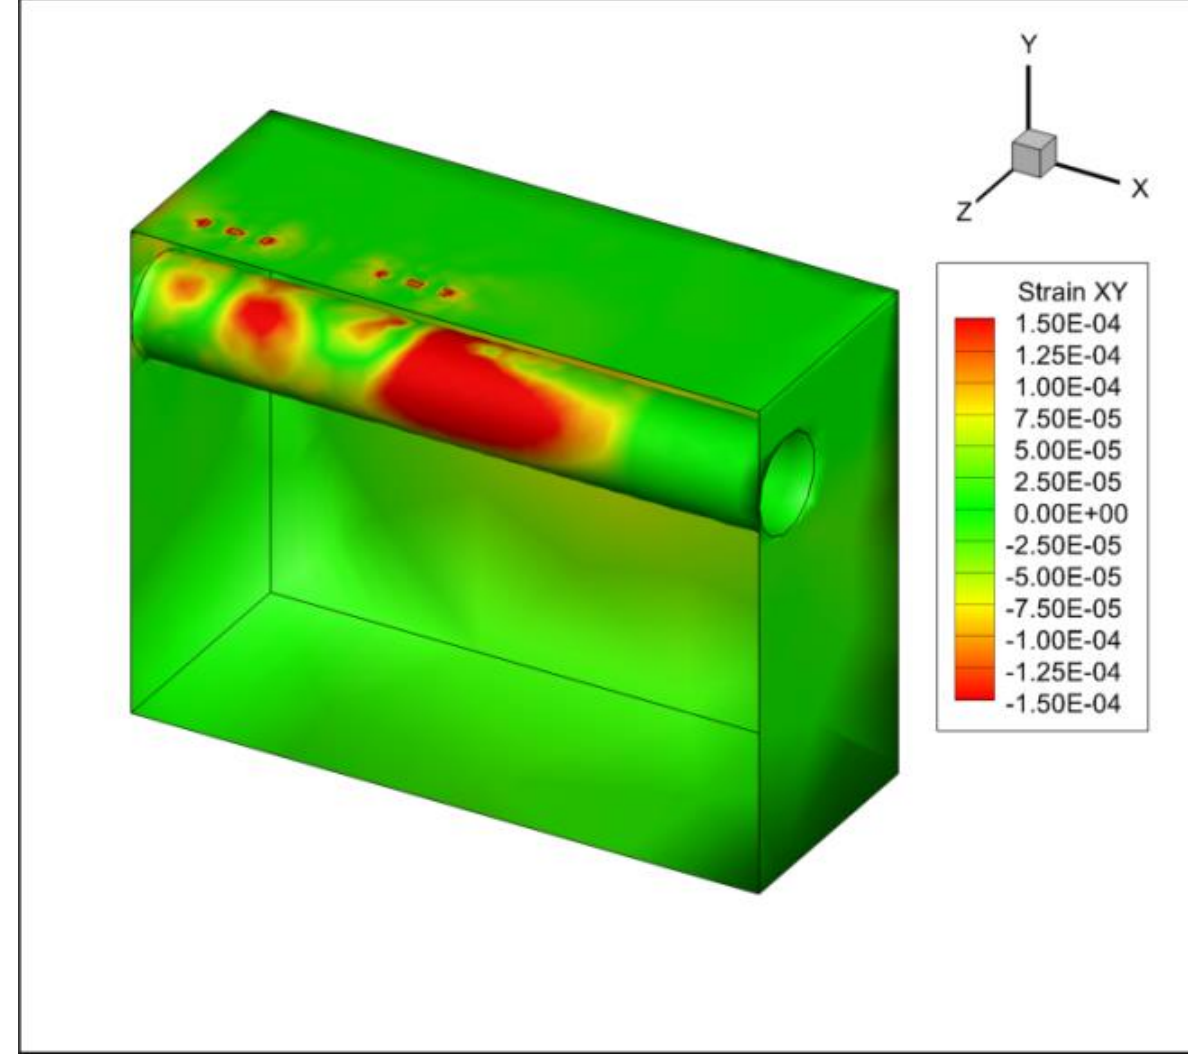
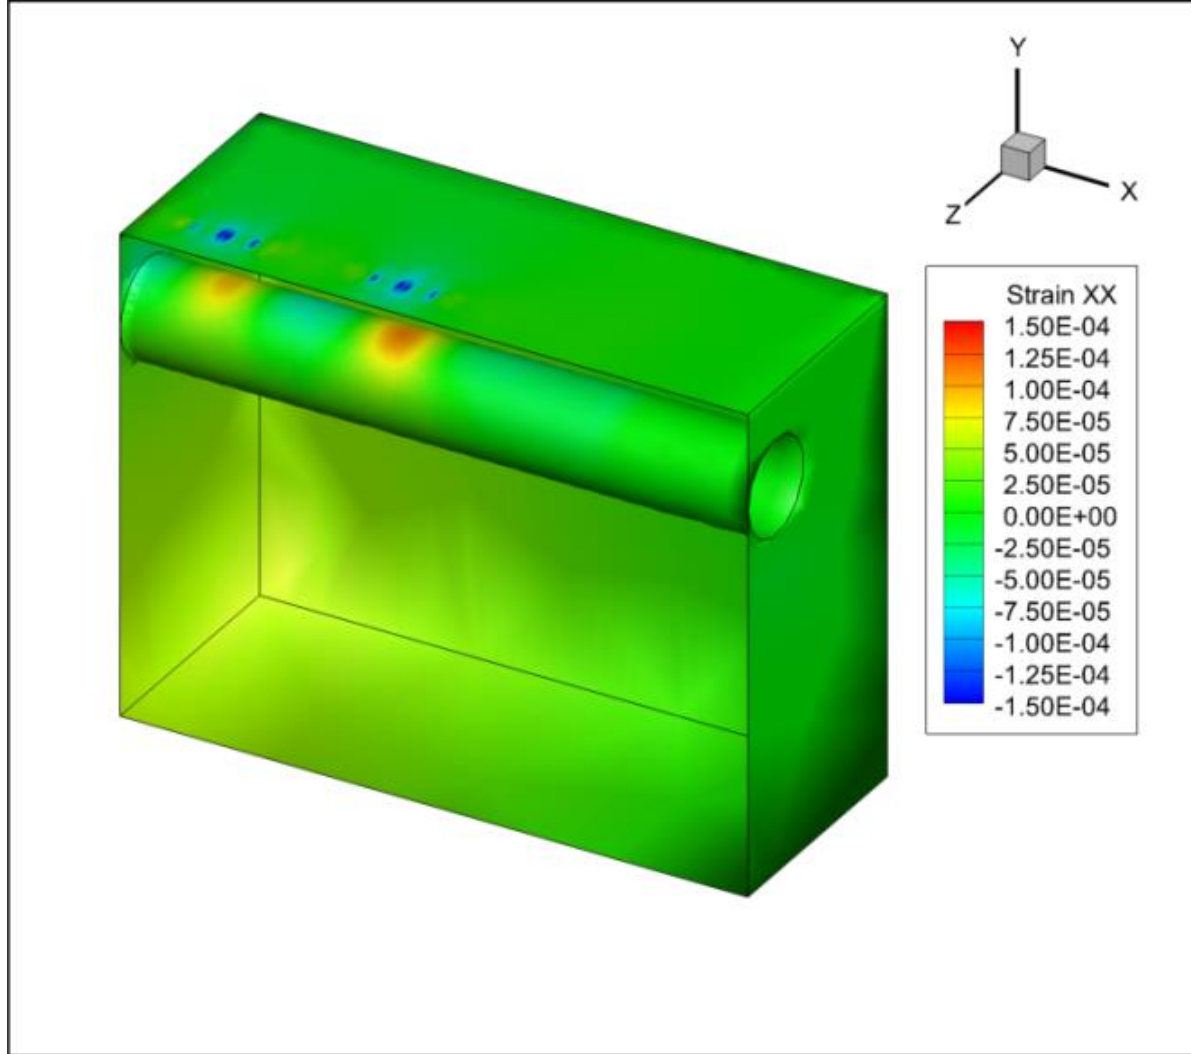
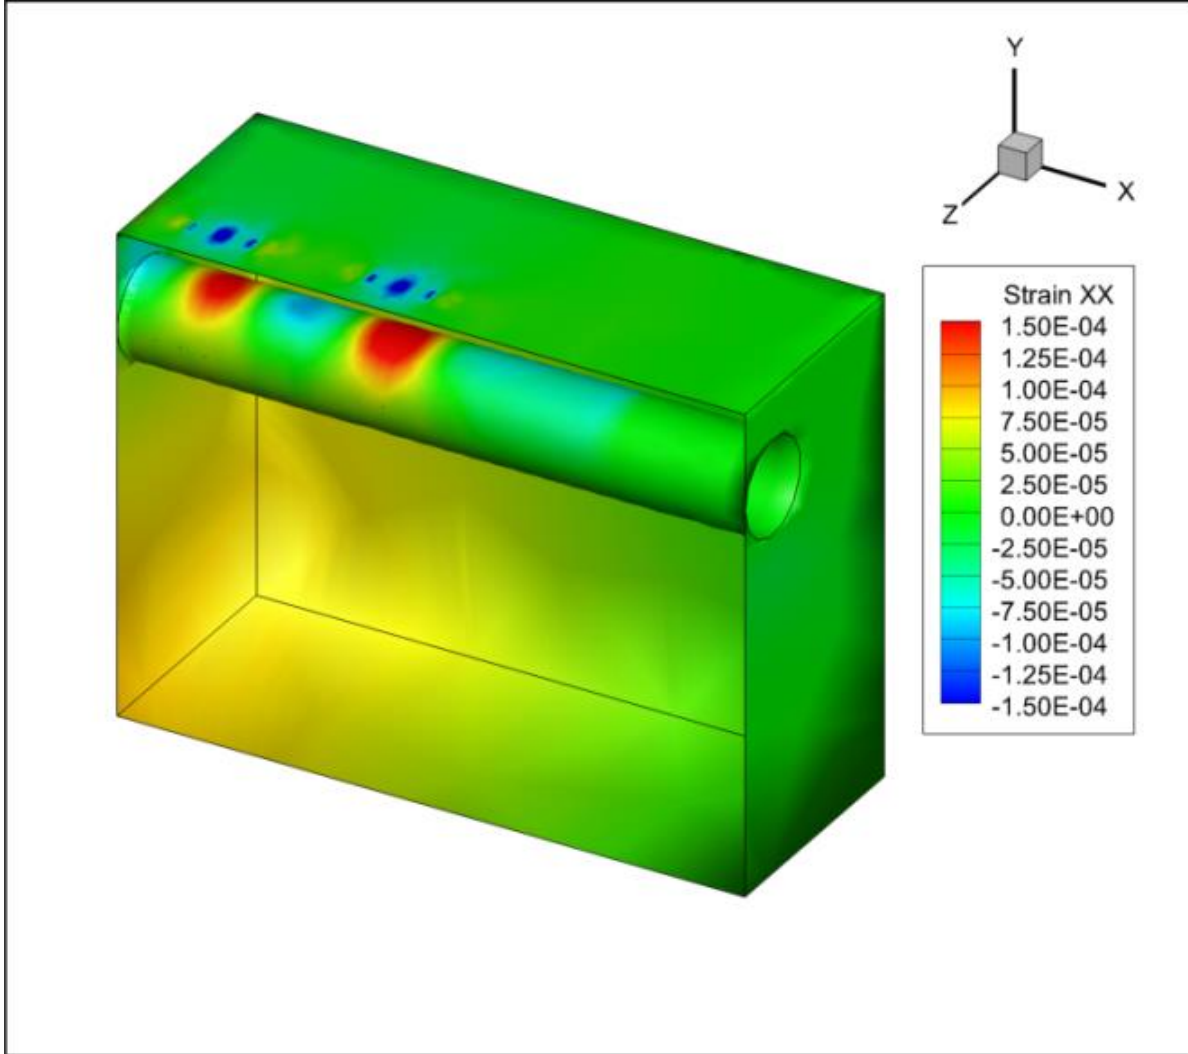
Modeling Results				
	Dry Condition State	Wet Condition State	Dry Condition State	Wet Condition State
Shear Strain

- For the primary road structure, from a dry to wet moisture condition state:
 - The shear strain increased by 245%;
 - The horizontal strain in the longitudinal direction increased by 93%; and

- The horizontal strain in the transverse direction increased by 90%
- For the secondary road structure, from a dry to wet moisture condition state:
 - The shear strain increased by 119%;

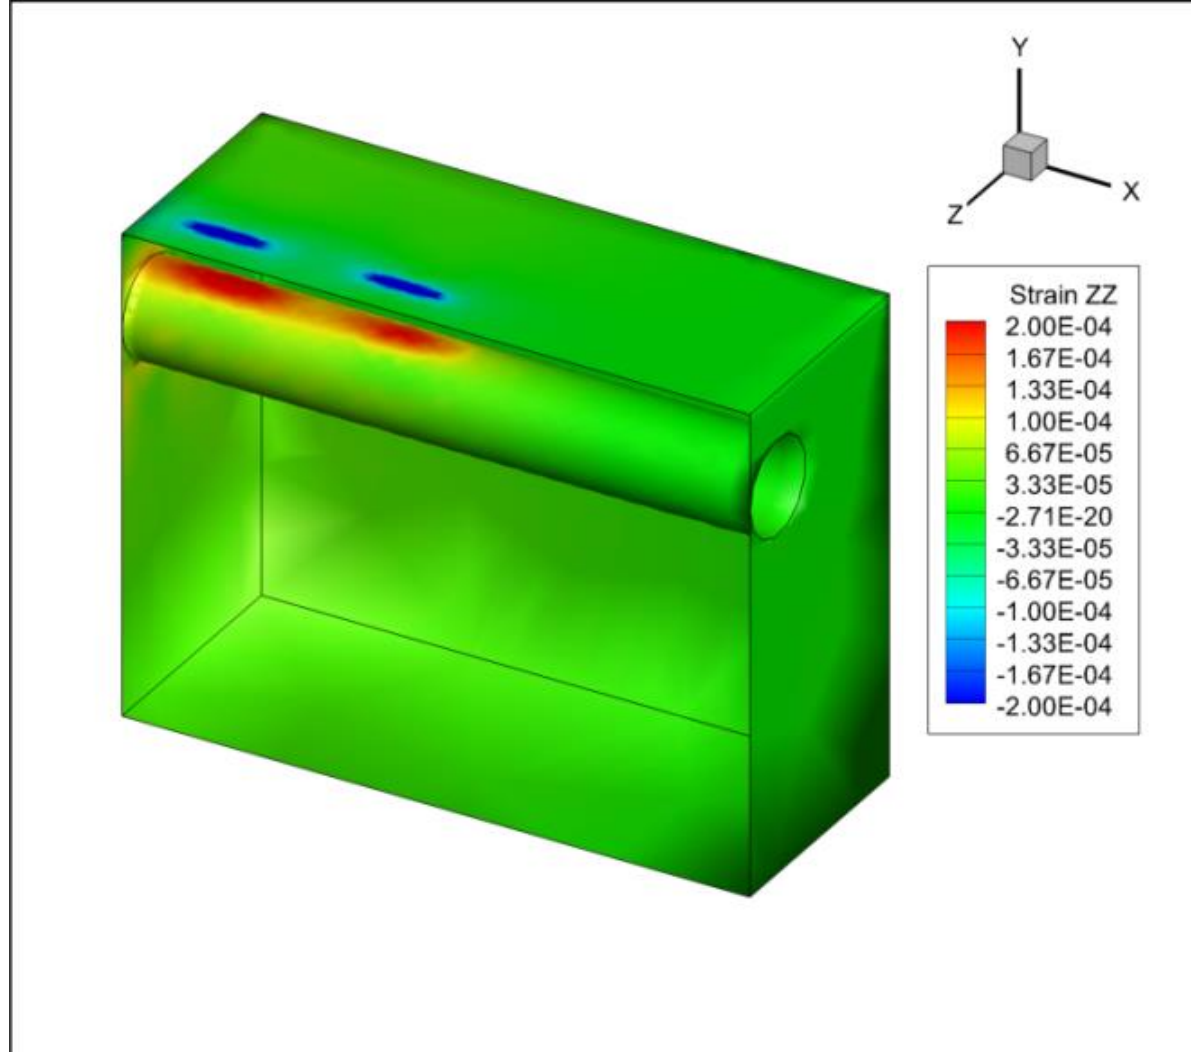
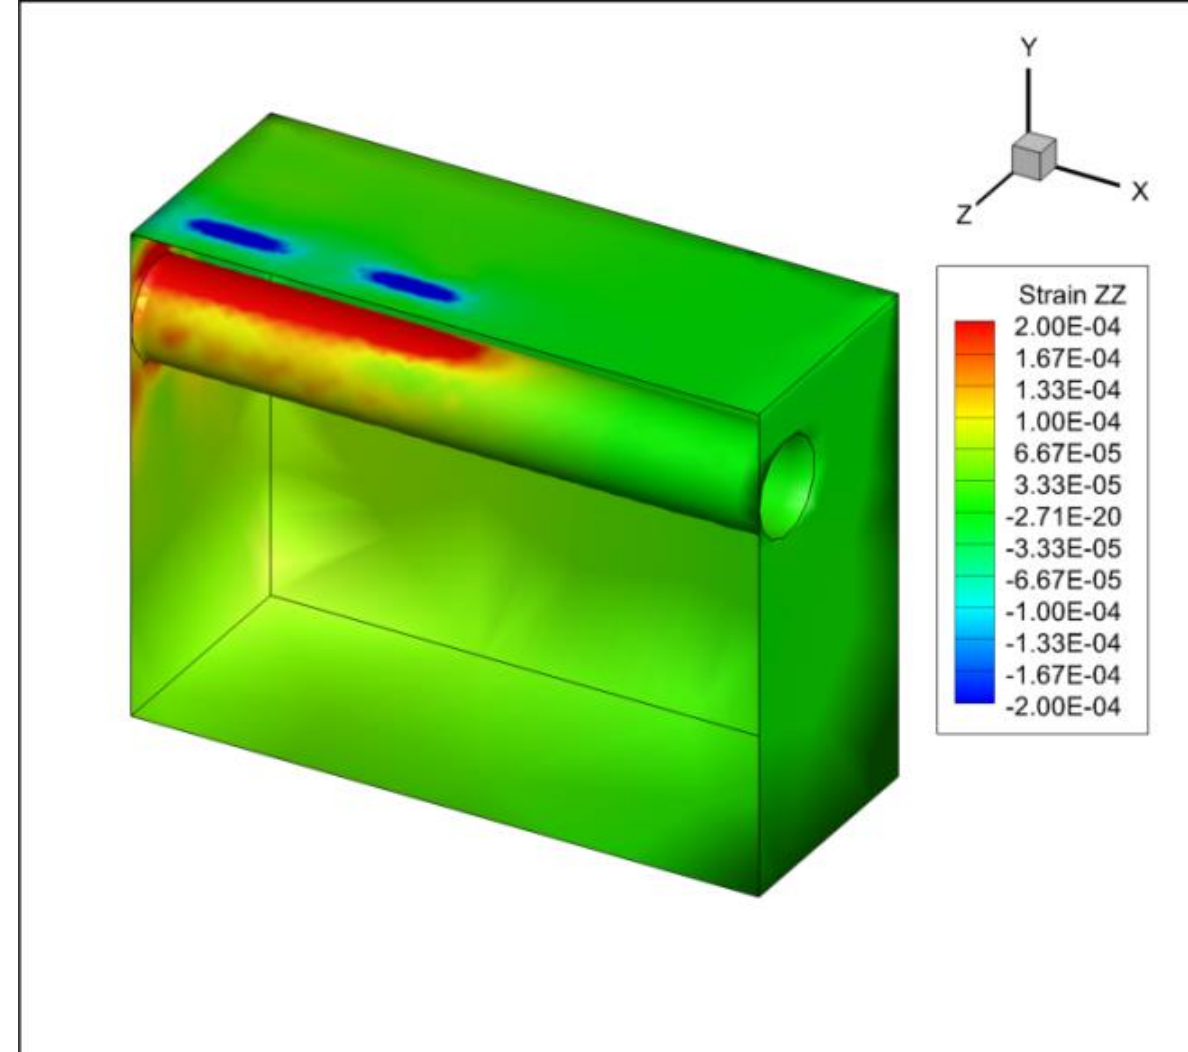
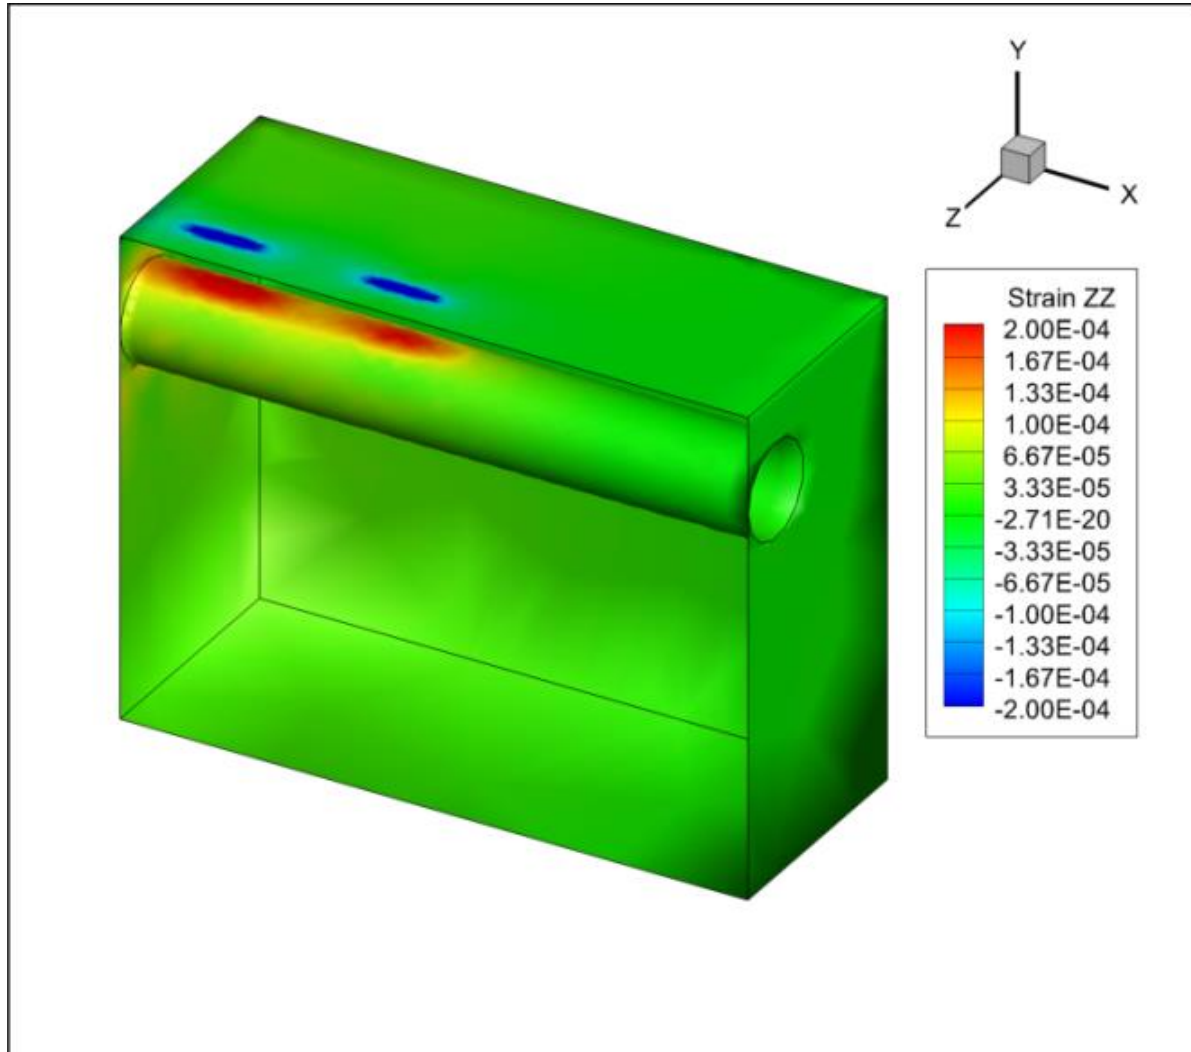
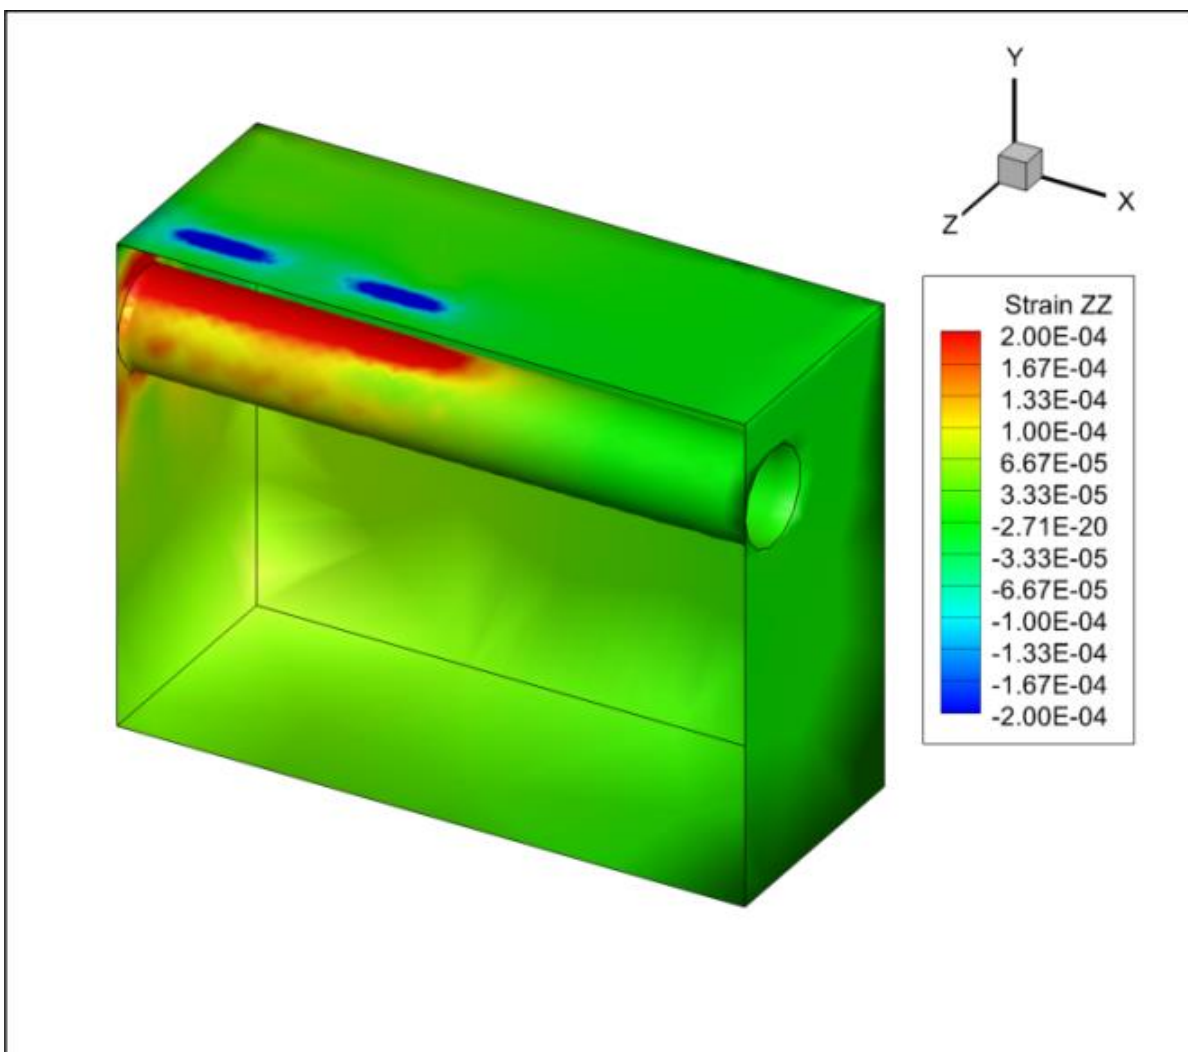
Horizontal Strain in the Transverse Direction

- The horizontal strain in the longitudinal direction increased by 114%; and
 - The horizontal strain in the transverse direction increased by 116%.
- The secondary road structure had higher strains compared to the primary road structure in both dry and wet moisture condition states.
